YEAR 5 (2016)
ANNUAL MONITORING REPORT
HERMAN DAIRY STREAM AND WETLAND RESTORATION SITE

Alexander County, North Carolina

DMS Project No. 94642

YEAR 5 of 7 (2016)
ANNUAL MONITORING REPORT
HERMAN DAIRY STREAM AND WETLAND RESTORATION SITE

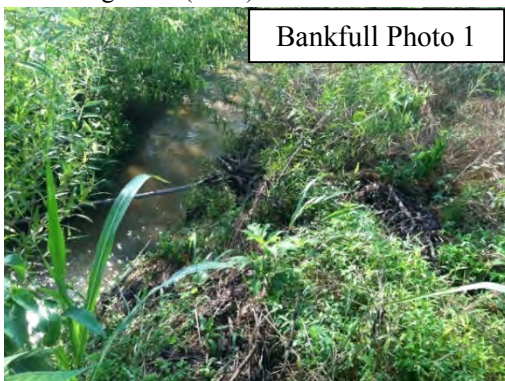
Bankfull Photo 1

Date of Data Collection	Date of Occurrence	Method	Photo (if available)
May 11, 2013	May 6, 2013	Bankfull event documented when sediment deposits were observed on top of banks after 3.00 inches of rain was documented* over a two-day period.	--
July 18, 2013	June 6, 2013	Bankfull event documented after wrack was observed on top of bank and throughout floodplain after 4.27 inches of rain was documented* over a two-day period.	1-2
November 19, 2014	August 11, 2014	Bankfull event likely occurred after 3.61 inches of rain over a two-day period that was preceded by 0.56 inches and followed by an additional 0.78 inches as documented by an onsite rain gauge.	--
July 31, 2015	April 19, 2015	Bankfull event likely occurred after 2.2 inches of rain was documented over a one day period by an onsite rain gauge.	--
November 23, 2015	November 21, 2015	Bankfull event documented after sediment deposits were observed in floodplain of the main tributary and 1.96 inches of rain was documented over a three day period by an onsite rain gauge.	3

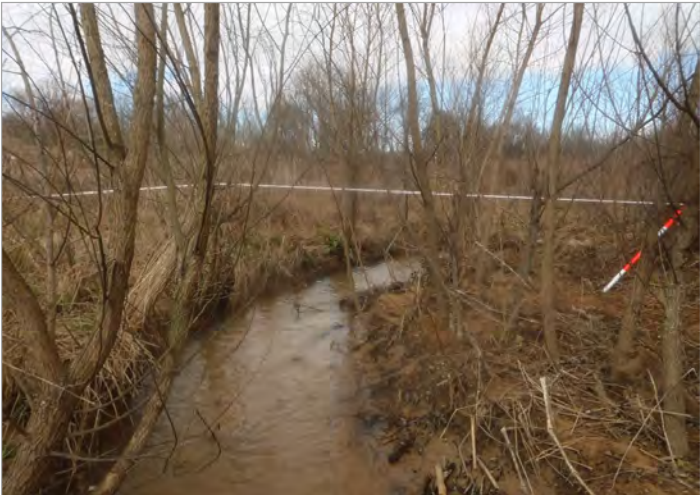
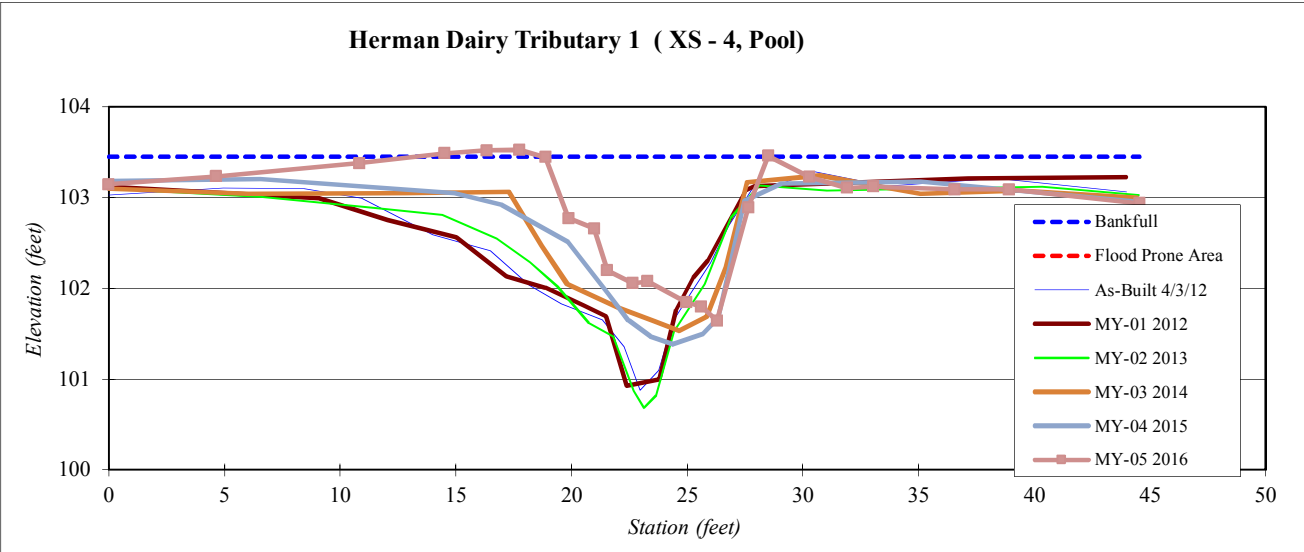
SUMMARY DATA	
Bankfull Elevation:	103.5
Bankfull Cross-Sectional Area:	10.6
Bankfull Width:	6.7
Flood Prone Area Elevation:	-
Flood Prone Width:	-
Max Depth at Bankfull:	1.8
Mean Depth at Bankfull:	1.6
W / D Ratio:	-
Entrenchment Ratio:	-
Bank Height Ratio:	-

Stream Type E

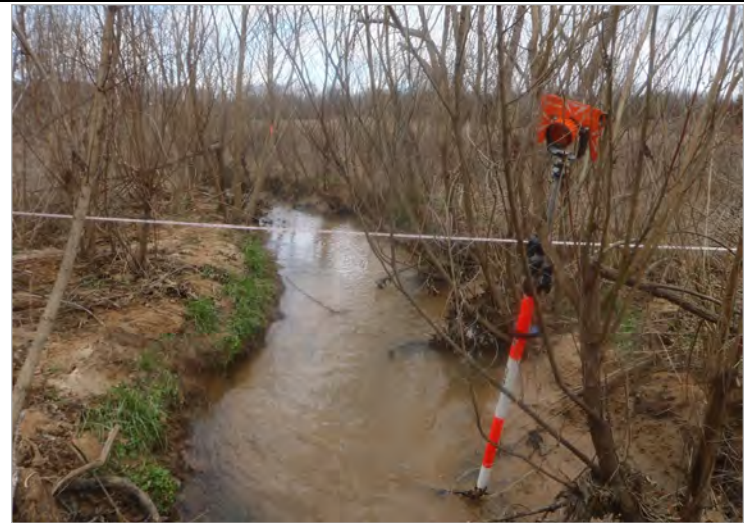
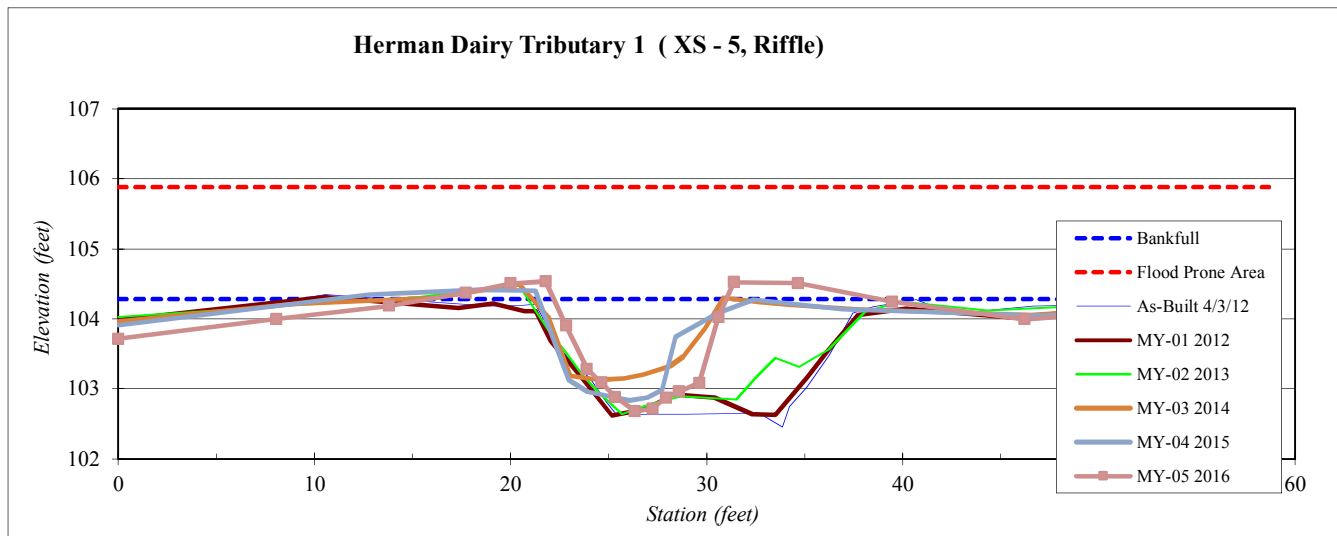
Site Name:	Herman Dairy
Watershed:	30501001120030
XS ID	Tributary 1 (XS - 5, Riffle)
Drainage Area (sq mi):	1.01
Date:	2/20/2016
Field Crew:	Perkinson, Jernigan

SUMMARY DATA	
Bankfull Elevation:	104.3
Bankfull Cross-Sectional Area:	9.5
Bankfull Width:	8.8
Flood Prone Area Elevation:	105.9
Flood Prone Width:	>80
Max Depth at Bankfull:	1.6
Mean Depth at Bankfull:	1.1
W / D Ratio:	8.2
Entrenchment Ratio:	>5
Bank Height Ratio:	1.0

Stream Type E/C

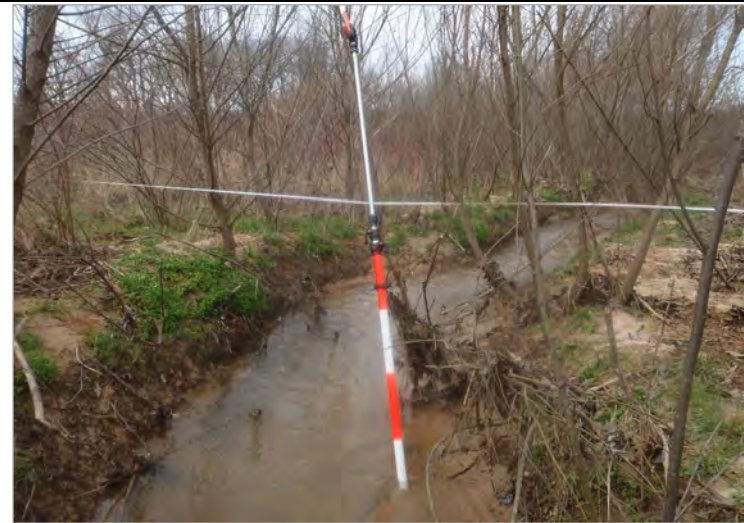
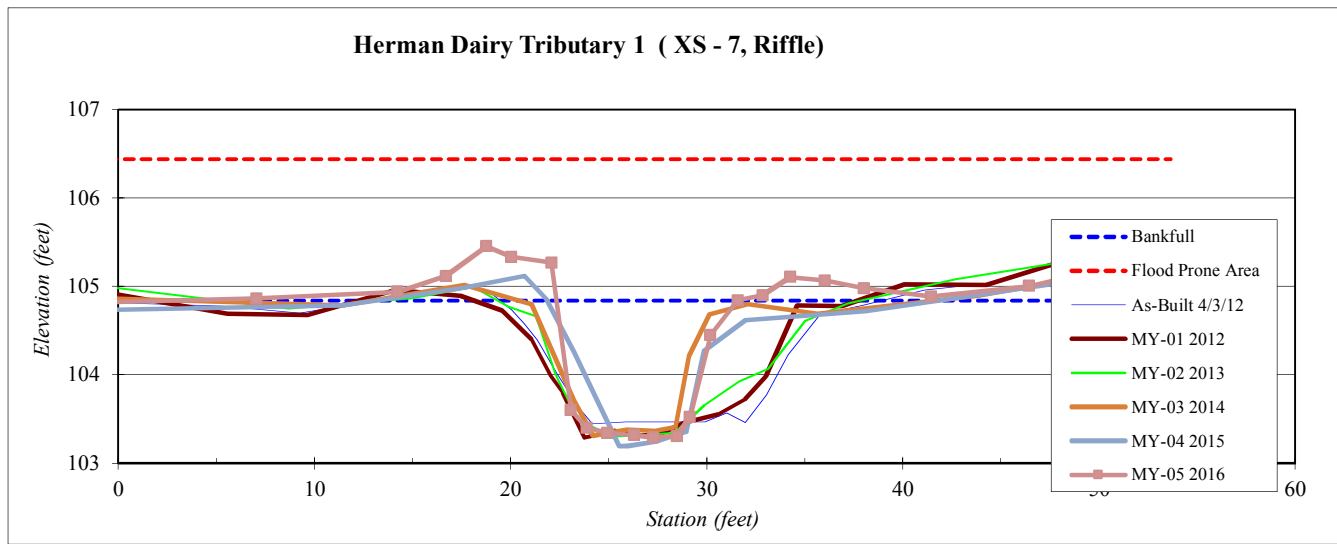
Site Name:	Herman Dairy
Watershed:	30501001120030
XS ID	Tributary 1 (XS - 7, Riffle)
Drainage Area (sq mi):	1.01
Date:	2/20/2016
Field Crew:	Perkinson, Jernigan

SUMMARY DATA	
Bankfull Elevation:	104.8
Bankfull Cross-Sectional Area:	10.6
Bankfull Width:	9.2
Flood Prone Area Elevation:	106.4
Flood Prone Width:	>80
Max Depth at Bankfull:	1.6
Mean Depth at Bankfull:	1.2
W / D Ratio:	8.0
Entrenchment Ratio:	>5
Bank Height Ratio:	1.0

Stream Type	E/C
--------------------	-----

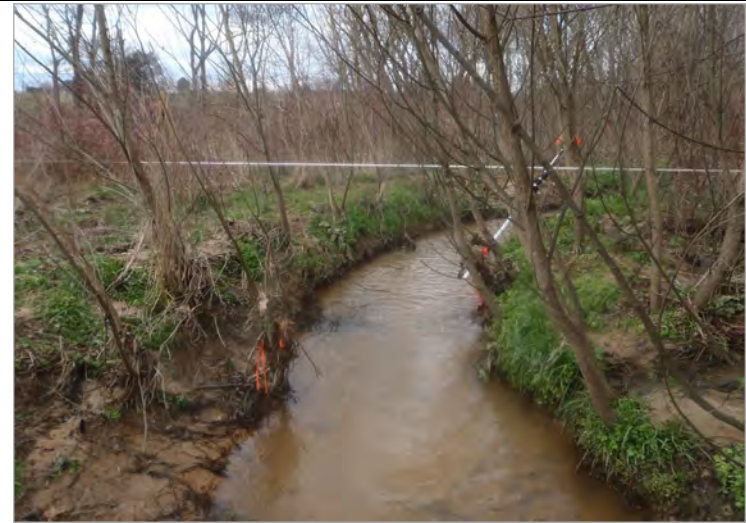
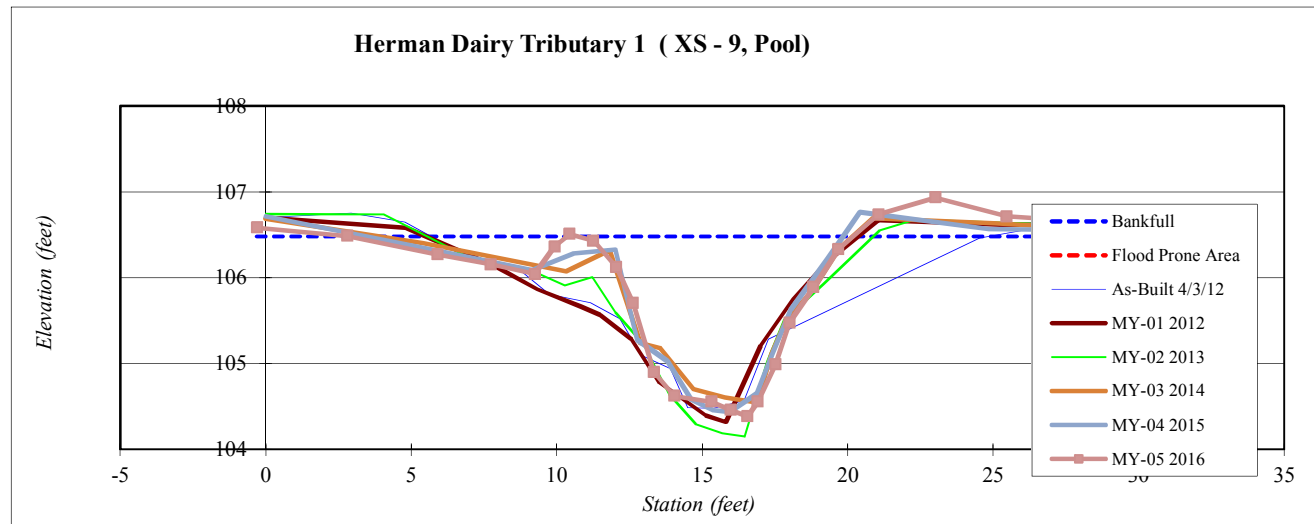
Site Name:	Herman Dairy
Watershed:	30501001120030
XS ID	Tributary 1 (XS -9, Pool)
Drainage Area (sq mi):	1.01
Date:	2/20/2016
Field Crew:	Perkinson, Jernigan

Stream Type E/C

SUMMARY DATA	
Bankfull Elevation:	106.5
Bankfull Cross-Sectional Area:	12.4
Bankfull Width:	16.9
Flood Prone Area Elevation:	-
Flood Prone Width:	-
Max Depth at Bankfull:	2.1
Mean Depth at Bankfull:	0.7
W / D Ratio:	-
Entrenchment Ratio:	-
Bank Height Ratio:	-

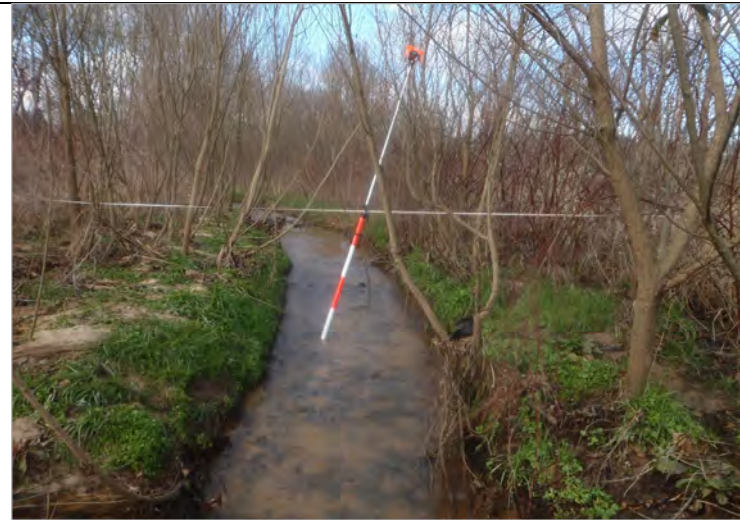
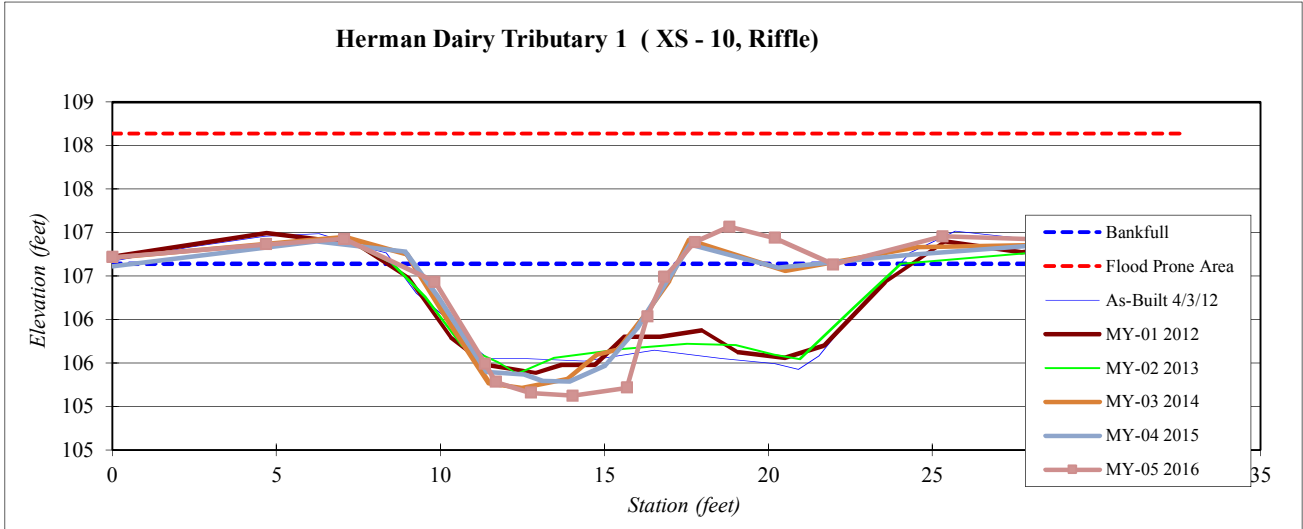
Site Name:	Herman Dairy
Watershed:	30501001120030
XS ID	Tributary 1 (XS - 10, Riffle)
Drainage Area (sq mi):	1.01
Date:	2/20/2016
Field Crew:	Perkinson, Jernigan

Stream Type	E/C
--------------------	-----

SUMMARY DATA	
Bankfull Elevation:	106.6
Bankfull Cross-Sectional Area:	8.3
Bankfull Width:	8.5
Flood Prone Area Elevation:	108.1
Flood Prone Width:	>80
Max Depth at Bankfull:	1.5
Mean Depth at Bankfull:	1.0
W / D Ratio:	8.7
Entrenchment Ratio:	>5
Bank Height Ratio:	1.0

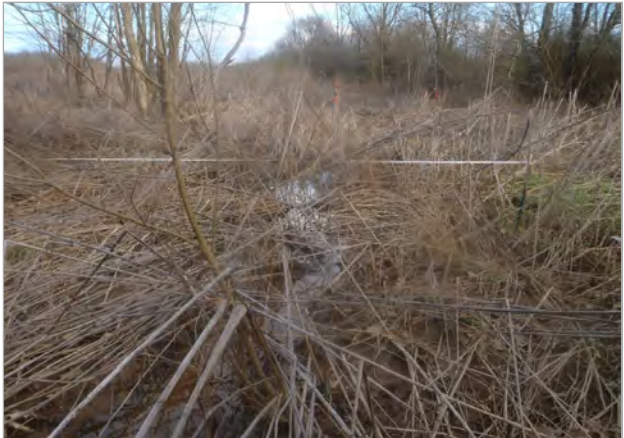
Site Name:	Herman Dairy
Watershed:	30501001120030
XS ID	Tributary 2 (XS - 11, Riffle)
Drainage Area (sq mi):	1.01
Date:	2/20/2016
Field Crew:	Perkinson, Jernigan

SUMMARY DATA	
Bankfull Elevation:	98.4
Bankfull Cross-Sectional Area:	1.5
Bankfull Width:	6.8
Flood Prone Area Elevation:	98.8
Flood Prone Width:	>80
Max Depth at Bankfull:	0.4
Mean Depth at Bankfull:	0.2
W / D Ratio:	30.8
Entrenchment Ratio:	>5
Bank Height Ratio:	1.0
