FINAL MONITORING REPORT
2022 (Year 4)

HERON STREAM AND WETLAND MITIGATION SITE

Alamance County, North Carolina

DMS Project ID No. 100014
Full Delivery Contract No. 7192
USACE Action ID No. SAW-2017-01471
DWR No. 17-0920
RFP No. 16-006990

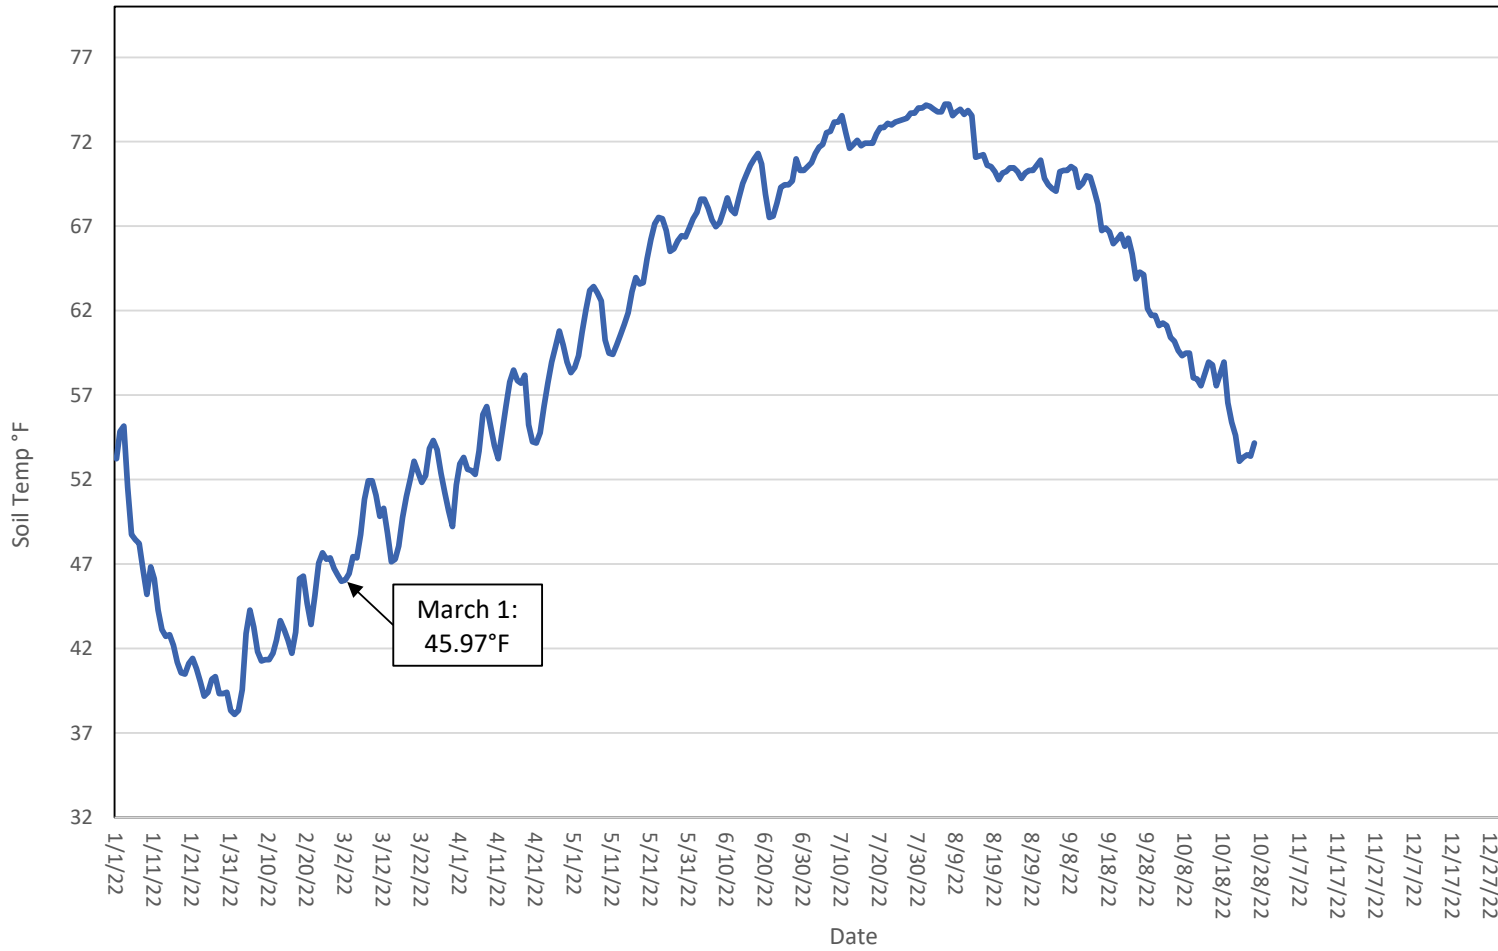
Heron Soil Temperature Year 4 (2022 Data)

[^]Based on bud burst documented on March 1, 2021. The soil temperature logger was damaged and stopped recording February 16, 2021, however at the time of the failure, the soil temperature had dropped below 41°F just twice in 2021 (January 5th and 31st) and exceeded thereafter.
