**FINAL
MY5 (2023) MONITORING REPORT**

HERON STREAM AND WETLAND MITIGATION SITE

Alamance County, North Carolina
Cape Fear River Basin
Cataloging Unit 03030002

DMS Project ID No. 100014
Full Delivery Contract No. 7192
RFP No. 16-006990
USACE Action ID No. SAW-2017-01471
DWR Project No. 17-0920

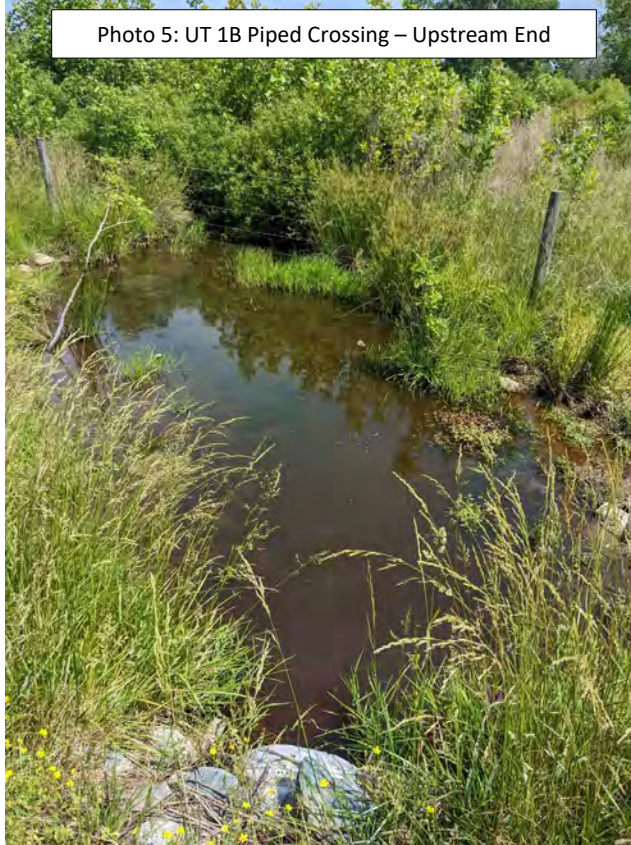
Photo 5: UT 1B Piped Crossing – Upstream End
