MY02 MONITORING REPORT

Hip Bone Creek Restoration Site

DMS Project #100059

Date: February 9, 2023
To: Jeremiah Dow, DMS Project Manager
From: Adam Spiller, Project Manager
KCI Associates of North Carolina, PA
Subject: MY-02 Monitoring Report Comments
Hip Bone Creek DMS#100059, Contract 007528
Cape Fear River Basin CU 03040101
Chatham County, North Carolina

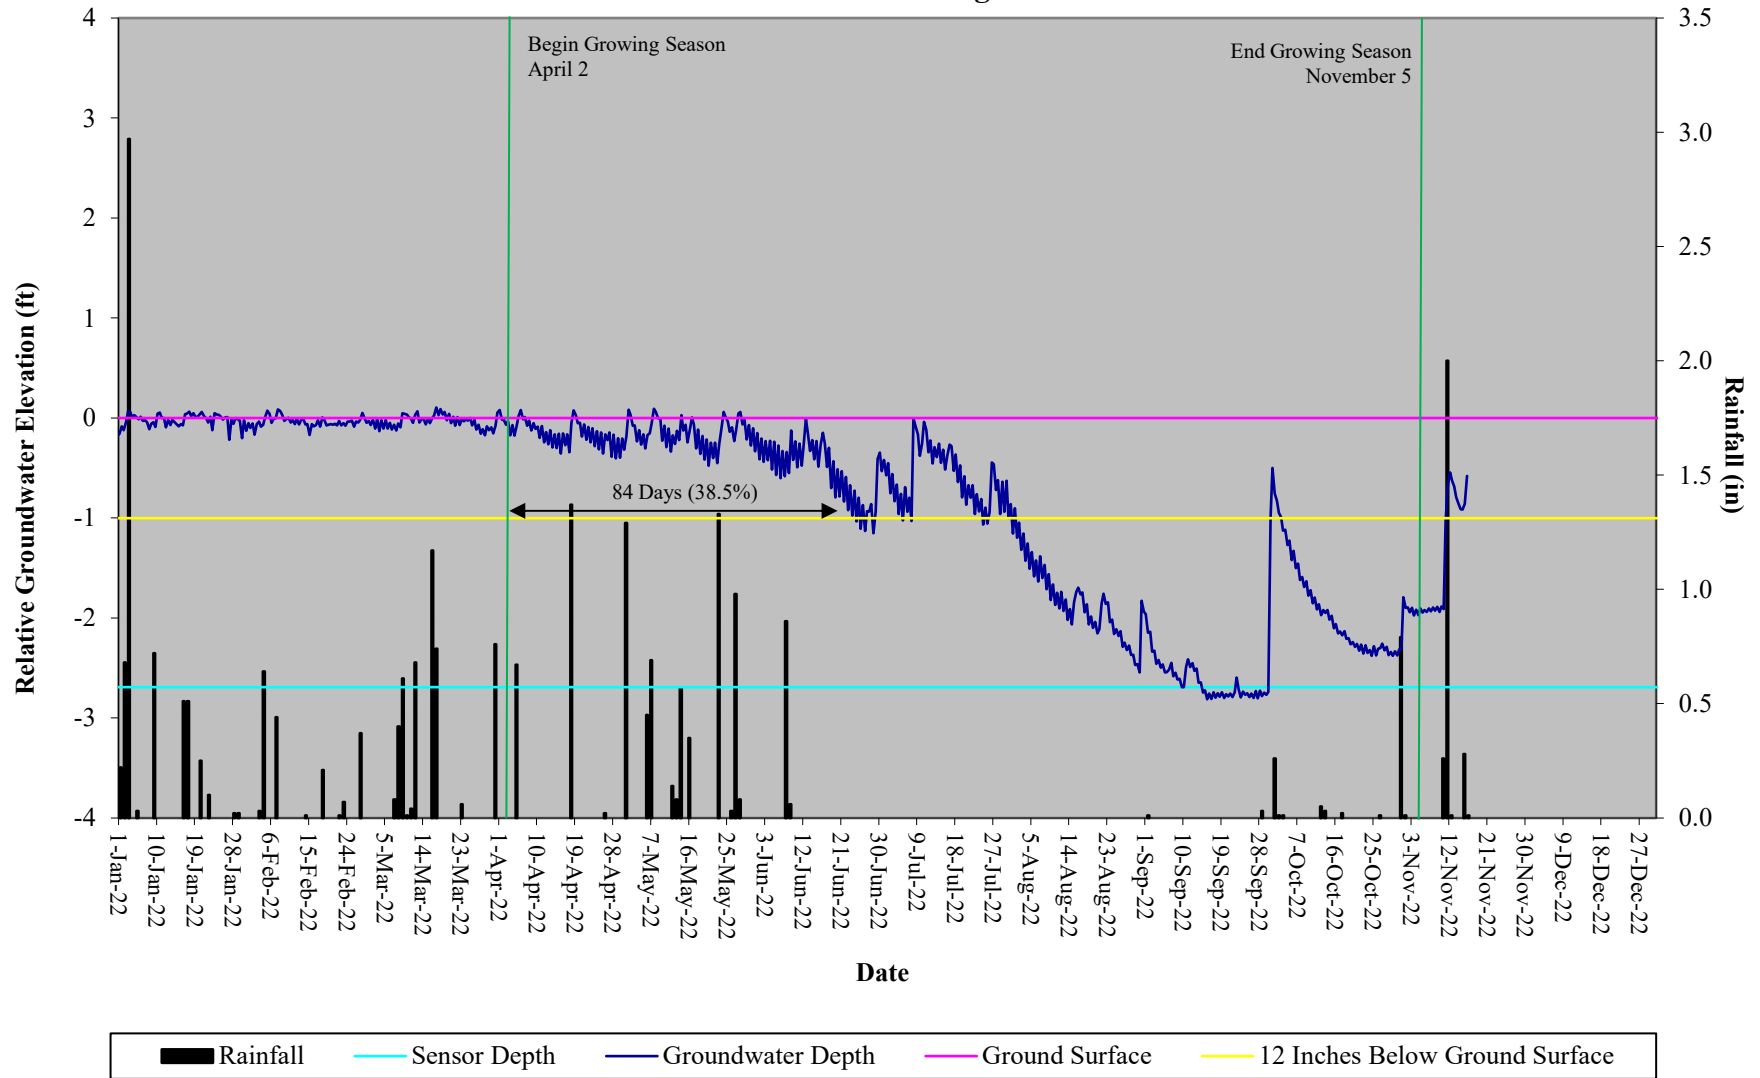
Hip Bone Creek Restoration Site Hydrograph Wetland Gauge 6

Table 13. Wetland Hydrology Criteria Attainment, Hip Bone Creek Restoration Site (ID-100059)							
	Performance Standard: 12 %						
	WETS Station: Siler City 2N						
	Growing Season: 4/2 to 11/5 (217 days)						
	Max. Consecutive Hydroperiod (%)						
Monitoring Gauge	MY1 2021	MY2 2022	MY3 2023	MY4 2024	MY5 2025	MY6 2026	MY7 2027
WM-1	5.5%	22.9%					
WM-2	6.0%	6.4%					
WM-3	30.9%	38.5%					
WM-4	5.1%	12.4%					
WM-5	3.2%	23.4%					
WM-6	19.8%	38.5%					
WM-7	28.1%	9.6%					
WM-8	2.3%	22.9%
