# MY03 MONITORING REPORT

Hip Bone Creek Restoration Site  
Chatham County  
Cape Fear River Basin - 3030003

DMS Project #100059

Monitoring Data Collected: 2023

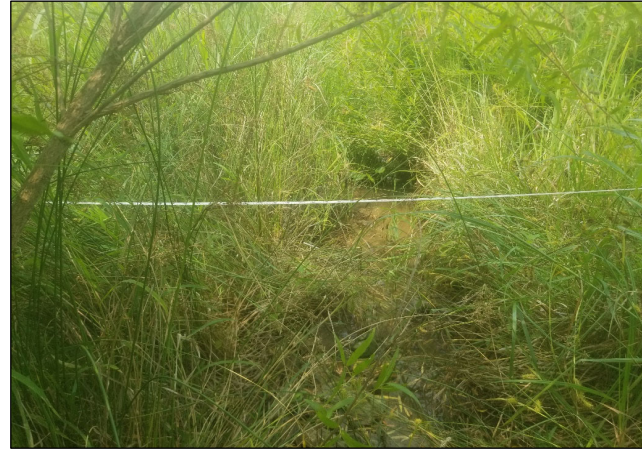
<b>River Basin:</b>	Cape Fear River
<b>Site:</b>	Hip Bone Creek Restoration Site
<b>XS ID</b>	XS13
<b>Drainage Area (sq mi):</b>	0.05
<b>Date:</b>	7/17/2023
<b>Field Crew:</b>	TS, CK, KB, ET

SUMMARY DATA	
<b>Bankfull Elevation (ft) - Based on AB-Bankfull Area</b>	548.84
<b>Bankfull Cross-Sectional Area (sq ft):</b>	3.4
<b>LTOB Cross-Sectional Area (sq ft):</b>	3.6
<b>Bankfull Width (ft):</b>	6.4
<b>Flood Prone Area Elevation (ft):</b>	549.78
<b>Flood Prone Width (ft):</b>	47
<b>Max Depth at Bankfull (ft):</b>	0.9
<b>Mean Depth at Bankfull (ft):</b>	0.5
<b>W / D Ratio (ft/ft):</b>	12.0
<b>Entrenchment Ratio (ft/ft):</b>	7.3
<b>Bank Height Ratio (ft/ft):</b>	1.0
<b>Thalweg Elevation (ft):</b>	547.90

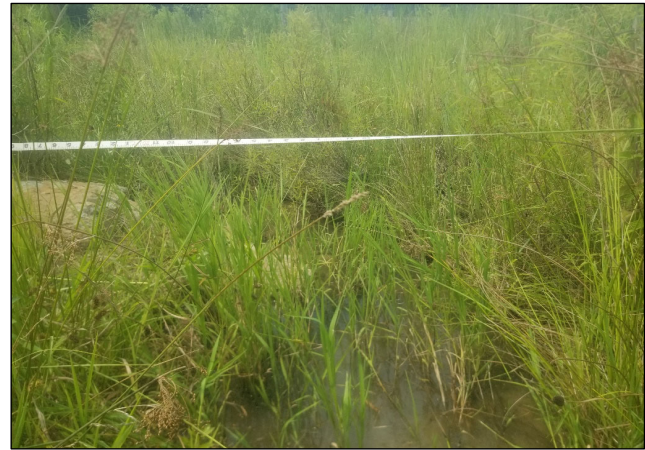
<b>River Basin:</b>	Cape Fear River
<b>Site:</b>	Hip Bone Creek Restoration Site
<b>XS ID</b>	XS14
<b>Drainage Area (sq mi):</b>	0.05
<b>Date:</b>	7/17/2023
<b>Field Crew:</b>	TS, CK, KB, ET

SUMMARY DATA	
<b>Bankfull Elevation (ft) - Based on AB-Bankfull Area</b>	548.39
<b>Bankfull Cross-Sectional Area (sq ft):</b>	4.3
<b>LTOB Cross-Sectional Area (sq ft):</b>	4.1
<b>Bankfull Width (ft):</b>	6.8
<b>Flood Prone Area Elevation (ft):</b>	---
<b>Flood Prone Width (ft):</b>	---
<b>Max Depth at Bankfull (ft):</b>	547.9
<b>Mean Depth at Bankfull (ft):</b>	0.6
<b>W / D Ratio (ft/ft):</b>	---
<b>Entrenchment Ratio (ft/ft):</b>	---
<b>Bank Height Ratio (ft/ft):</b>	---
<b>Thalweg Elevation (ft):</b>	0.50

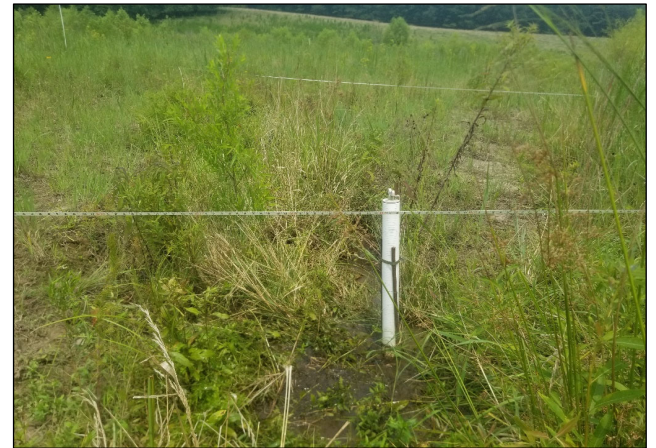
<b>River Basin:</b>	Cape Fear River
<b>Site:</b>	Hip Bone Creek Restoration Site
<b>XS ID</b>	XS15
<b>Drainage Area (sq mi):</b>	0.06
<b>Date:</b>	7/17/2023
<b>Field Crew:</b>	TS, CK, KB, ET

SUMMARY DATA	
<b>Bankfull Elevation (ft) - Based on AB-Bankfull Area</b>	544.84
<b>Bankfull Cross-Sectional Area (sq ft):</b>	3.9
<b>LTOB Cross-Sectional Area (sq ft):</b>	3.0
<b>Bankfull Width (ft):</b>	6.2
<b>Flood Prone Area Elevation (ft):</b>	545.80
<b>Flood Prone Width (ft):</b>	50
<b>Max Depth at Bankfull (ft):</b>	1.0
<b>Mean Depth at Bankfull (ft):</b>	0.6
<b>W / D Ratio (ft/ft):</b>	10.0
<b>Entrenchment Ratio (ft/ft):</b>	8.0
<b>Bank Height Ratio (ft/ft):</b>	0.9
<b>Thalweg Elevation (ft):</b>	543.88

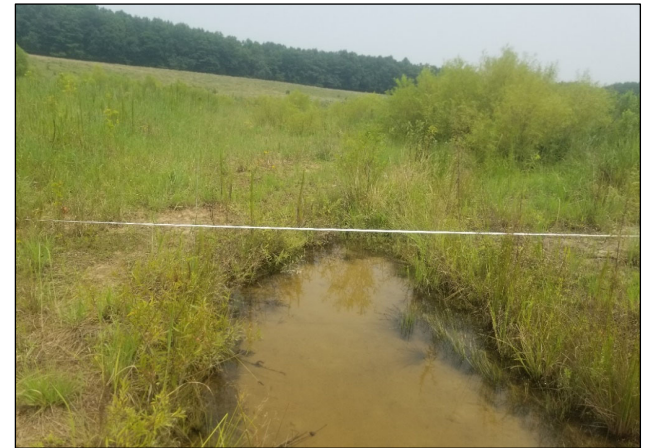
<b>River Basin:</b>	Cape Fear River
<b>Site:</b>	Hip Bone Creek Restoration Site
<b>XS ID</b>	XS16
<b>Drainage Area (sq mi):</b>	0.06
<b>Date:</b>	7/17/2023
<b>Field Crew:</b>	TS, CK, KB, ET

SUMMARY DATA	
<b>Bankfull Elevation (ft) - Based on AB-Bankfull Area</b>	544.18
<b>Bankfull Cross-Sectional Area (sq ft):</b>	8.6
<b>LTOB Cross-Sectional Area (sq ft):</b>	9.2
<b>Bankfull Width (ft):</b>	9.7
<b>Flood Prone Area Elevation (ft):</b>	---
<b>Flood Prone Width (ft):</b>	---
<b>Max Depth at Bankfull (ft):</b>	1.5
<b>Mean Depth at Bankfull (ft):</b>	0.9
<b>W / D Ratio (ft/ft):</b>	---
<b>Entrenchment Ratio (ft/ft):</b>	---
<b>Bank Height Ratio (ft/ft):</b>	---
<b>Thalweg Elevation (ft):</b>	542.65
