**Annual Monitoring Report Final
Monitoring Year 1 of 5
Hogan Creek Stream Mitigation Project**

DEQ Contract Number: 6496
USACE Action ID: SAW-2011-02268
DWR Project Number: 20120182
SCO# 09-08566-01

Surry County, North Carolina
Data Collected: October 26-December 11, 2015
Data Submitted: January 2016

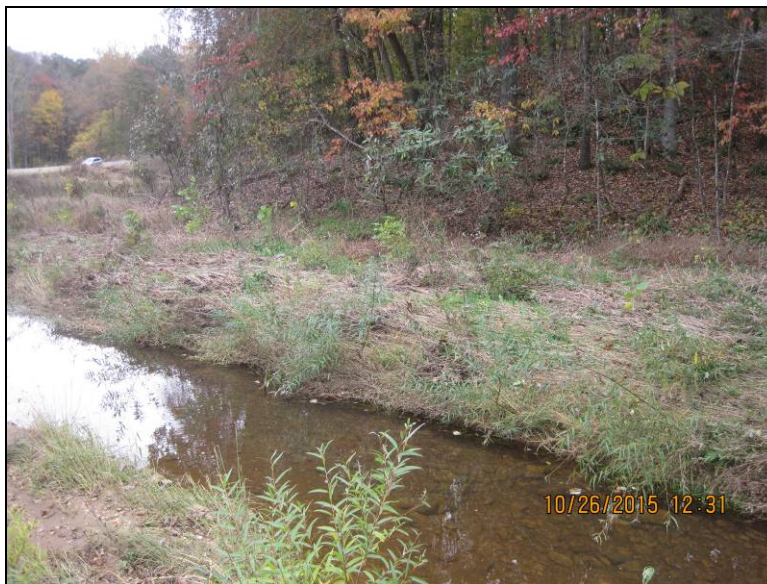
Photograph of wrack lines on Hogan Creek Reach 1 Station 25+00
