**Annual Monitoring Report Final
Monitoring Year 2 of 5
Hogan Creek Stream Mitigation Project**

DEQ Contract Number: 6496
USACE Action ID: SAW-2011-02268
DWR Project Number: 20120182
SCO# 09-08566-01

Surry County, North Carolina
Data Collected: April 12-October 13, 2016
Data Submitted: November 29, 2016
Revised: December 15, 2016

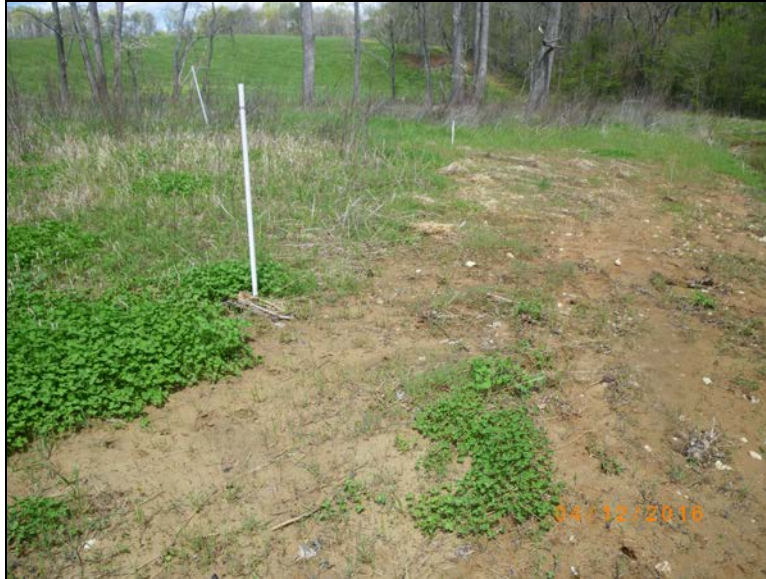
Photo 3. Wrack lines and sediment deposition on Hogan Creek Reach 3 Station 37+00, April 12, 2016
