# MONITORING YEAR 4 ANNUAL REPORT

## HOGAN CREEK STREAM MITIGATION PROJECT

Surry County, NC

DMS Project Number 94708

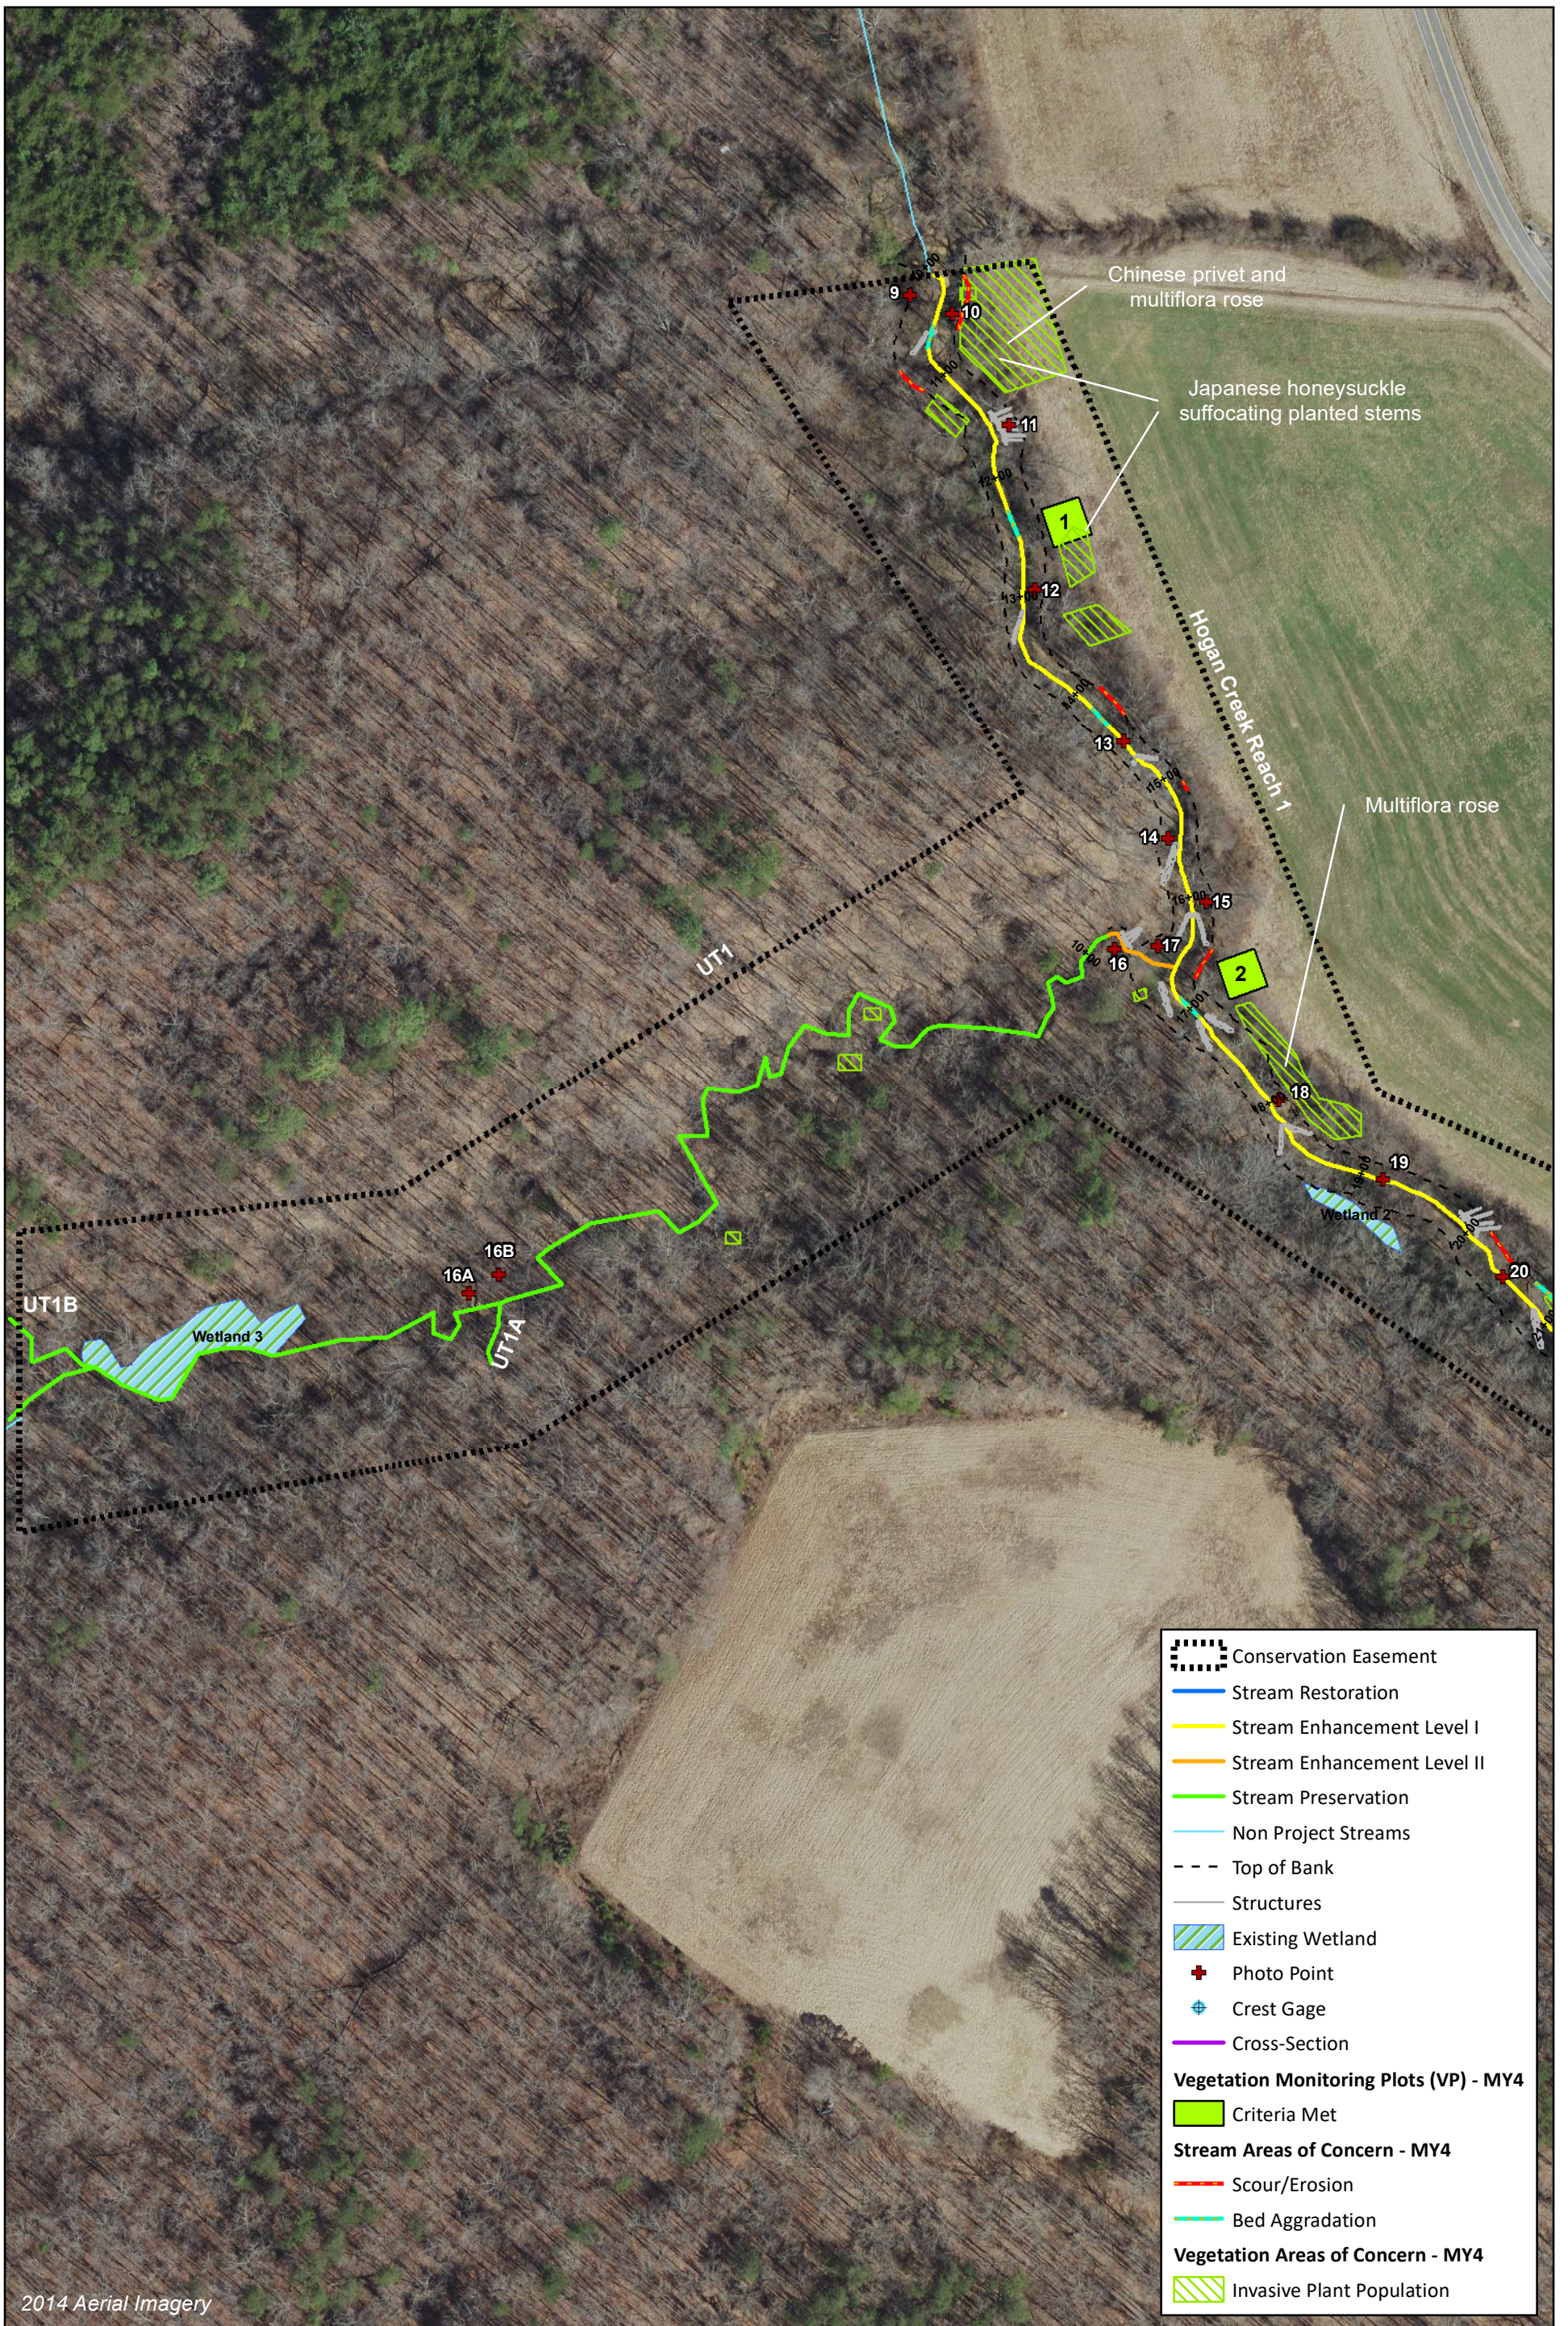
Figure 3.2 Integrated Current Condition Plan View Map (Sheet 2 of 3)  
 Hogan Creek Stream Mitigation Project  
 DMS Project No. 94708  
 Monitoring Year 4 - 2018  
 Surry County, NC

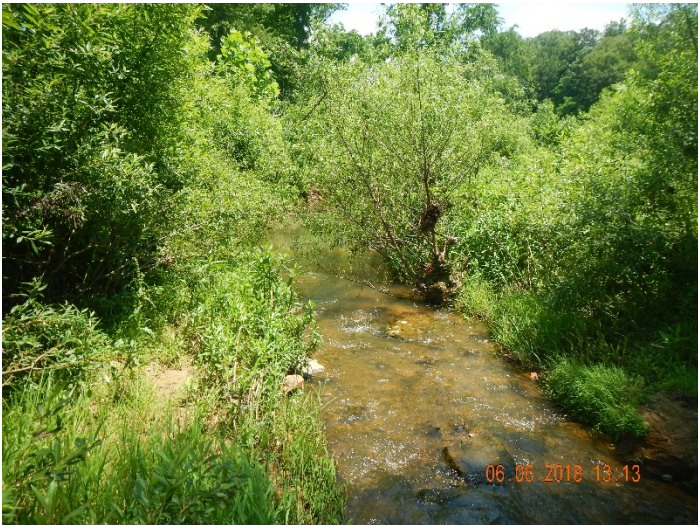
**PP27** – Reach 2 Hogan Creek, looking downstream (6/06/2018)

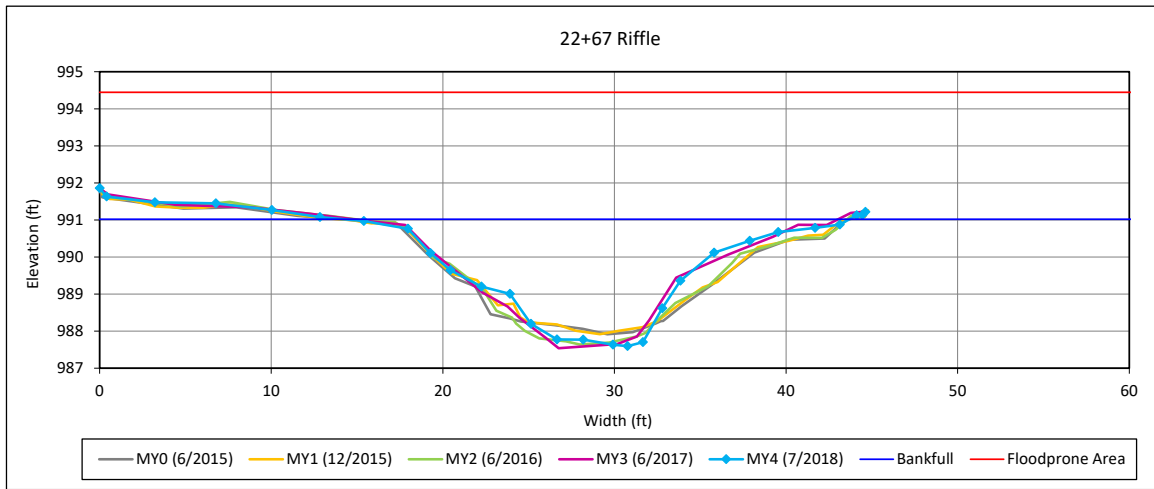
#### Cross-Section 1-Hogan Creek Reach 1

43.9	x-section area (ft.sq.)
29.4	width (ft)
1.5	mean depth (ft)
3.4	max depth (ft)
30.8	wetted perimeter (ft)
1.4	hydraulic radius (ft)
19.7	width-depth ratio
100.0	W flood prone area (ft)
3.4	entrenchment ratio
0.9	low bank height ratio

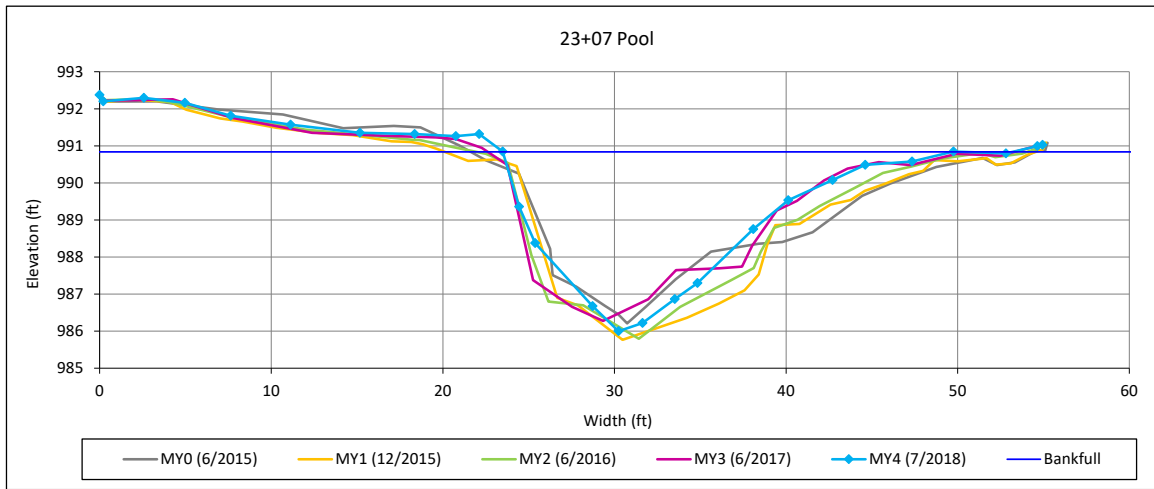
**Cross-Section 2-Hogan Creek Reach 1**

57.6	x-section area (ft.sq.)
29.1	width (ft)
2.0	mean depth (ft)
4.8	max depth (ft)
31.7	wetted perimeter (ft)
1.8	hydraulic radius (ft)
14.7	width-depth ratio

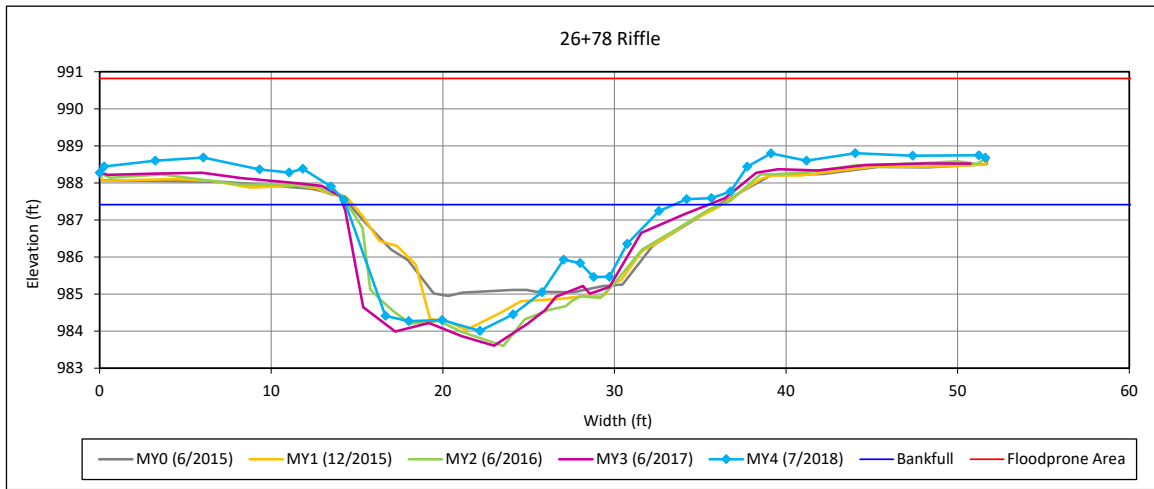
**Cross-Section 3-Hogan Creek Reach 1**

41.4	x-section area (ft.sq.)
19.1	width (ft)
2.2	mean depth (ft)
3.4	max depth (ft)
21.7	wetted perimeter (ft)
1.9	hydraulic radius (ft)
8.8	width-depth ratio
100.0	W flood prone area (ft)
5.2	entrenchment ratio
1.1	low bank height ratio

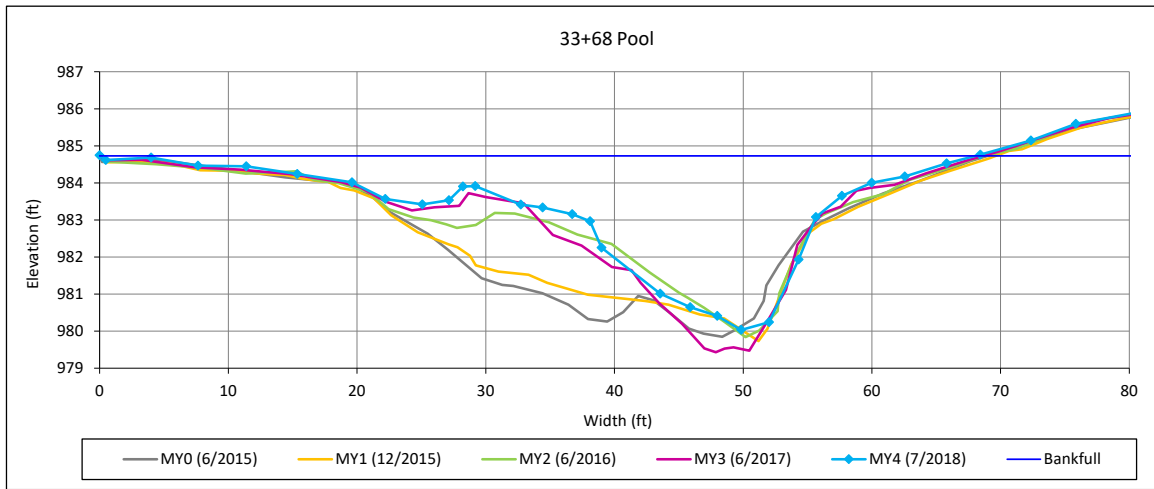
#### Cross-Section 4-Hogan Creek Reach 2

98.9	x-section area (ft.sq.)
60.4	width (ft)
1.6	mean depth (ft)
4.7	max depth (ft)
62.2	wetted perimeter (ft)
1.6	hydraulic radius (ft)
36.9	width-depth ratio

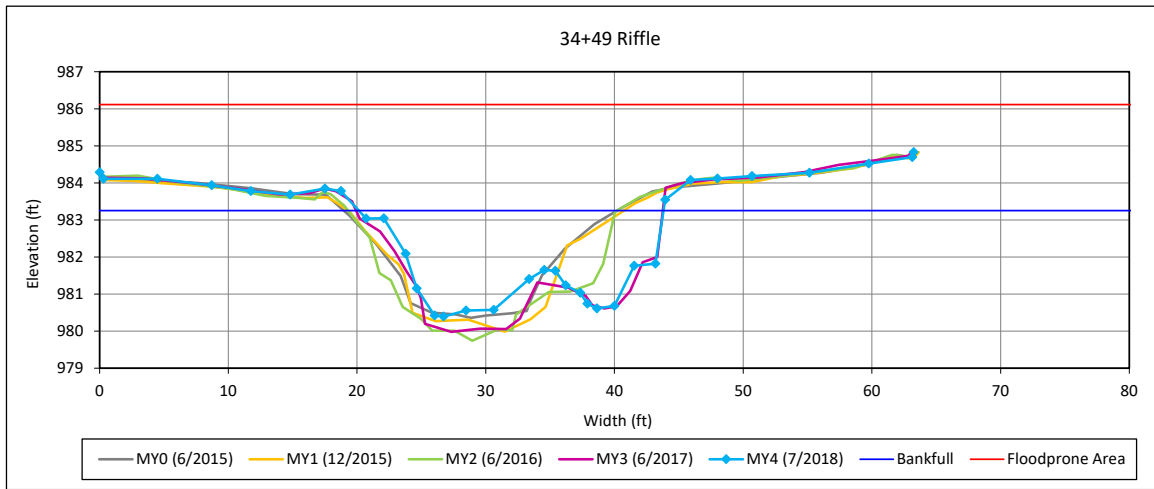
**Cross-Section 5-Hogan Creek Reach 2**

45.2	x-section area (ft.sq.)
23.7	width (ft)
1.9	mean depth (ft)
2.9	max depth (ft)
26.2	wetted perimeter (ft)
1.7	hydraulic radius (ft)
12.4	width-depth ratio
100.0	W flood prone area (ft)
4.2	entrenchment ratio
1.2	low bank height ratio

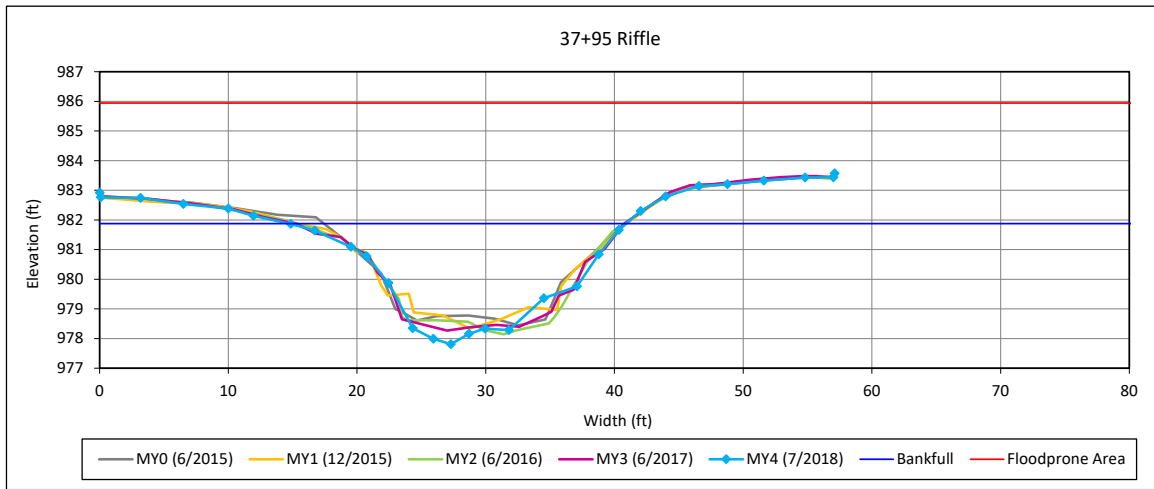
**Cross-Section 6-Hogan Creek Reach 2**

56.6	x-section area (ft.sq.)
26.1	width (ft)
2.2	mean depth (ft)
4.1	max depth (ft)
27.8	wetted perimeter (ft)
2.0	hydraulic radius (ft)
12.0	width-depth ratio
100.0	W flood prone area (ft)
3.8	entrenchment ratio
1.0	low bank height ratio

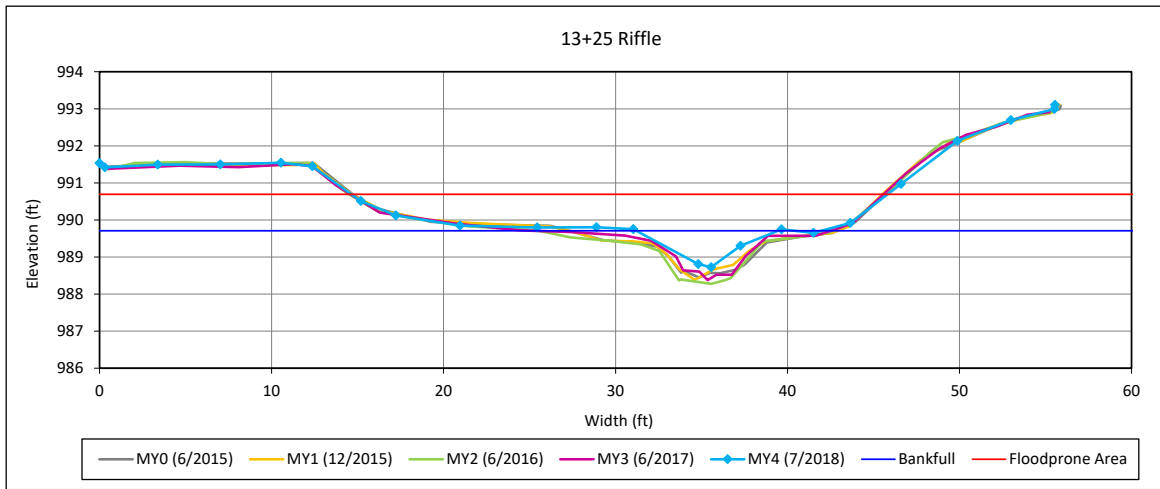
**Cross-Section 7-UT2**

4.0	x-section area (ft.sq.)
8.2	width (ft)
0.5	mean depth (ft)
1.0	max depth (ft)
8.5	wetted perimeter (ft)
0.5	hydraulic radius (ft)
17.1	width-depth ratio
25.9	W flood prone area (ft)
3.1	entrenchment ratio
1.0	low bank height ratio

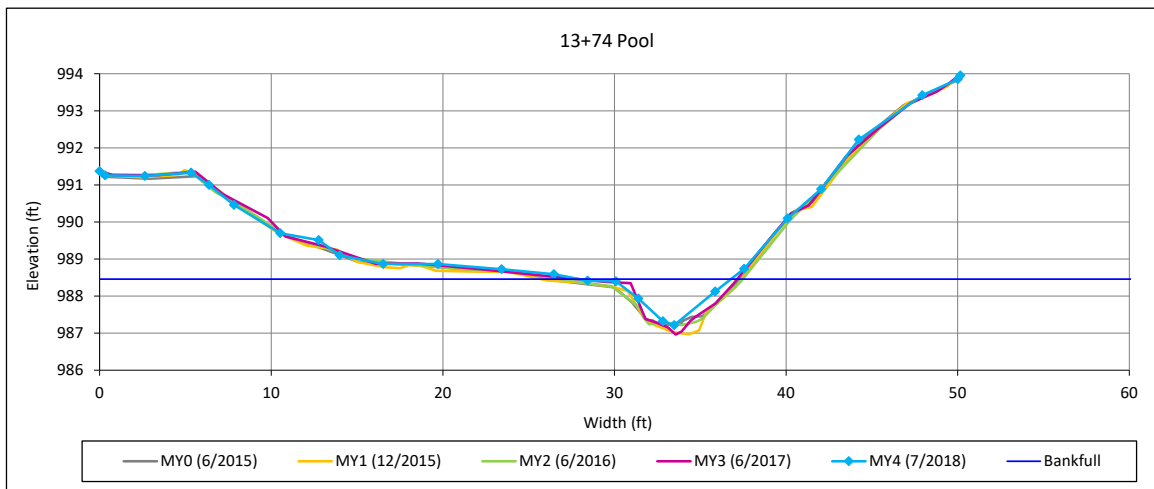
### Cross-Section 8-UT2

- 4.4 x-section area (ft.sq.)
- 6.7 width (ft)
- 0.7 mean depth (ft)
- 1.2 max depth (ft)
- 7.2 wetted perimeter (ft)
- 0.6 hydraulic radius (ft)
- 10.3 width-depth ratio

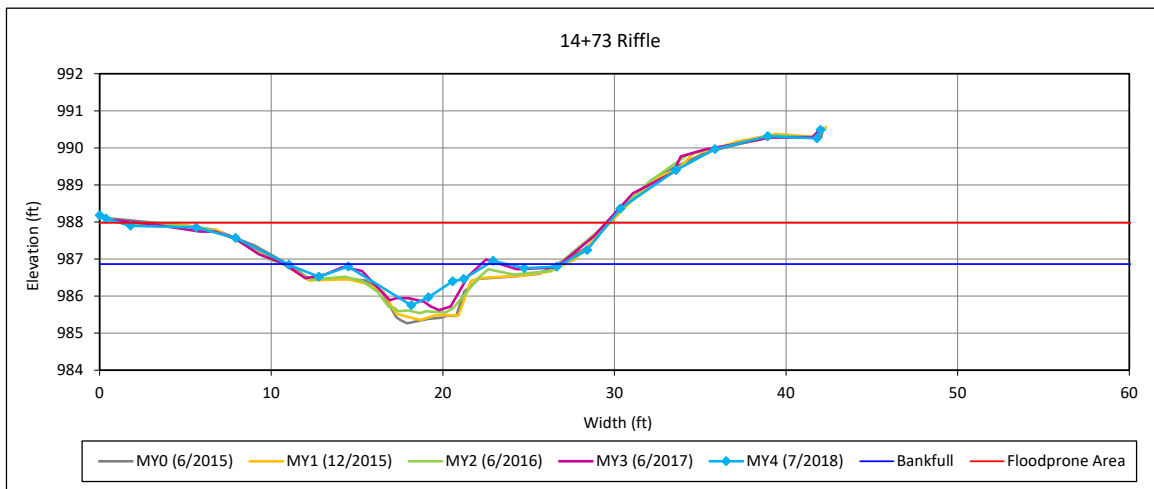
**Cross-Section 9-UT2**

4.7	x-section area (ft.sq.)
8.1	width (ft)
0.6	mean depth (ft)
1.1	max depth (ft)
8.4	wetted perimeter (ft)
0.6	hydraulic radius (ft)
14.1	width-depth ratio
17.8	W flood prone area (ft)
2.2	entrenchment ratio
0.9	low bank height ratio

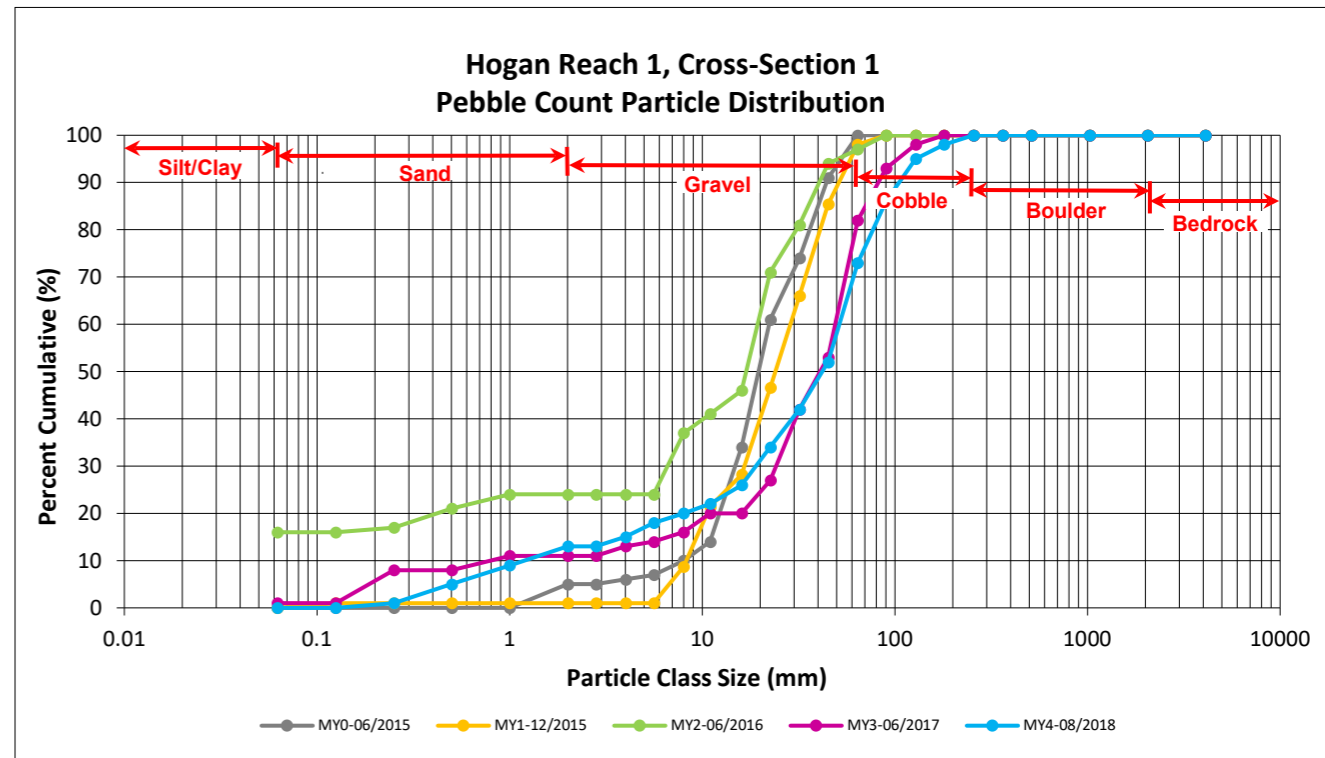
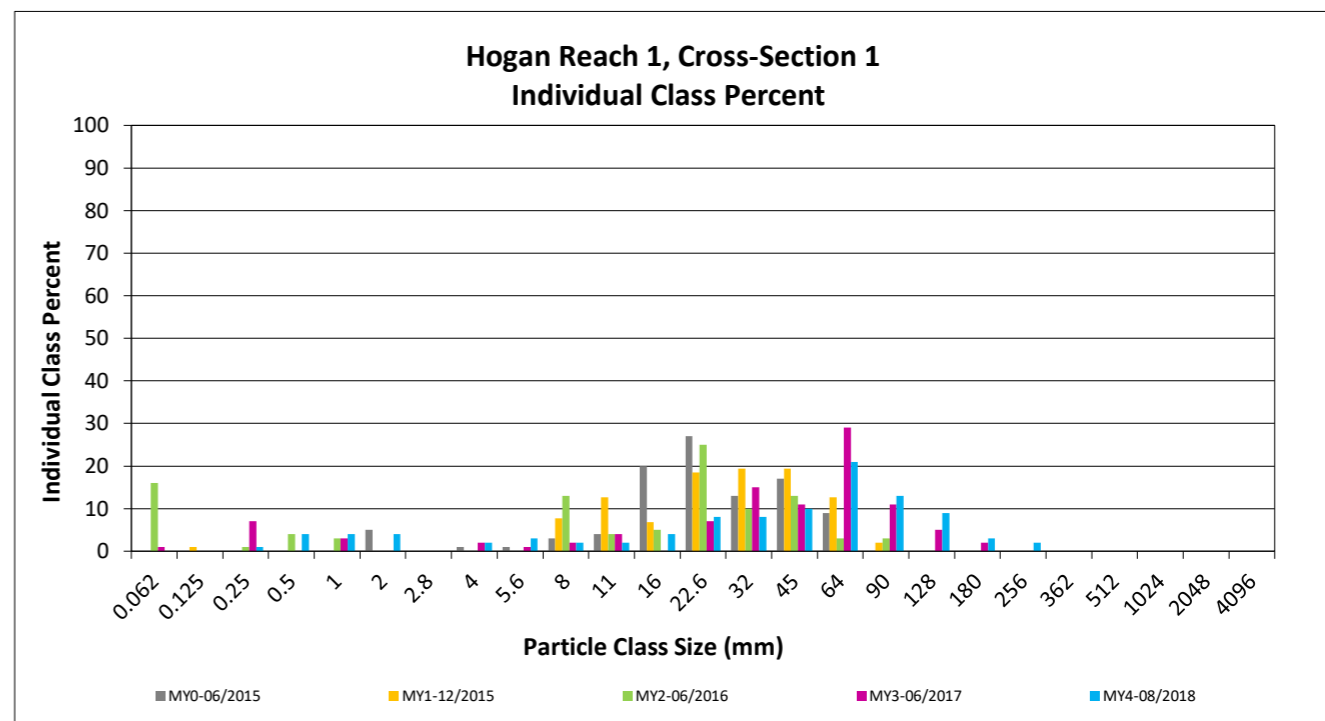
Cross-Section 1 Channel materials (mm)	
D <sub>16</sub> =	4.47
D <sub>35</sub> =	23.60
D <sub>50</sub> =	42.0
D <sub>84</sub> =	85.4
D <sub>95</sub> =	128.0
D <sub>100</sub> =	256.0
