MONITORING YEAR 5 ANNUAL REPORT

HOGAN CREEK STREAM MITIGATION PROJECT

Surry County, NC

DMS Project Number 94708

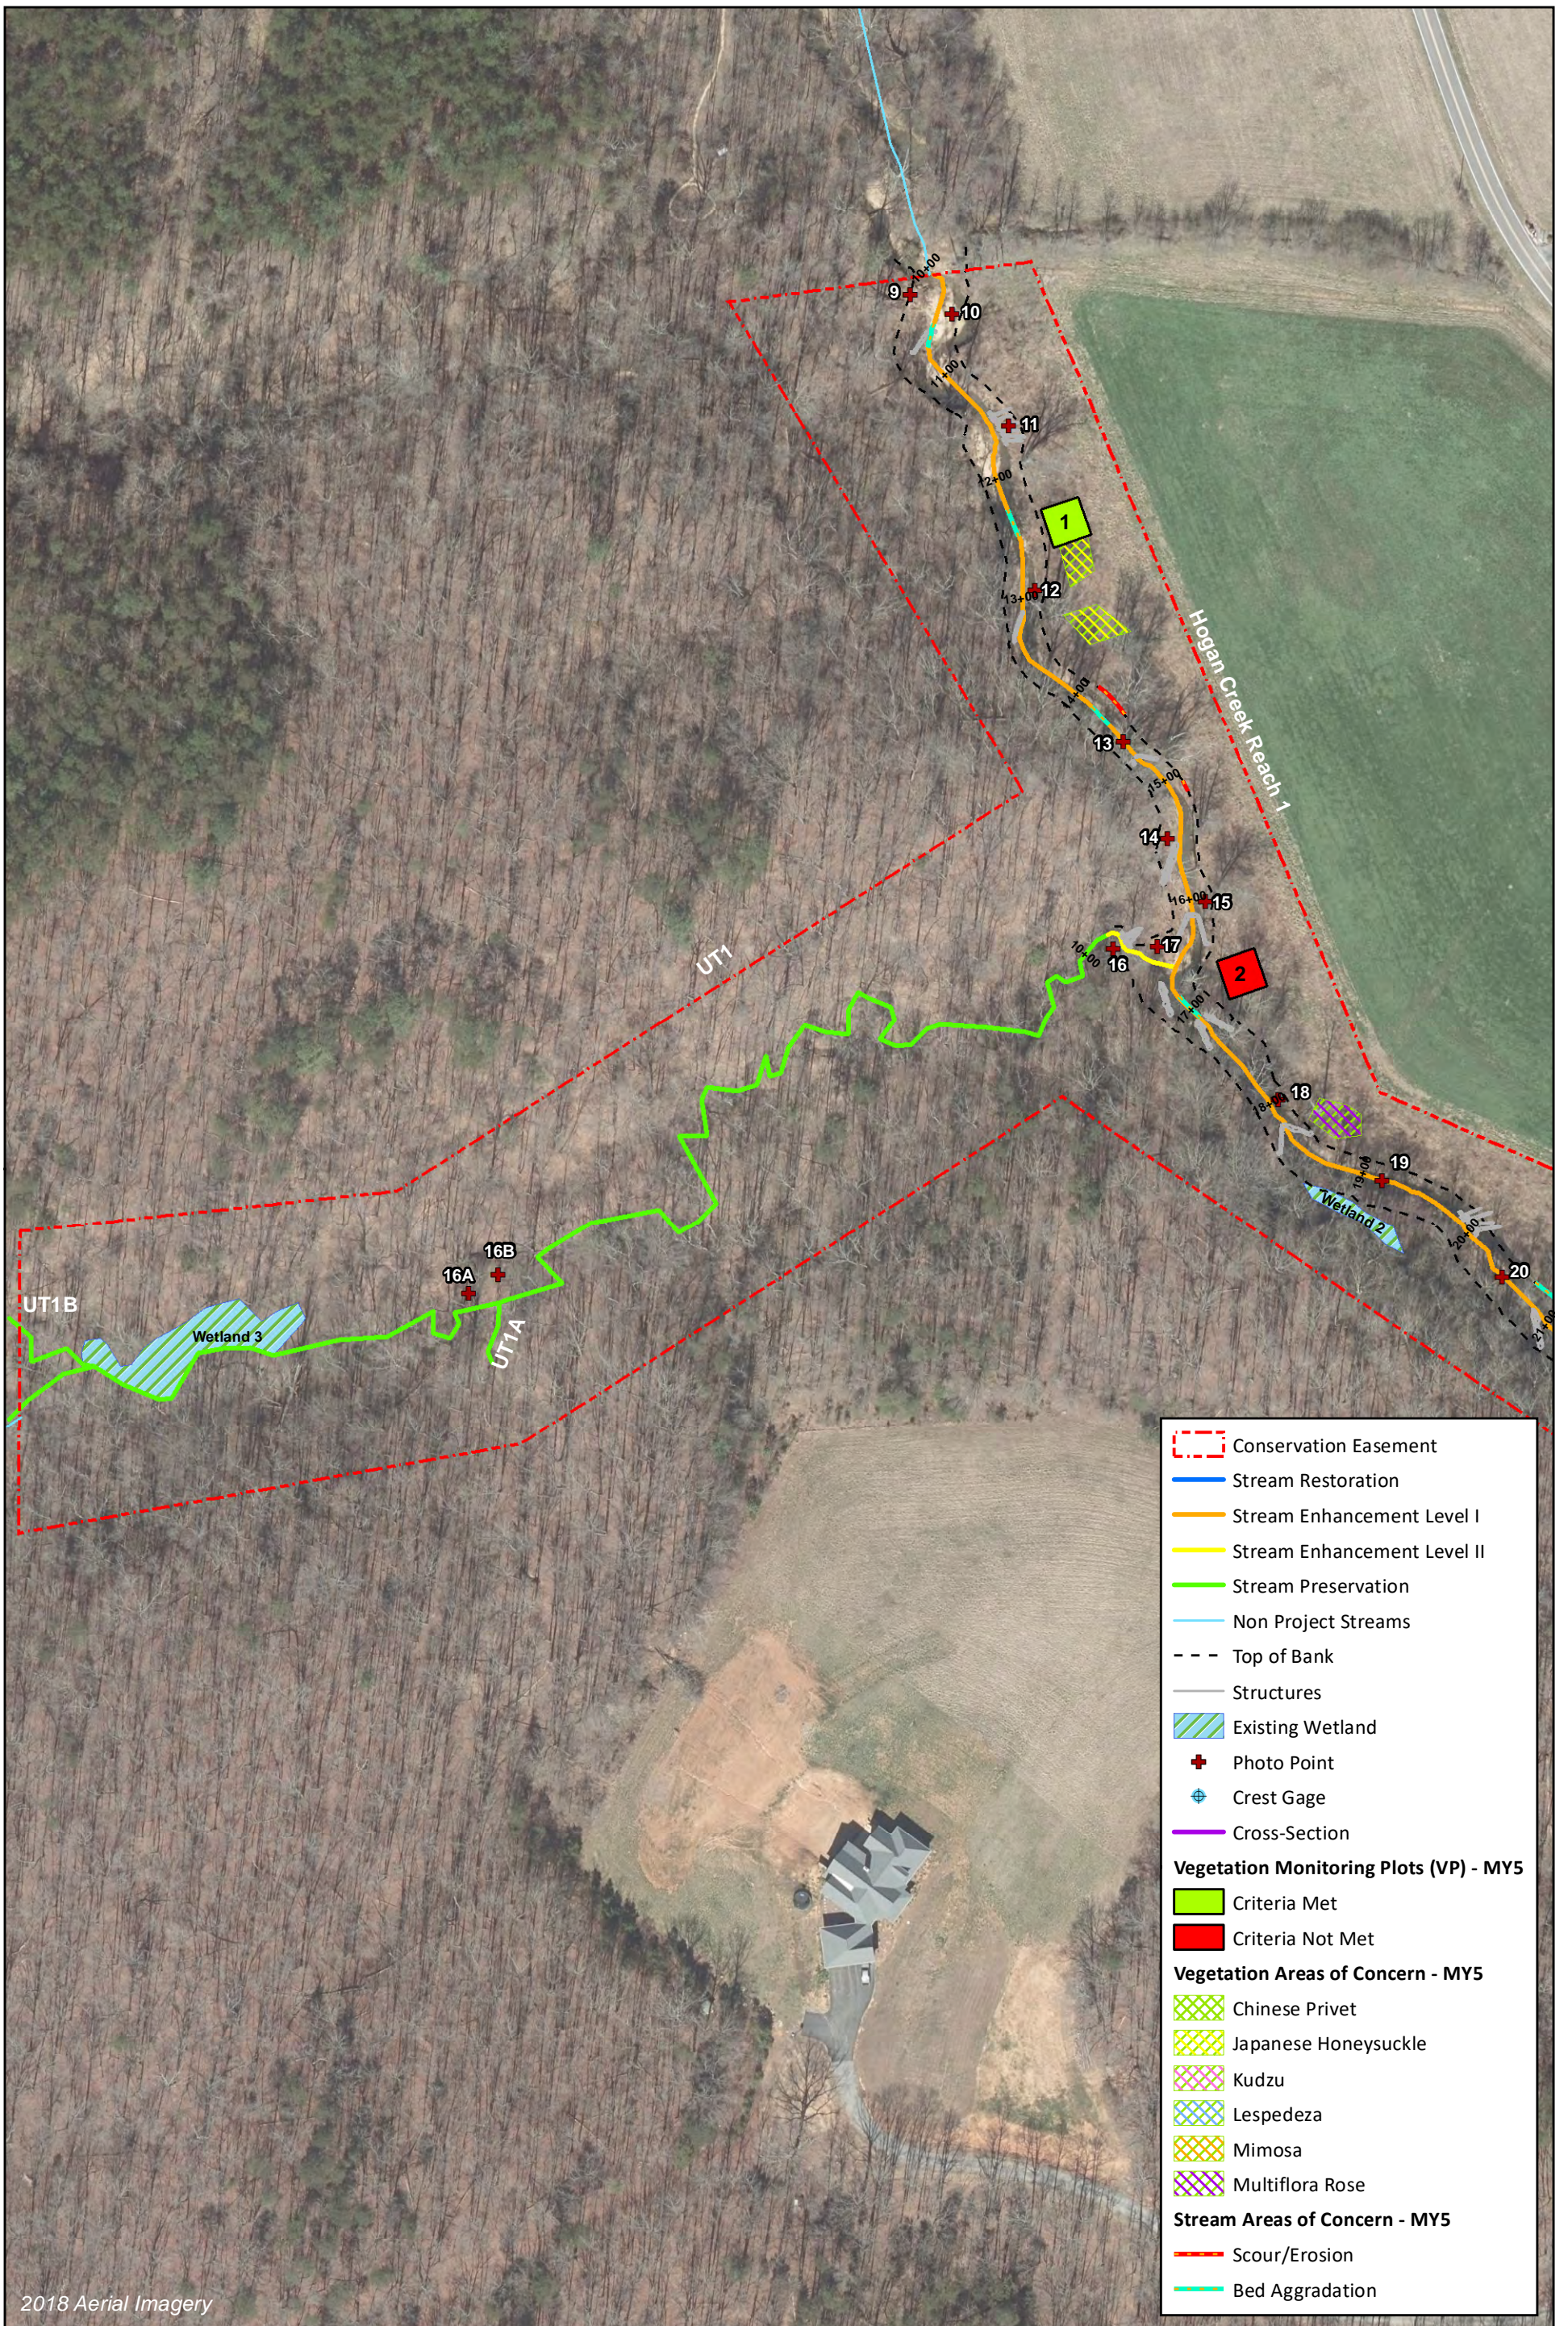
Figure 3.1 Integrated Current Condition Plan View Map (Sheet 1 of 3)
 Hogan Creek Stream Mitigation Project
 DMS Project No. 94708
 Monitoring Year 5 - 2019

floodplain of UT2 and UT2B. Approximately 1.3% of the easement acreage continues to be affected by invasive species. Current vegetation areas of concern are shown in Figure 3.0-3.3 of Appendix B.

In previous monitoring years, several significant stream areas of concern were noted on Hogan Creek Reach 1 and Reach 2 near stations 10+20, 10+80, 16+50, 20+10, 23+20, 26+70, 31+30, 34+00, and 37+70. To address previously noted areas of bank erosion, construction repairs on Hogan Creek began in January 2019 and concluded in March 2019. The repairs appear to be performing well and livestock vegetation already becoming well established on the banks. These repairs have decreased bank erosion along Reach 1 of Hogan Creek from 9% in MY4 to 1% in MY5 and along Hogan Creek Reach 2, from 10% in MY4 to 2% in MY5. Please refer to a photolog of the repair work in Appendix B. Additional areas of concern are depicted on the current condition plan view Figures 3.0-3.3 and Table 6 in Appendix B.

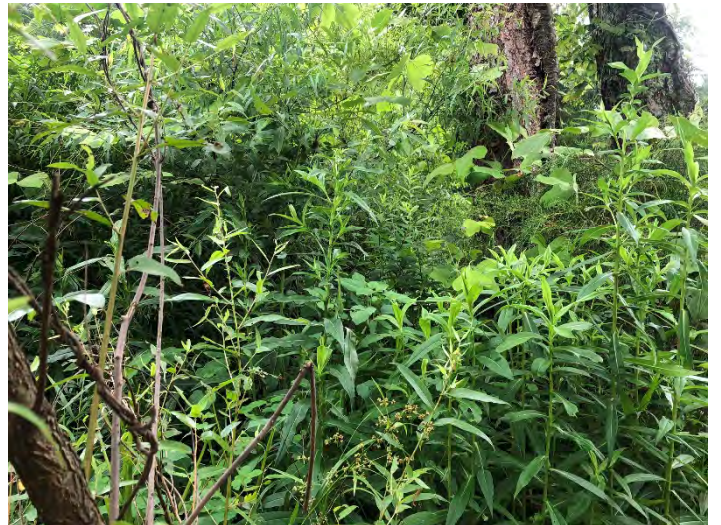
PP28 – UT3, looking upstream (6/18/2019)

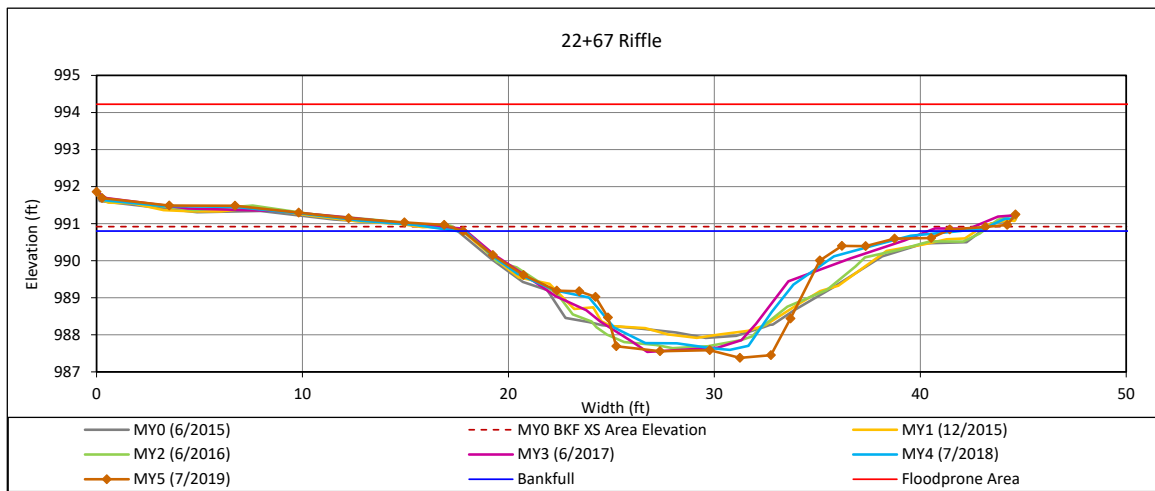
Cross Section 1-Hogan Creek Reach 1

41.0	x-section area (ft.sq.)
23.5	width (ft)
1.7	mean depth (ft)
3.4	max depth (ft)
25.7	wetted perimeter (ft)
1.6	hydraulic radius (ft)
13.4	width-depth ratio
100.0	W flood prone area (ft)
4.3	entrenchment ratio
0.97	low bank height ratio

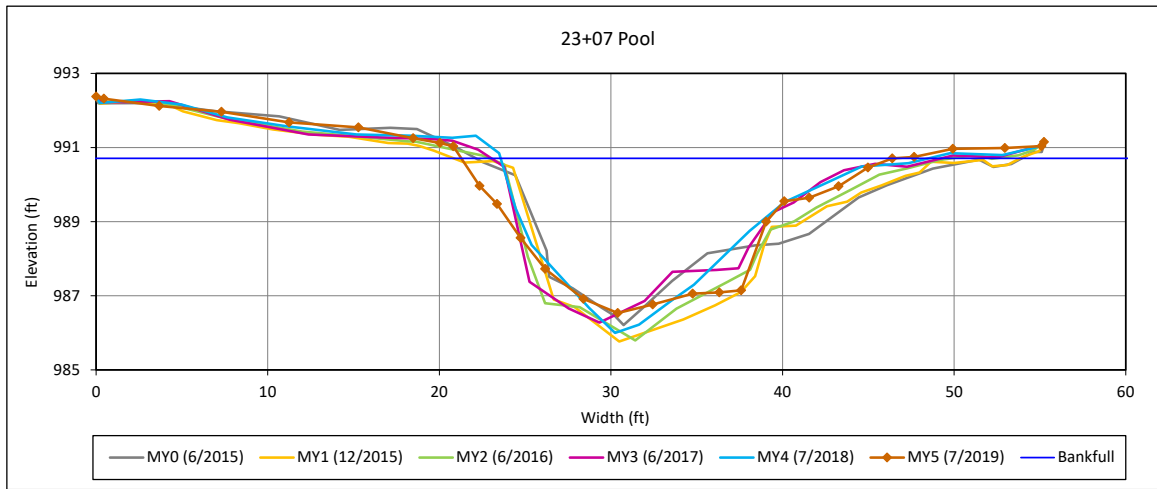
Cross Section 2-Hogan Creek Reach 1

59.8	x-section area (ft.sq.)
25.1	width (ft)
2.4	mean depth (ft)
4.2	max depth (ft)
27.3	wetted perimeter (ft)
2.2	hydraulic radius (ft)
10.6	width-depth ratio

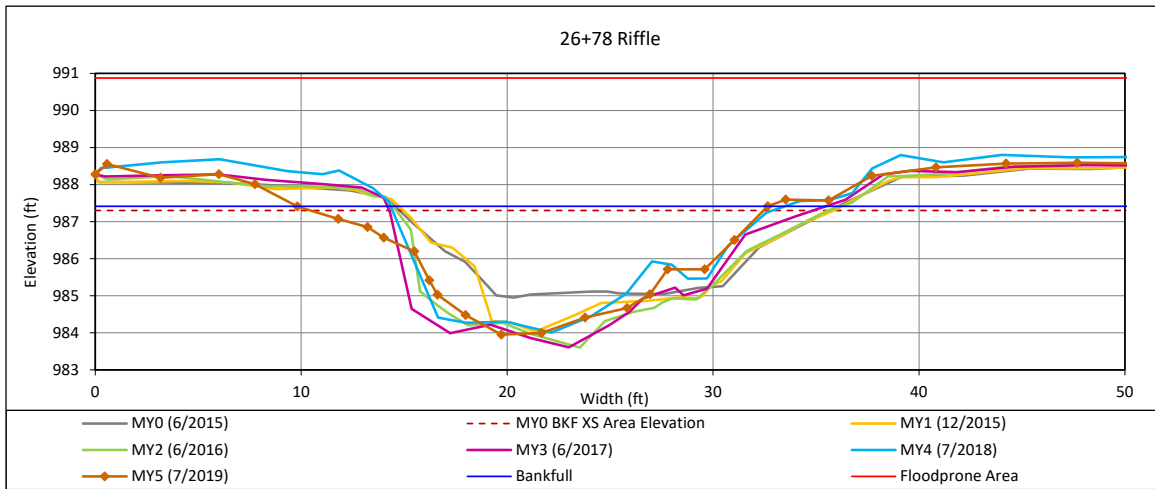
Cross Section 3-Hogan Creek Reach 1

43.9	x-section area (ft.sq.)
22.9	width (ft)
1.9	mean depth (ft)
3.5	max depth (ft)
24.5	wetted perimeter (ft)
1.8	hydraulic radius (ft)
11.9	width-depth ratio
100.0	W flood prone area (ft)
4.4	entrenchment ratio
1.03	low bank height ratio

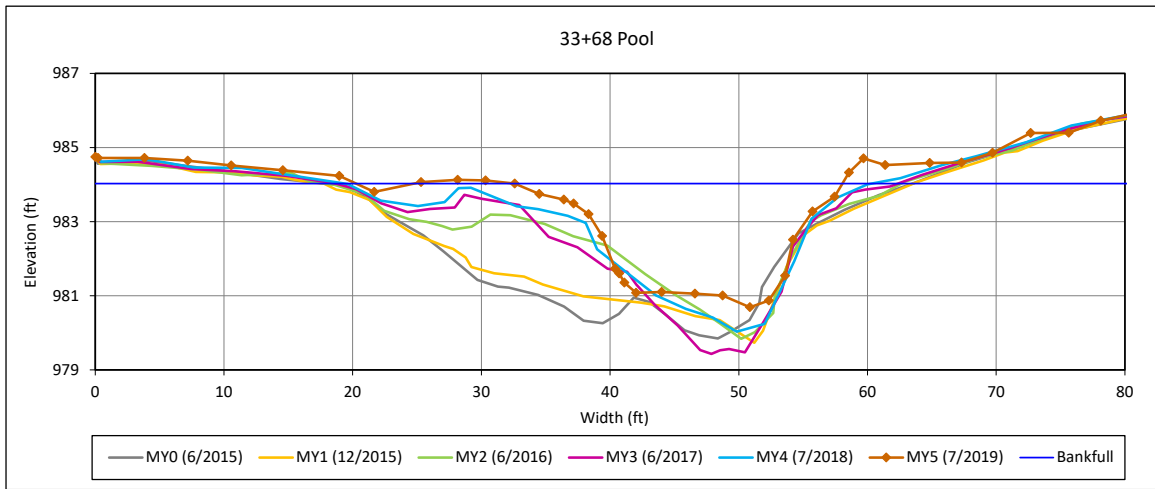
Cross Section 4-Hogan Creek Reach 2

- 48.5 x-section area (ft.sq.)
- 25.5 width (ft)
- 1.9 mean depth (ft)
- 3.3 max depth (ft)
- 27.2 wetted perimeter (ft)
- 1.8 hydraulic radius (ft)
- 13.4 width-depth ratio

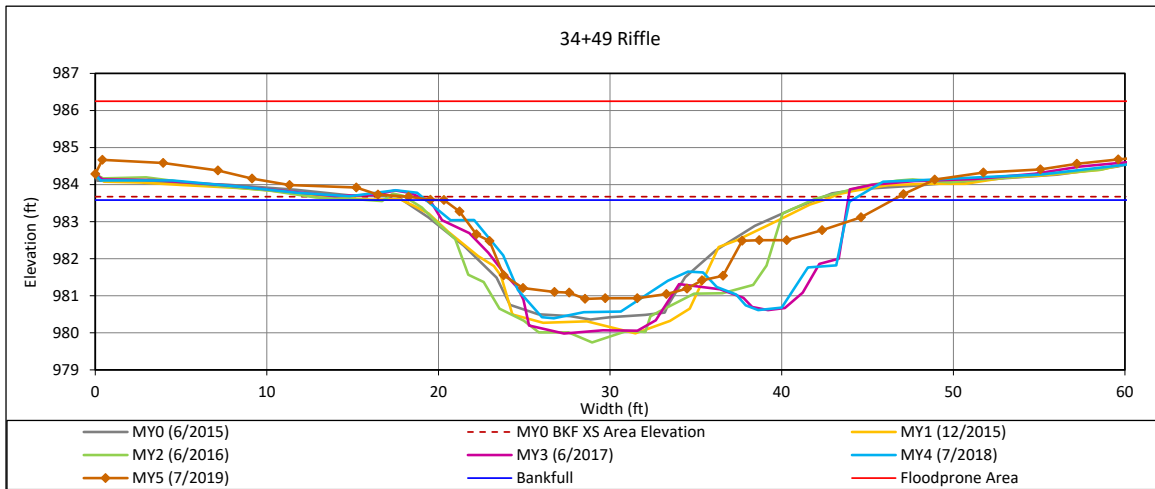
Cross Section 5-Hogan Creek Reach 2

42.7	x-section area (ft.sq.)
26.2	width (ft)
1.6	mean depth (ft)
2.7	max depth (ft)
27.4	wetted perimeter (ft)
1.6	hydraulic radius (ft)
16.0	width-depth ratio
100.0	W flood prone area (ft)
3.8	entrenchment ratio
0.97	low bank height ratio

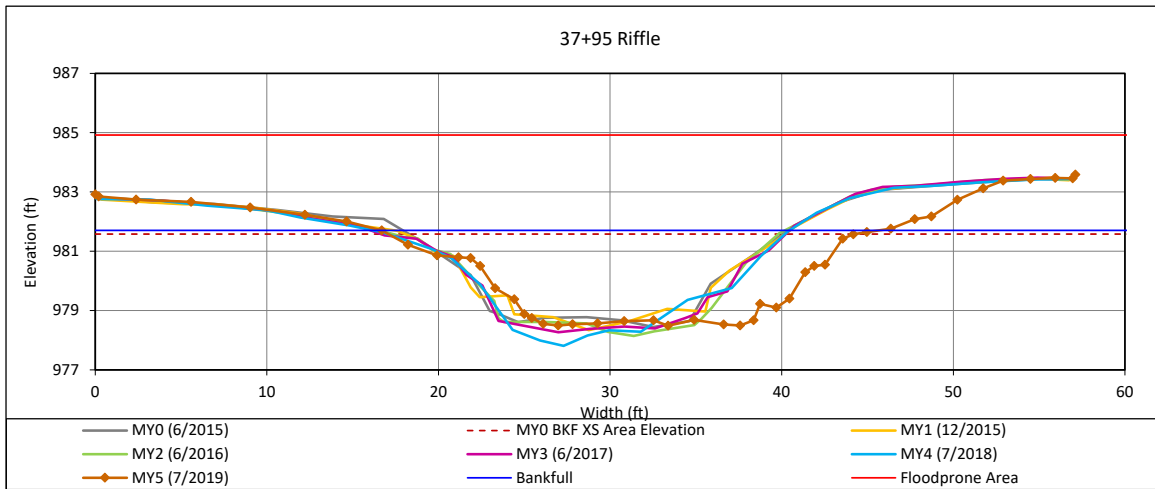
Cross Section 6-Hogan Creek Reach 2

60.1	x-section area (ft.sq.)
29.0	width (ft)
2.1	mean depth (ft)
3.2	max depth (ft)
30.9	wetted perimeter (ft)
1.9	hydraulic radius (ft)
14.0	width-depth ratio
100.0	W flood prone area (ft)
3.4	entrenchment ratio
1.04	low bank height ratio

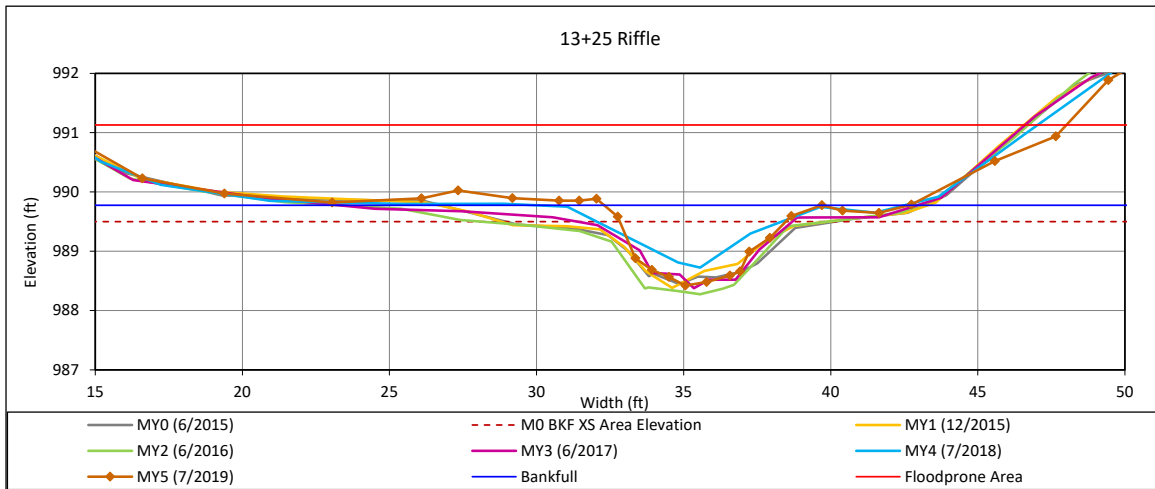
Cross Section 7-UT2

5.8	x-section area (ft.sq.)
7.4	width (ft)
0.8	mean depth (ft)
1.4	max depth (ft)
8.1	wetted perimeter (ft)
0.7	hydraulic radius (ft)
9.5	width-depth ratio
34.6	W flood prone area (ft)
4.7	entrenchment ratio
1.3	low bank height ratio

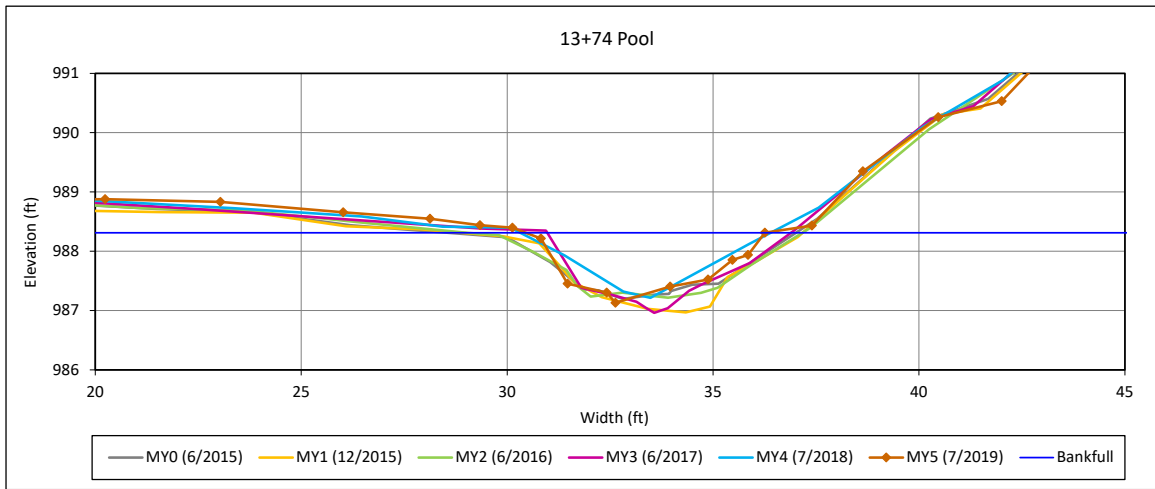
Cross Section 8-UT2

- 4.2 x-section area (ft.sq.)
- 5.8 width (ft)
- 0.7 mean depth (ft)
- 1.2 max depth (ft)
- 6.5 wetted perimeter (ft)
- 0.6 hydraulic radius (ft)
- 8.0 width-depth ratio

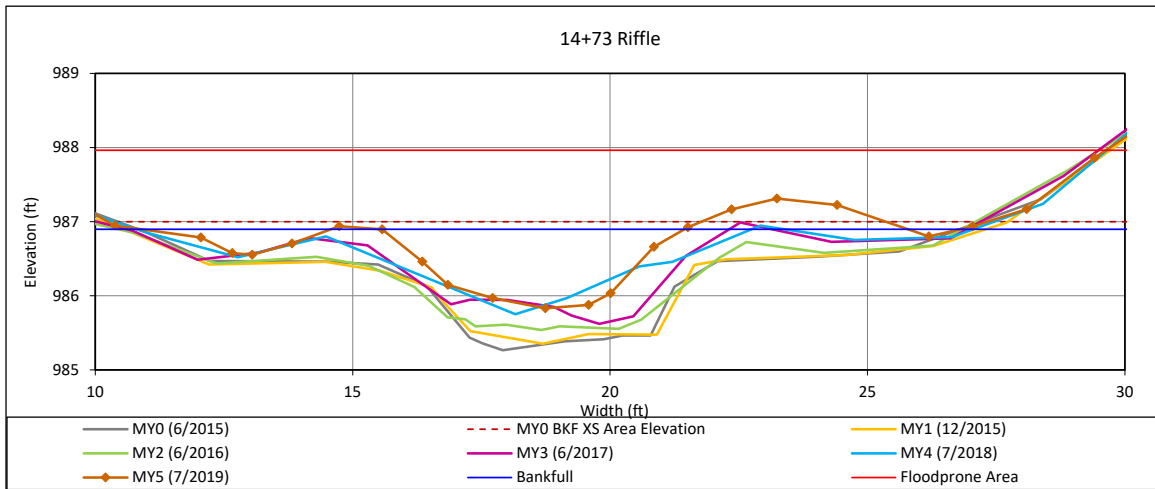
Cross Section 9-UT2

- 4.0 x-section area (ft.sq.)
- 5.9 width (ft)
- 0.7 mean depth (ft)
- 1.1 max depth (ft)
- 6.4 wetted perimeter (ft)
- 0.6 hydraulic radius (ft)
- 8.6 width-depth ratio
- 27.9 W flood prone area (ft)
- 4.8 entrenchment ratio
- 0.9 low bank height ratio
