Holly Grove Stream Restoration Site

Guilford County, North Carolina

MONITORING REPORT 2011 (YEAR 3)

Restoration Systems, LLC

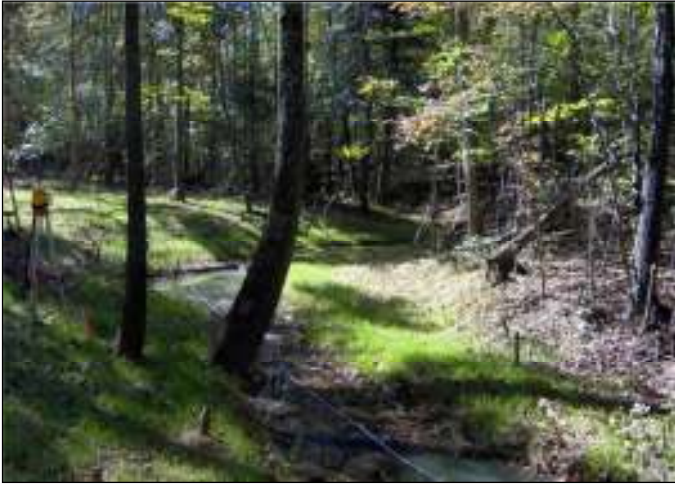
Photo Point 12

Southwest Creek facing upstream
Year 0 Photo No. 45

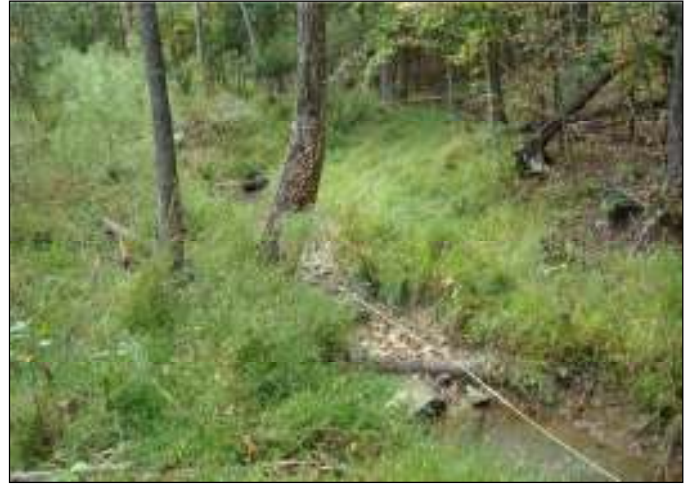
Southwest Creek facing upstream
Year 2 Photo No. 47

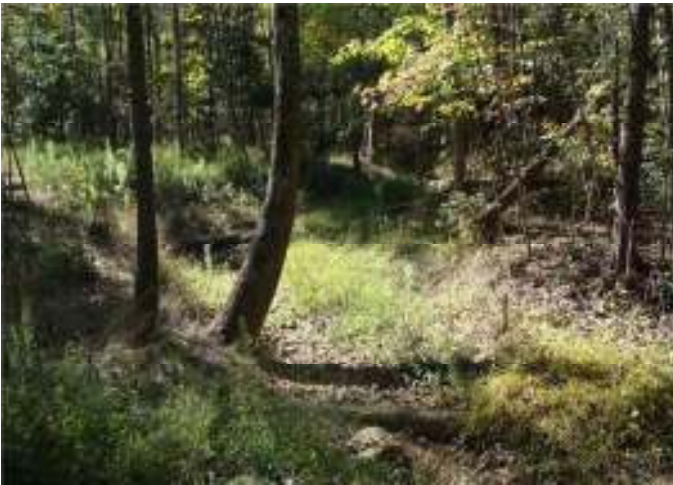
Southwest Creek facing upstream
Year 1 Photo No. 46

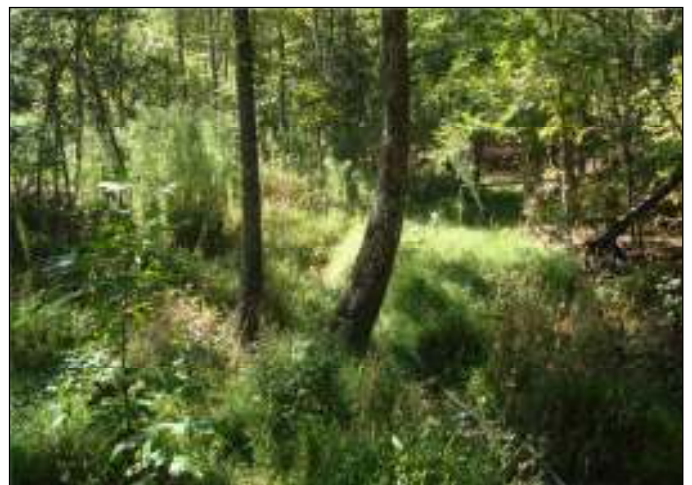
Southwest Creek facing upstream
Year 3 Photo No. 48
