Holly Grove Stream Restoration Site

Guilford County, North Carolina

MONITORING REPORT 2012 (YEAR 4)

Wolf Creek Engineering, pllc
7 Florida Avenue
Weaverville, NC 28787

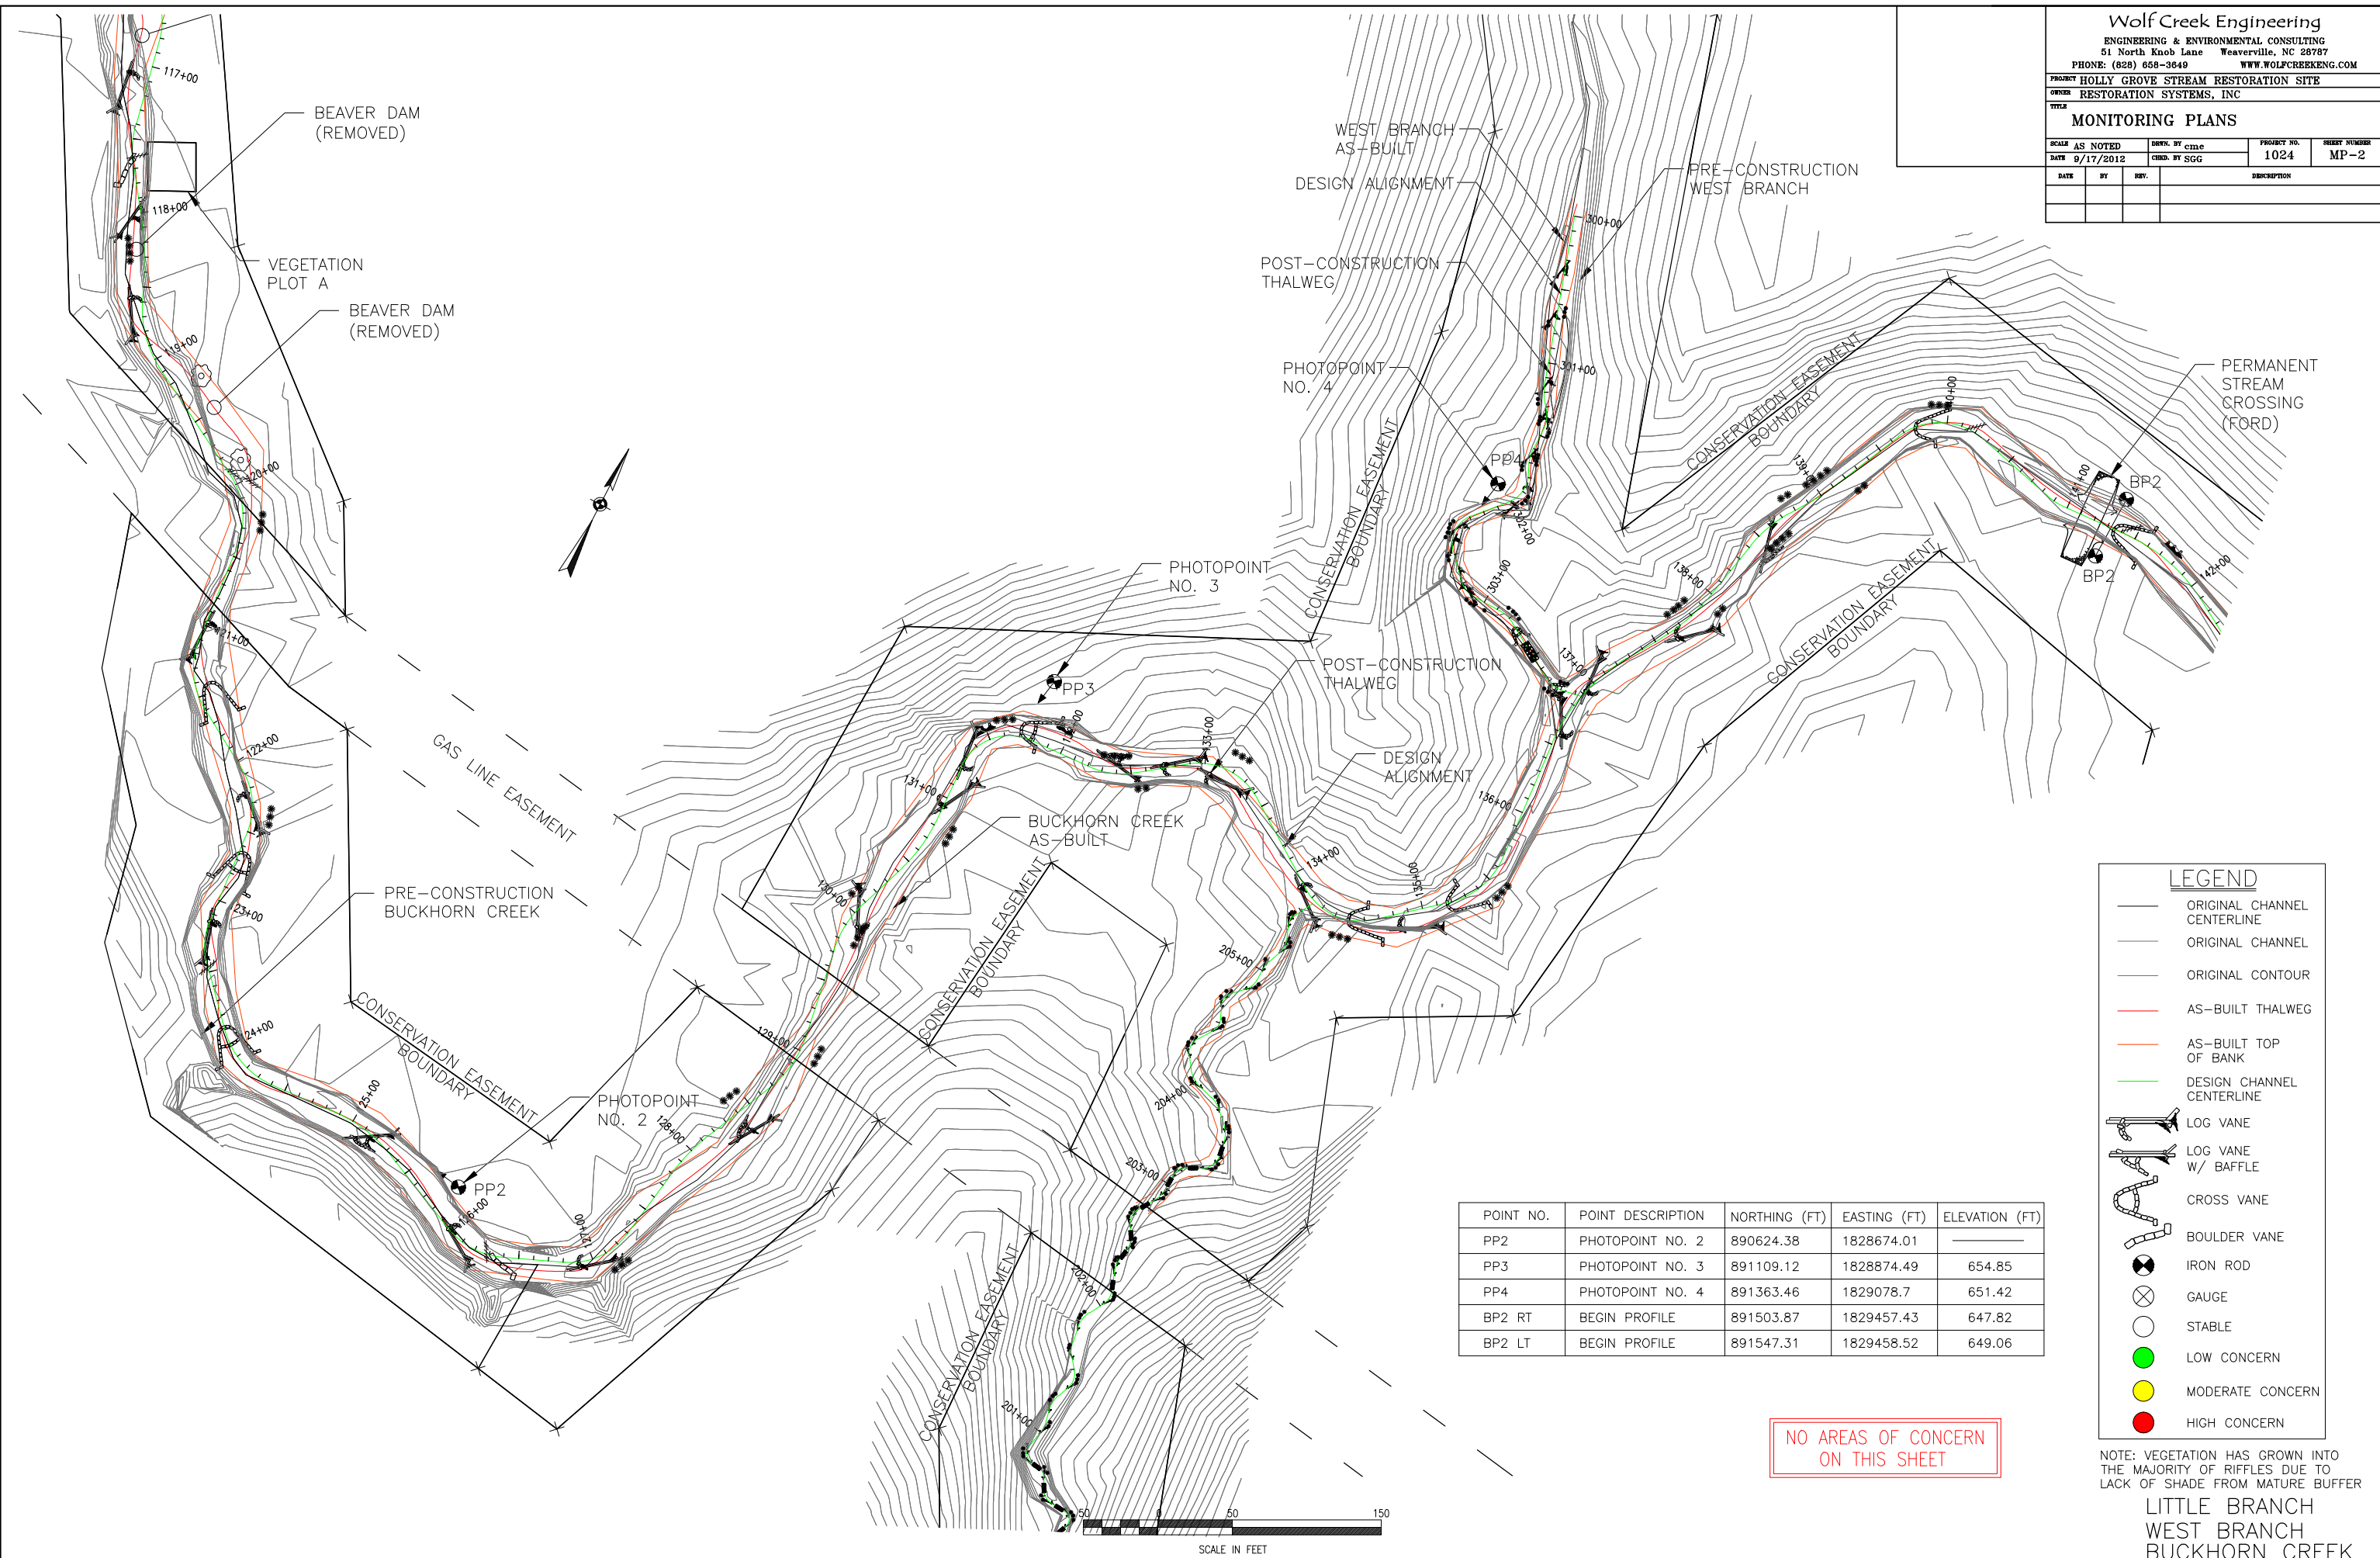
NOTE: VEGETATION HAS GROWN INTO THE MAJORITY OF RIFFLES DUE TO LACK OF SHADE FROM MATURE BUFFER

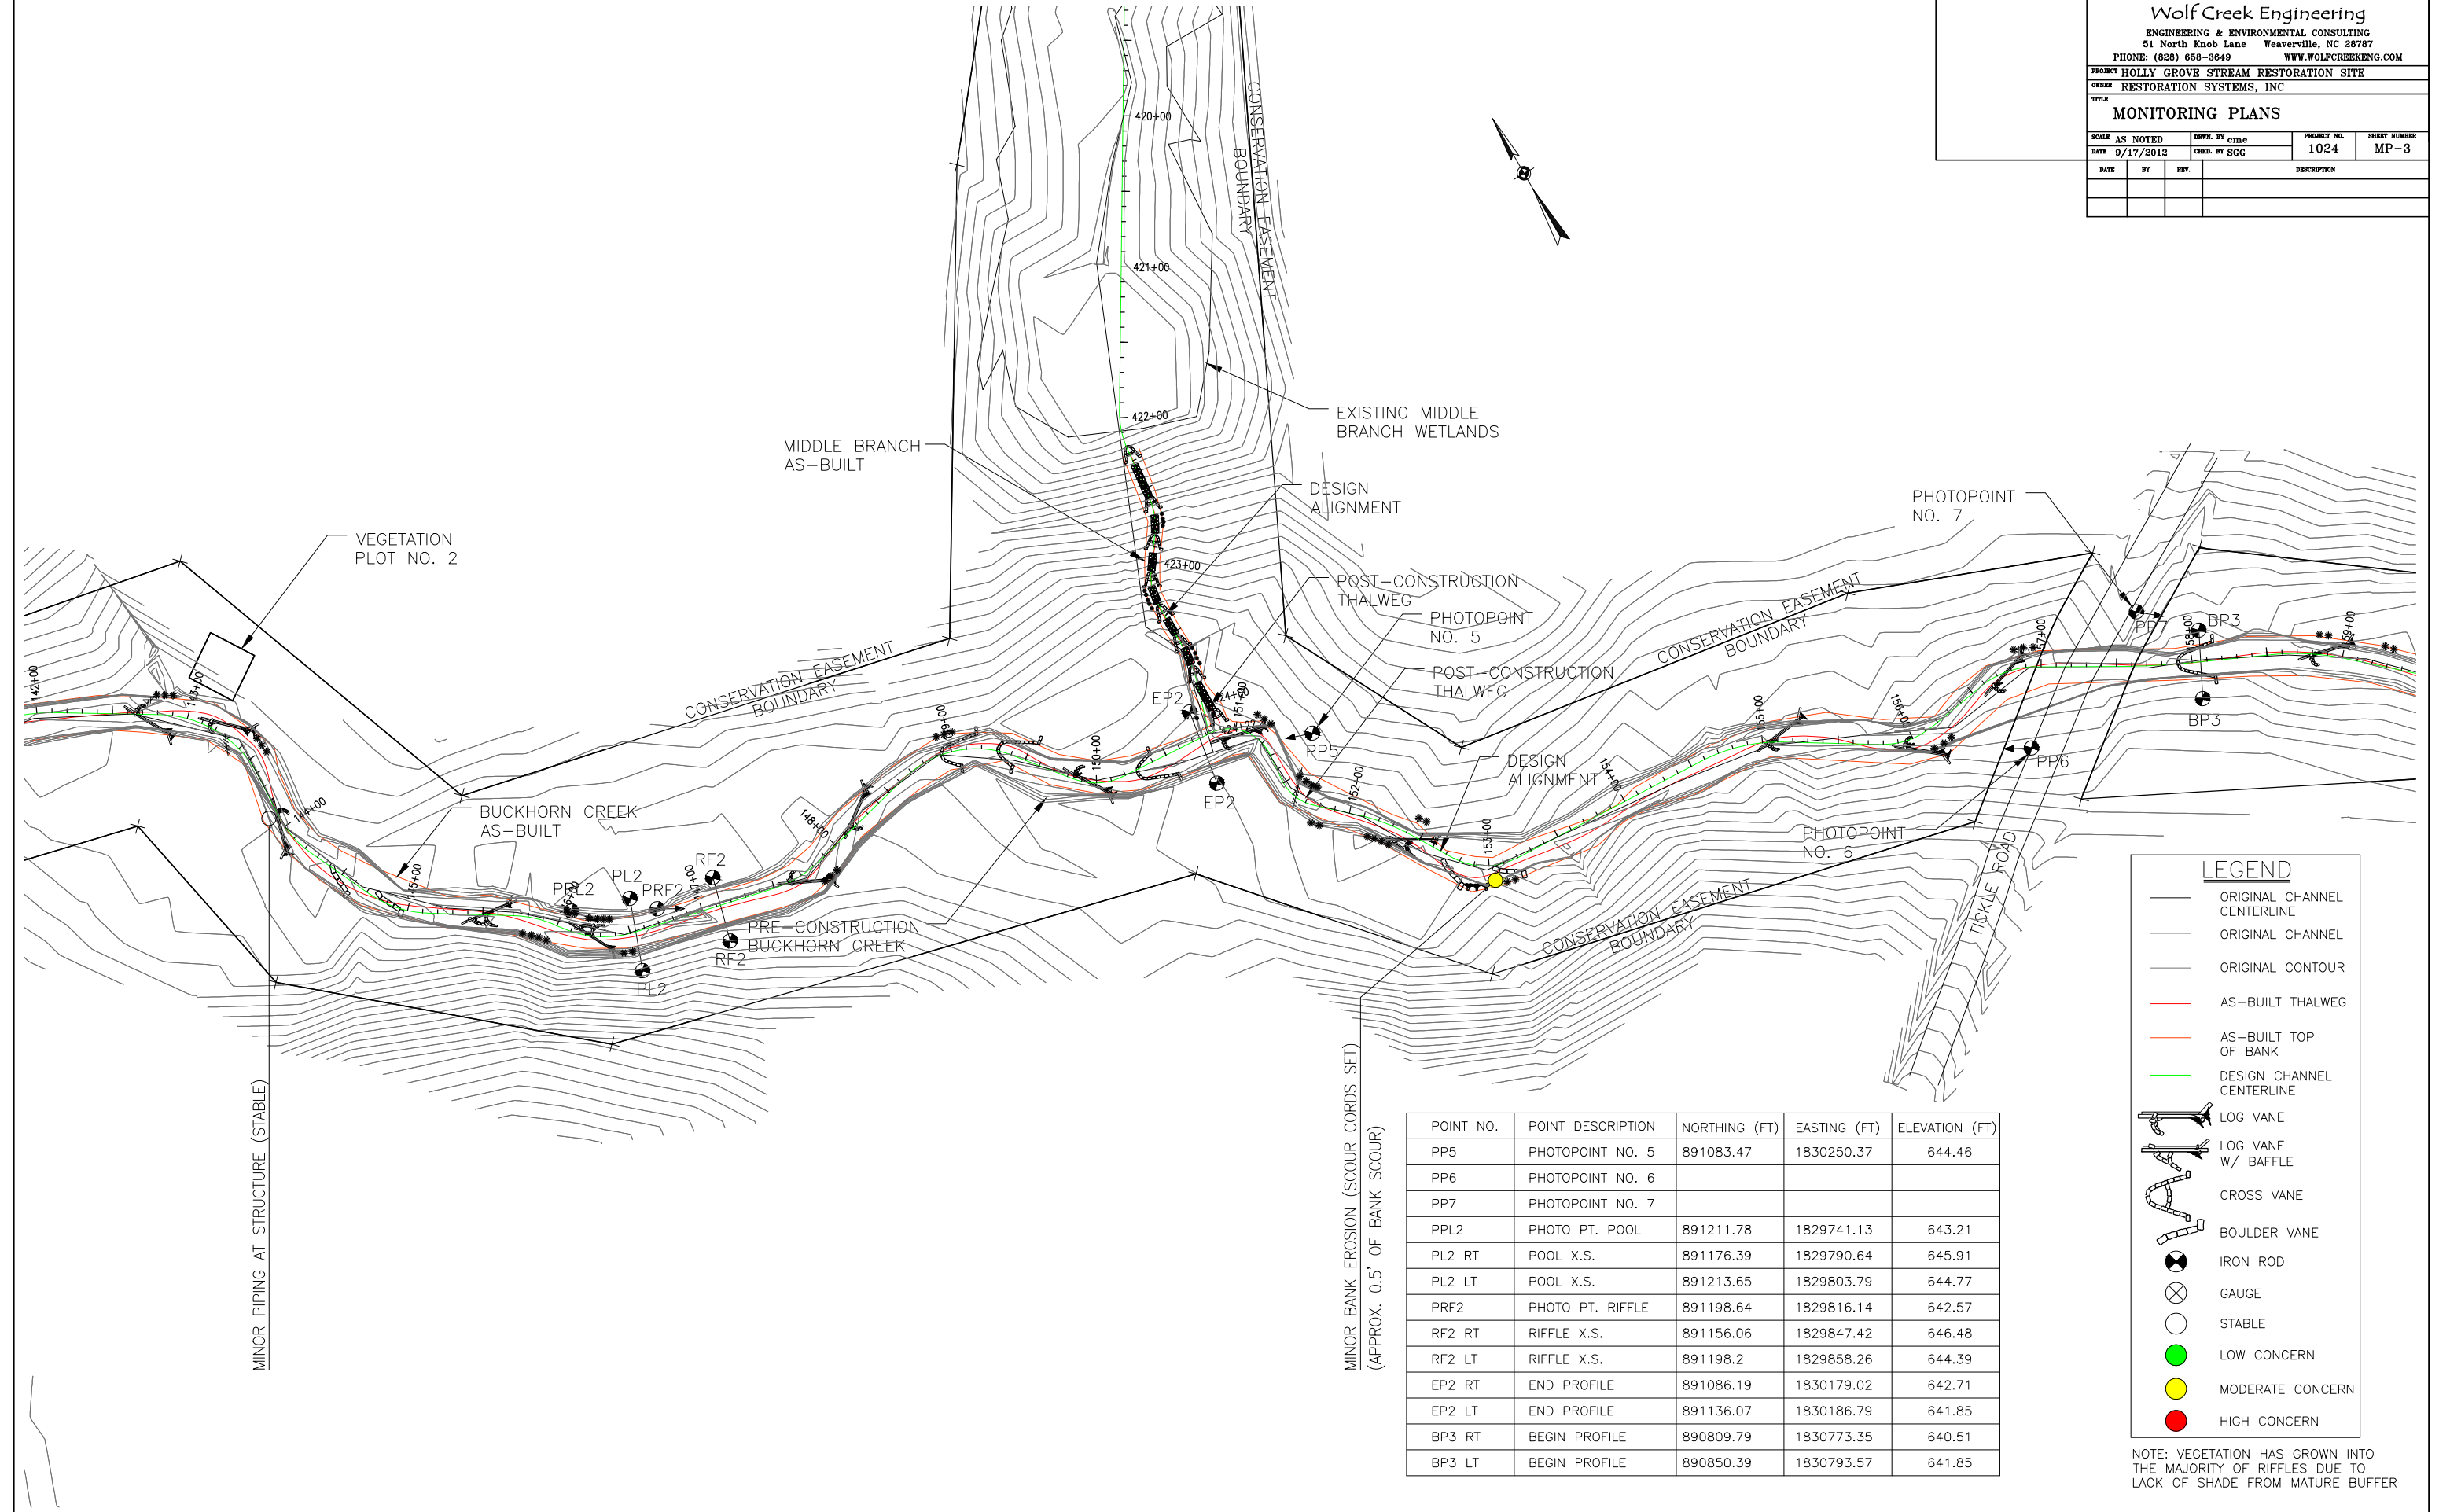
NOTE: VEGETATION HAS GROWN INTO THE MAJORITY OF RIFFLES DUE TO LACK OF SHADE FROM MATURE BUFFER
 LITTLE BRANCH
 WEST BRANCH
 BUCKHORN CREEK

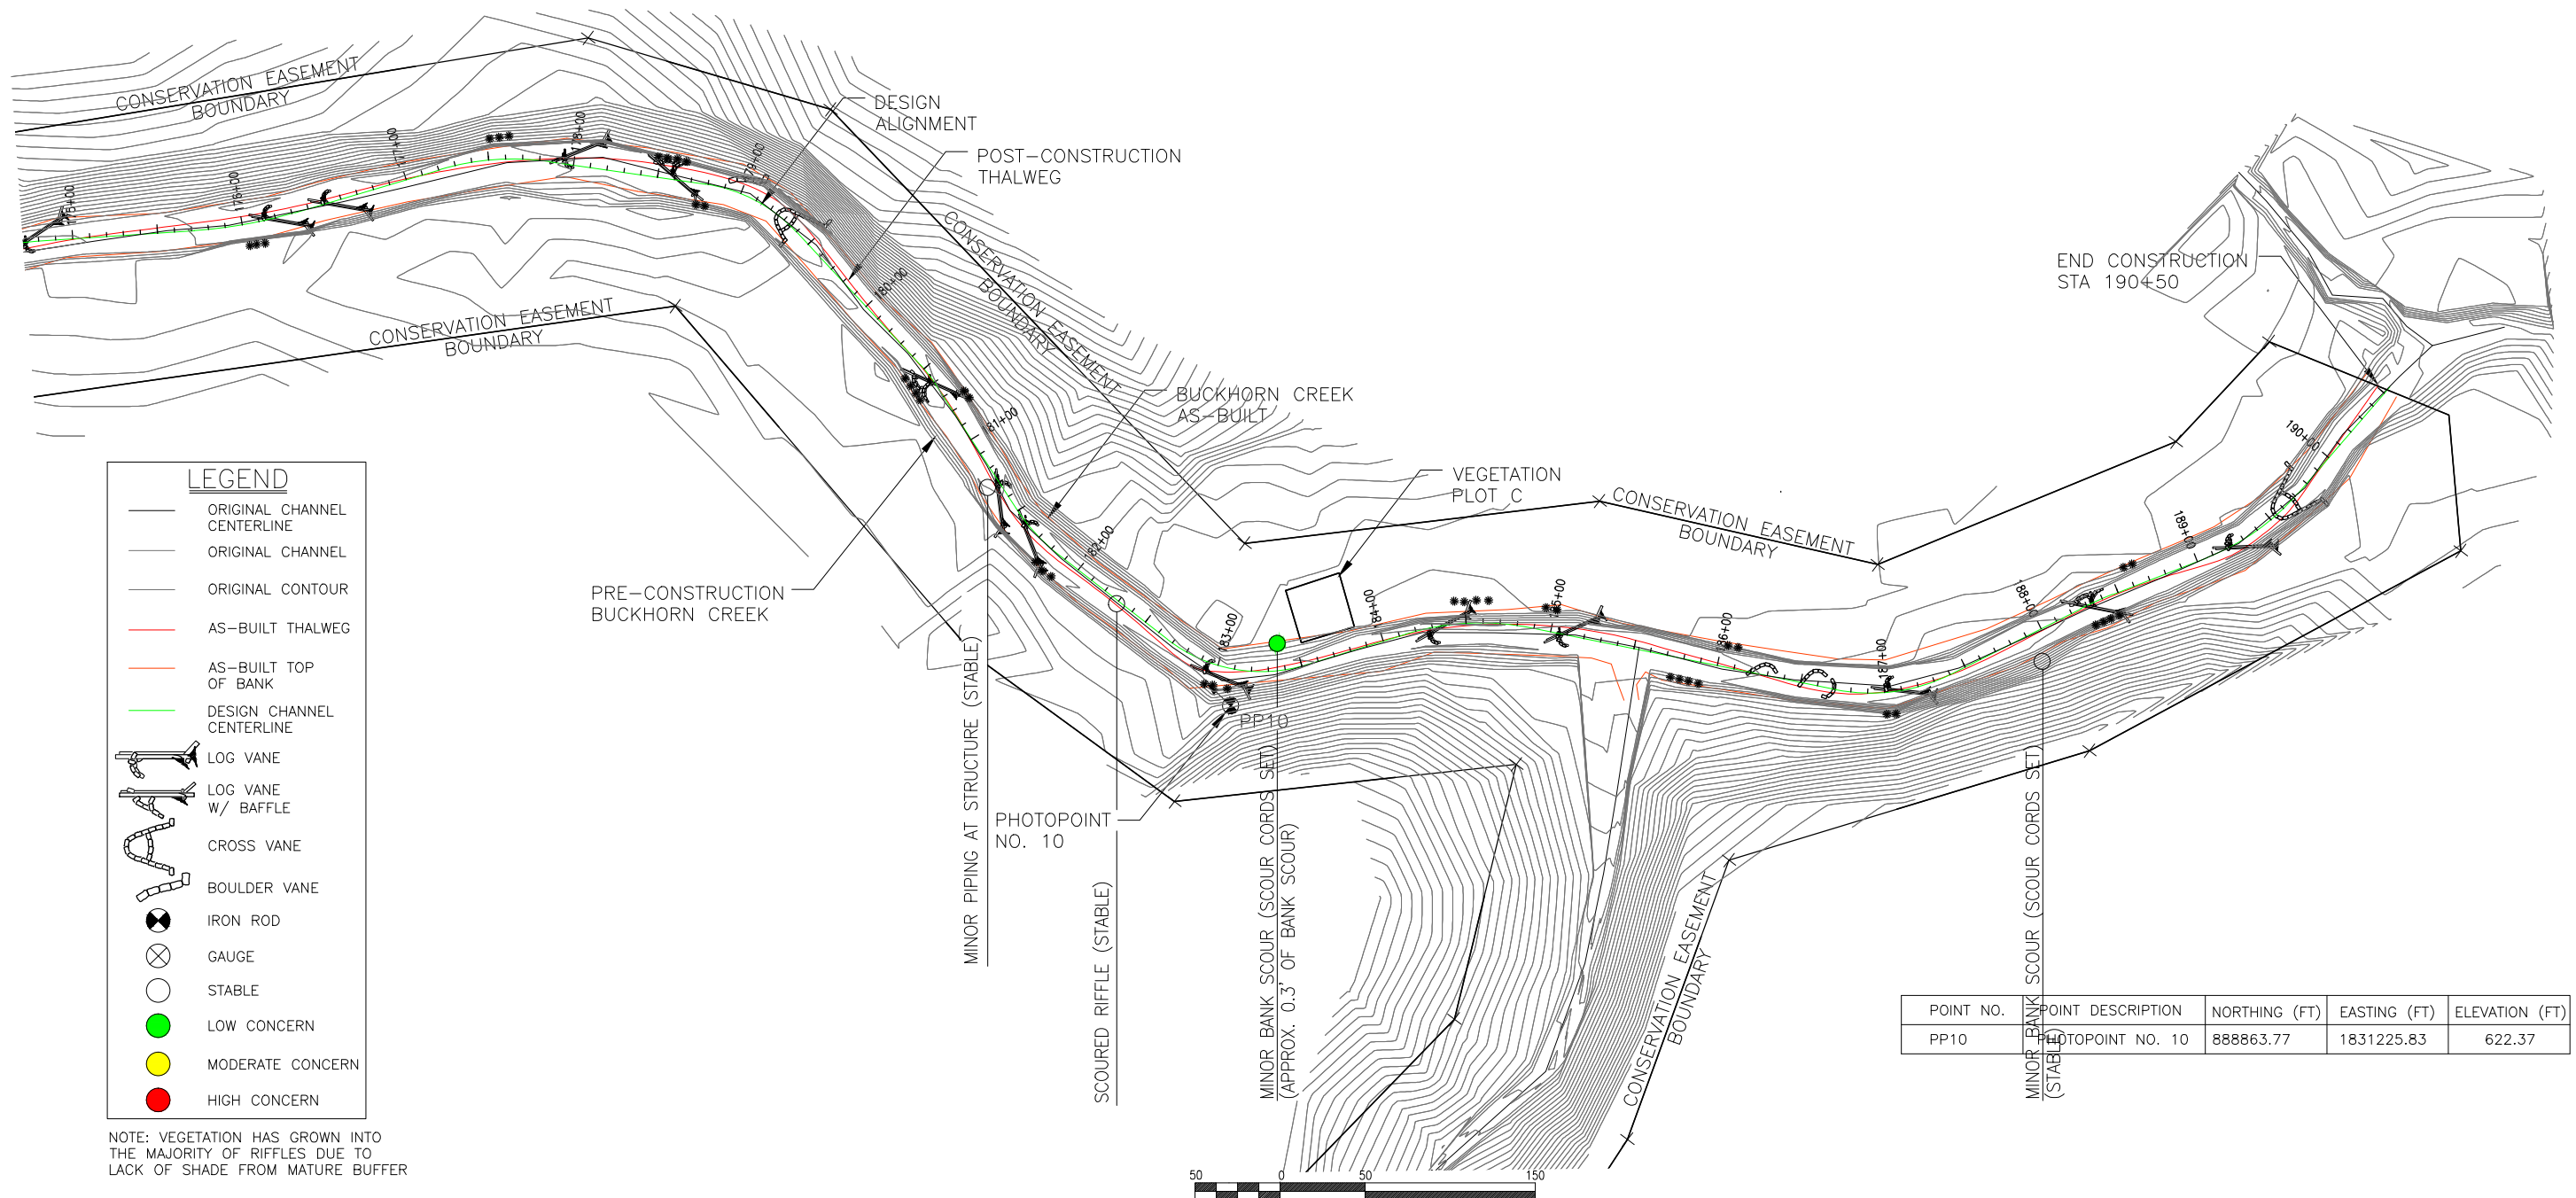
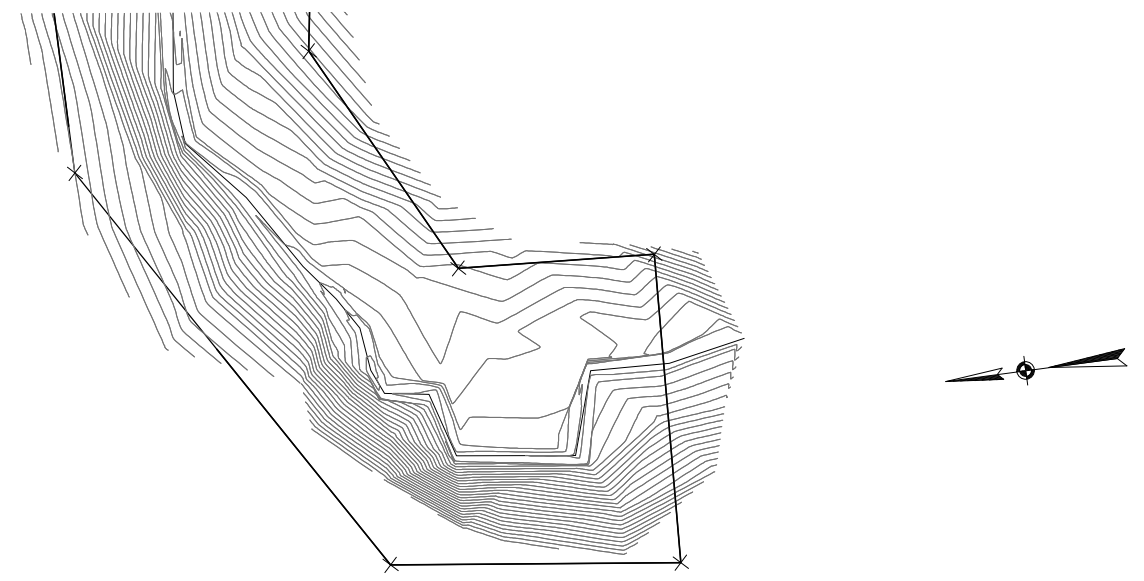
LOWER EAST BRANCH BUCKHORN CREEK

NO AREAS OF CONCERN ON THIS SHEET

NOTE: VEGETATION HAS GROWN INTO THE MAJORITY OF RIFFLES DUE TO LACK OF SHADE FROM MATURE BUFFER

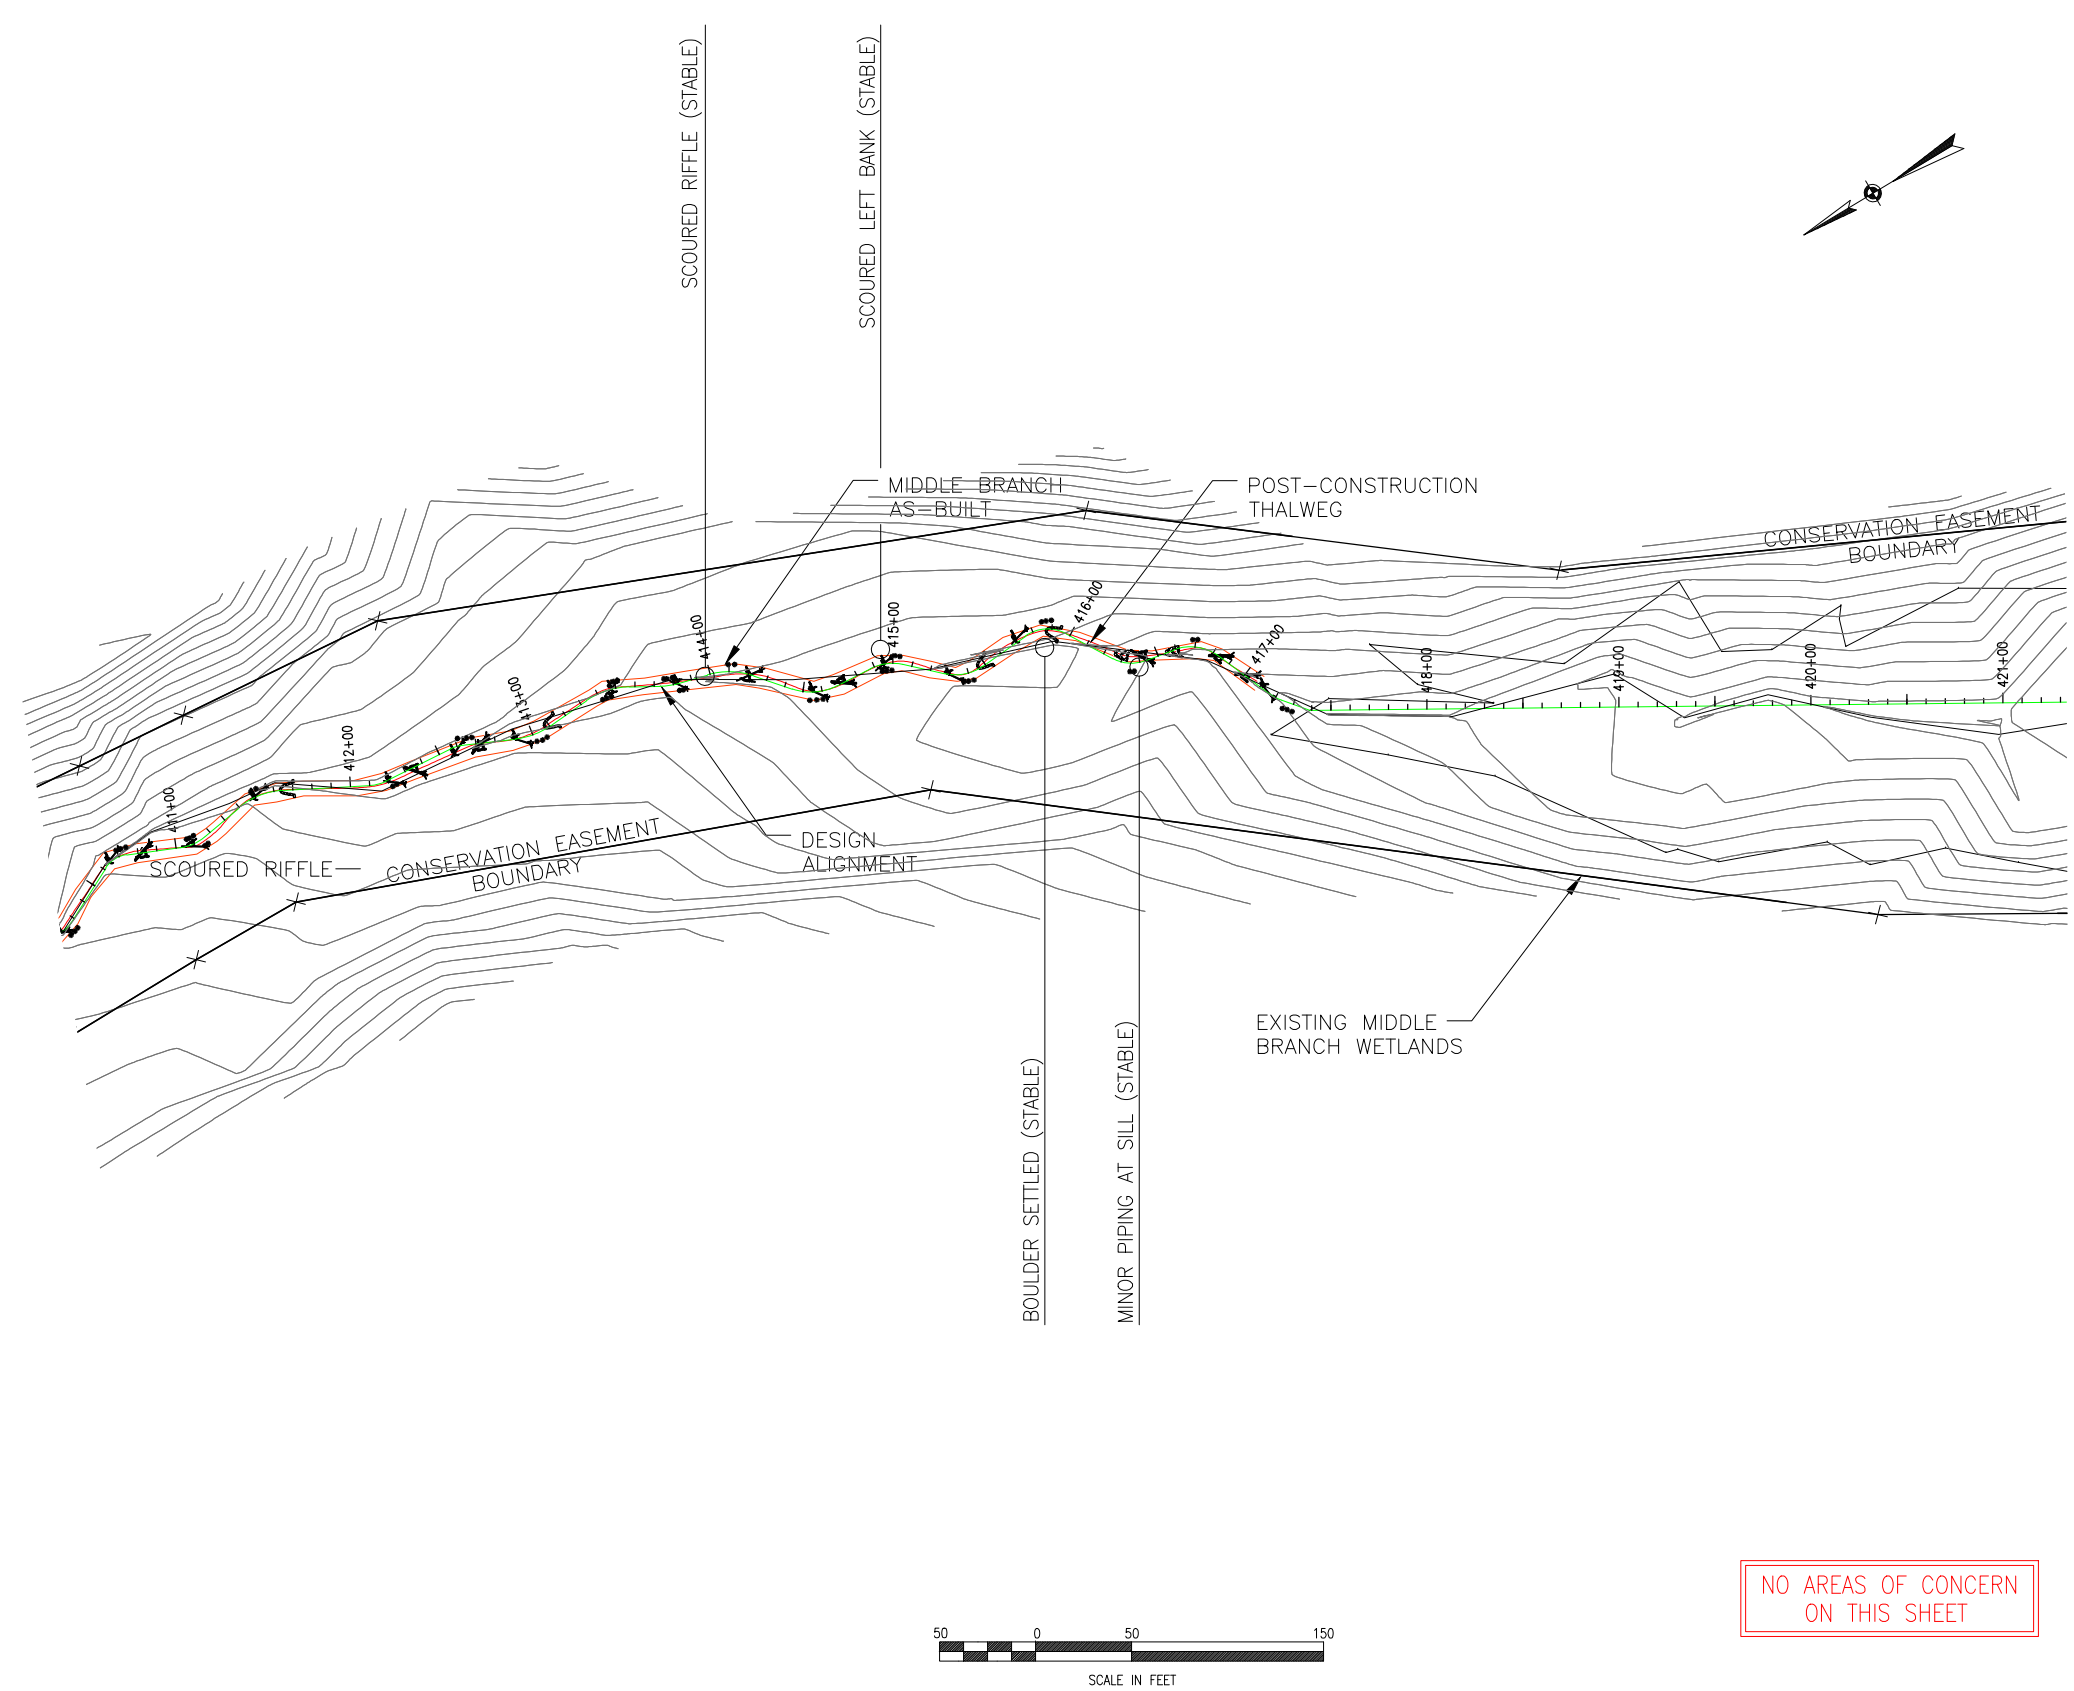
NOTE: VEGETATION HAS GROWN INTO THE MAJORITY OF RIFFLES DUE TO LACK OF SHADE FROM MATURE BUFFER

NO AREAS OF CONCERN ON THIS SHEET

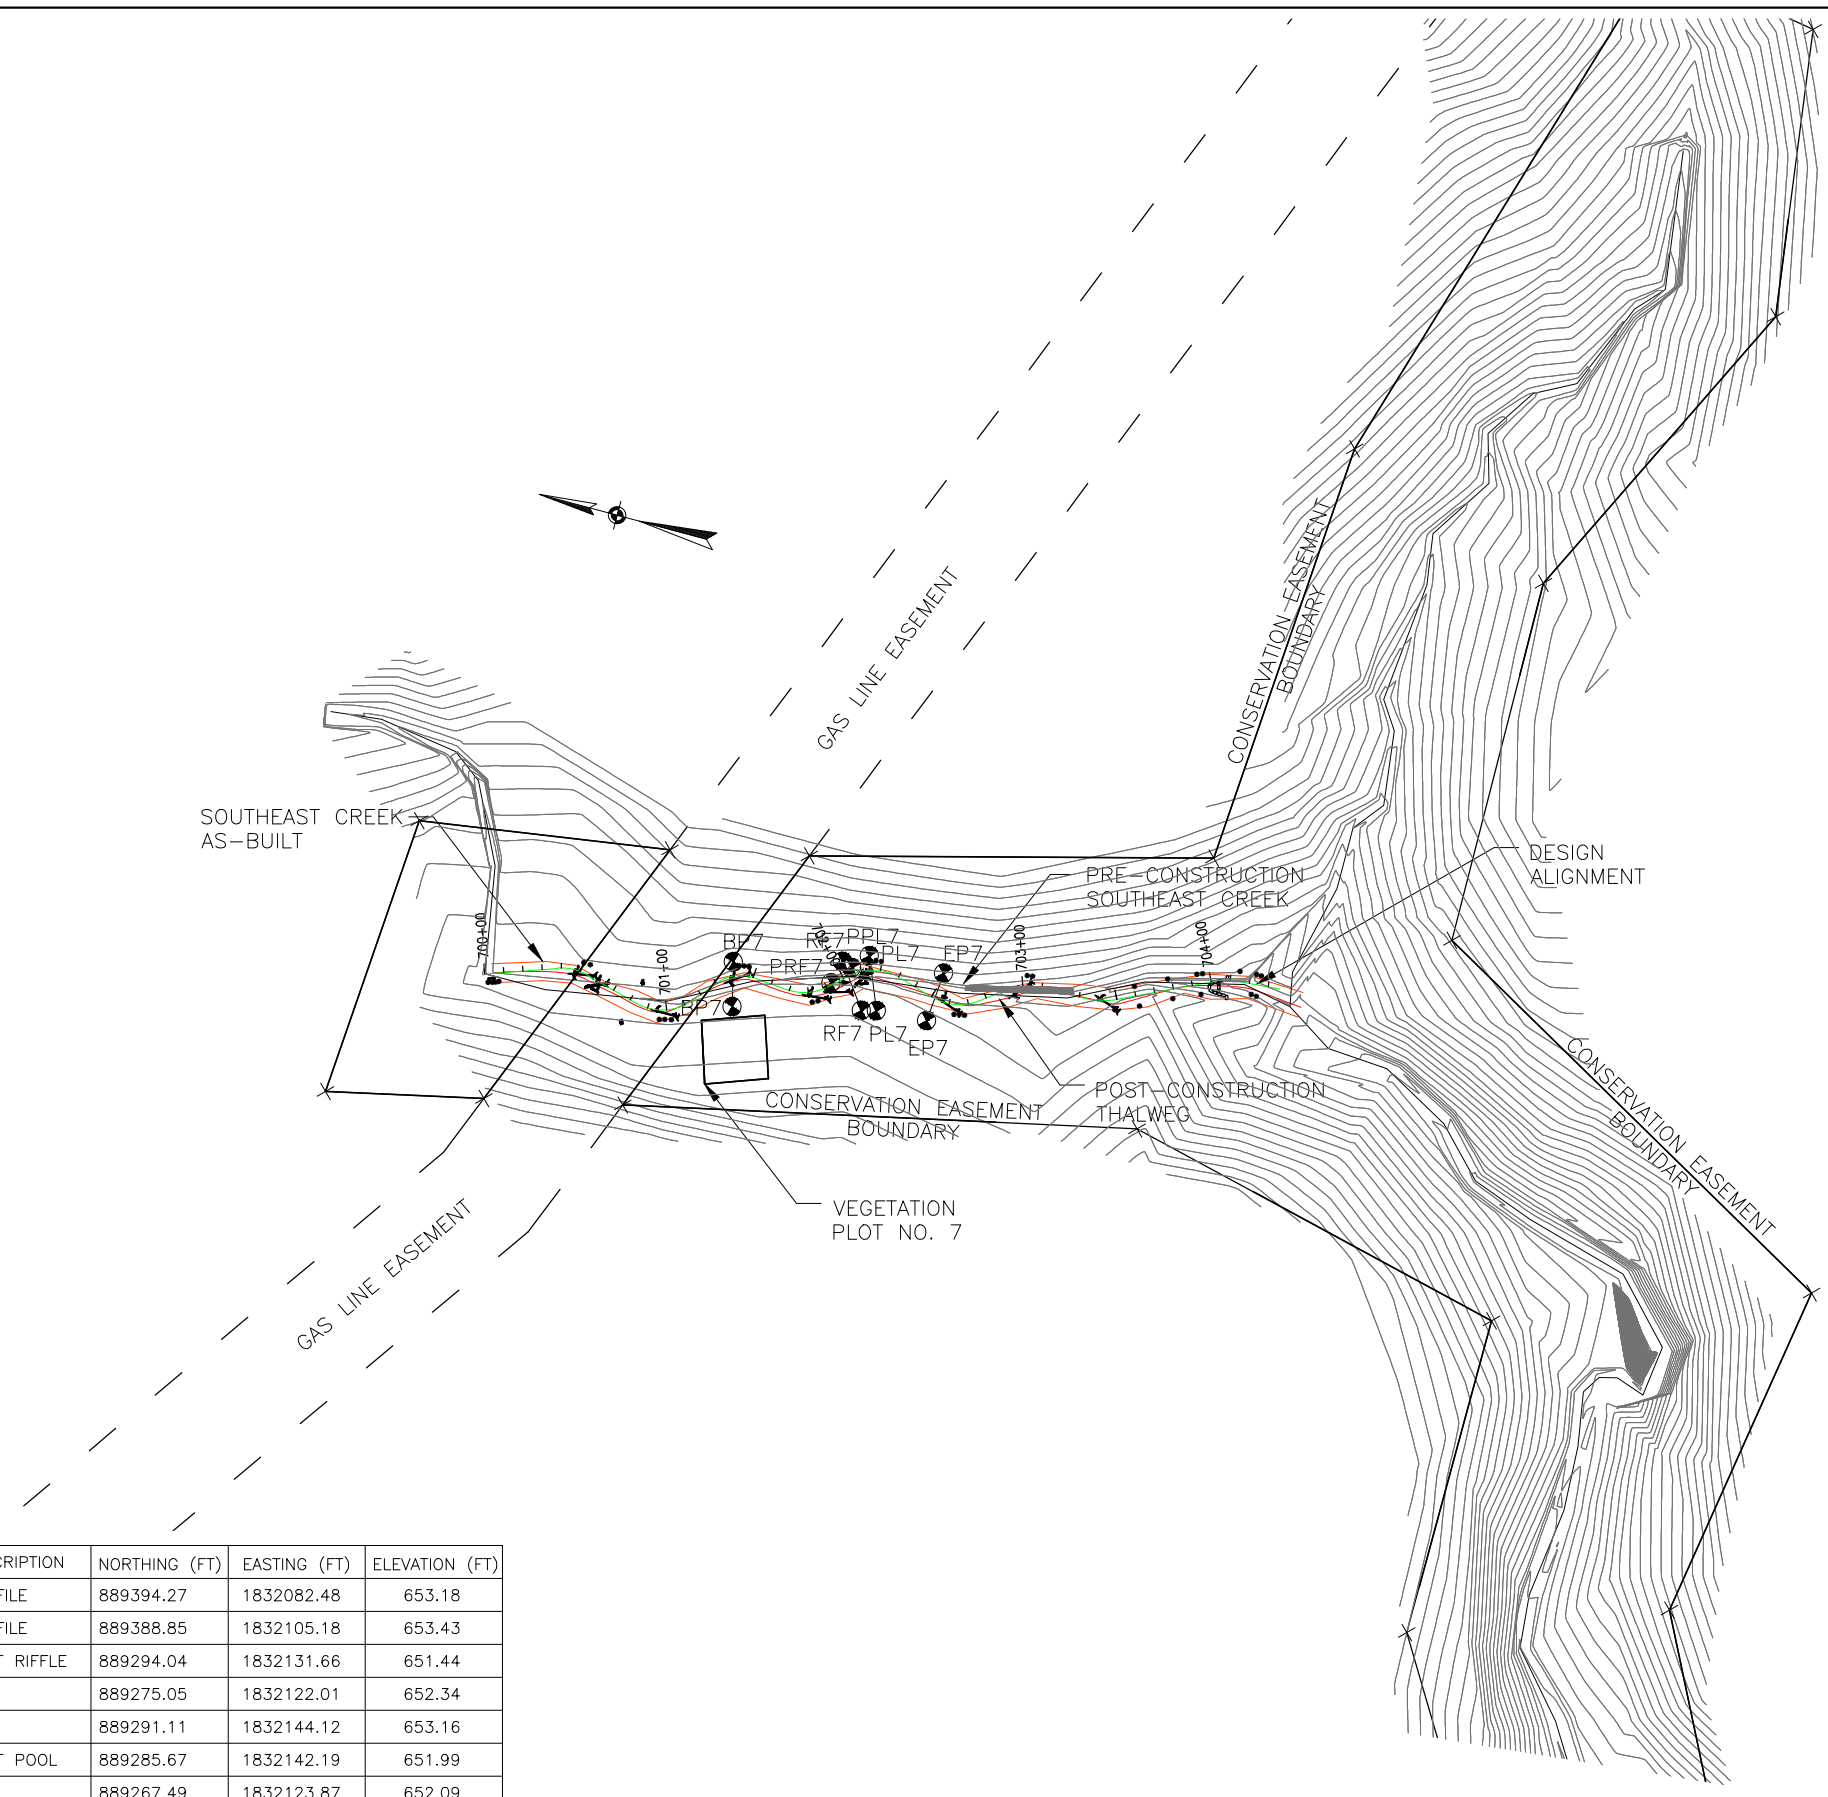
NOTE: VEGETATION HAS GROWN INTO THE MAJORITY OF RIFFLES DUE TO LACK OF SHADE FROM MATURE BUFFER
