Holly Grove Stream Restoration Site

October 28, 2013

MONITORING REPORT 2013 (YEAR 5)

Restoration Systems, LLC

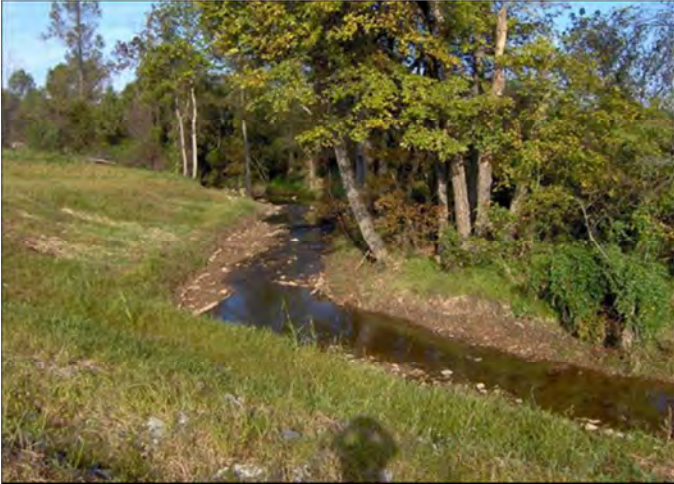
Buckhorn Creek at bridge, facing upstream Year 0 Photo No. 31

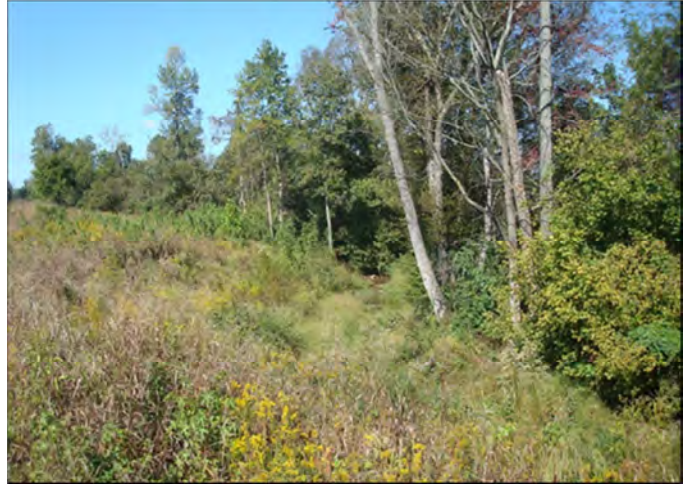
Buckhorn Creek at bridge, facing upstream Year 3 Photo No. 34

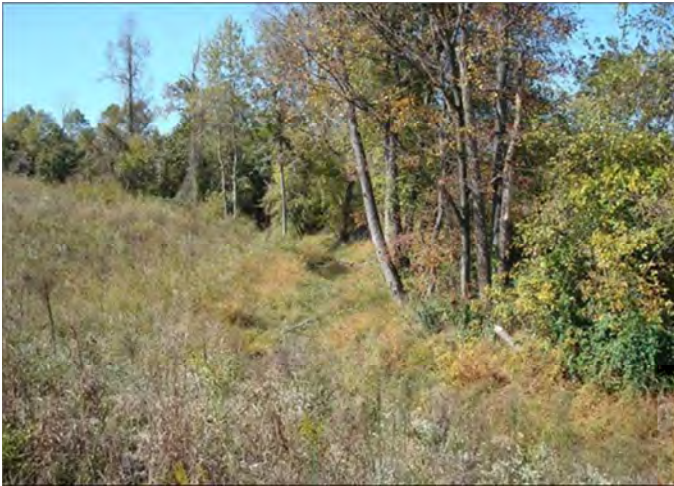
Buckhorn Creek at bridge, facing upstream Year 1 Photo No. 32

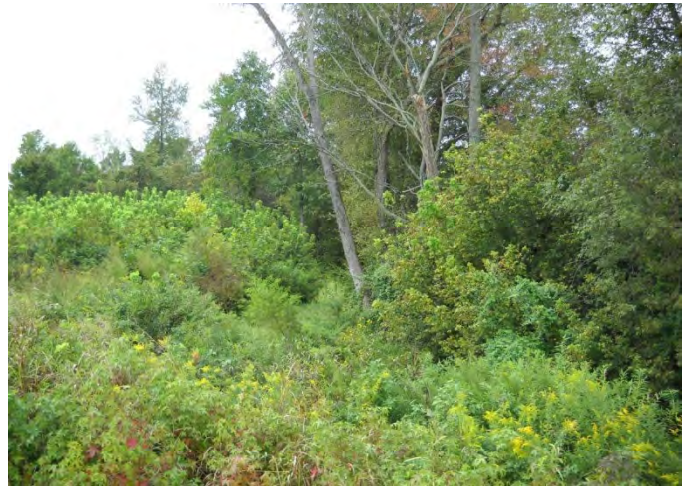
Buckhorn Creek at bridge, facing upstream Year 4 Photo No. 35

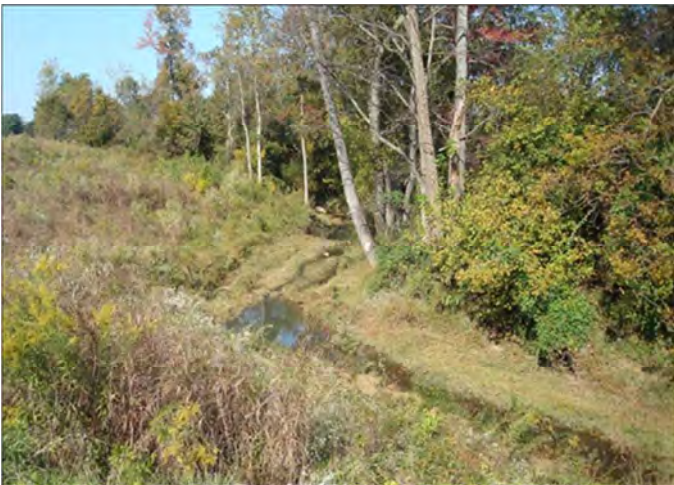
Buckhorn Creek at bridge, facing upstream Year 2 Photo No. 33

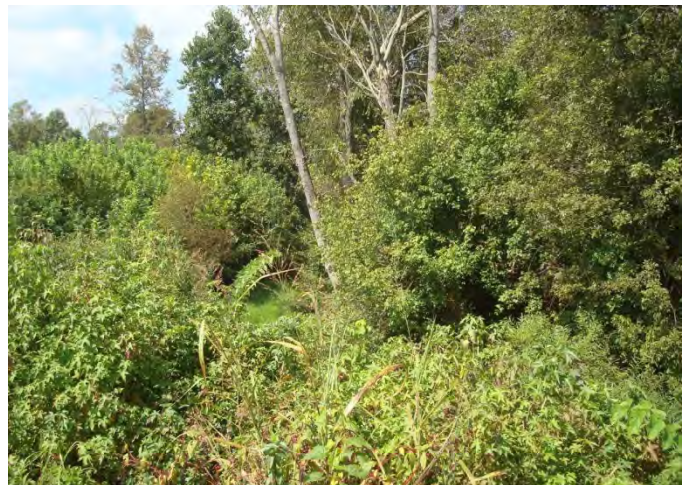
Buckhorn Creek at bridge, facing upstream Year 5 Photo No. 36

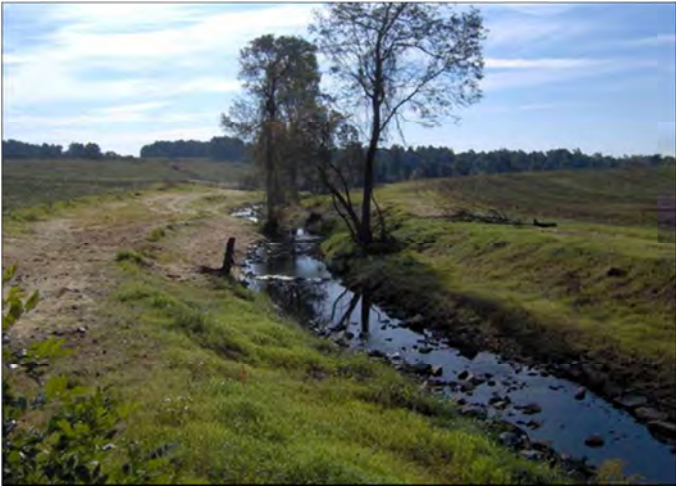
Buckhorn Creek at bridge, facing downstream Year 0 Photo No. 37

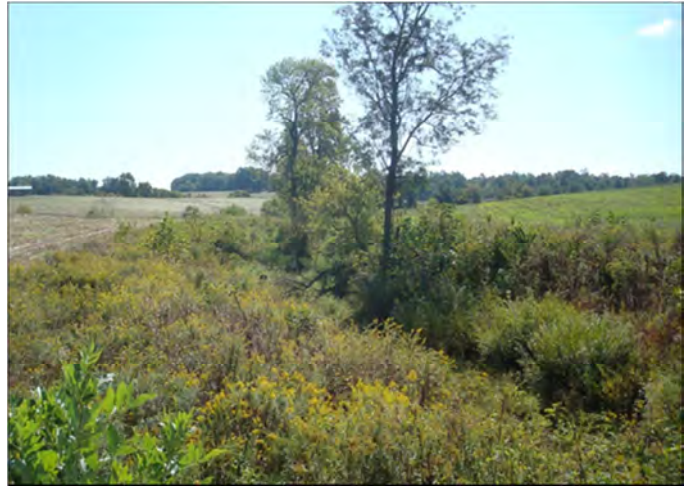
Buckhorn Creek at bridge, facing downstream Year 3 Photo No.40

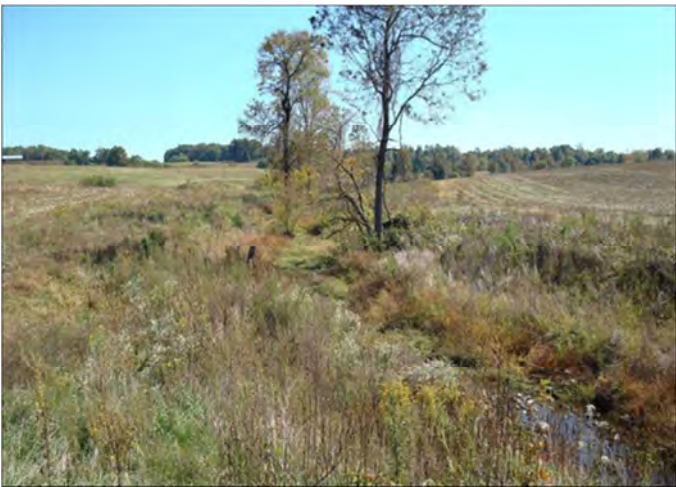
Buckhorn Creek at bridge, facing downstream Year 1 Photo No. 38

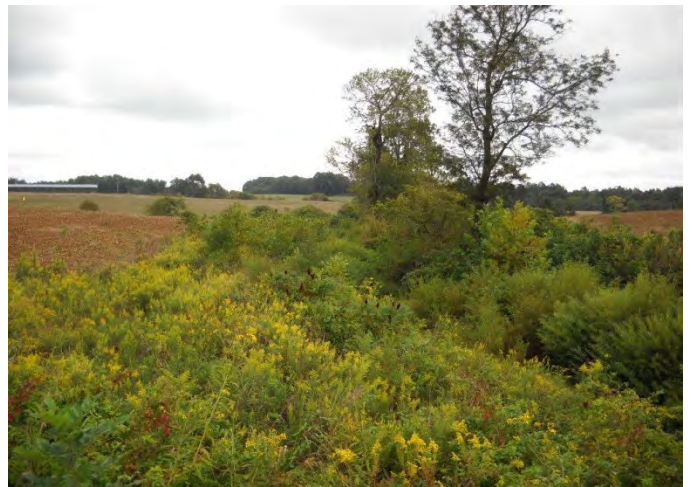
Buckhorn Creek at bridge, facing downstream Year 4 Photo No. 41

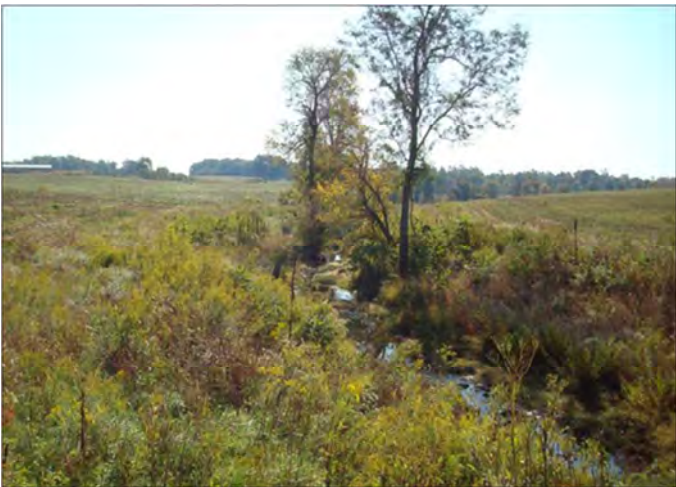
Buckhorn Creek at bridge, facing downstream Year 2 Photo No. 39

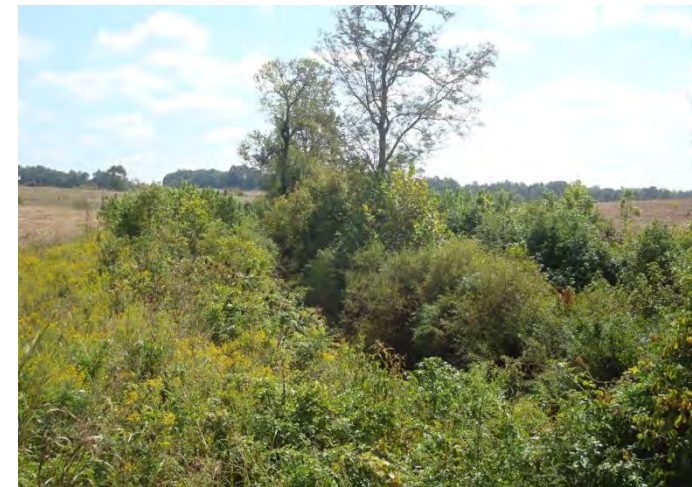
Buckhorn Creek at bridge, facing downstream Year 5 Photo No. 42
