MONITORING YEAR 2 ANNUAL REPORT

HOLMAN MILL MITIGATION SITE

Alamance County, NC
NCDEQ Contract 005795
DMS ID No. 96316

Data Collection Period: January - October 2017
Draft Submission Date: November 14, 2017
Final Submission Date:

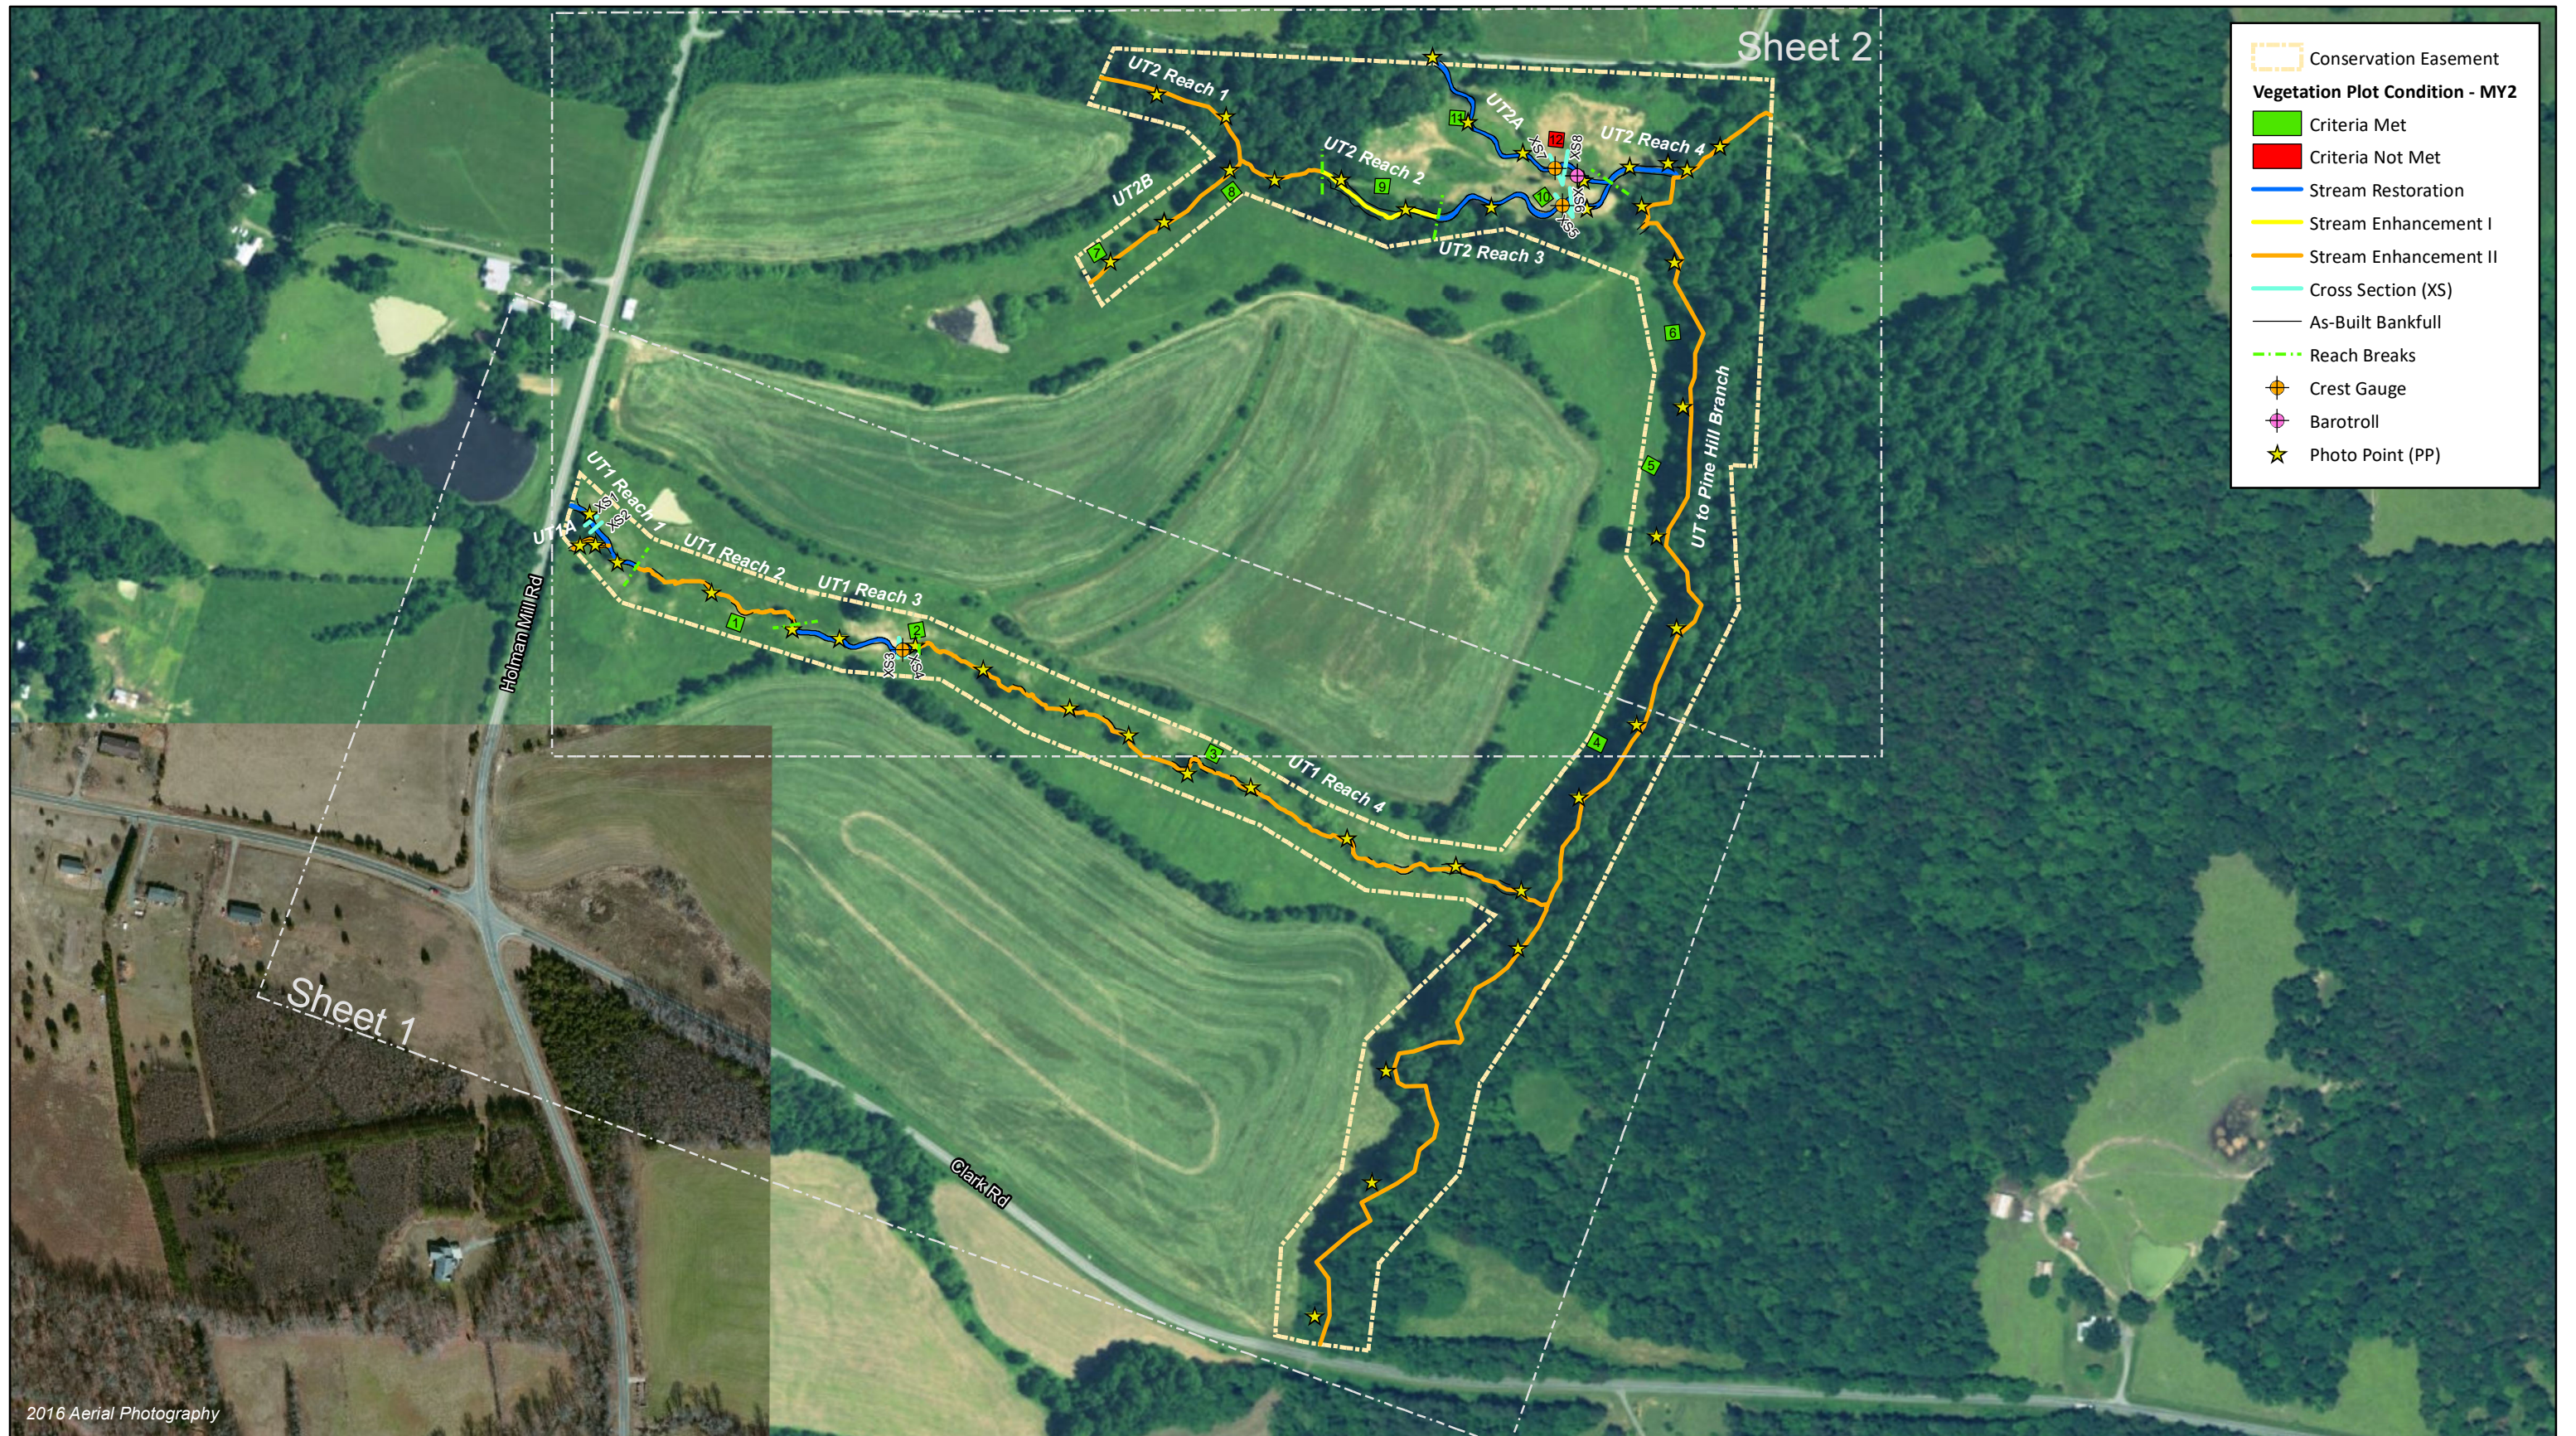
Figure 3.0 Integrated Current Condition Plan View (Key)
 Holman Mill Mitigation Site
 DMS Project No. 96316
 Monitoring Year 2 - 2017
 Alamance County, NC

Vegetation Plot Condition - MY2

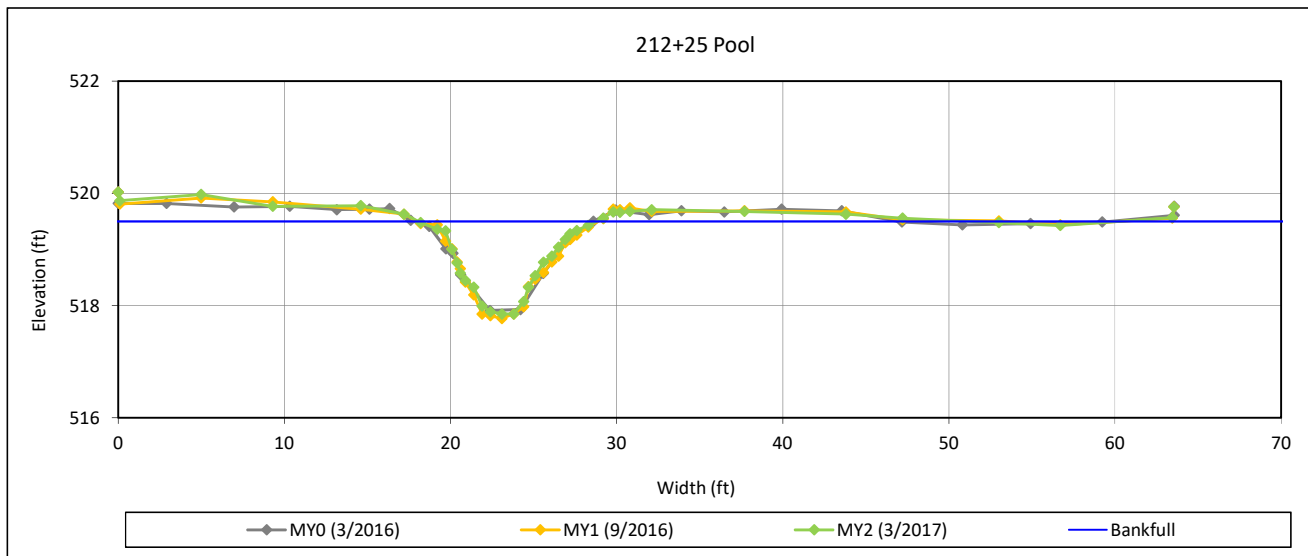
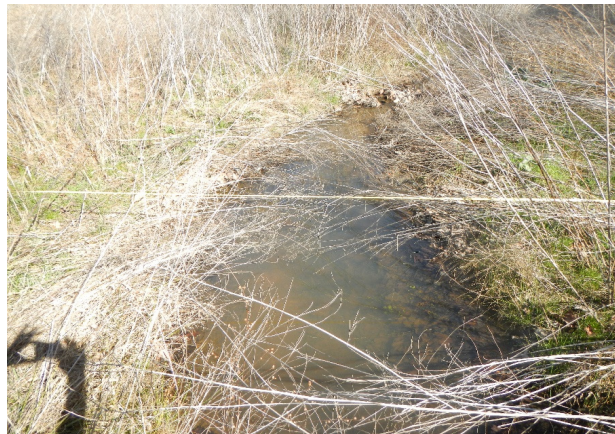
Cross Section 6-UT2

8.4	x-section area (ft.sq.)
10.6	width (ft)
0.8	mean depth (ft)
1.6	max depth (ft)
11.4	wetted perimeter (ft)
0.7	hydraulic radius (ft)
13.4	width-depth ratio

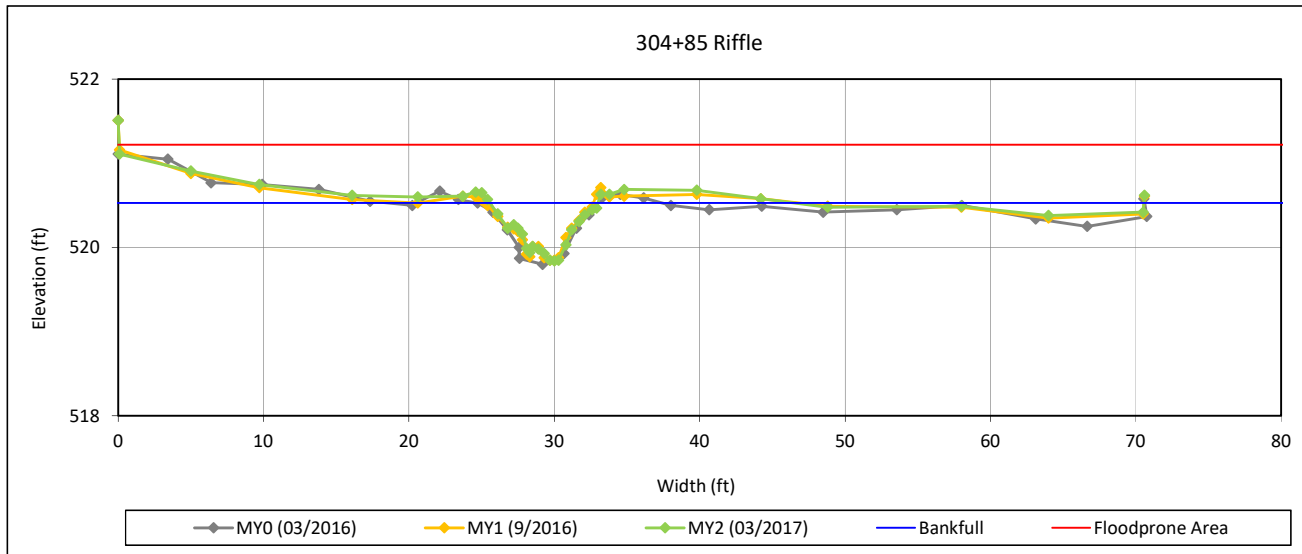
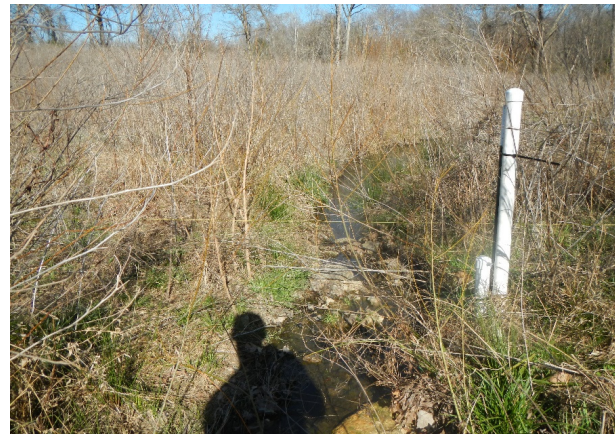
Cross Section 7-UT2A

2.7	x-section area (ft.sq.)
7.4	width (ft)
0.4	mean depth (ft)
0.7	max depth (ft)
7.7	wetted perimeter (ft)
0.4	hydraulic radius (ft)
20.6	width-depth ratio
100.0	W flood prone area (ft)
13.4	entrenchment ratio
1.0	low bank height ratio

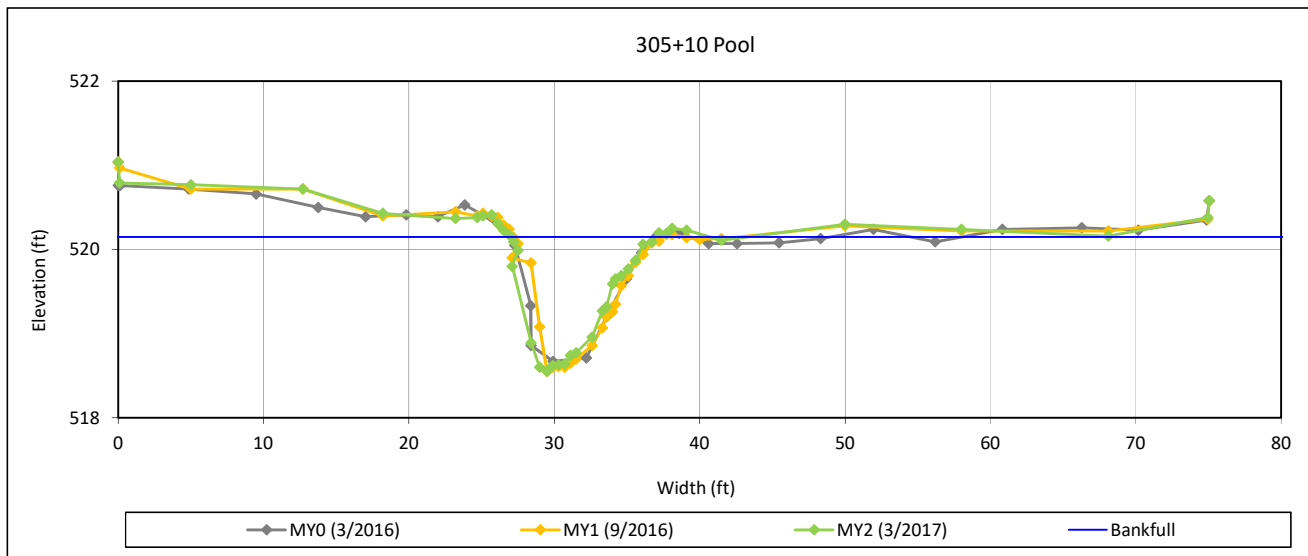
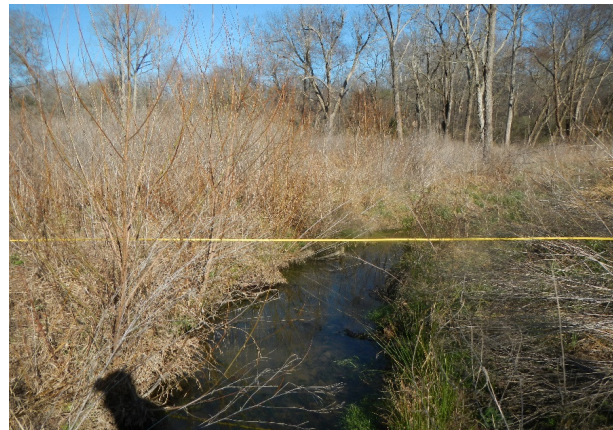
Cross Section 8-UT2A

- 9.1 x-section area (ft.sq.)
- 9.8 width (ft)
- 0.9 mean depth (ft)
- 1.6 max depth (ft)
- 11.2 wetted perimeter (ft)
- 0.8 hydraulic radius (ft)
- 10.5 width-depth ratio
