MONITORING YEAR 5 ANNUAL REPORT

HOLMAN MILL MITIGATION SITE

Alamance County, NC
NCDEQ Contract 005795
DMS ID No. 96316
USACE Action ID Number 2015-00019
NCDWR Project Number 2014-0333

Data Collection Period: January 2020 - October 2020
Draft Submission Date: October 14, 2020
Final Submission Date: November 2, 2020

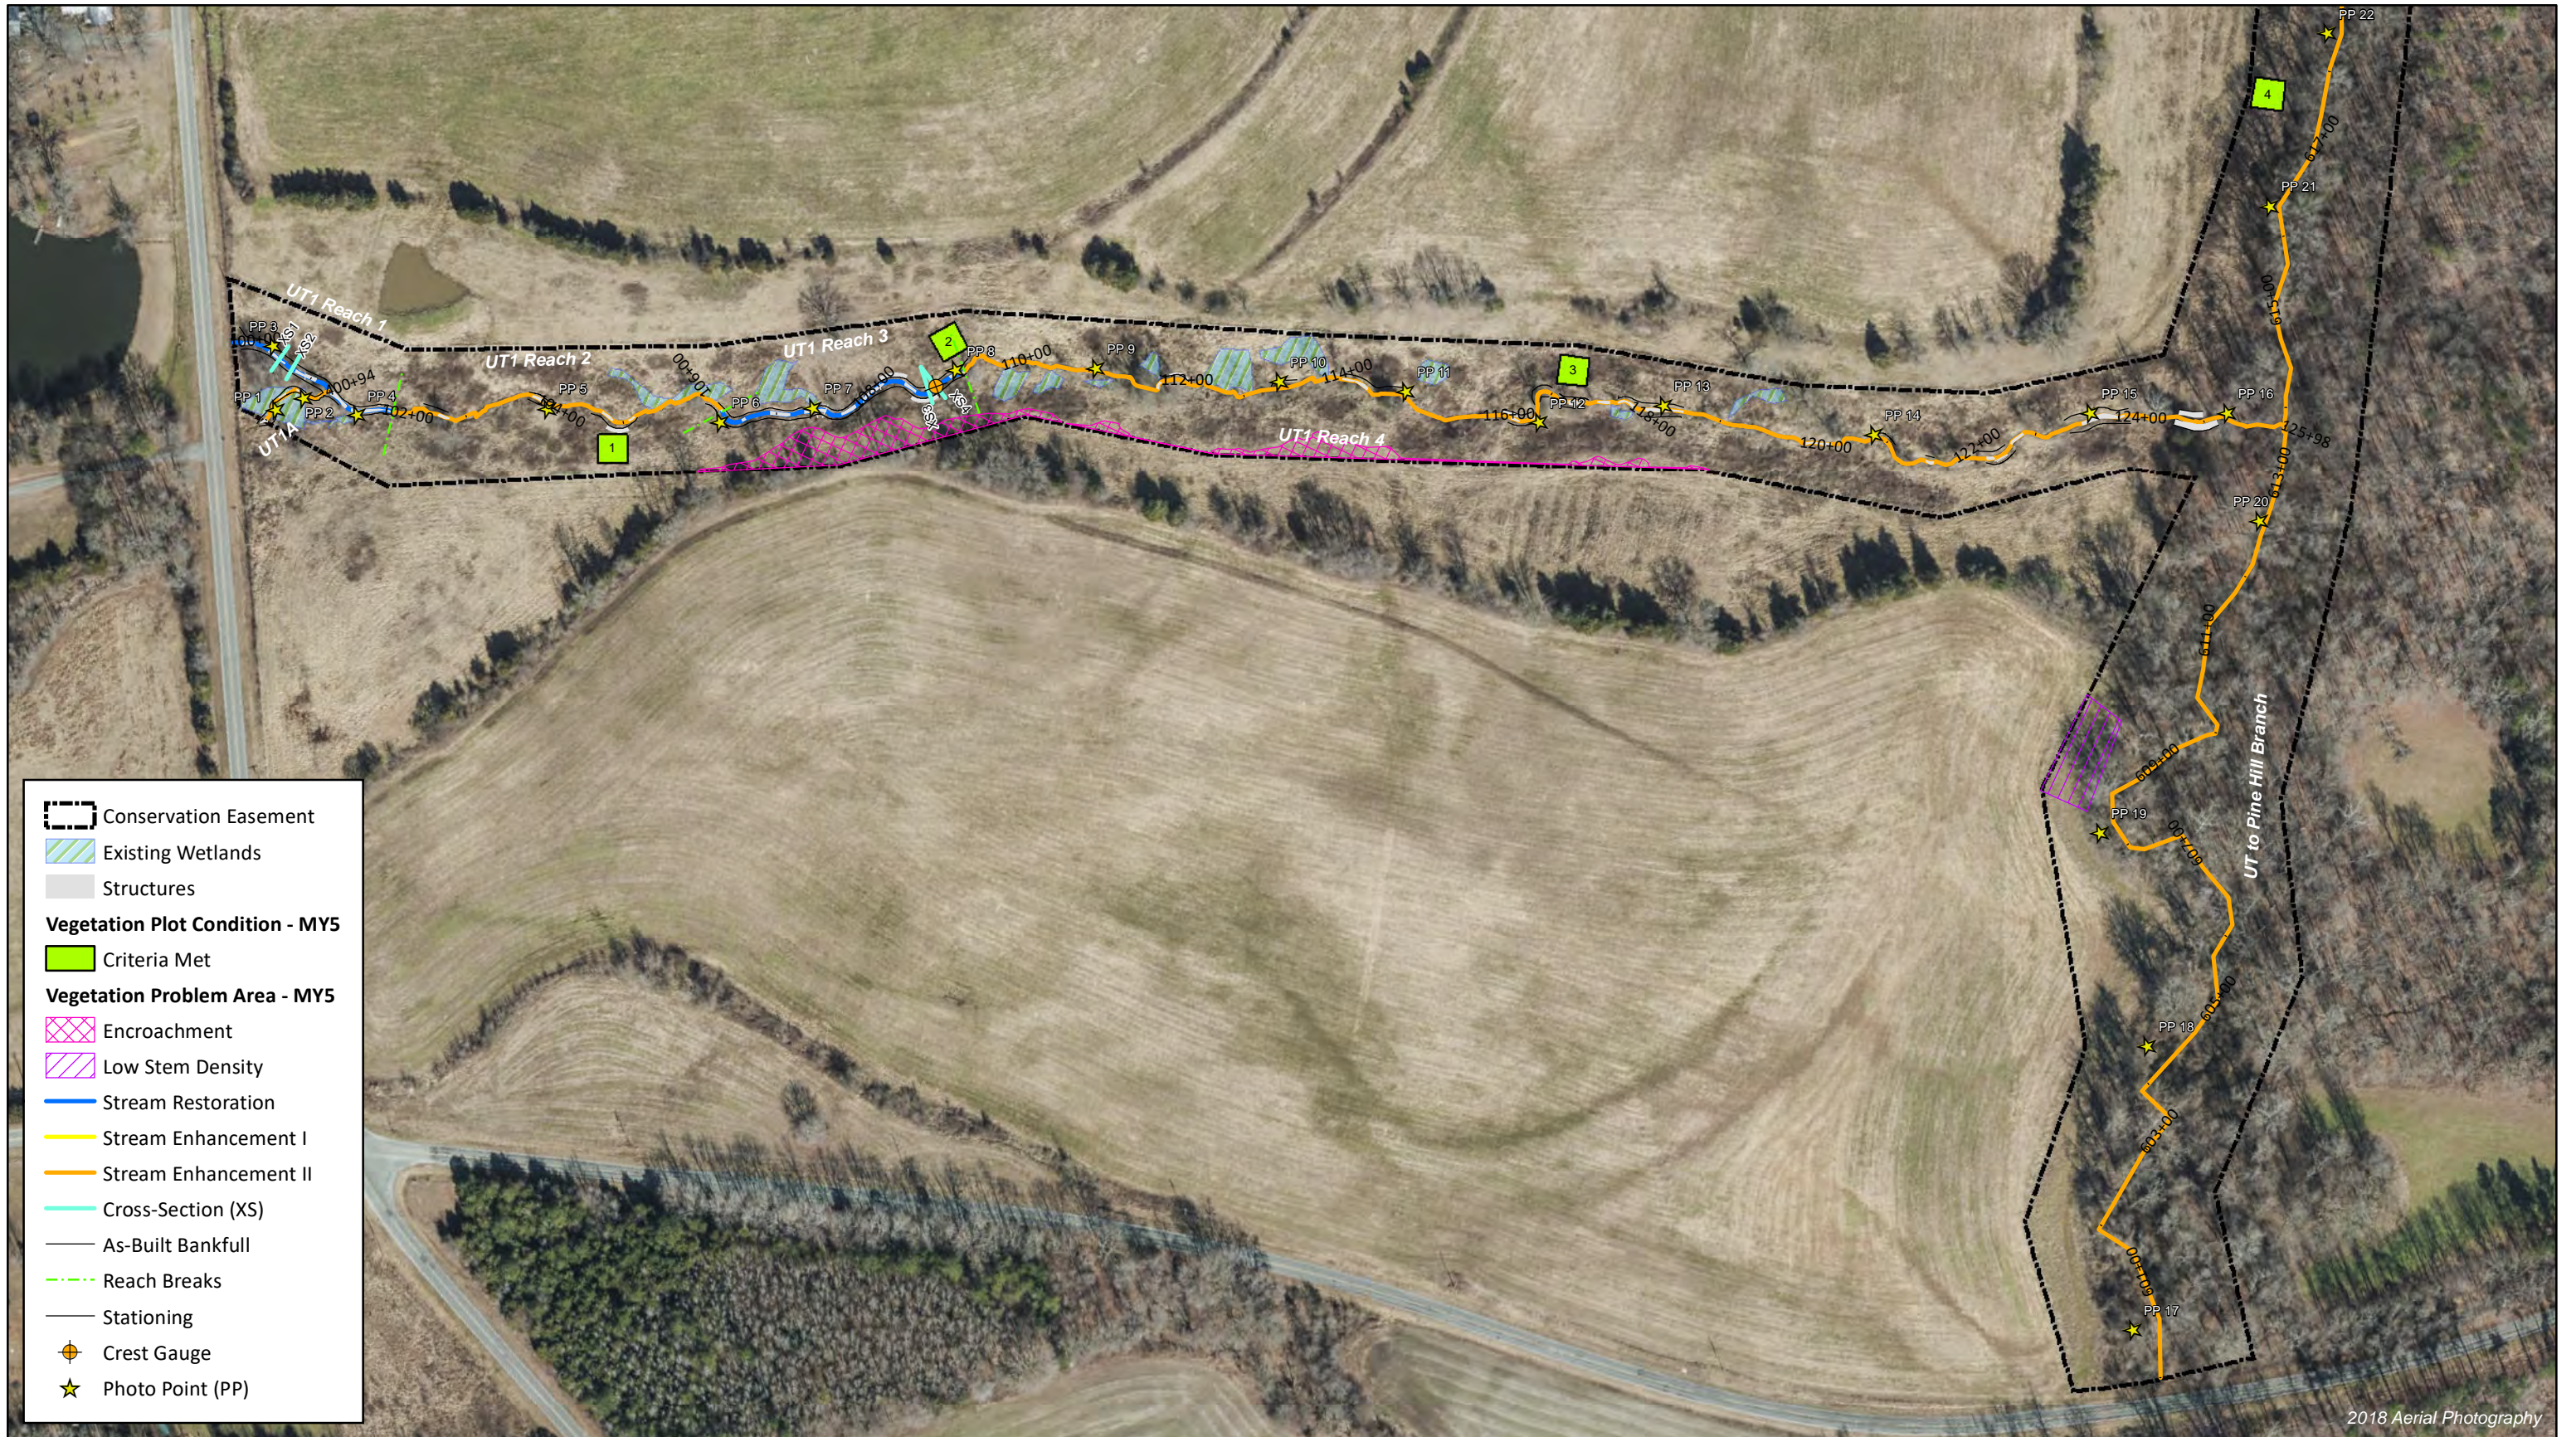
Figure 3.1 Integrated Current Condition Plan View
 Holman Mill Mitigation Site
 DMS Project No. 96316
 Monitoring Year 5 - 2020

Encroachment occurred along the right floodplain of UT1 (Figure 3.0) for 1,100 linear feet and a total of 0.3 acres in December 2019. Horse tape and additional easement signs were installed to clearly mark the conservation easement boundary and prevent future encroachment. In February 2020 thirty supplemental trees were planted in this area which included a mixture of one-gallon and three-gallon willow oak (*Quercus phellos*), sycamore (*Platanus occidentalis*), and river birch (*Betula nigra*). Herbaceous vegetation has grown back and planted trees are healthy. This area will continue to be assessed, but no further action will be taken at this time.

An area of low stem density (Figure 3.0) was noted during MY5 for a total of 0.14 acres. Dense herbaceous vegetation has outcompeted the planted trees in the area adjacent to UT to Pine Hill

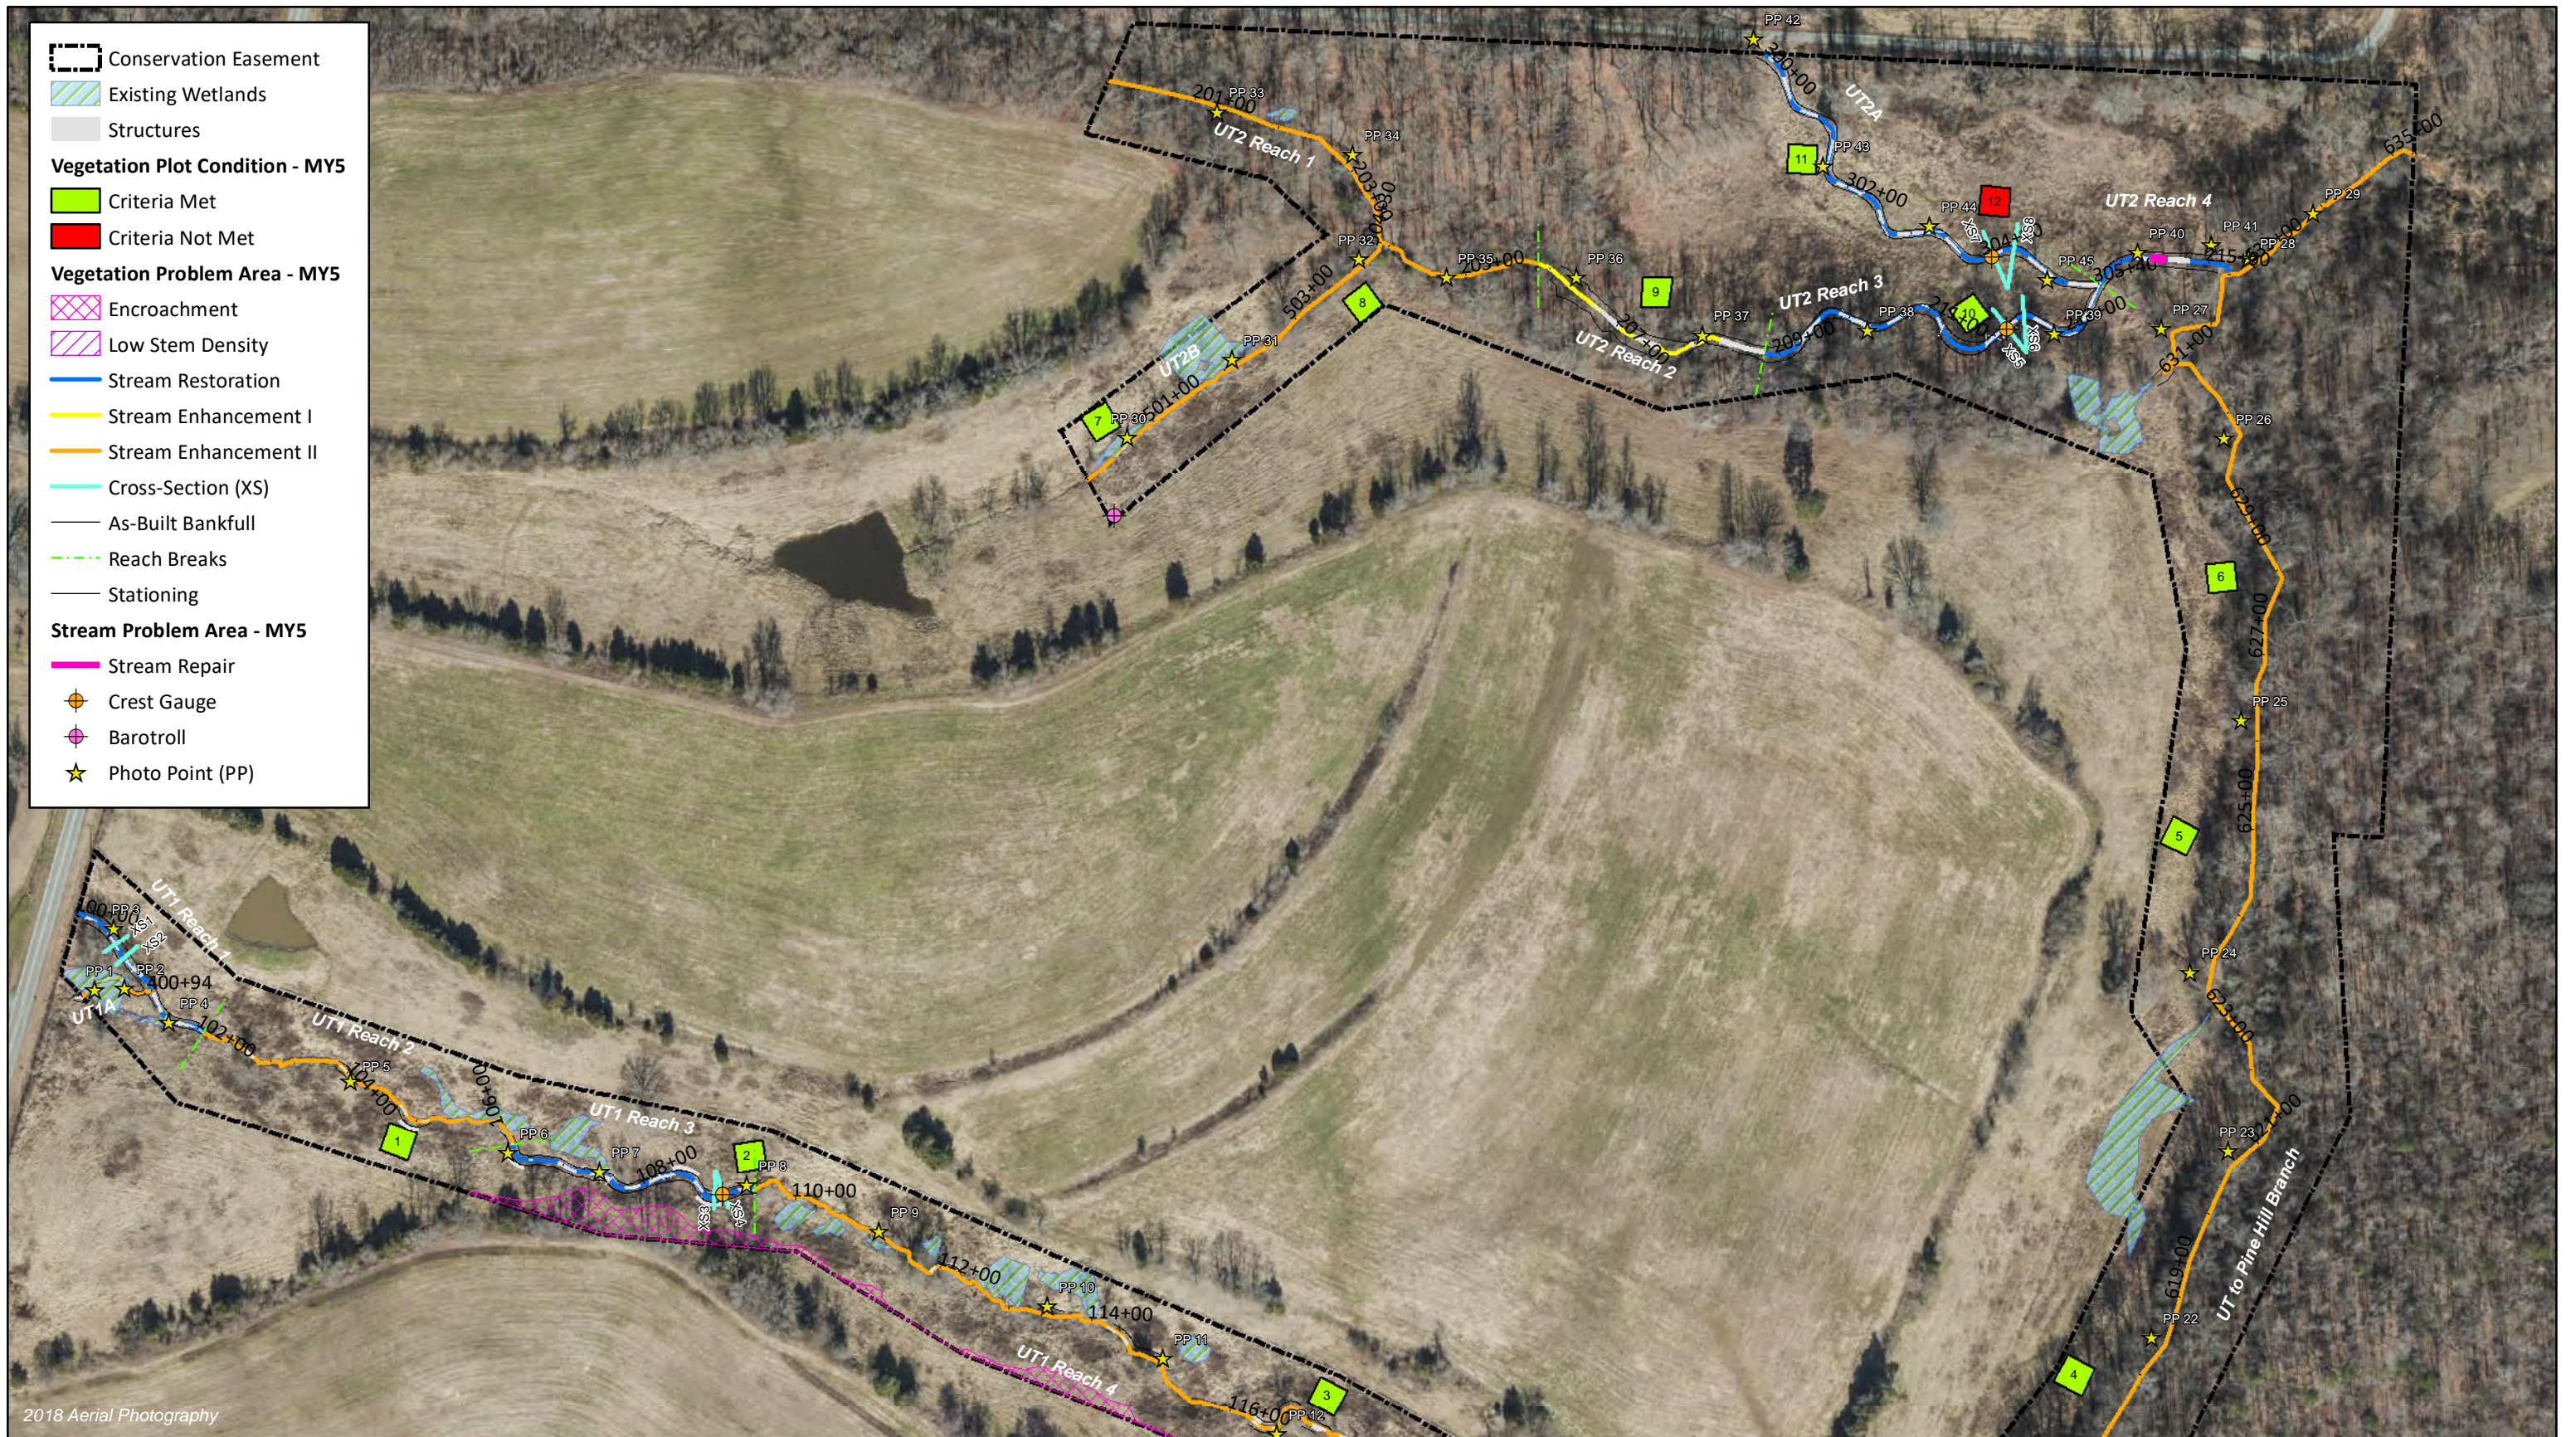
Figure 3.2 Integrated Current Condition Plan View
 Holman Mill Mitigation Site
 DMS Project No. 96316
 Monitoring Year 5 - 2020

Localized erosion below a log sill on UT2 between stations 214+35 and 214+50 identified during MY4 was repaired in May 2020. The stream bank repair included installing sod mats and live stakes. See before and after photos of the area in Appendix 2. This area will continue to be monitored to determine the success of the repair work.

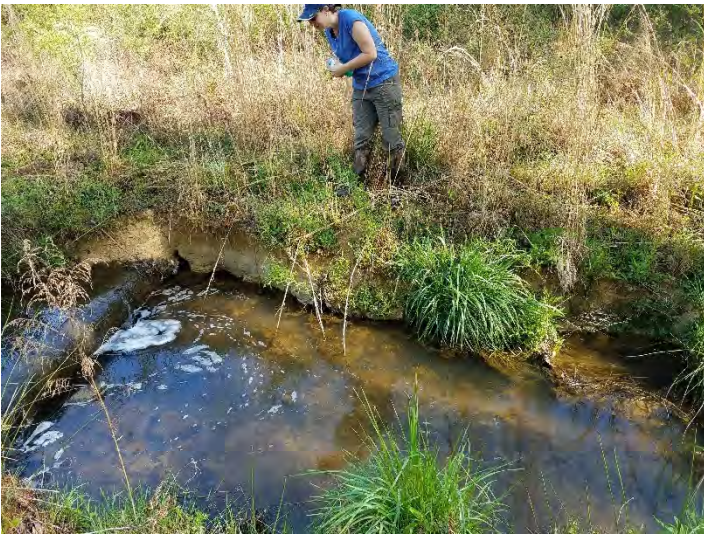
Before - Localized Erosion (4/7/2020)
