MONITORING YEAR 2 ANNUAL REPORT

HONEY MILL MITIGATION SITE

Surry County, NC
DEQ Contract No. 7619
DMS Project No. 100083

Data Collection Period: January 2022 – October 2022
FINAL Submission Date: February, 2022

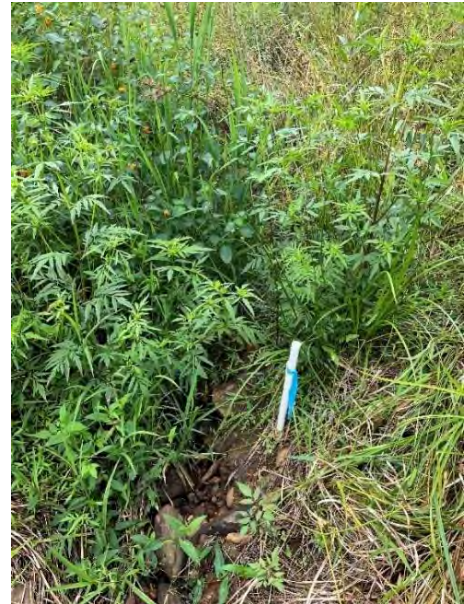
UT3 Subsurface Flow to Venable Creek– upstream (08/16/2022)

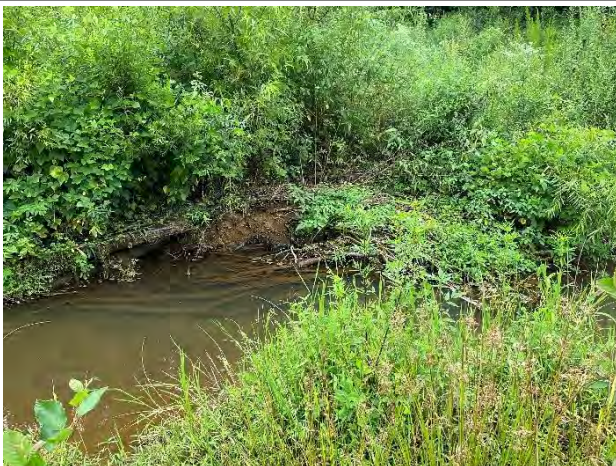
VC R3- Meander Bend above UT3 confluence to be live staked before 2023 growing season on left bank (08/16/2022)
