# MONITORING YEAR 3 ANNUAL REPORT

## HONEY MILL MITIGATION SITE

Surry County, NC  
DEQ Contract No. 7619  
DMS Project No. 100083

Data Collection Period: January 2023 – October 2023  
FINAL Submission Date: January, 2024

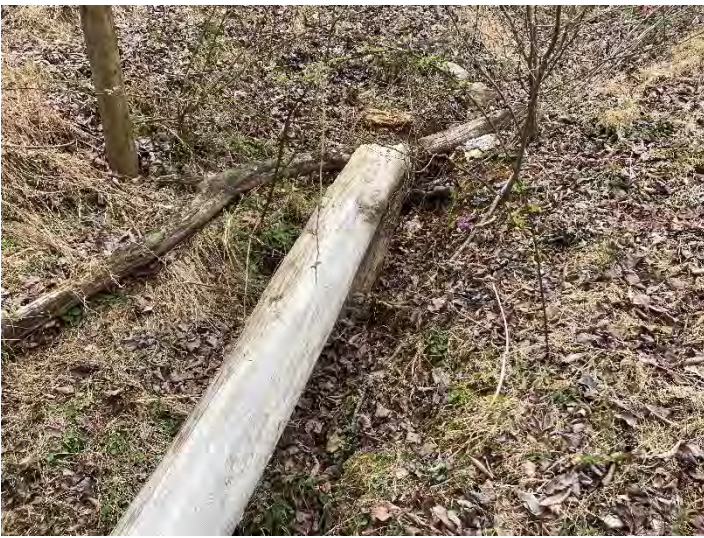
**PHOTO POINT 8 UT2 R1 Headcut – upstream (03/23/2023)**

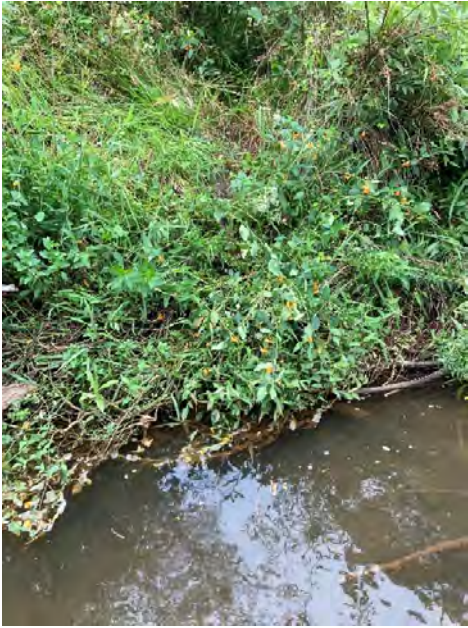
**VC R3-** Wetland Seep to Main Channel on right floodplain stable  
(08/30/2023)
