## **MONITORING YEAR 2 ANNUAL REPORT**

### **HOPEWELL STREAM MITIGATION SITE**

Randolph County, NC

NCDMS Project Number 95352

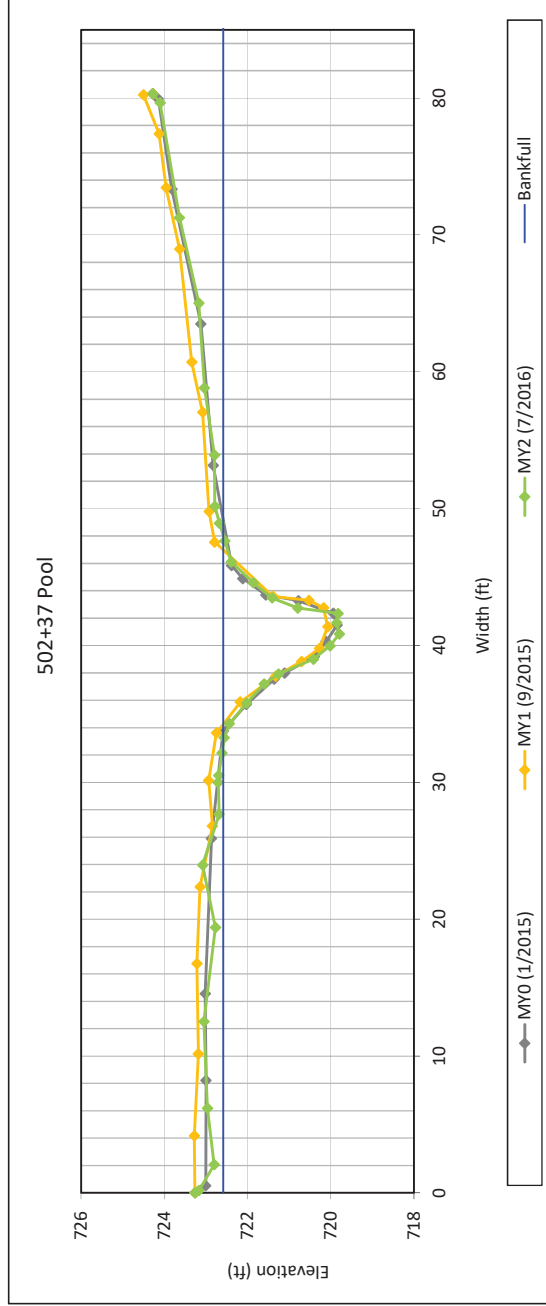
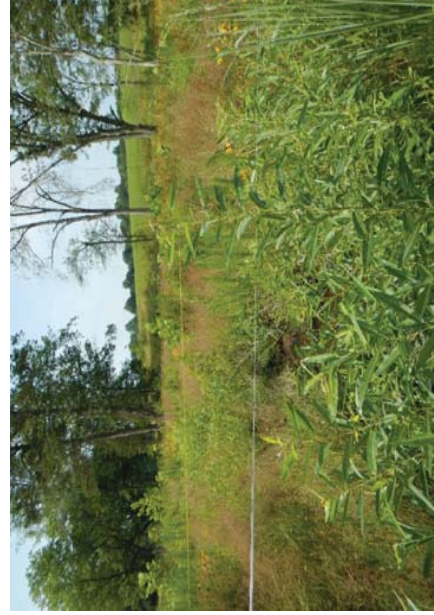
**Cross Section 1, UTZA Reach 1**

17.0	x-section area (ft.sq.)
13.4	width (ft)
1.3	mean depth (ft)
2.8	max depth (ft)
15.0	wetted perimeter (ft)
1.1	hyd radi (ft)
10.5	width-depth ratio
---	W flood prone area (ft)
---	entrenchment ratio
1.0	low bank height ratio

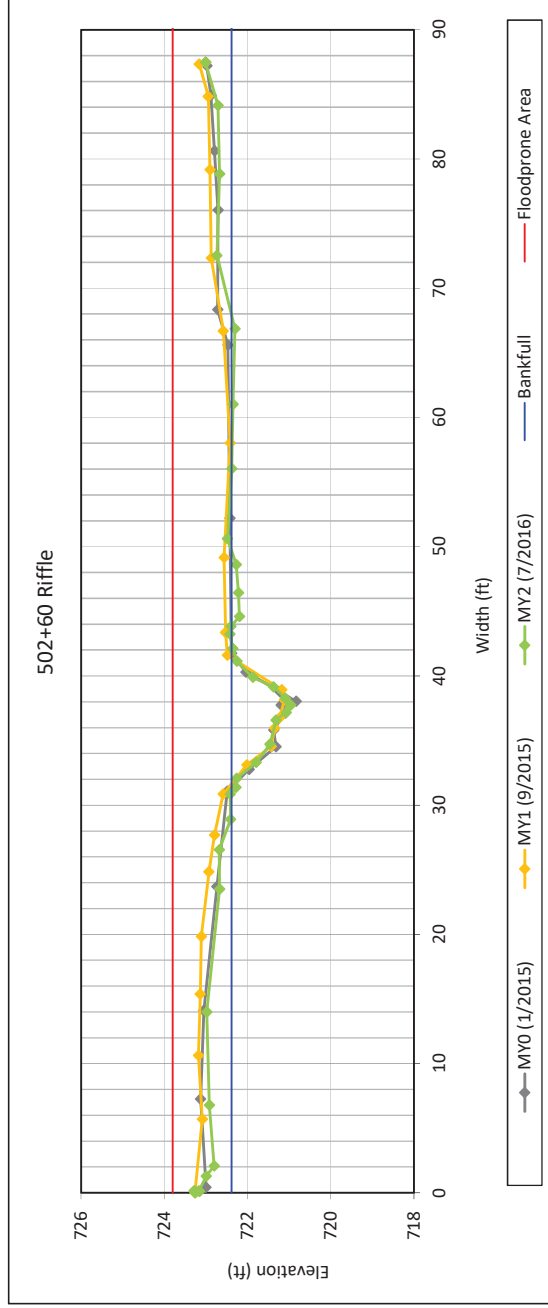
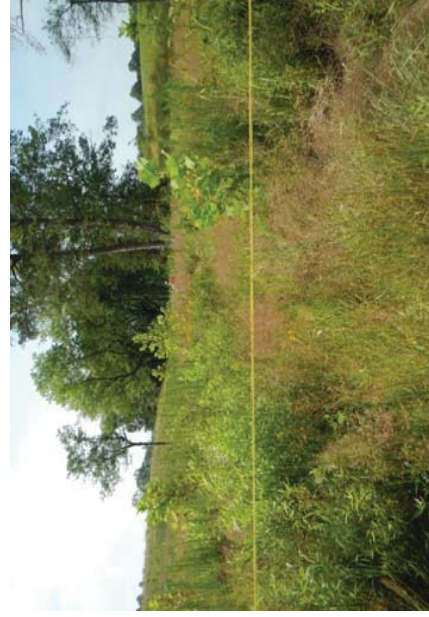
#### Cross Section 2, UT2A Reach 1

7.6	x-section area (ft.sq.)
10.1	width (ft)
0.8	mean depth (ft)
1.4	max depth (ft)
10.5	wetted perimeter (ft)
0.7	hyd radi (ft)
13.3	width-depth ratio
87.5	W flood prone area (ft)
8.7	entrenchment ratio
1.0	low bank height ratio

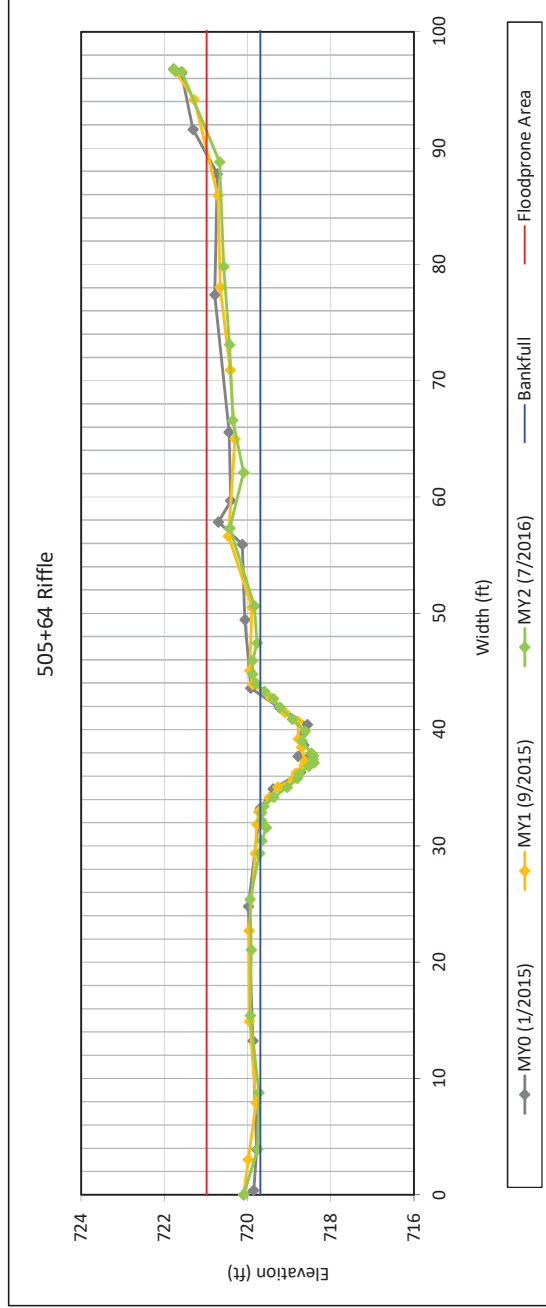
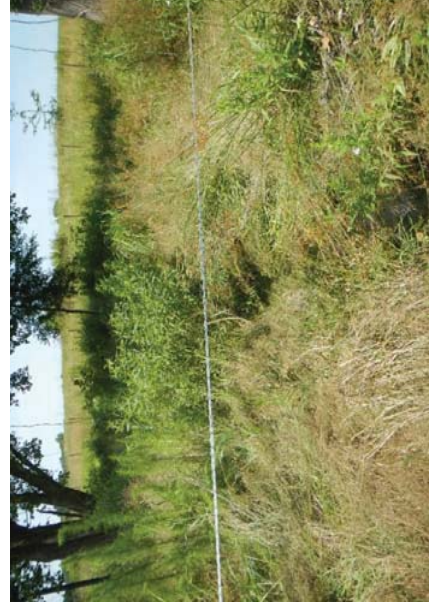
**Cross Section 3, UTZA Reach 2**

7.7	x-section area (ft.sq.)
10.2	width (ft)
0.8	mean depth (ft)
1.3	max depth (ft)
10.6	wetted perimeter (ft)
0.7	hyd radi (ft)
13.6	width-depth ratio
91.5	W flood prone area (ft)
9.0	entrenchment ratio
1.0	low bank height ratio

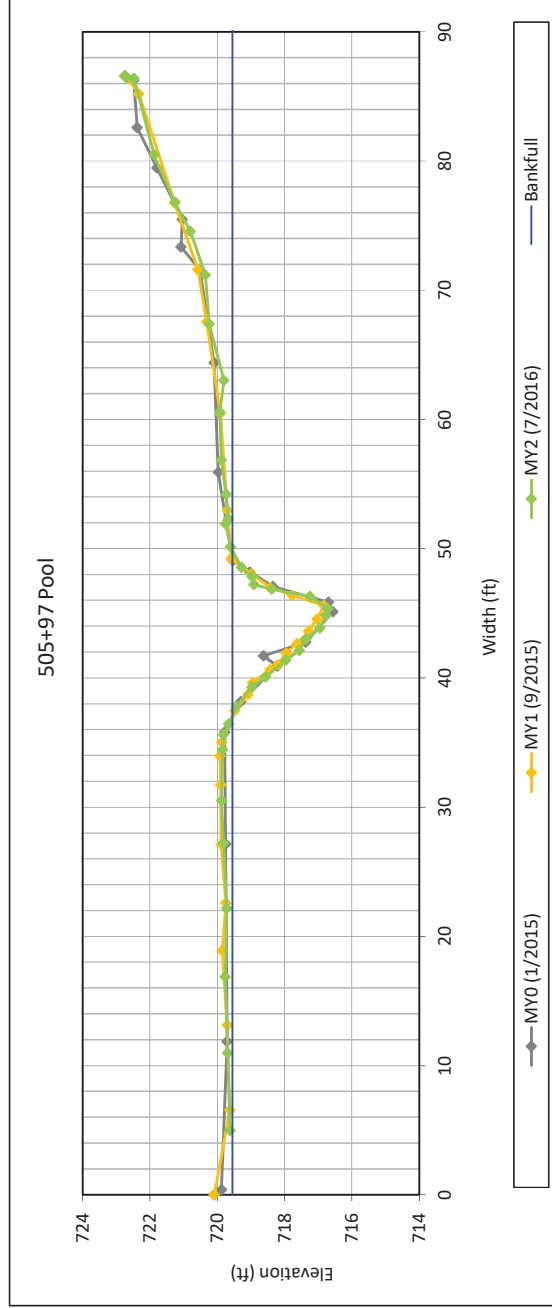
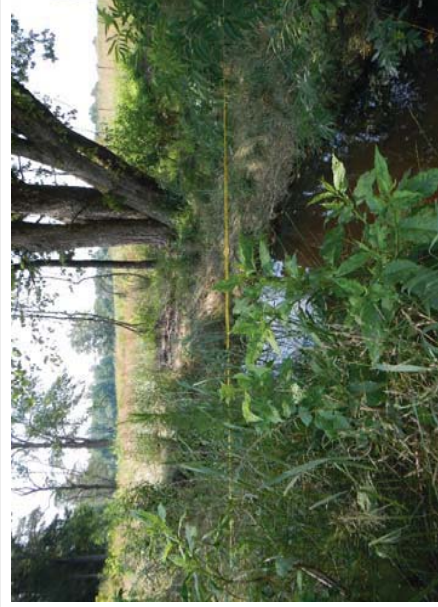
**Cross Section 4, UT2A Reach 2**

16.7	x-section area (ft.sq.)
12.7	width (ft)
1.3	mean depth (ft)
2.8	max depth (ft)
14.5	wetted perimeter (ft)
1.2	hyd radi (ft)
9.7	width-depth ratio
---	W flood prone area (ft)
---	entrenchment ratio
1.0	low bank height ratio

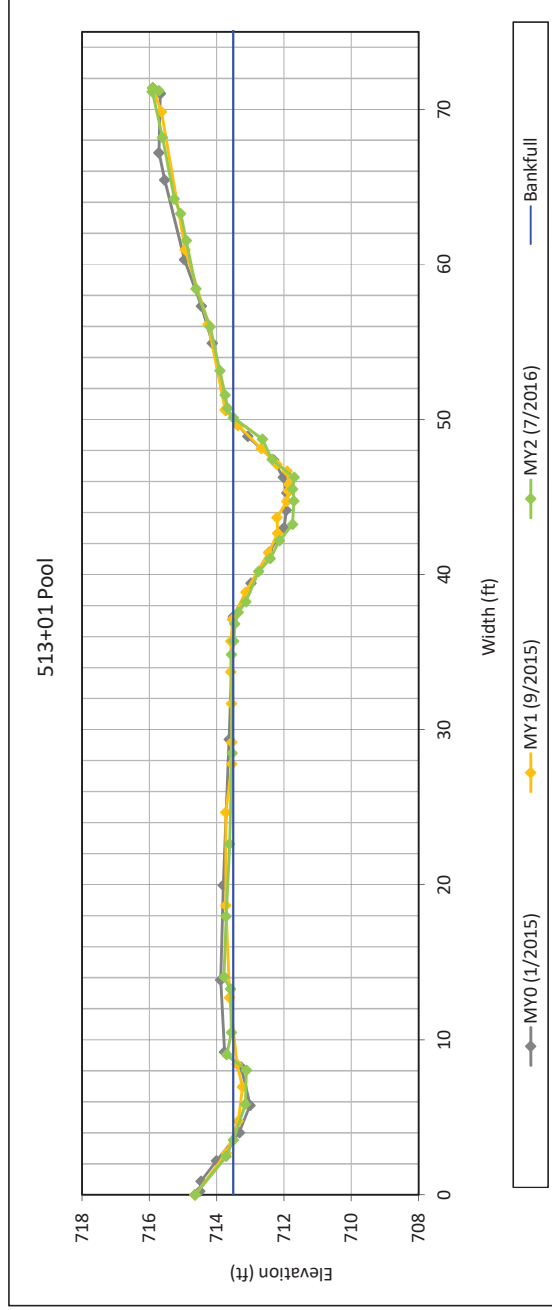
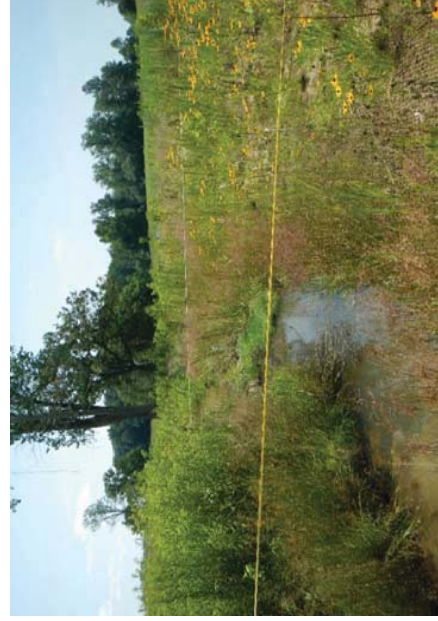
**Cross Section 5, UT2A Reach 2**

- 14.2 x-section area (ft.sq.)
- 12.6 width (ft)
- 1.1 mean depth (ft)
- 1.8 max depth (ft)
- 13.3 wetted perimeter (ft)
- 1.1 hyd radi (ft)
- 11.1 width-depth ratio
- W flood prone area (ft)
- entrenchment ratio
- 1.0 low bank height ratio

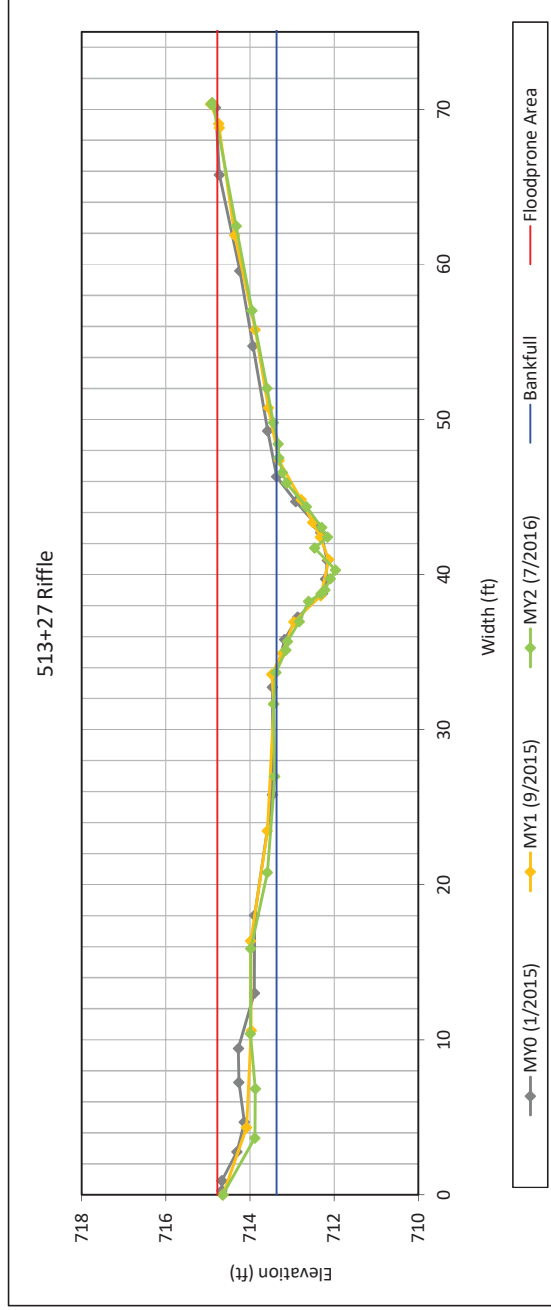
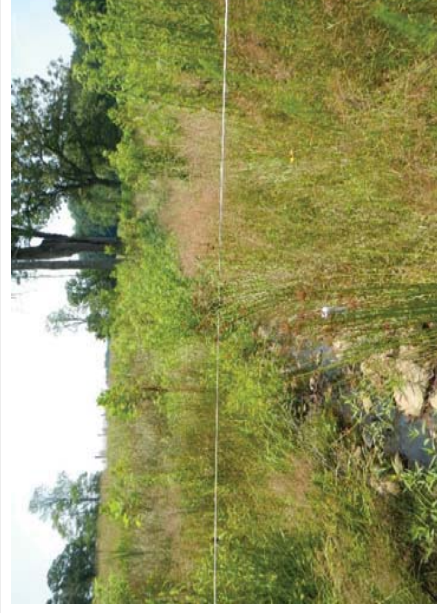
**Cross Section 6, UT2A R2**

9.2	x-section area (ft.sq.)
13.8	width (ft)
0.7	mean depth (ft)
1.4	max depth (ft)
14.3	wetted perimeter (ft)
0.6	hyd radi (ft)
20.6	width-depth ratio
68.9	W flood prone area (ft)
5.0	entrenchment ratio
1.0	low bank height ratio

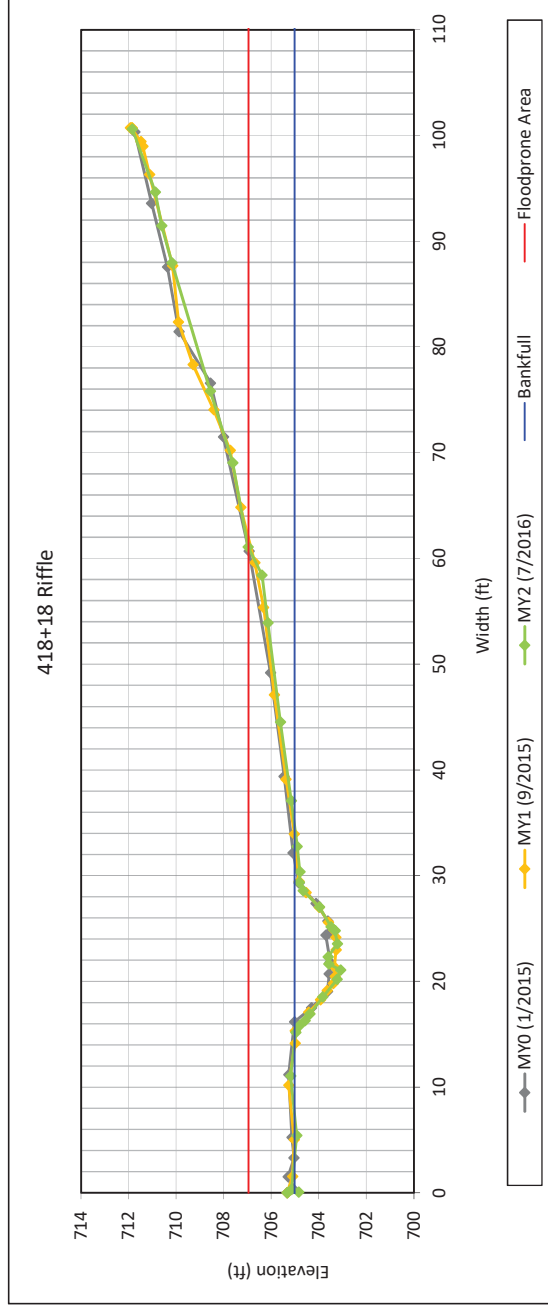
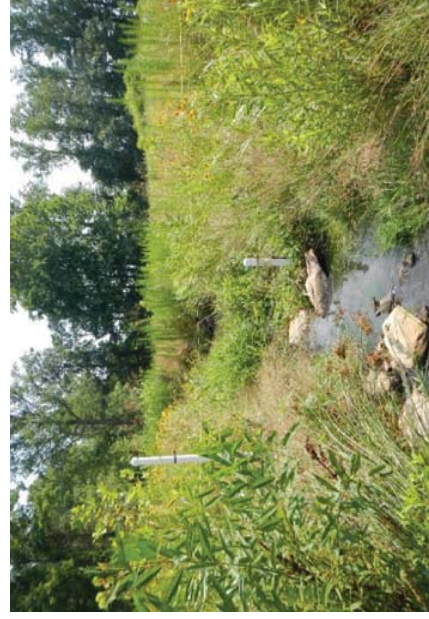
**Cross Section 8, UT2 R2**

16.5	x-section area (ft.sq.)
13.5	width (ft)
1.2	mean depth (ft)
1.9	max depth (ft)
14.3	wetted perimeter (ft)
1.2	hyd radi (ft)
11.1	width-depth ratio
61.0	W flood prone area (ft)
4.5	entrenchment ratio
1.0	low bank height ratio

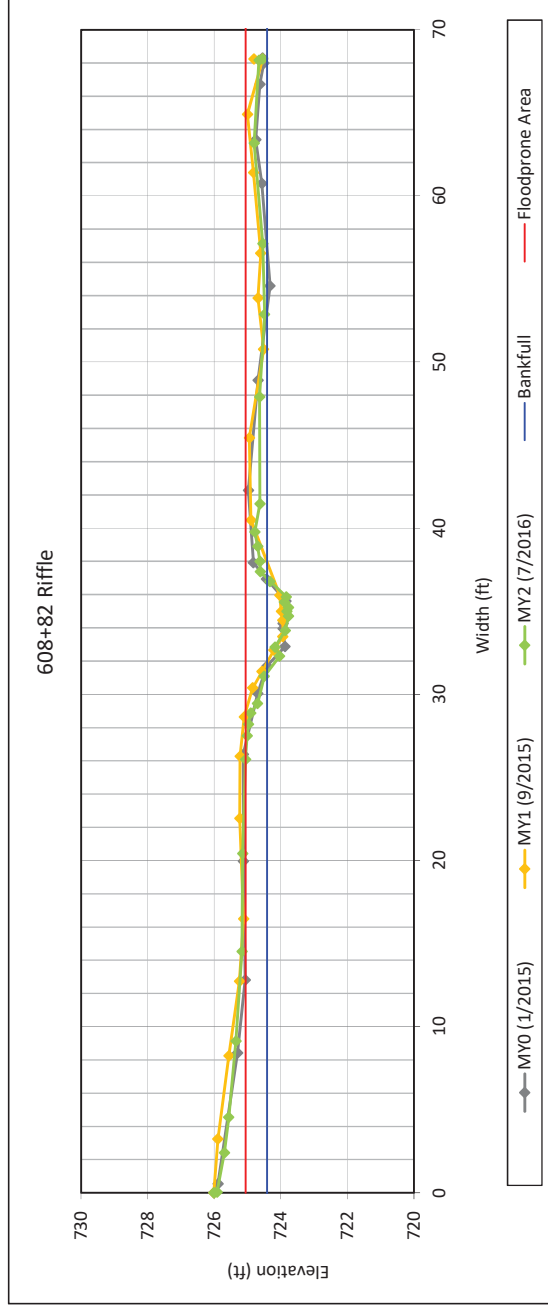
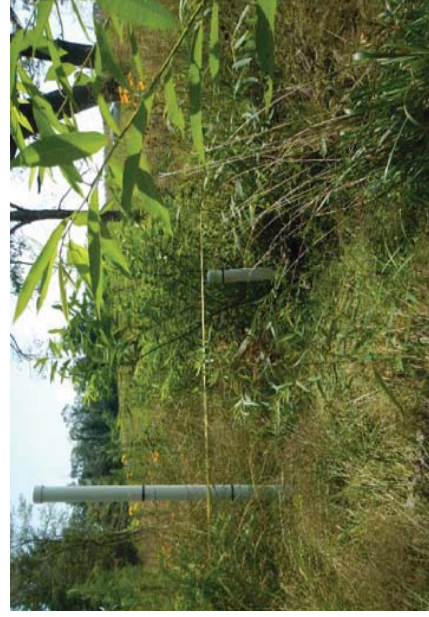
**Cross Section 9, UT2B R2**

2.3	x-section area (ft.sq.)
5.7	width (ft)
0.4	mean depth (ft)
0.6	max depth (ft)
6.0	wetted perimeter (ft)
0.4	hyd radi (ft)
14.2	width-depth ratio
42.3	W flood prone area (ft)
7.5	entrenchment ratio
1.0	low bank height ratio

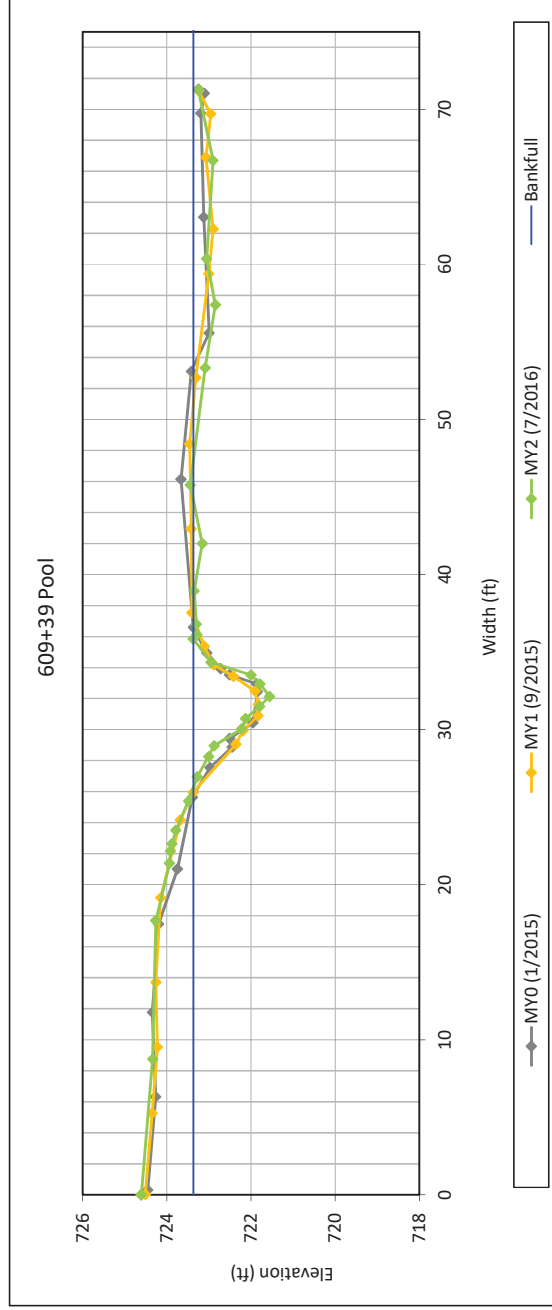
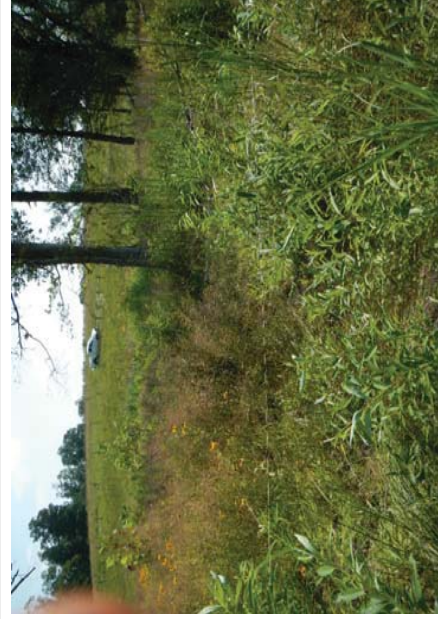
**Cross Section 10, UT2B R2**

7.8	x-section area (ft.sq.)
10.5	width (ft)
0.7	mean depth (ft)
1.8	max depth (ft)
11.4	wetted perimeter (ft)
0.7	hyd radi (ft)
14.0	width-depth ratio
---	W flood prone area (ft)
---	entrenchment ratio
1.0	low bank height ratio

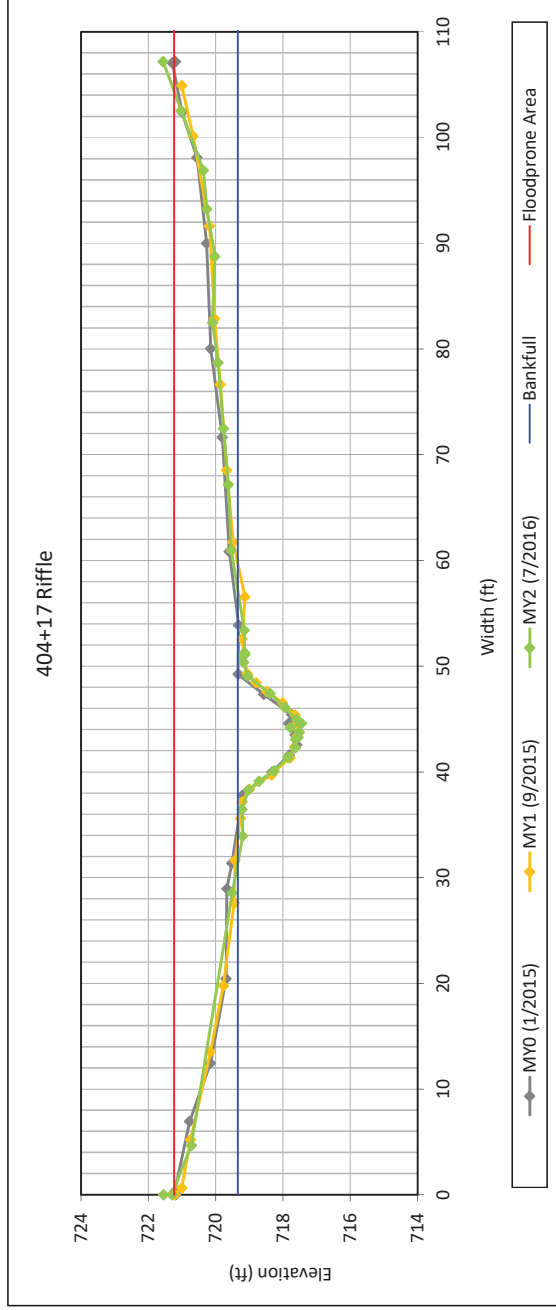
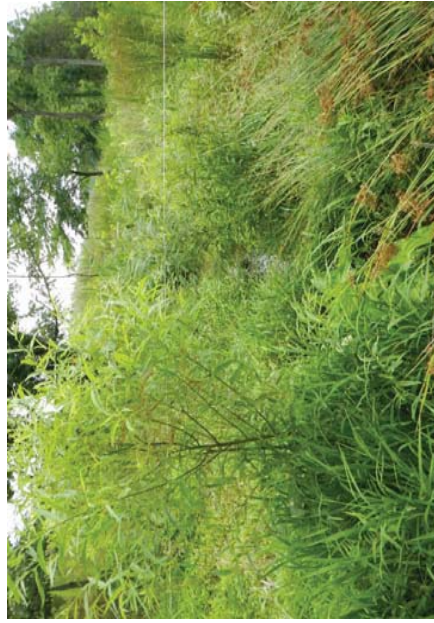
**Cross Section 11, UT2 R1**

14.0	x-section area (ft.sq.)
13.9	width (ft)
1.0	mean depth (ft)
1.9	max depth (ft)
14.7	wetted perimeter (ft)
1.0	hyd radi (ft)
13.8	width-depth ratio
103.7	W flood prone area (ft)
7.4	entrenchment ratio
1.0	low bank height ratio

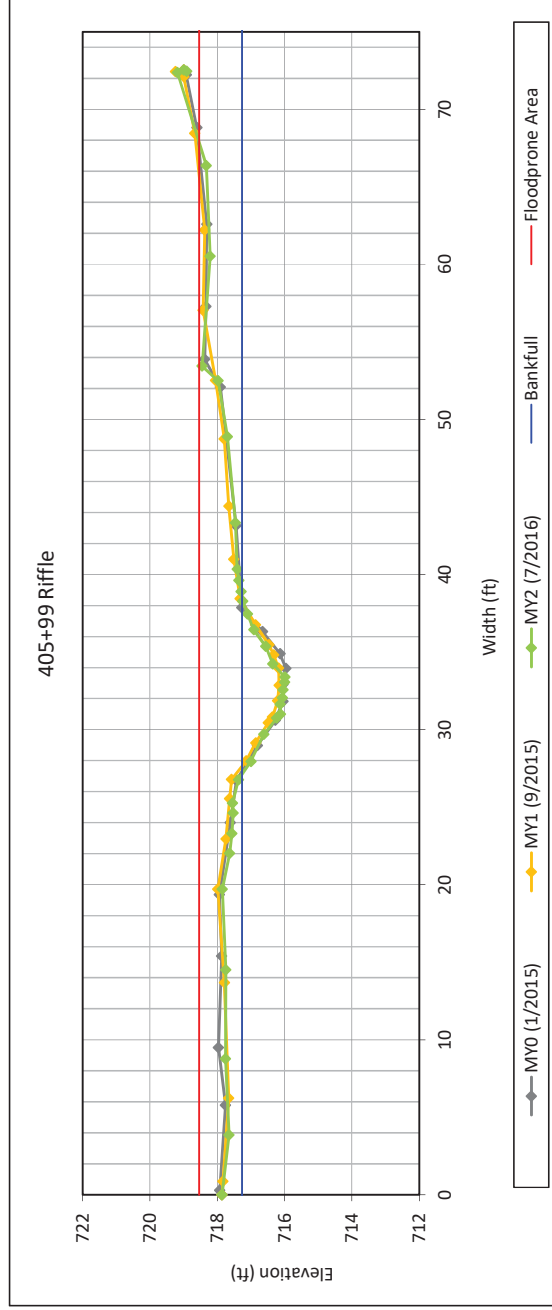
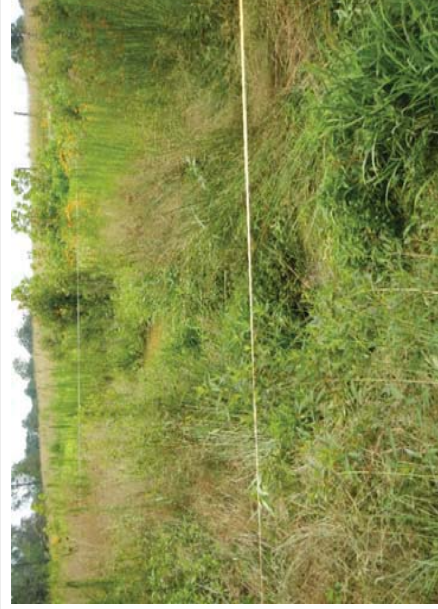
**Cross Section 12, UT2 R1**

7.7	x-section area (ft.sq.)
11.2	width (ft)
0.7	mean depth (ft)
1.3	max depth (ft)
11.5	wetted perimeter (ft)
0.7	hyd radi (ft)
16.2	width-depth ratio
67.9	W flood prone area (ft)
6.1	entrenchment ratio
1.0	low bank height ratio

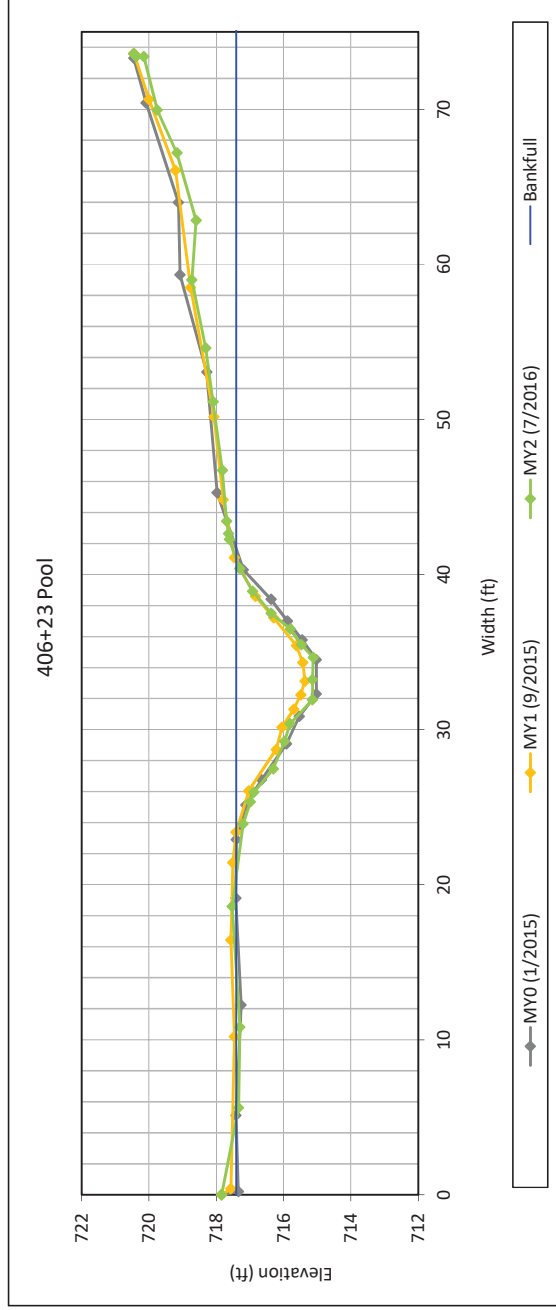
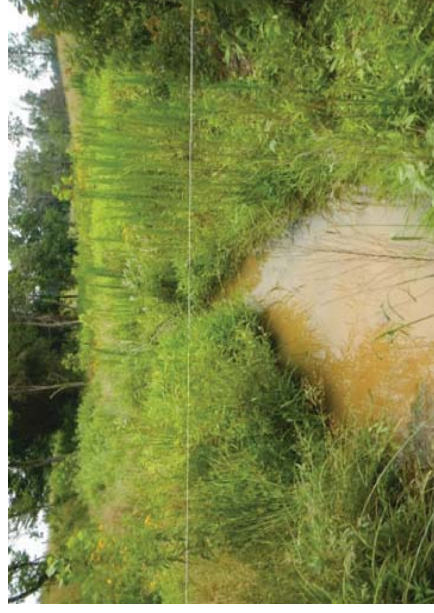
**Cross Section 13, UT2 R1**

21.5	x-section area (ft.sq.)
17.1	width (ft)
1.3	mean depth (ft)
2.3	max depth (ft)
17.9	wetted perimeter (ft)
1.2	hyd radi (ft)
13.6	width-depth ratio
---	W flood prone area (ft)
---	entrenchment ratio
1.0	low bank height ratio

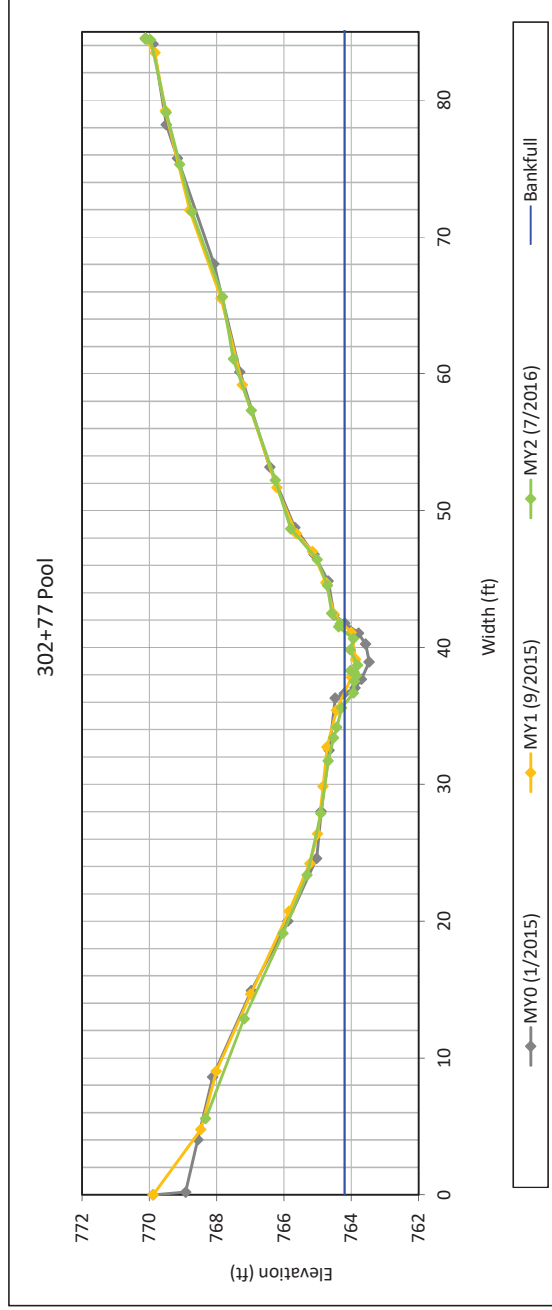
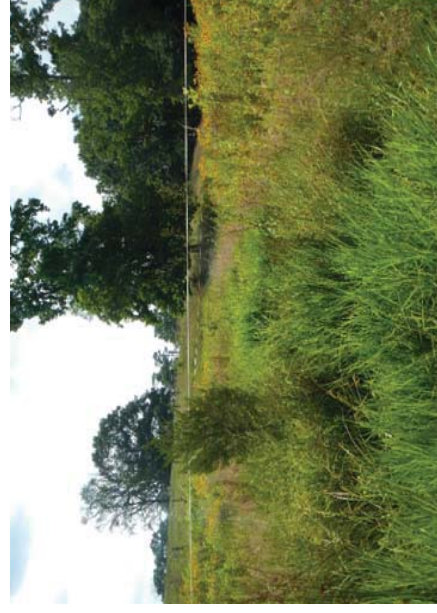
**Cross Section 14, UT1B R1**

1.2	x-section area (ft.sq.)
5.3	width (ft)
0.2	mean depth (ft)
0.4	max depth (ft)
5.5	wetted perimeter (ft)
0.2	hyd radi (ft)
22.5	width-depth ratio
---	W flood prone area (ft)
---	entrenchment ratio
1.0	low bank height ratio

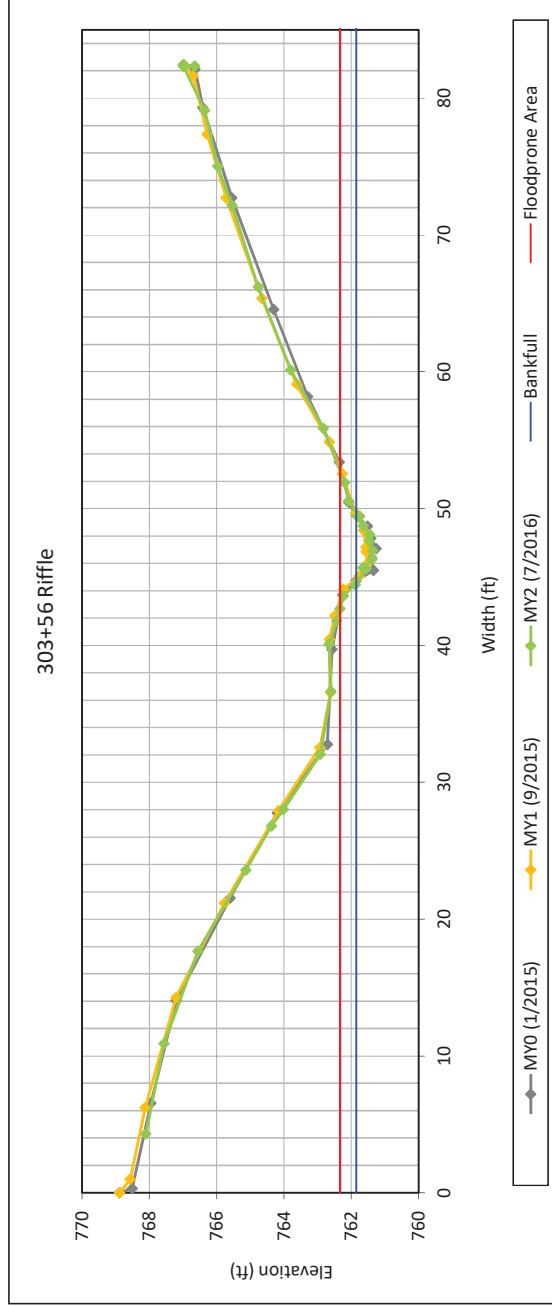
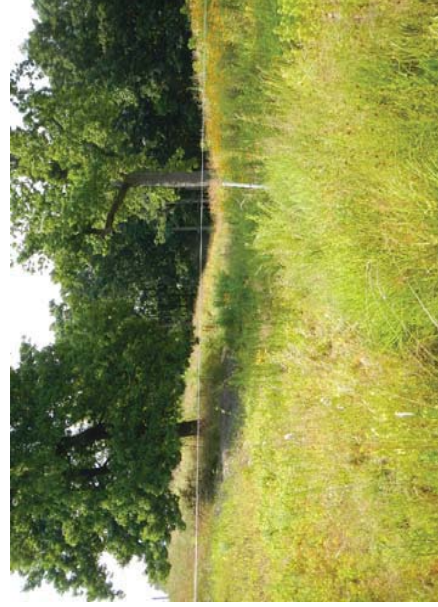
**Cross Section 15, UT1B R1**

- 1.5 x-section area (ft.sq.)
- 5.2 width (ft)
- 0.3 mean depth (ft)
- 0.5 max depth (ft)
- 5.5 wetted perimeter (ft)
- 0.3 hyd radi (ft)
- 18.8 width-depth ratio
- 10.0 W flood prone area (ft)
- 1.9 entrenchment ratio
- 1.0 low bank height ratio

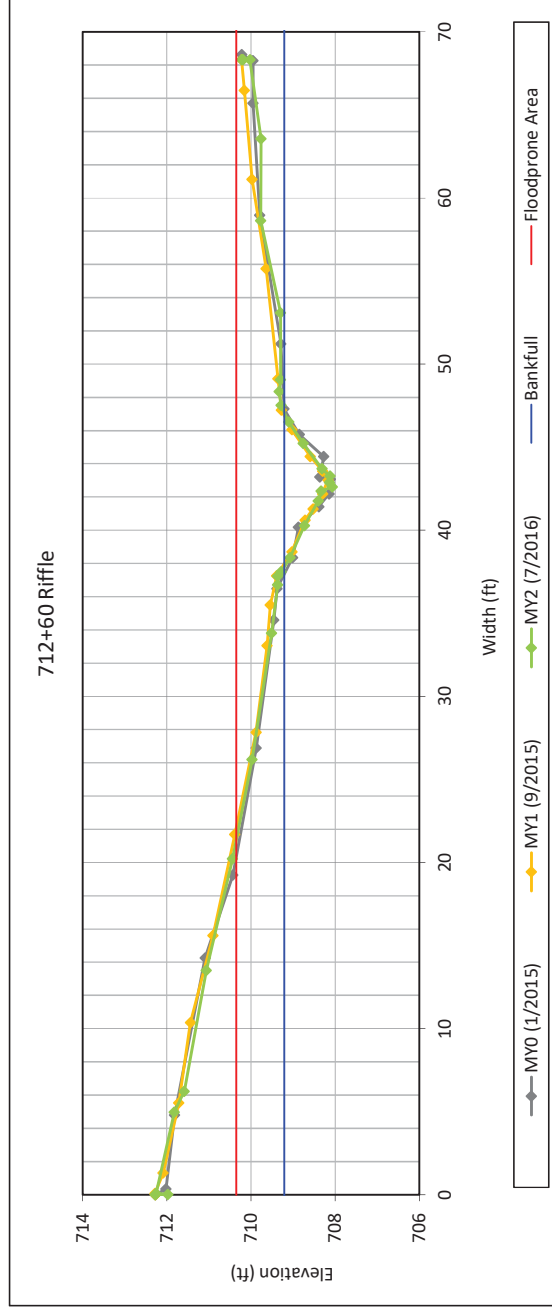
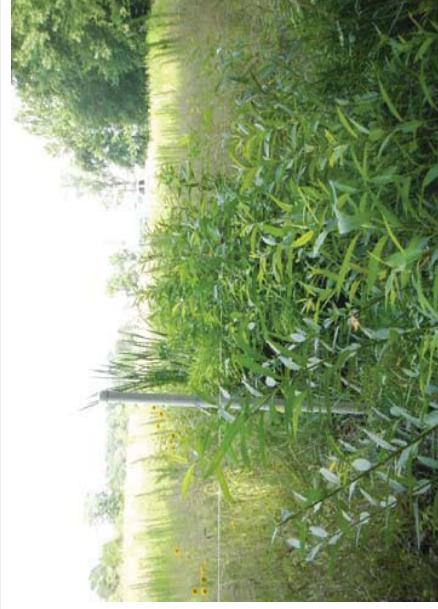
**Cross Section 16, UT2C R2**

4.9	x-section area (ft.sq.)
9.3	width (ft)
0.5	mean depth (ft)
1.1	max depth (ft)
9.7	wetted perimeter (ft)
0.5	hyd radi (ft)
17.6	width-depth ratio
46.9	W flood prone area (ft)
5.1	entrenchment ratio
1.0	low bank height ratio

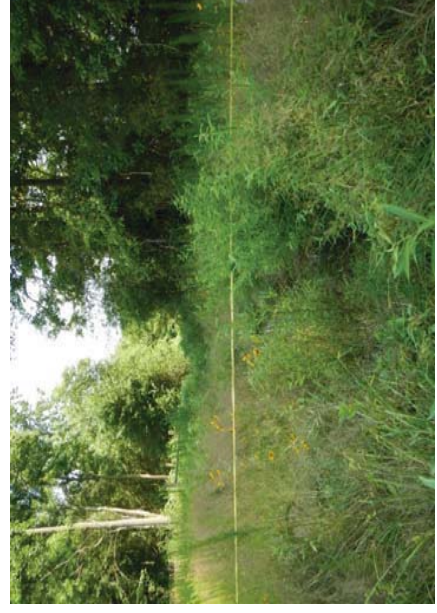
**Cross Section 17, UTZC R2**

In general, cross sections for UT2, UT2A, UT2B, UT2C, and UT1B show little to no change in the bankfull area, maximum depth ratio, or width-to-depth ratio. Changes observed at cross section 7 (UT2 - Reach - 2) were the result of pool scouring at this one location. Willow root mats are growing into the channel at cross section 17 (UT2C - Reach 2) resulting in a decreased bankfull area and depth in MY2.

The decrease in cross sectional area and depth noted on UT2C - Reach 2 will continue to be monitored during subsequent years for signs of instability and a maintenance plan will be established if deemed necessary. The increased pool depth at one location on UT2 does not constitute a problem as long as the stream is otherwise stable.

5.9	x-section area (ft.sq.)
11.8	width (ft)
0.5	mean depth (ft)
1.2	max depth (ft)
12.2	wetted perimeter (ft)
0.5	hyd radi (ft)
23.8	width-depth ratio
---	W flood prone area (ft)
---	entrenchment ratio
1.0	low bank height ratio
