MONITORING YEAR 3 ANNUAL REPORT

HOPEWELL STREAM MITIGATION SITE

Randolph County, NC
NCDEQ Contract 004642
NCDMS Project Number 95352

Data Collection Period: February 2017 - September 2017
Final Submission Date: December 20, 2017

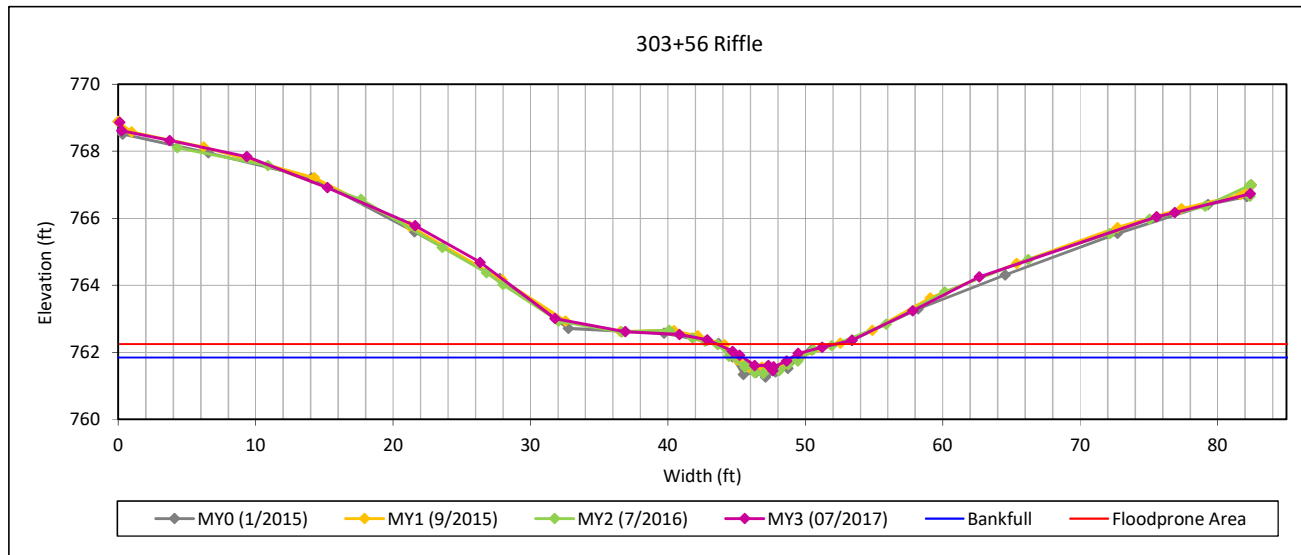
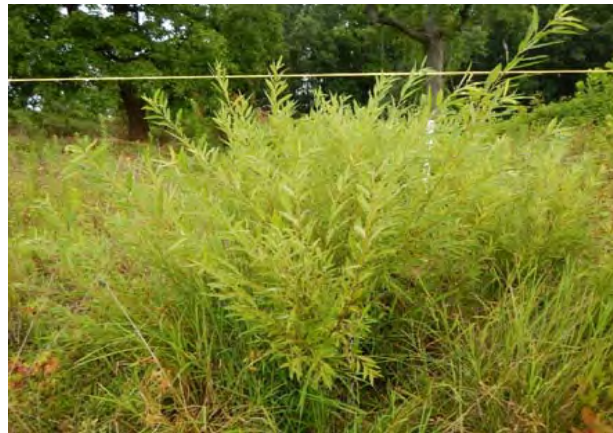
Cross Section 15, UT1B R1

0.7	x-section area (ft.sq.)
3.6	width (ft)
0.2	mean depth (ft)
0.4	max depth (ft)
3.7	wetted parimeter (ft)
0.2	hyd radi (ft)
19.0	width-depth ratio
8.6	W flood prone area (ft)
2.4	entrenchment ratio
1.3	low bank height ratio

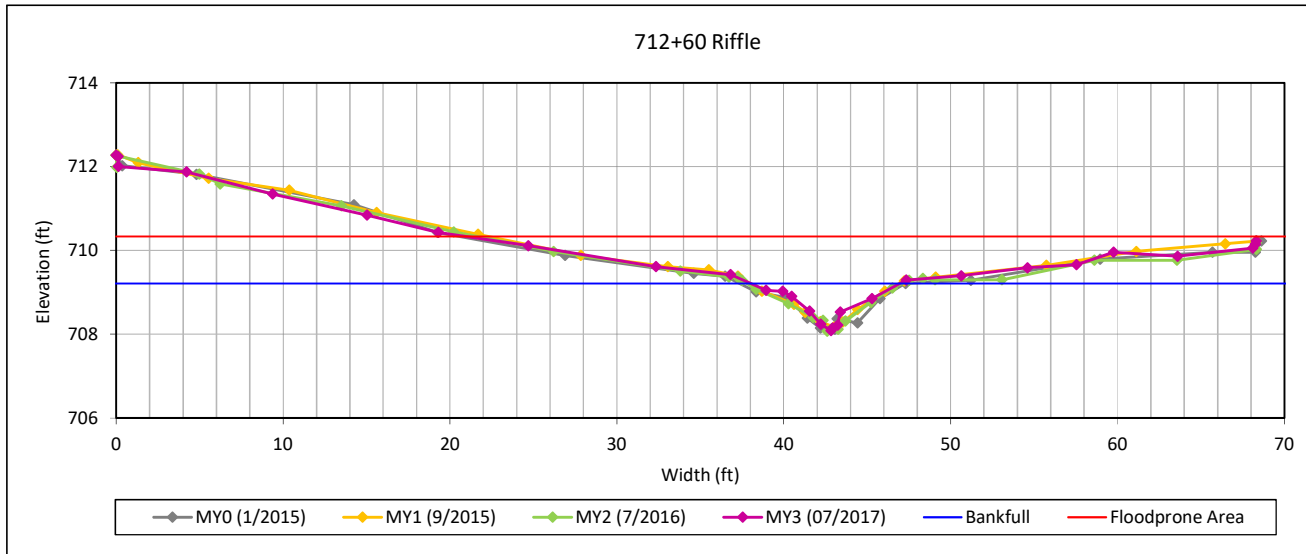
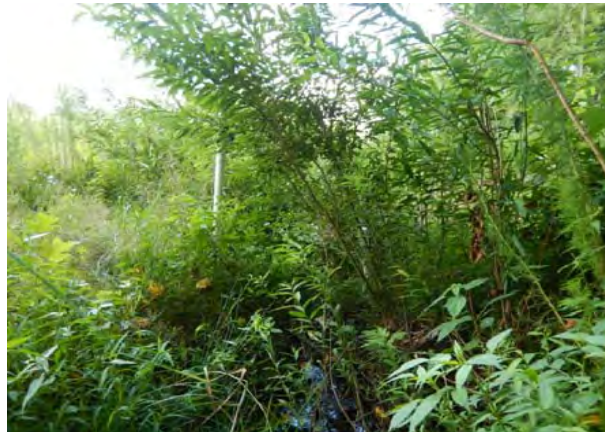
Cross Section 16, UT2C R2

3.9	x-section area (ft.sq.)
8.9	width (ft)
0.4	mean depth (ft)
1.1	max depth (ft)
9.4	wetted parimeter (ft)
0.4	hyd radi (ft)
20.3	width-depth ratio
47.3	W flood prone area (ft)
5.3	entrenchment ratio
1.1	low bank height ratio
