MONITORING YEAR 6 ANNUAL REPORT Final

HOPEWELL STREAM MITIGATION SITE

Randolph County, NC

DMS Project No. 95352

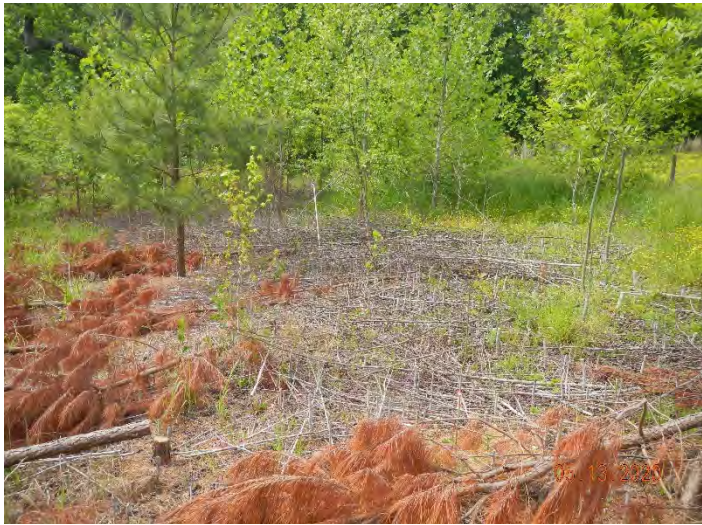
Small bare areas noted during previous monitoring years along the upper section of UT1B Reach 1 have established herbaceous cover because of re-seeding, liming, and fertilizing. No bare areas were noted in MY6. Pockets of dense sweetgum (*Liquidambar styraciflua*) volunteers were treated in late 2019 and early 2020 in the upper section of UT1B Reach 1 and UT2C Reach 2. In February 2020, 75 containerized trees were planted in the larger sweetgum treatment area on UT1B Reach 1 as discussed during the IRT/DMS site meeting in May 2019. Refer to Appendix 6 for IRT/DMS meeting minutes and Appendix 7 for photographs of sweetgum treatment and containerized tree planting areas taken in May 2020.

Right hillside at Station 303+00 – sweetgum treatment / plantings (05/13/20)

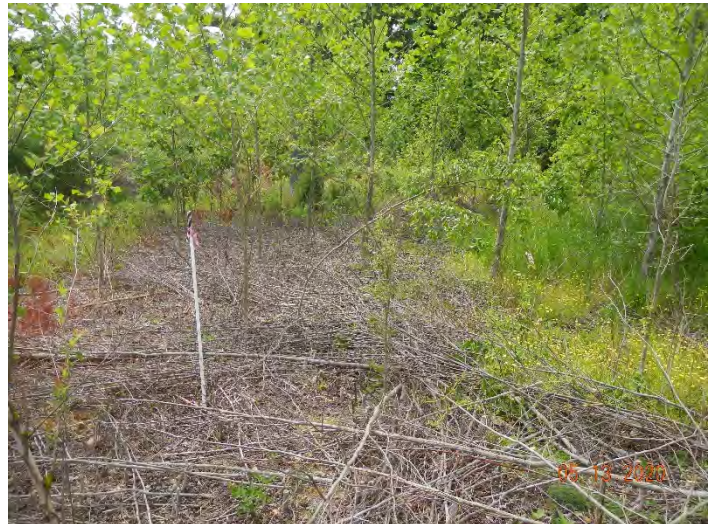
Right hillside at Station 303+50 – sweetgum treatment / plantings (05/13/20)

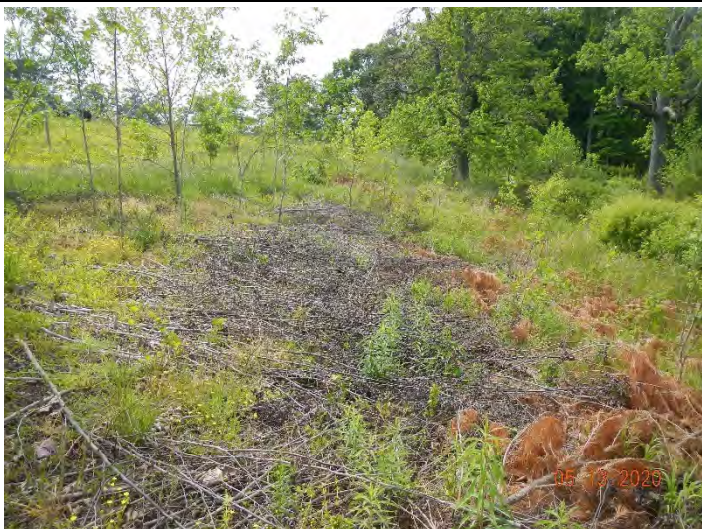
Left hillside at Station 303+50 – sweetgum treatment / plantings (05/13/2020)

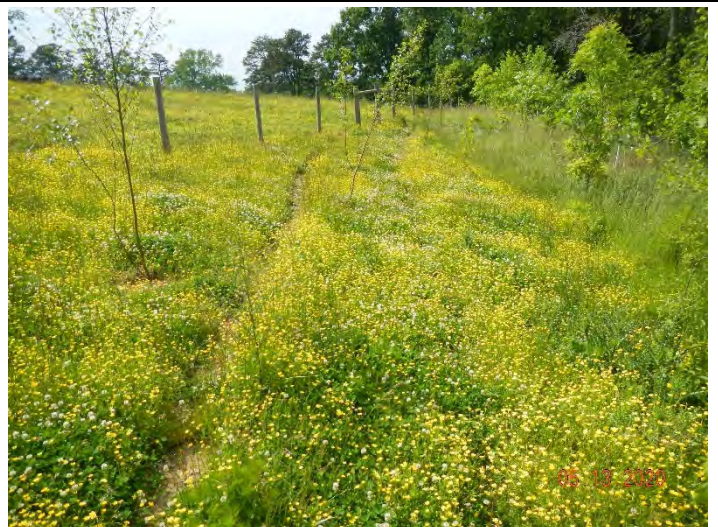
Left easement corner at Station 303+50 – new fencing / plantings (05/13/2020)
