FINAL MONITORING REPORT (MY7) / CLOSEOUT REPORT

HOPEWELL STREAM MITIGATION SITE

Randolph County, NC

DMS Project No. 95352

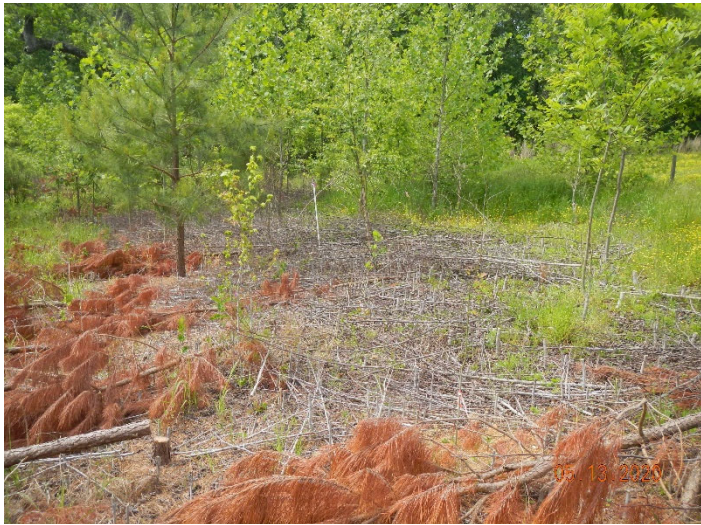
Right hillside at Station 303+00 – sweetgum treatment / plantings (05/13/2020)
