South Muddy Creek Stream Restoration Project Final Baseline Monitoring Document and As-Built Baseline Report

McDowell County, North Carolina

NCEEP Project Numbers - 737 and 92251

Submission Date: June 30, 2011

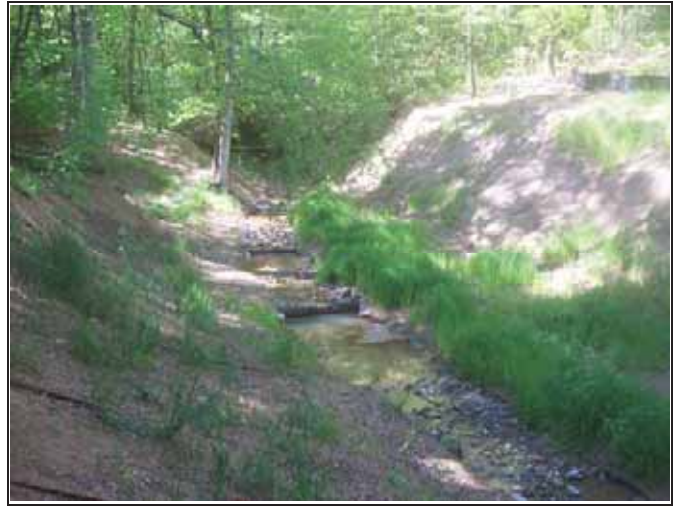
UT2 PID 2 – Constructed Riffles & Log Sills

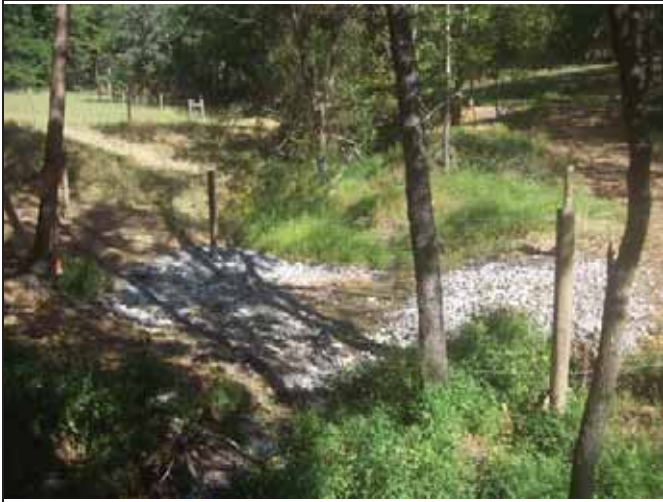
UT2 PID 3 – Stream crossing
