Hoppers Creek-Melton Farm Stream Restoration Project

Year 1 Monitoring Report

McDowell County, North Carolina

NCEEP Project Number – 92251

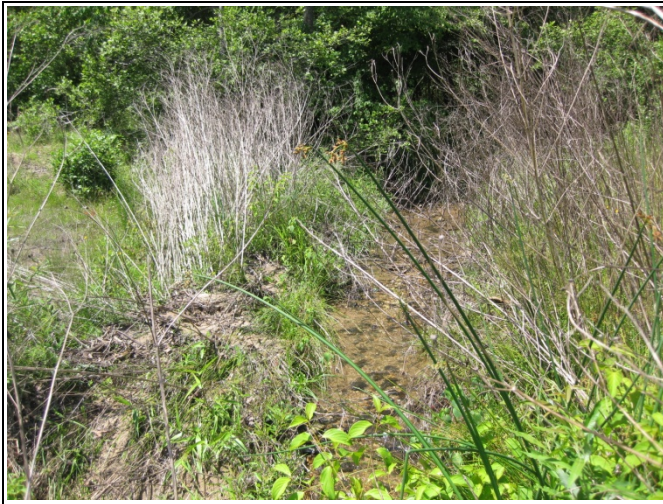
SFHC PID 1 – Constructed Riffle

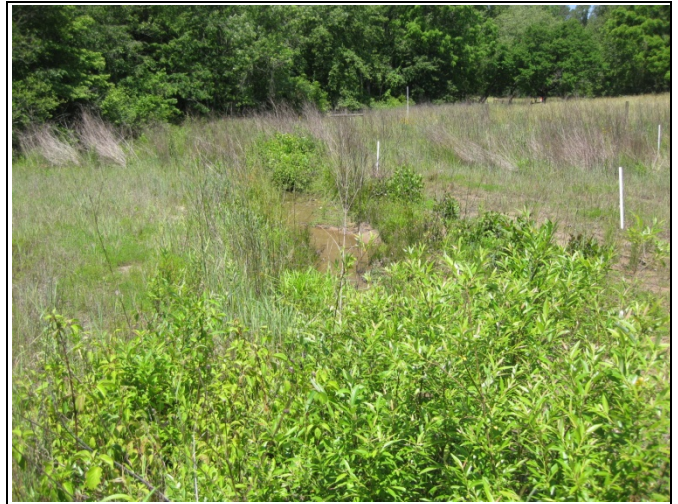
SFHC PID 2 – Constructed Riffle

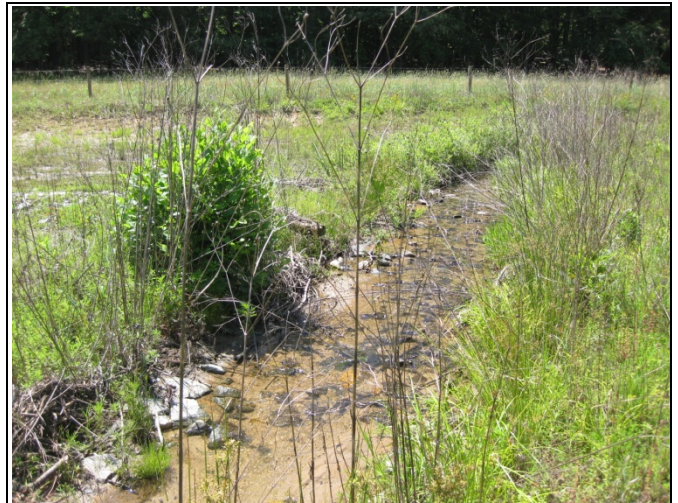
SFHC PID 4 – Constructed Riffle

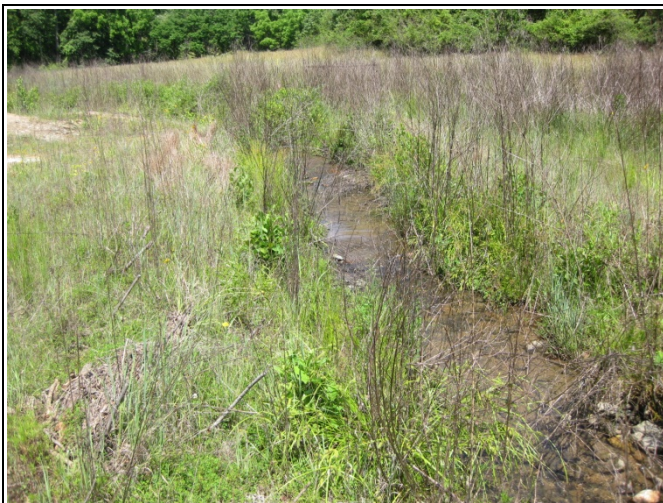
SFHC PID 5 – Constructed Riffle

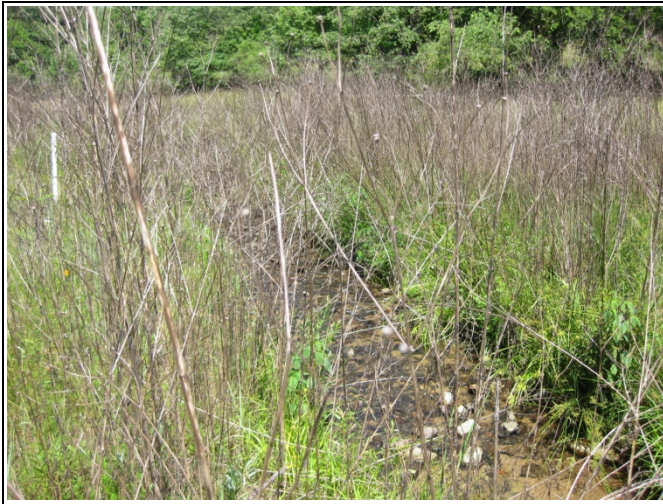
SFHC PID 7 – Constructed Riffle

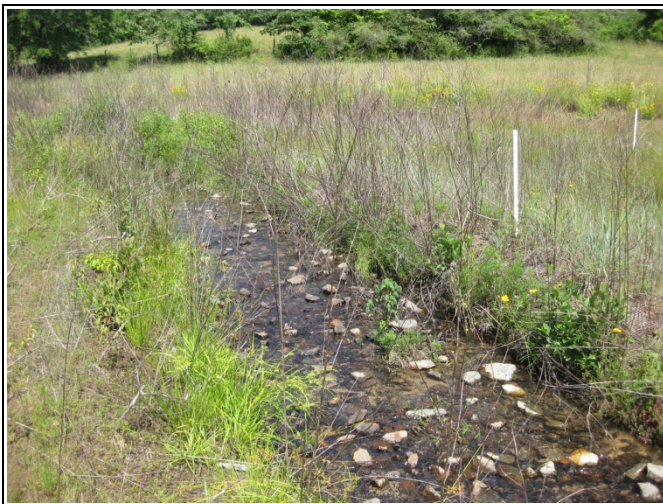
SFHC PID 9 – Constructed Riffle

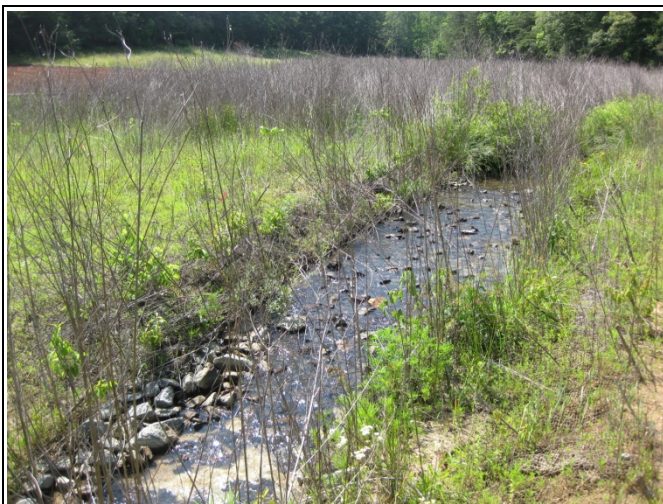
SFHC PID 11 – Constructed Riffle

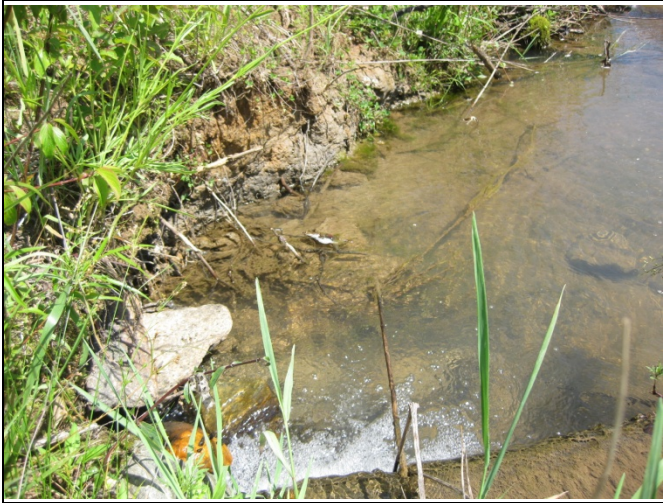
SPA1 – SFHC Reach 1 Left bank scour

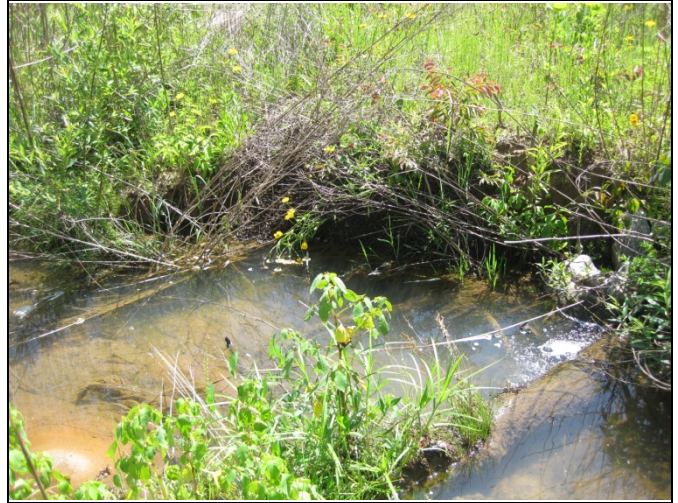
SPA2 – SFHC Reach 1 Right bank scour

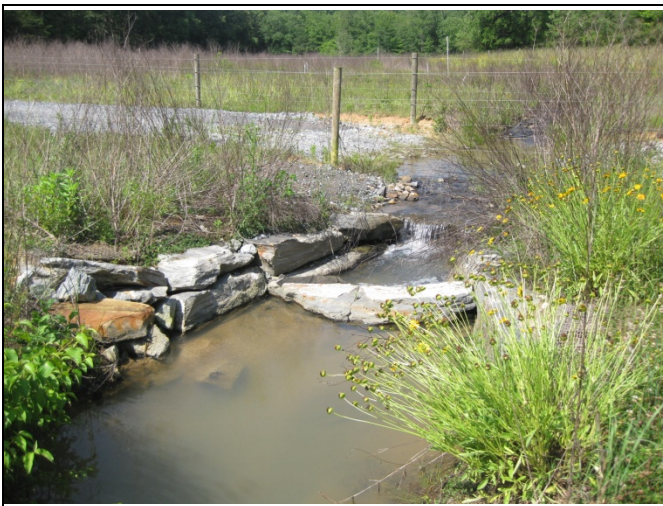
SPA3 – SFHC Reach 2 Piping of cross vane

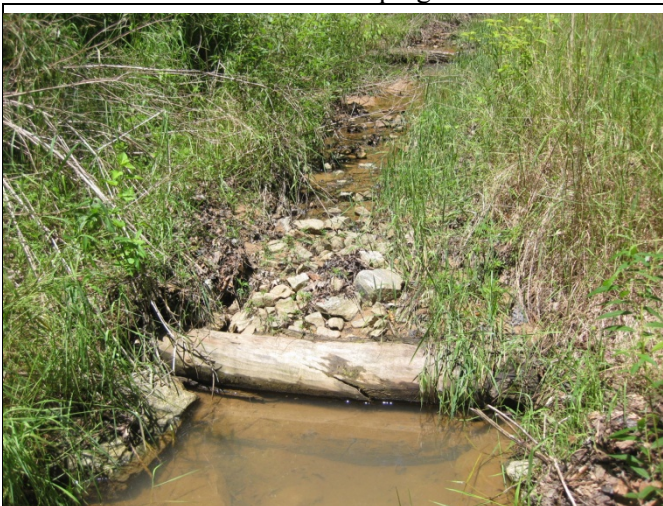
SPA5 – UT2 Reach A Piping within riffle cascade around log sill
