# Hoppers Creek-Melton Farm Stream Restoration Project

## Year 2 Monitoring Report

**NCEEP Project Number – 92251**

# **Site Assessment Report – Monitoring Year 2**

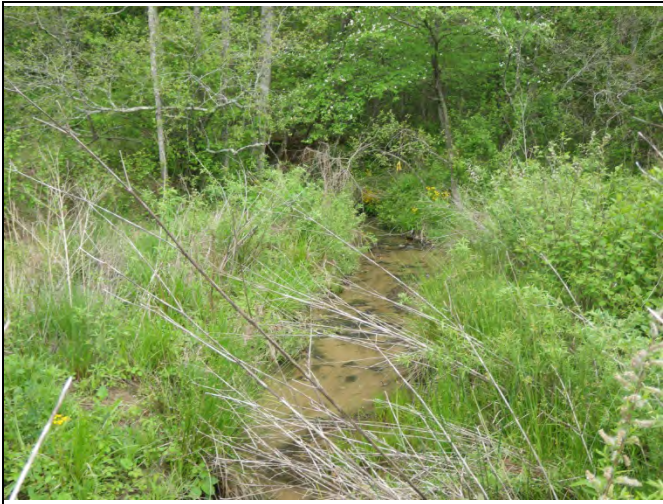
SFHC PID 1 – Constructed Riffle

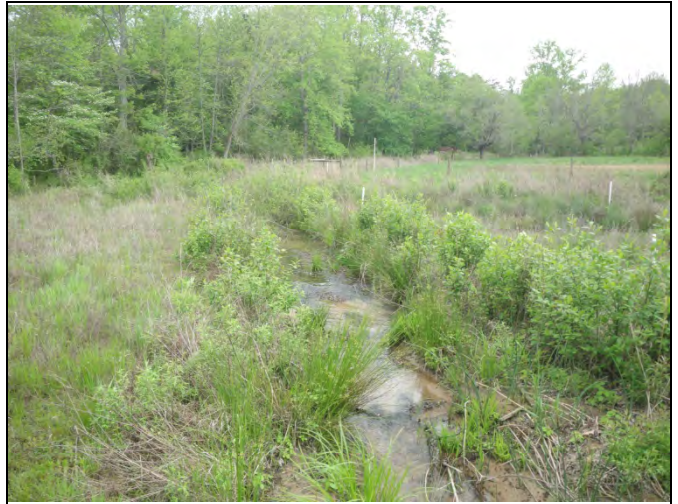
SFHC PID 2 – Constructed Riffle

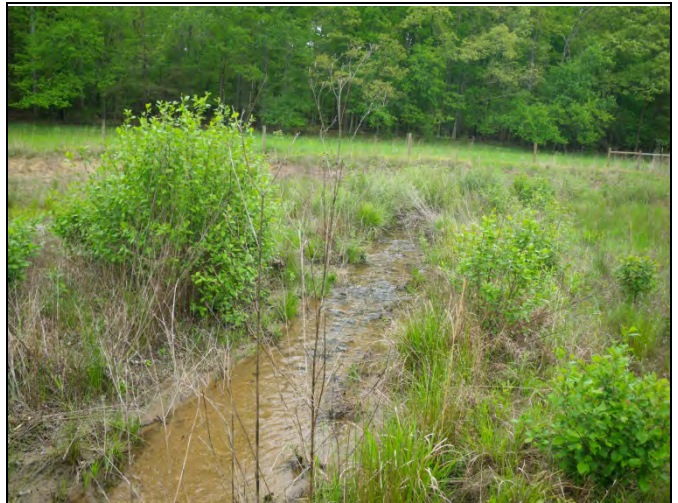
SFHC PID 4 – Constructed Riffle

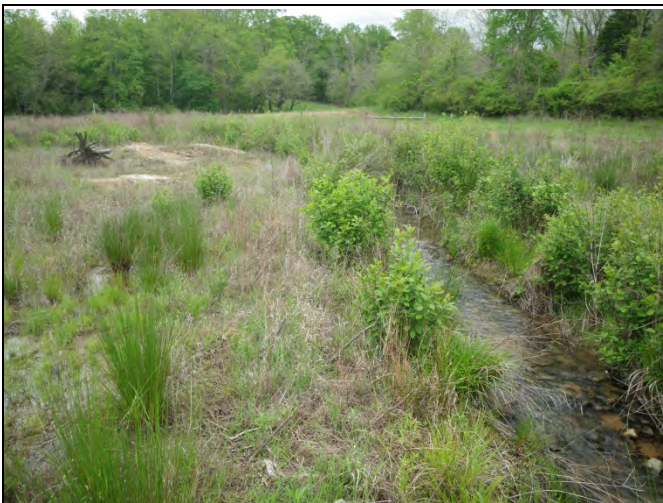
SFHC PID 5 – Constructed Riffle

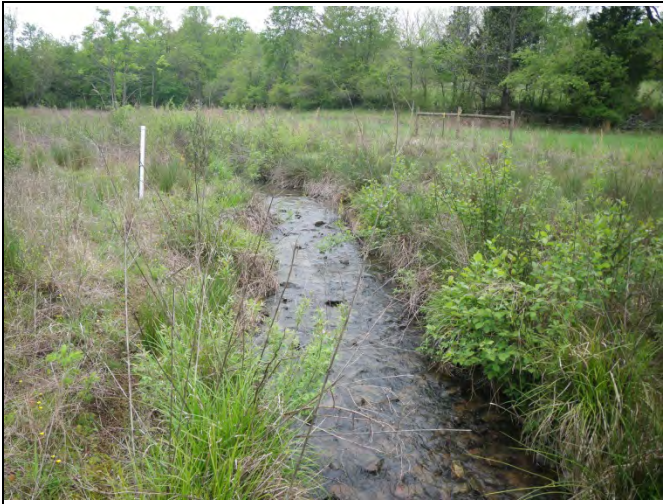
SFHC PID 7 – Constructed Riffle

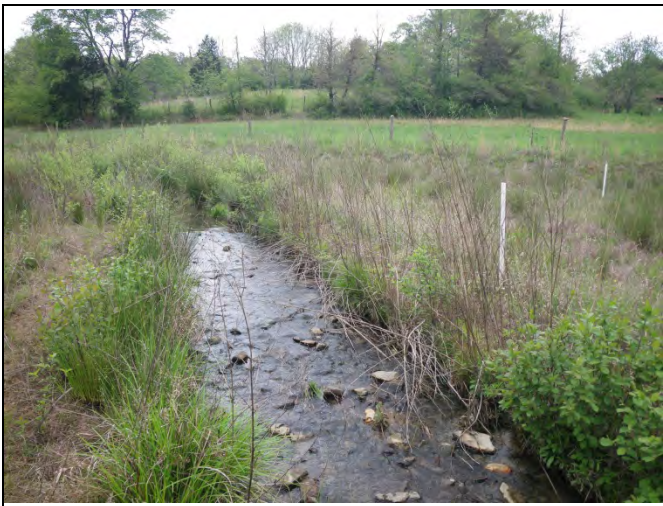
SFHC PID 9 – Constructed Riffle

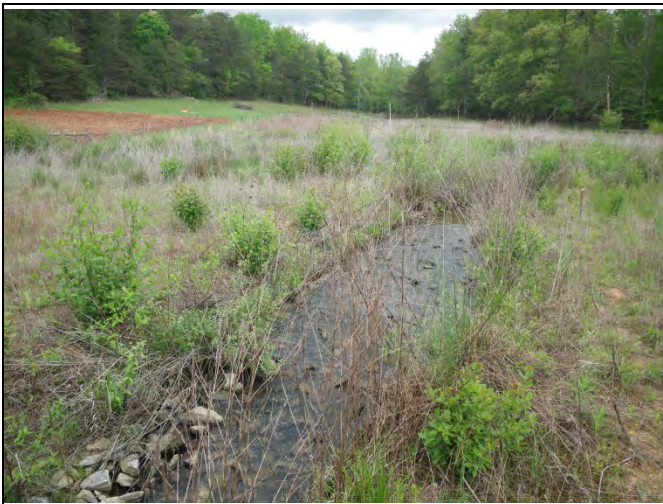
SFHC PID 11 – Constructed Riffle

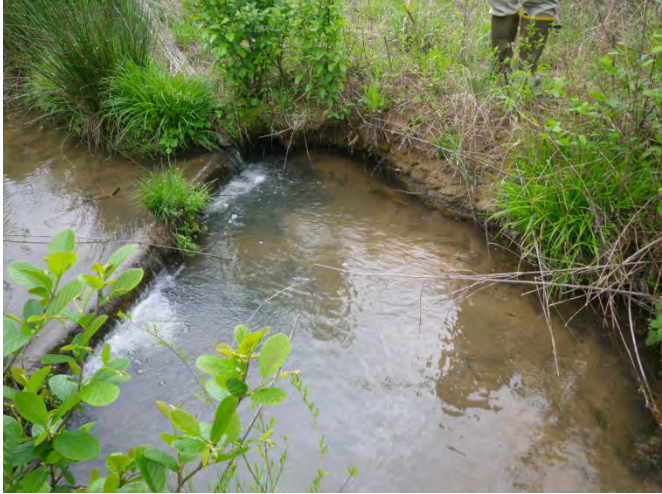
SPA1-1 – SFHC Reach 1 Left bank scour

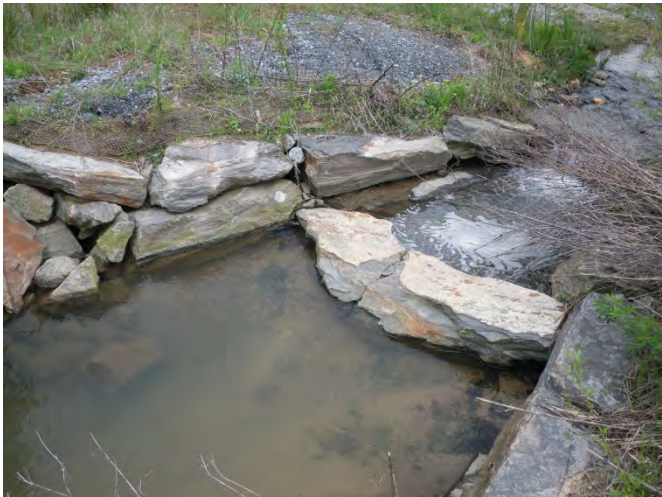
SPA1-3 – SFHC Reach 2 Piping of cross vane

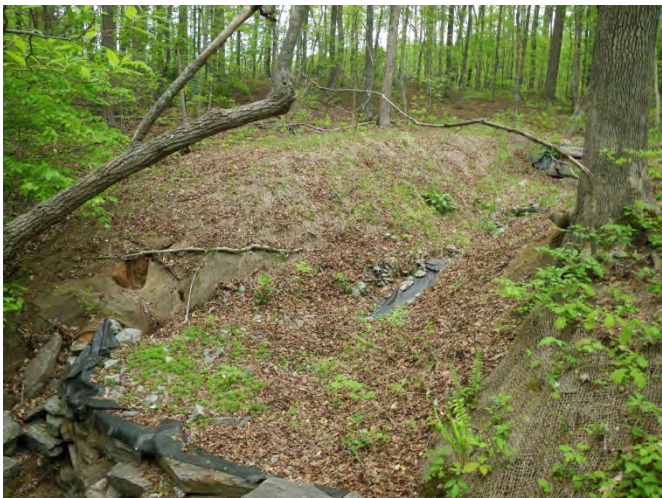
SPA1-6 – Ephemeral drainage channel bed erosion

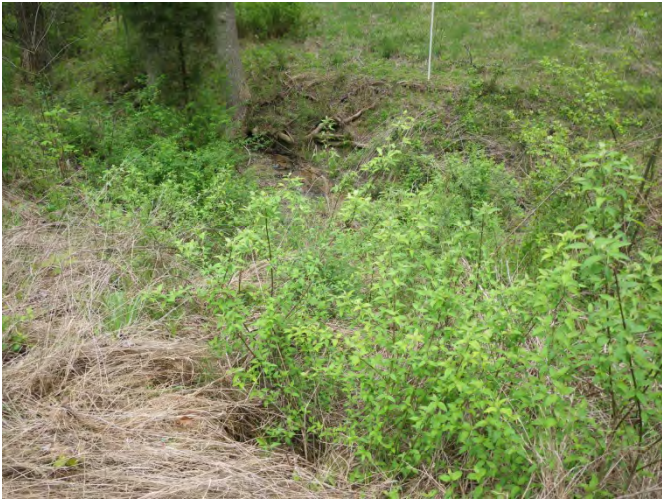
SPA2-4 – UT2 Reach B Left bank slumping
