Hoppers Creek-Melton Farm Stream Restoration Project

Year 3 Monitoring Report

McDowell County, North Carolina

NCEEP Project Number – 92251

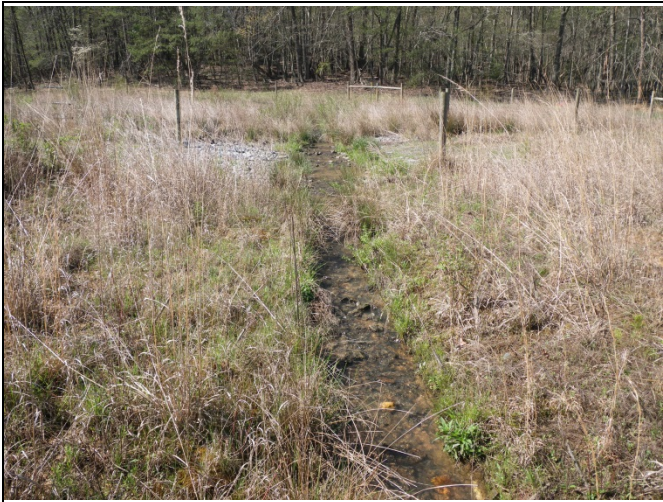
UT1 PID 15 – Constructed Riffle below stream crossing

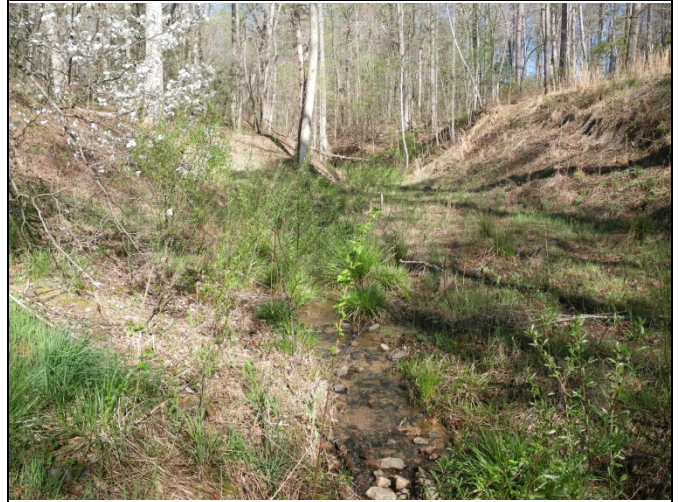
UT2 PID 2 – Constructed Riffles & Log Sills

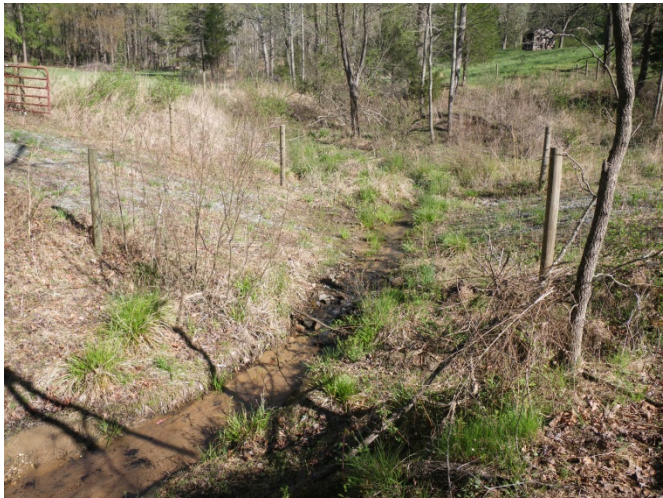
UT2 PID 3 – Stream crossing

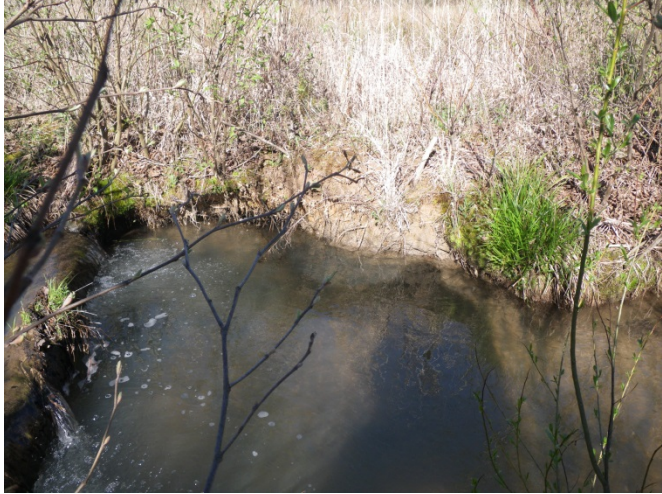
SPA1-1 – SFHC Reach 1 Left bank scour

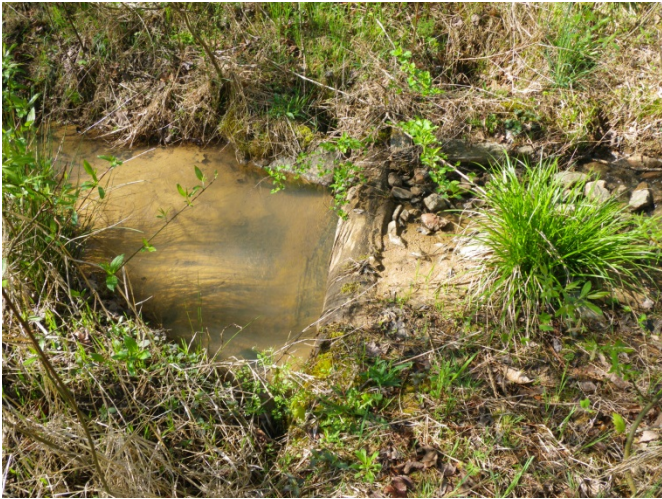
SPA1-5 – UT2 Reach A Piping within riffle cascade around log sill

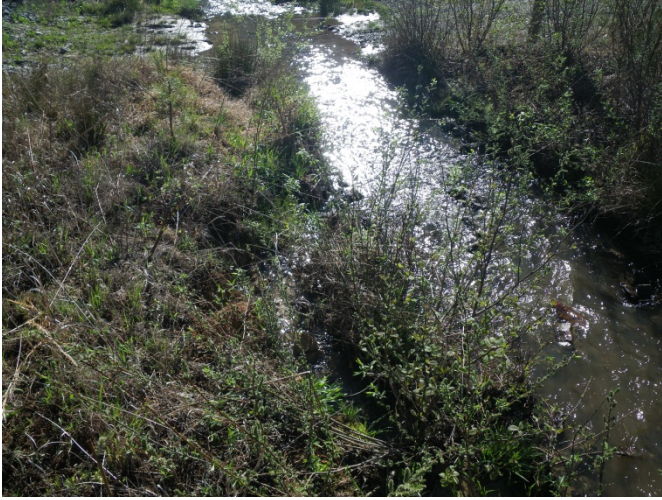
SPA2-3 – SFHC Reach 2 Left bank scour
