South Fork Hoppers Creek - Melton Farm Stream Restoration Project Year 4 Monitoring Report

NCDMS Project Number – 92251

FINAL

Report Prepared and Submitted by Michael Baker Engineering, Inc.

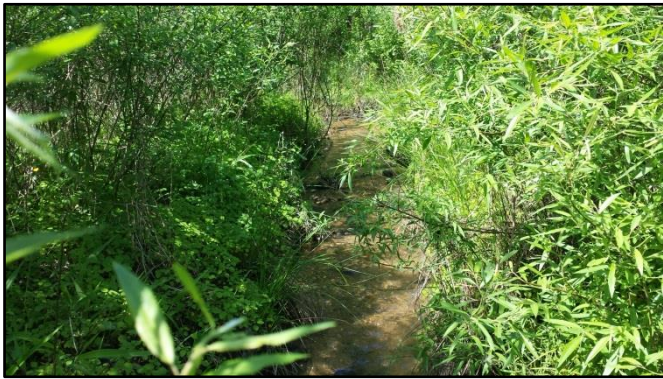
SFHC PID 1 – Constructed riffle

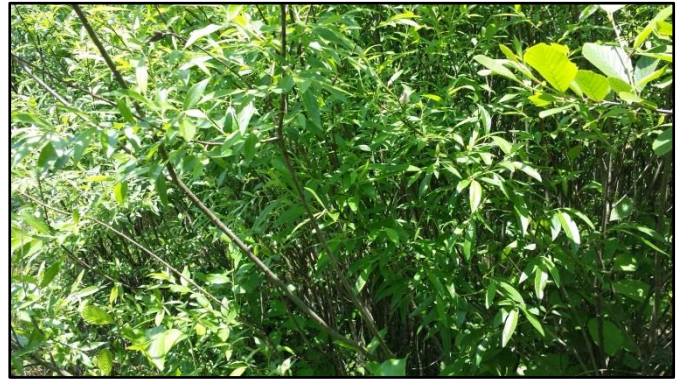
SFHC PID 2 – Constructed riffle

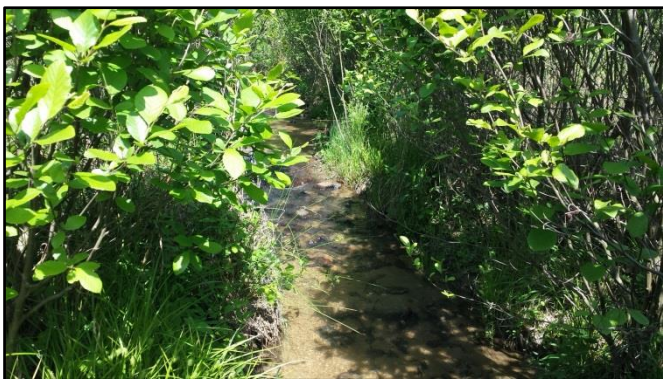
SFHC PID 5 – Constructed riffle

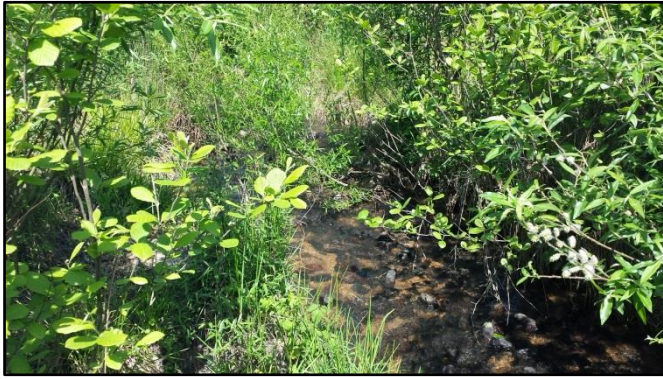
SFHC PID 7 – Constructed riffle

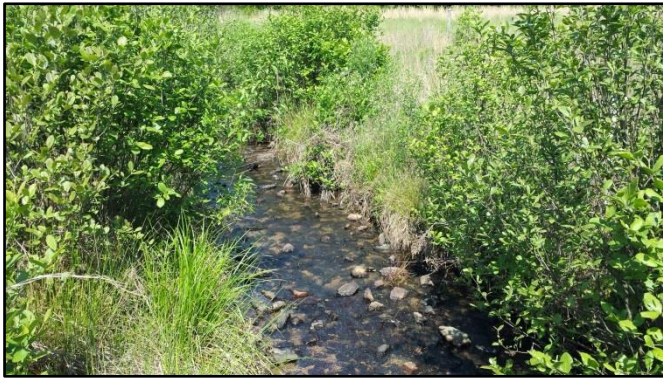
SFHC PID 9 – Constructed riffle

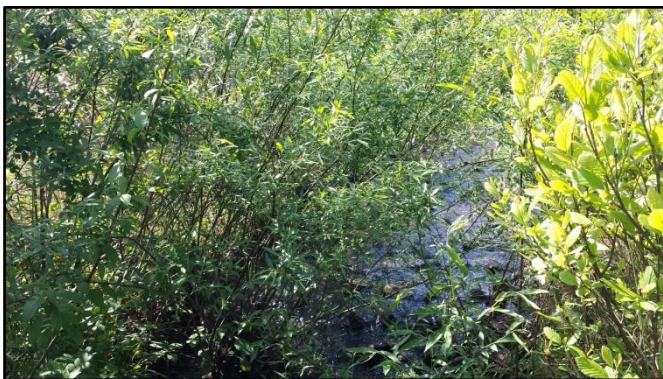
SFHC PID 11 – Constructed riffle

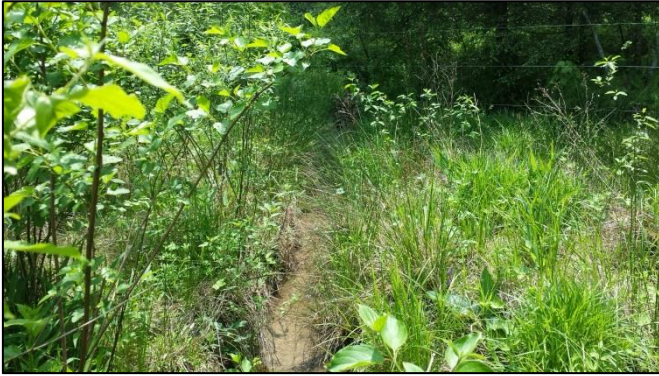
UT1 PID 1 – Constructed riffle

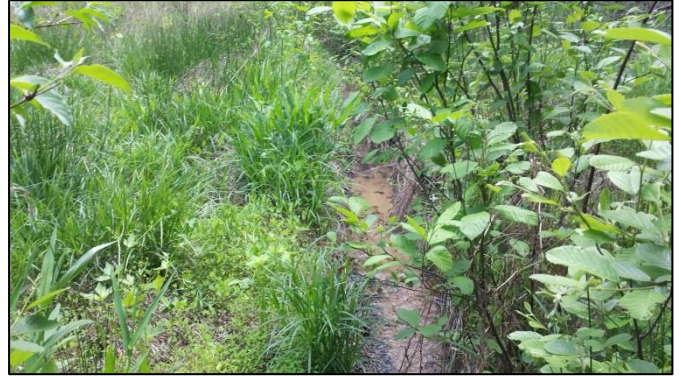
UT1 PID 2 – Constructed riffle

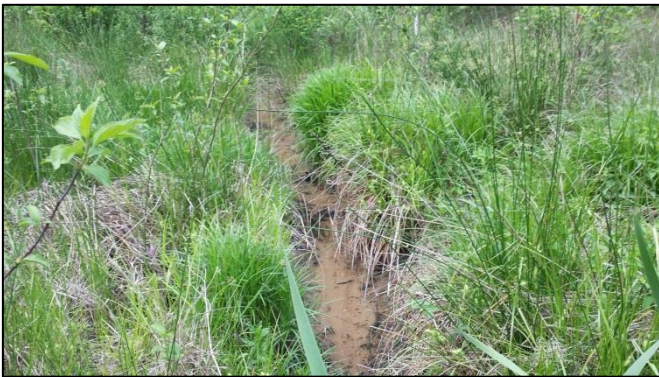
UT1 PID 3 – Constructed riffle

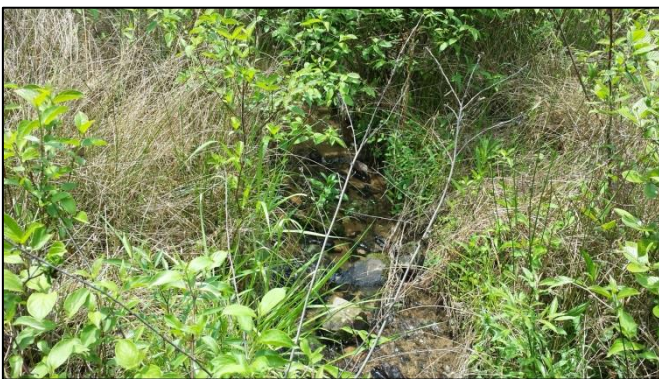
UT1 PID 5 – Constructed riffle

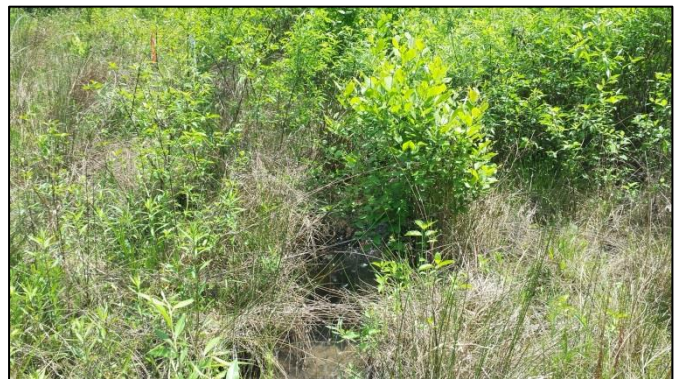
UT1 PID 6 – Log sills

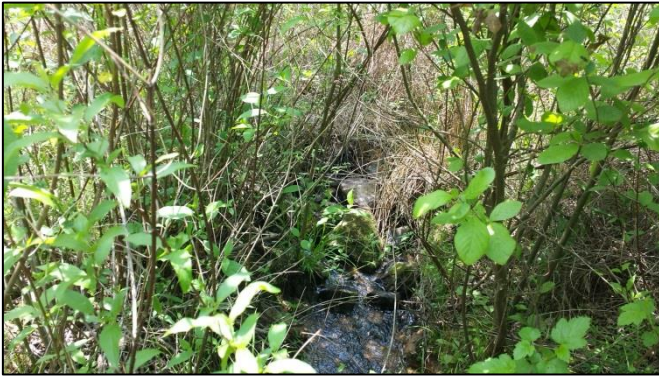
UT1 PID 7 – Constructed riffle

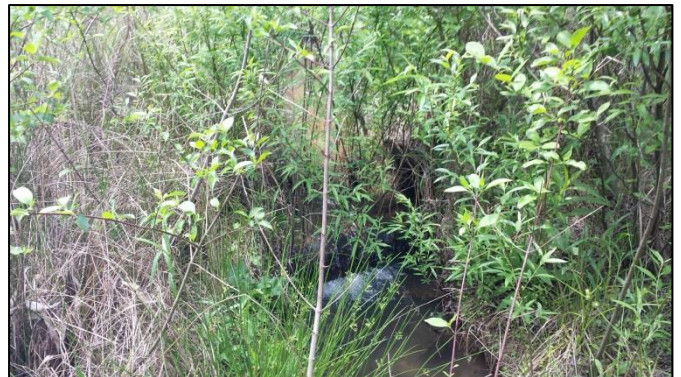
UT1 PID 10 – Log sills

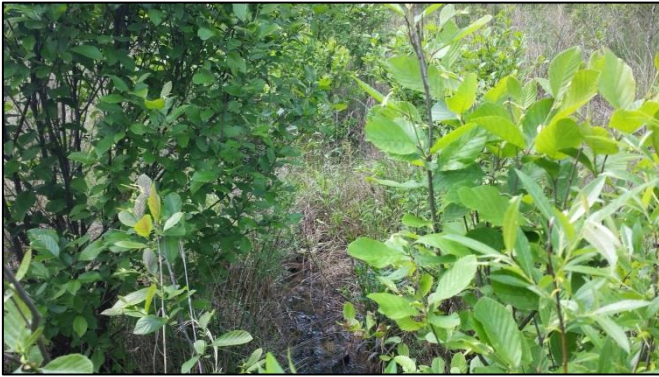
UT1 PID 13 – Constructed riffle

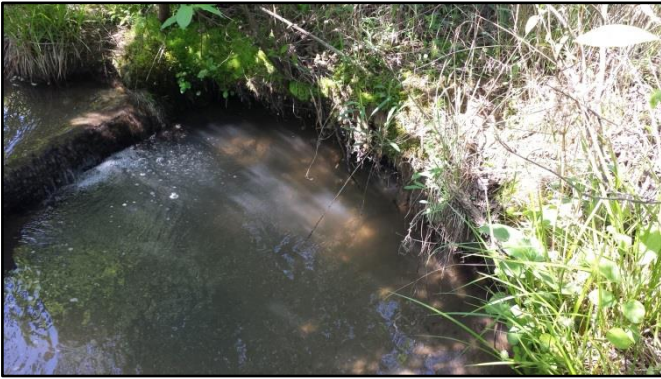
SPA1-1 – SFHC Reach 1: Left bank scour.

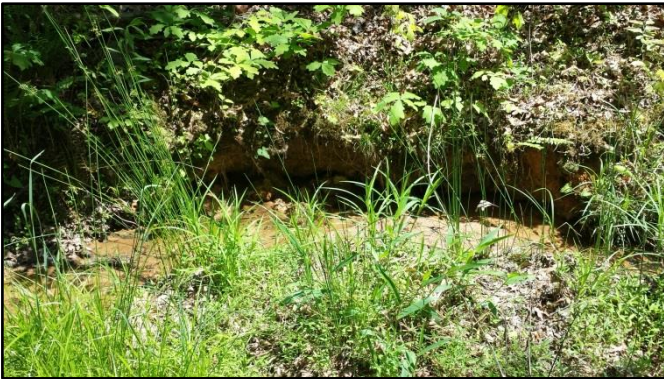
Bank Scour	12+36.50 to 12+53.50	Left bank scour on outside bend. Appears to be caused by high near bank stress during bankfull storm events.	SPA4-3
Ephemeral Drainage (near upstream extents of UT2)**			
Feature Issue	Station No.	Suspected Cause	Photo Number
Bed Scour/Degradation	Riffle cascade downstream of second boulder sill	Scour of riffle cascade from large storm events over time has eroded the channel bed, depositing the coarse riffle substrate downstream, and exposed the underlying filter fabric.	SPA1-6

SPA4-3 – UT2 Reach A: Small area of erosion along the left bank.
