Monitoring Report
FINAL VERSION
Horne Creek Tributaries Mitigation Project
Monitoring Year 3
Calendar Year of Data Collection: 2022

NCDEQ DMS Project Identification # 100026
NCDEQ DMS Contract # 7181
Yadkin River Basin (Cataloging Unit 03040101)
USACE Action ID Number: SAW-2017-01510
NCDEQ DWR Project # 2017-1156
Surry County, NC
Contracted Under RFP # 16-006993, Date of Issue: August 16, 2016
Data Collection Period: July - October 2022
Submission Date: November 2022

RE: WLS Responses to NCDEQ DMS Review Comments for Task 9 Submittal, Monitoring Year 3 Report for the Horne Creek Tributaries Mitigation Project, DMS Full-Delivery Project ID #100026, Contract #7181, Yadkin River Basin, Cataloging Unit 03040101, Surry County, NC

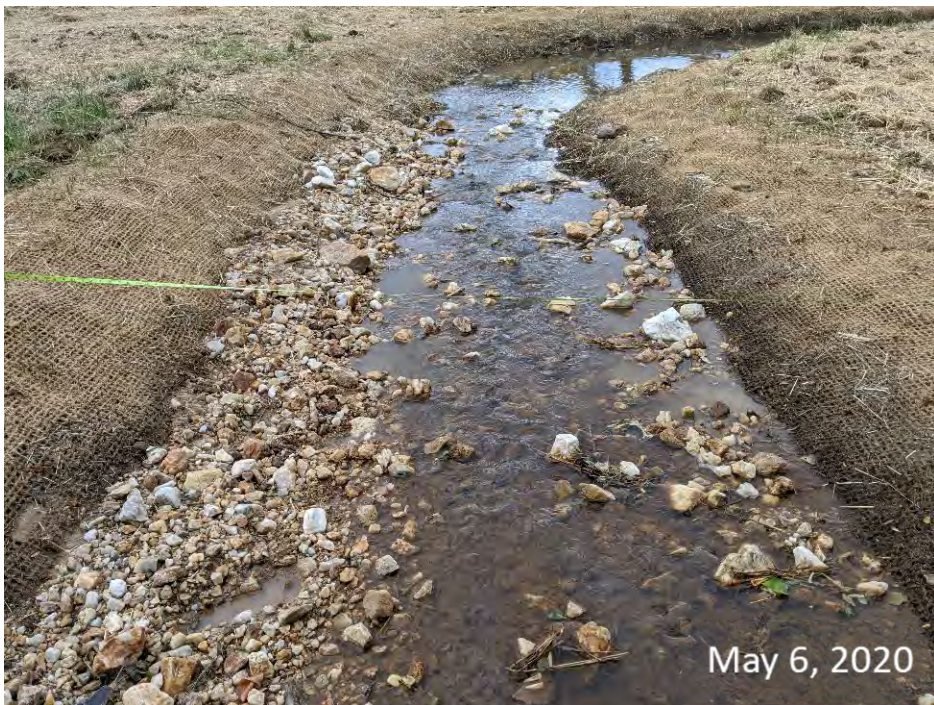
R5, XS14, Upstream (MY-03)

Spring 2022 during visual assessments for MY3 and the cross-section data showed no major changes from MY2. XS-14 is stable and shows minimal changes from MY1. Visual surveys indicate the areas affected through aggradation and degradation are functioning and stable. WLS will closely monitor any changes to all stream reaches during MY4.

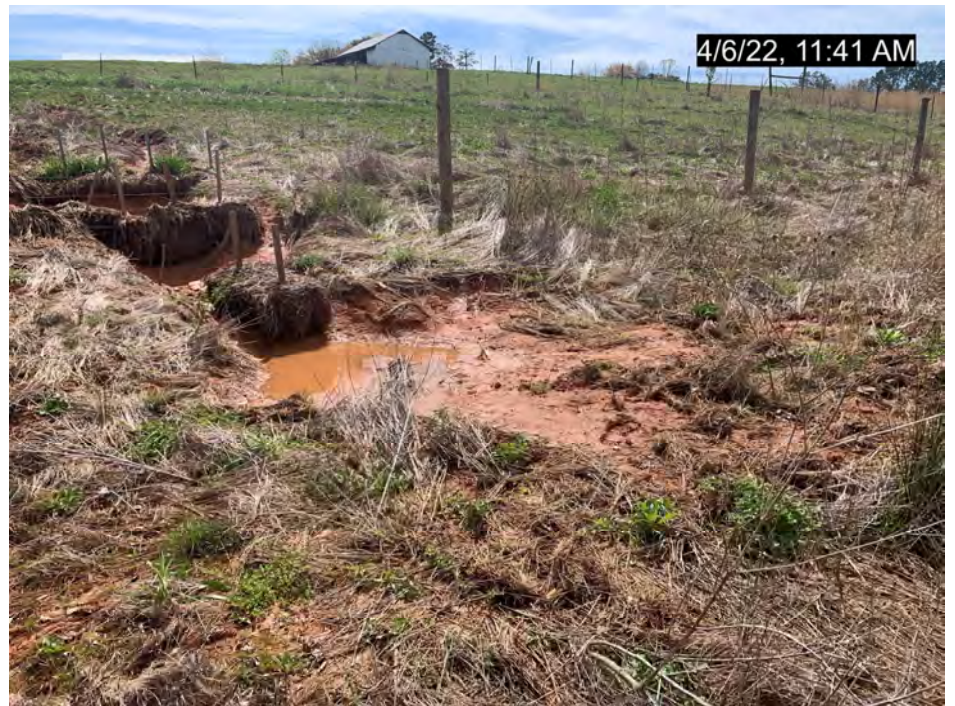
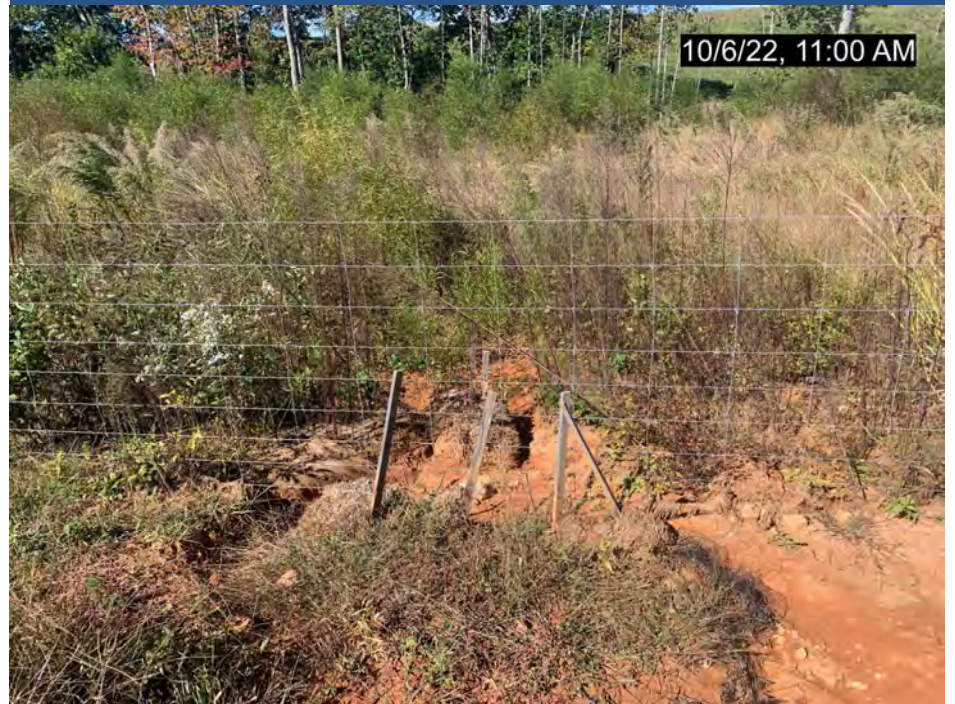
SPA5, R5 Left Floodplain, R5 Side Slope, Minor deposition and erosion as a result of erosion outside of the easement (MY-01)

- **MY3 Action:** No action was taken during MY3. During MY4, the area outside the easement will be repaired by grading the slope drainage feature, applying temporary and permanent seeding, and installing a permanent erosion control liner. All proposed work will take place outside the conservation easement.

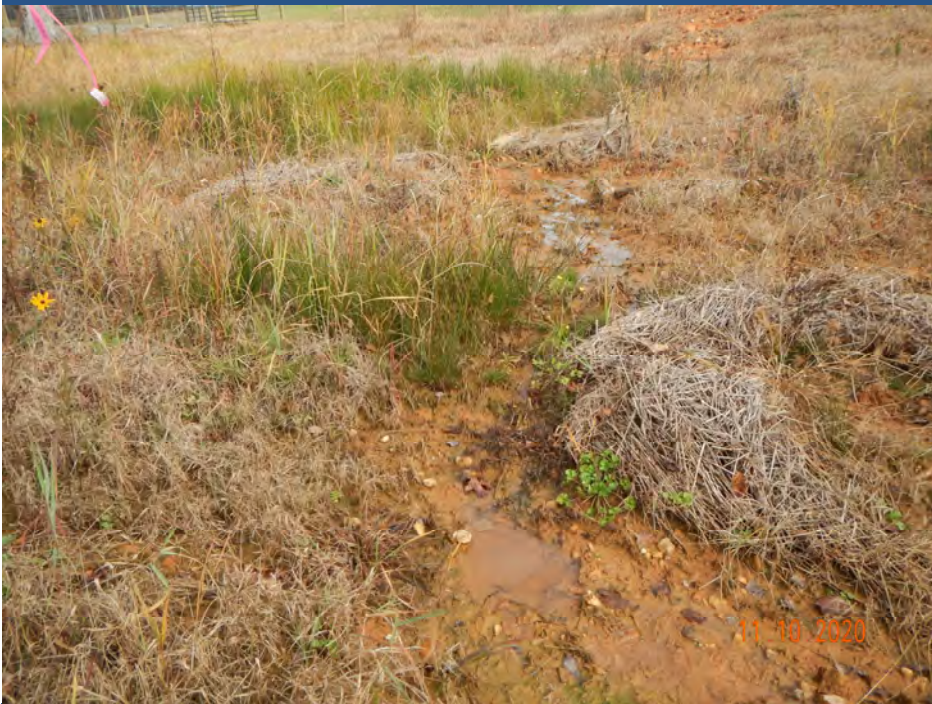
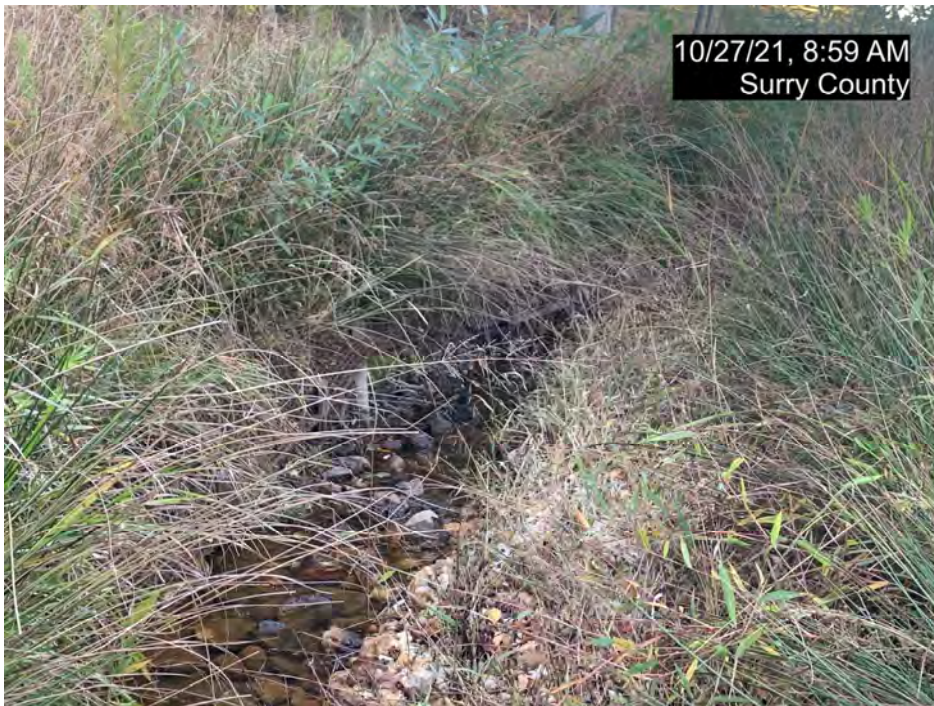
SPA5, R5 Side Slope, Minor deposition and erosion as a result of erosion outside of the easement (MY-03)

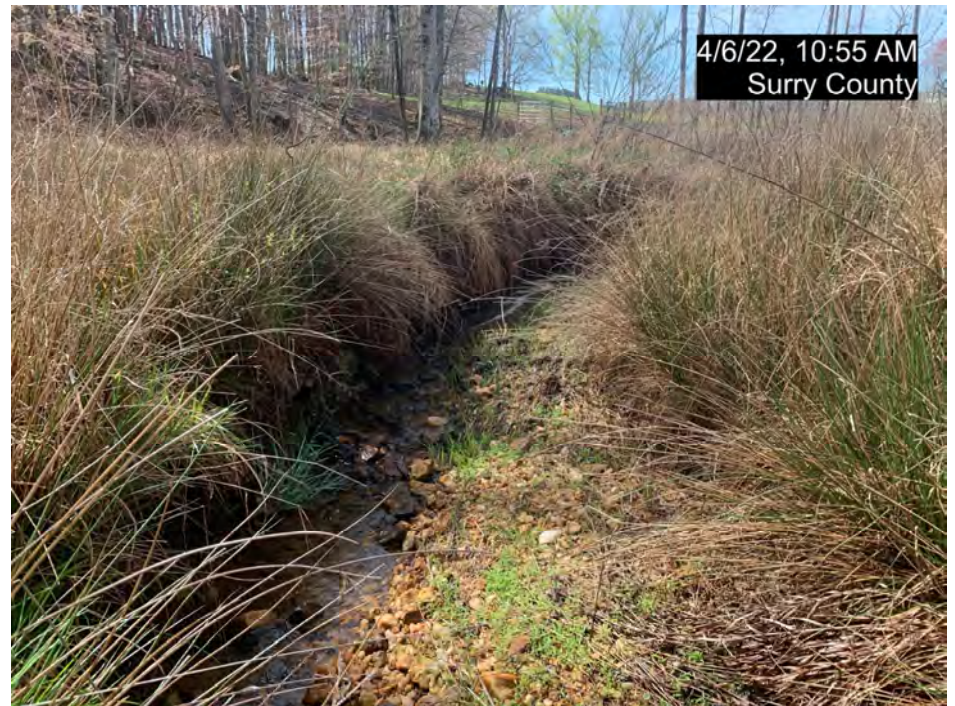
SPA8, R4, STA 20+75, Channel Bed Erosion (MY-02)

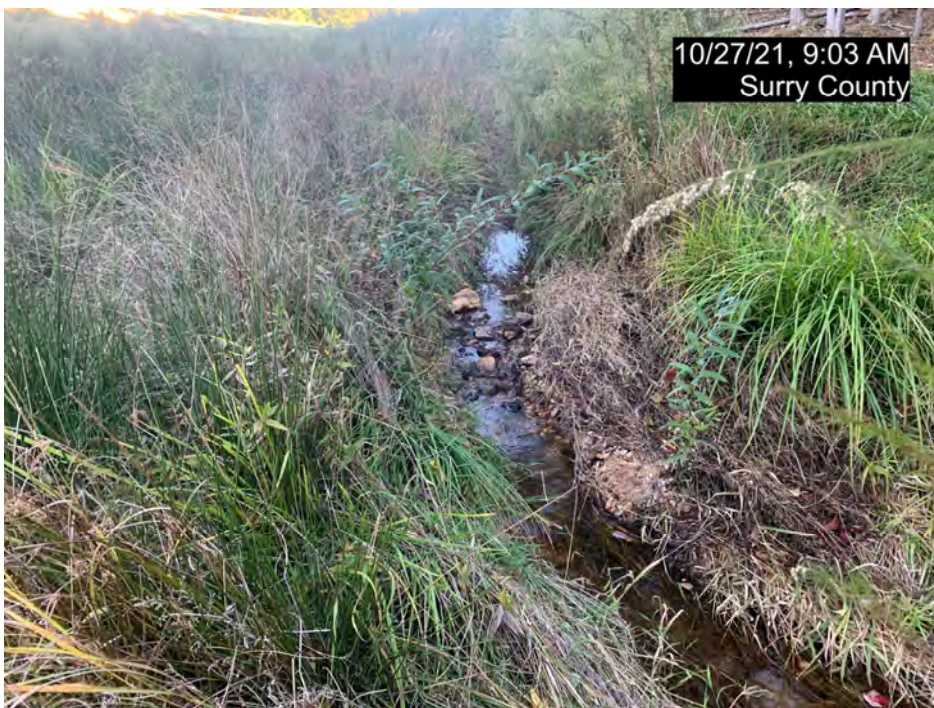
SPA8, R4, STA 20+75, Channel Bed Erosion (MY-03)

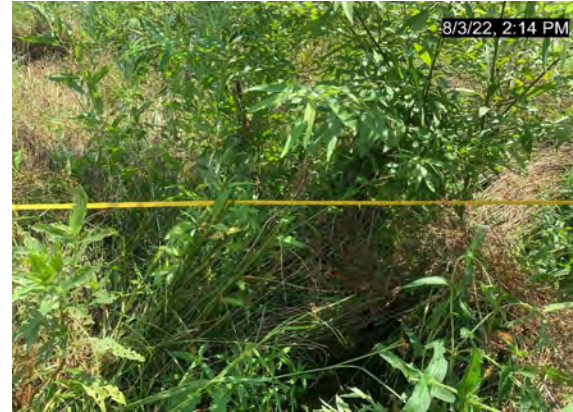
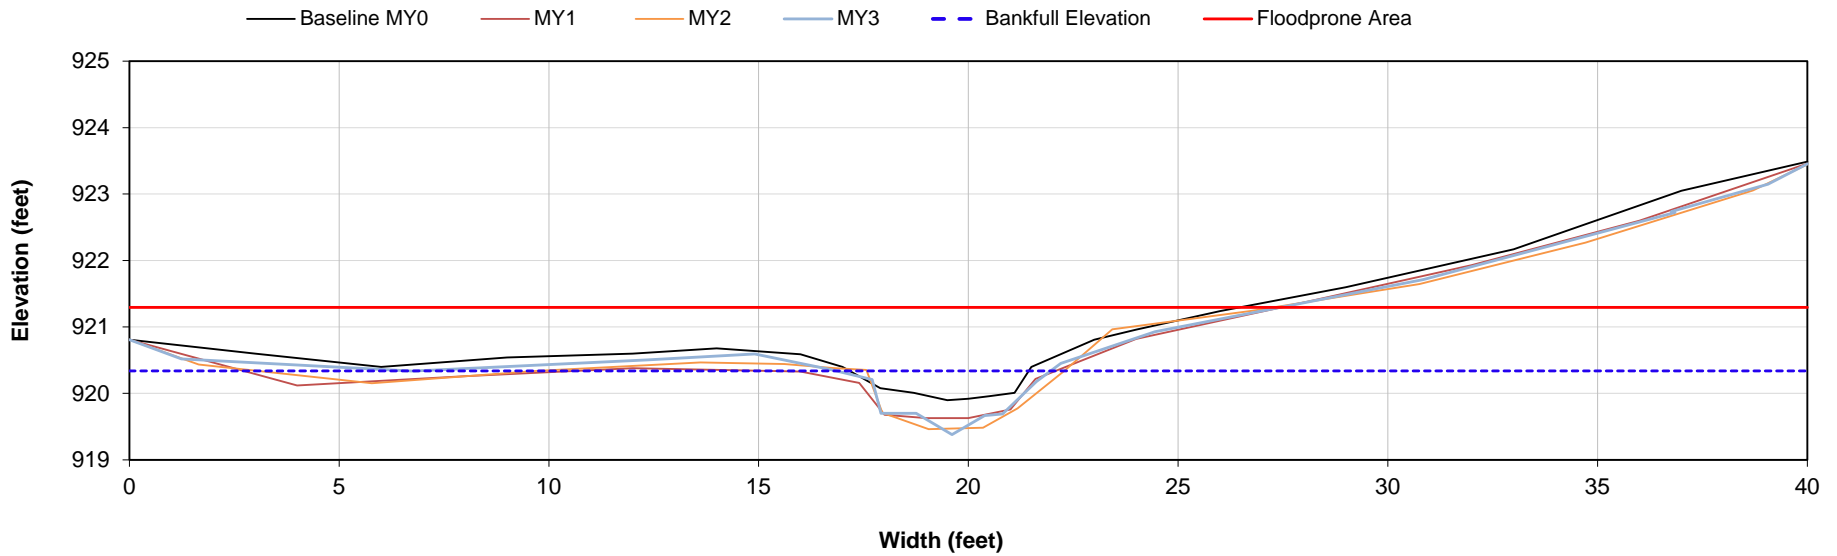
XS-4 Riffle, STA 20+47

Dimension Data Summary: MY3 2022	
Bankfull Elevation (ft)	920.3
Low Bank Height Elevation (ft)	920.4
Bankfull Max Depth (ft)	1.0
Low Bank Height (ft)	1.0
Bank Height Ratio	1.02
Bankfull X-section Area (ft ²)	2.6
% Change Bank Height Ratio	2.0%

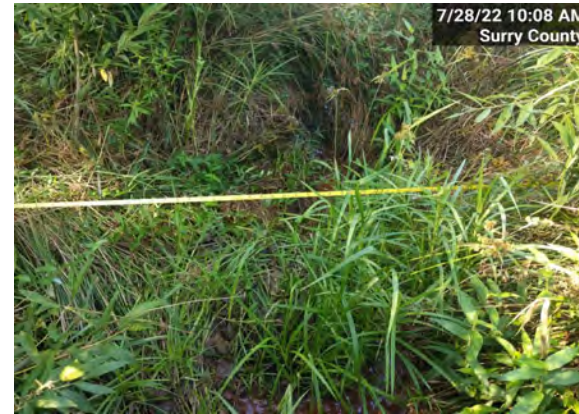
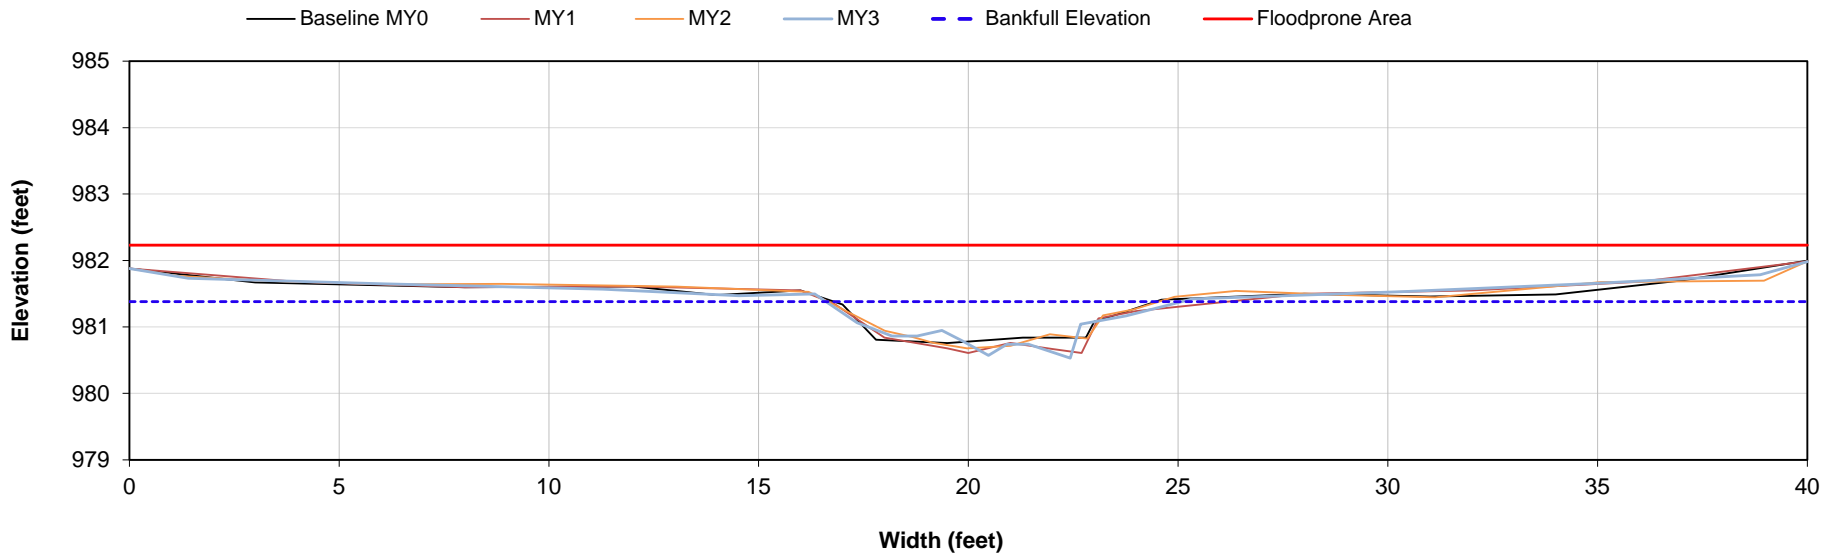
XS-5 Riffle, STA 13+84

Dimension Data Summary: MY3 2022	
Bankfull Elevation (ft)	981.4
Low Bank Height Elevation (ft)	981.4
Bankfull Max Depth (ft)	0.9
Low Bank Height (ft)	0.9
Bank Height Ratio	1.05
Bankfull X-section Area (ft ²)	3.7
% Change Bank Height Ratio	5.0%

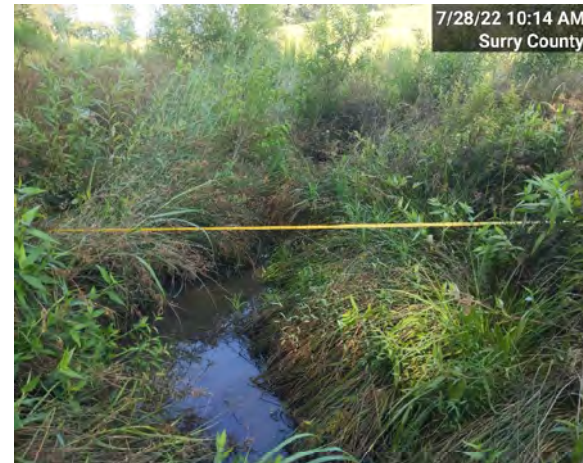
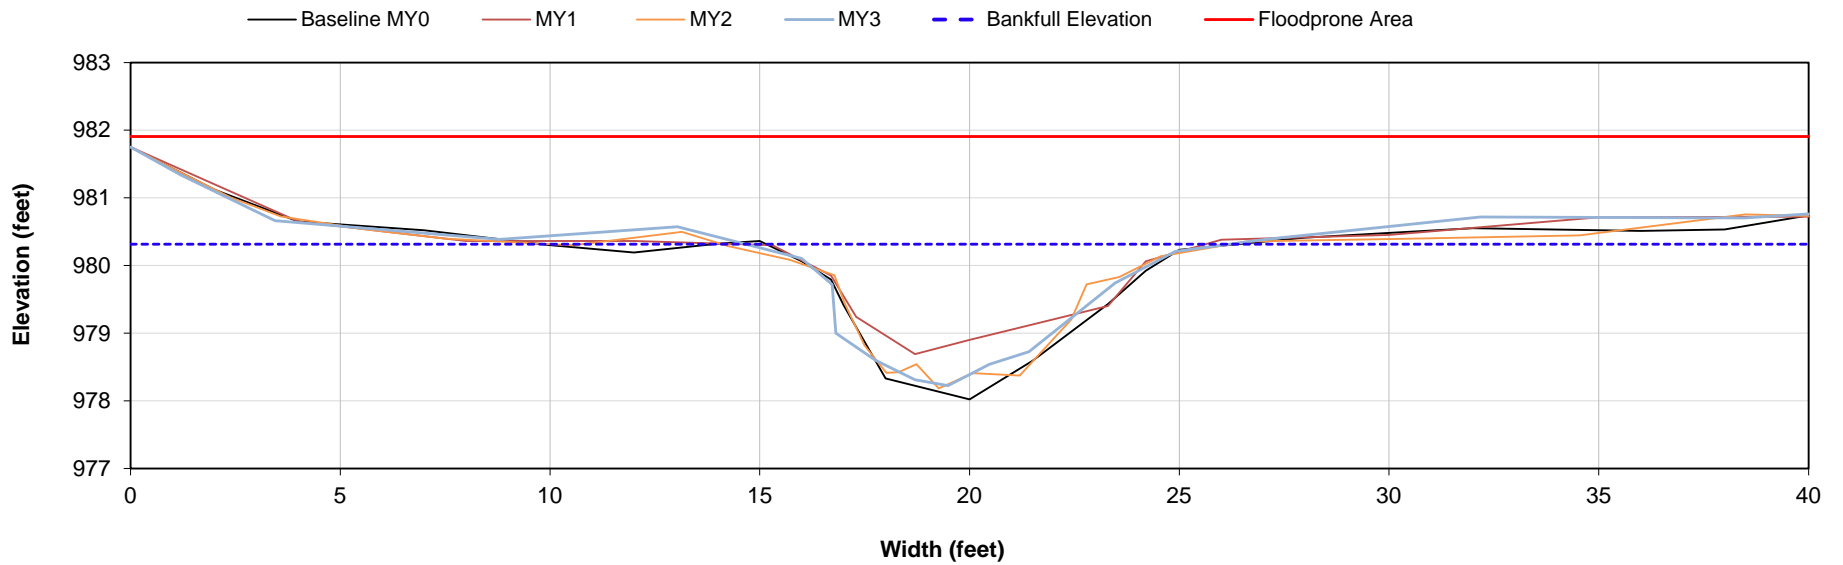
XS-6 Pool, STA 14+28

Dimension Data Summary: MY3 2022	
Bankfull Elevation (ft)	980.3
Low Bank Height Elevation (ft)	980.1
Bankfull Max Depth (ft)	2.1
Low Bank Height (ft)	1.9
Bank Height Ratio	0.90
Bankfull X-section Area (ft²)	11.6
% Change Bank Height Ratio	10.0%

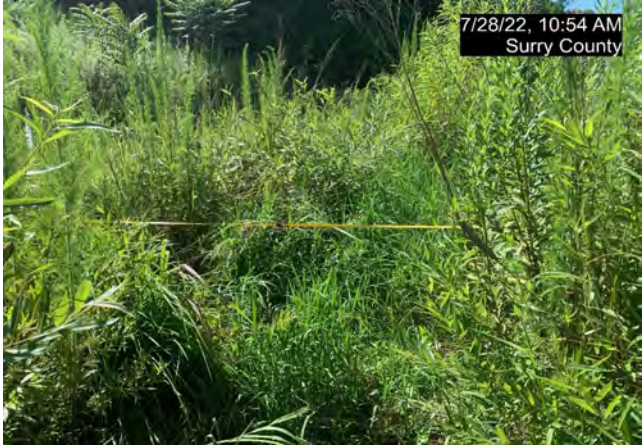
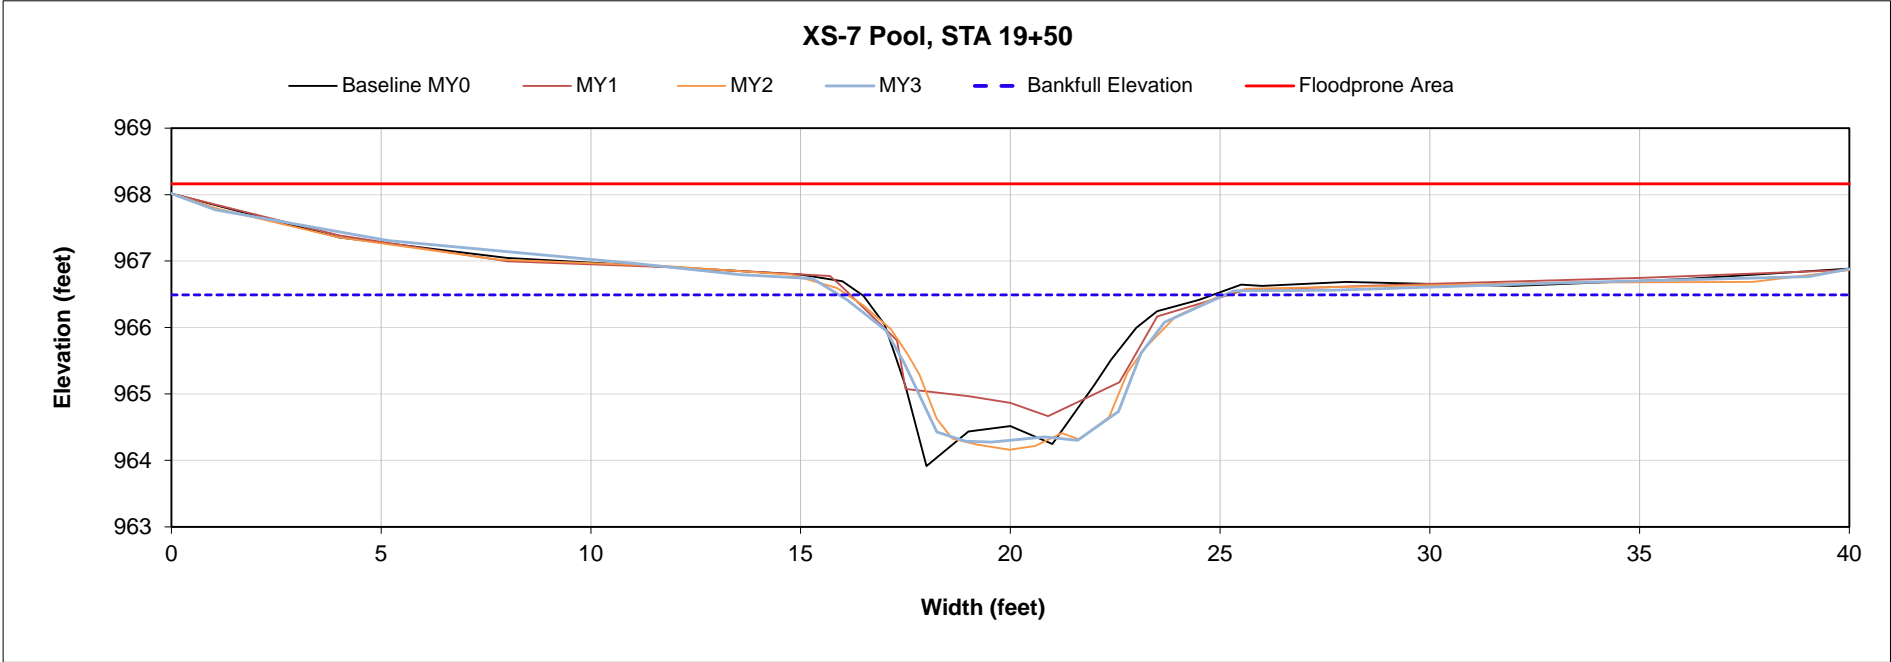
Project Name	Horne Creek Tributaries Mitigation Project
Project ID	100026
Reach ID	R4
Cross Section ID	XS-7
Field Crew	K. Obermiller, E. Dunnigan

Dimension Data Summary: MY3 2022	
Bankfull Elevation (ft)	966.5
Low Bank Height Elevation (ft)	966.6
Bankfull Max Depth (ft)	2.2
Low Bank Height (ft)	2.3
Bank Height Ratio	1.03
Bankfull X-section Area (ft²)	12.4
% Change Bank Height Ratio	3.0%

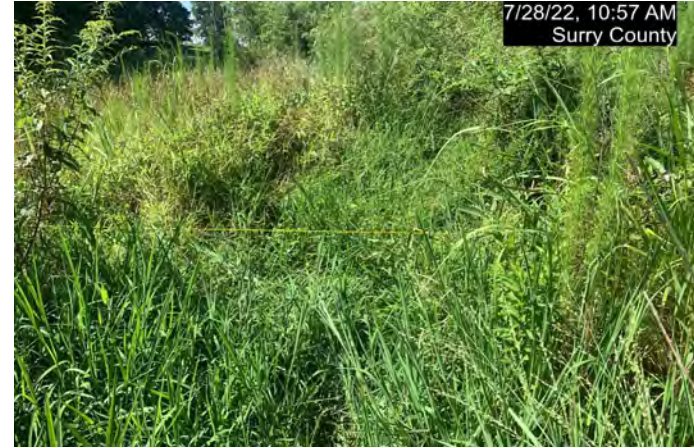
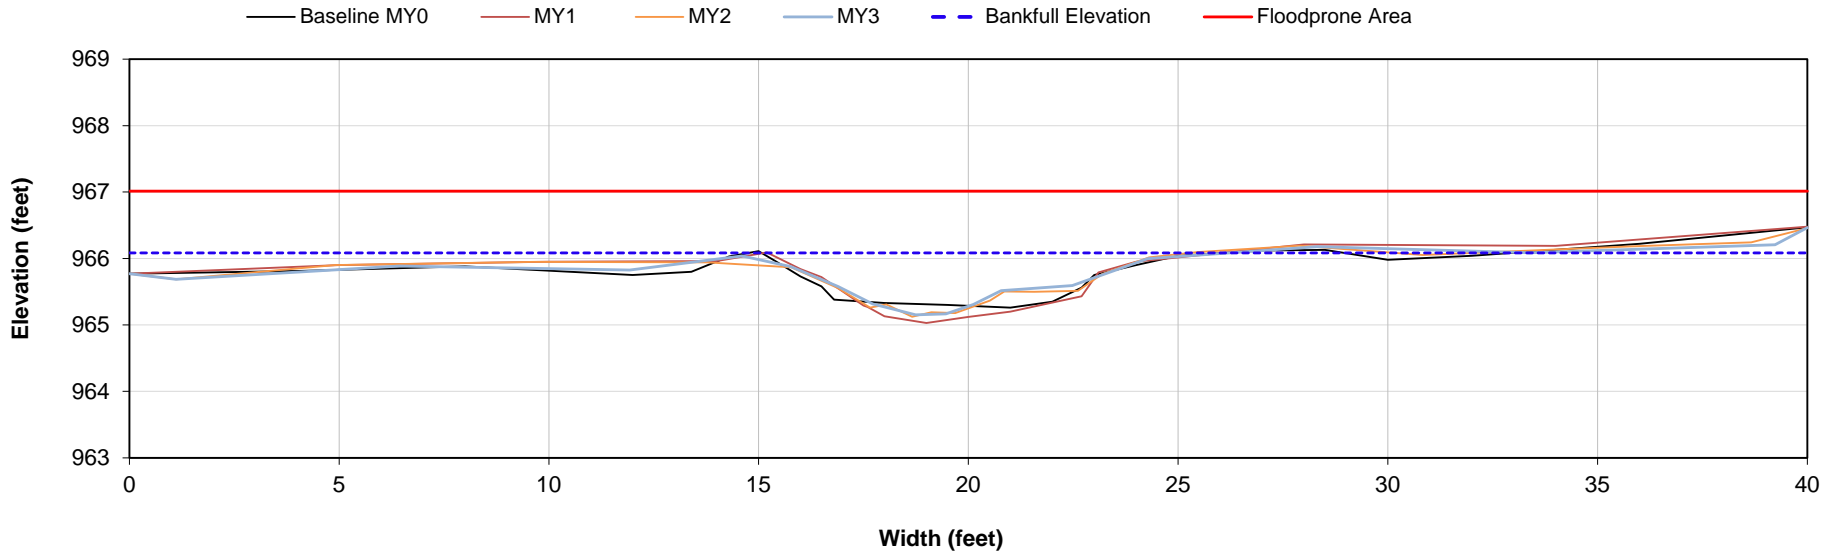
XS-8 Riffle, STA 19+75

Dimension Data Summary: MY3 2022	
Bankfull Elevation (ft)	966.1
Low Bank Height Elevation (ft)	966.0
Bankfull Max Depth (ft)	0.9
Low Bank Height (ft)	0.8
Bank Height Ratio	0.91
Bankfull X-section Area (ft ²)	5.1
% Change Bank Height Ratio	9.0%

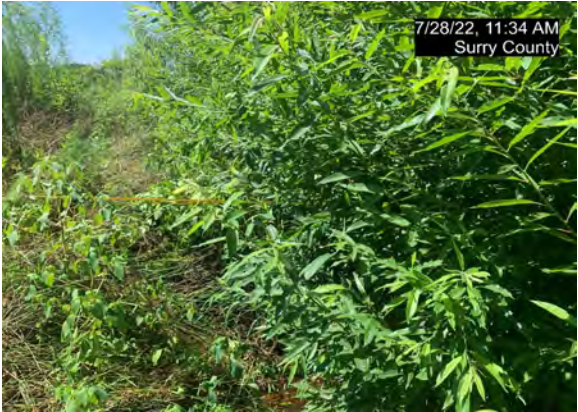
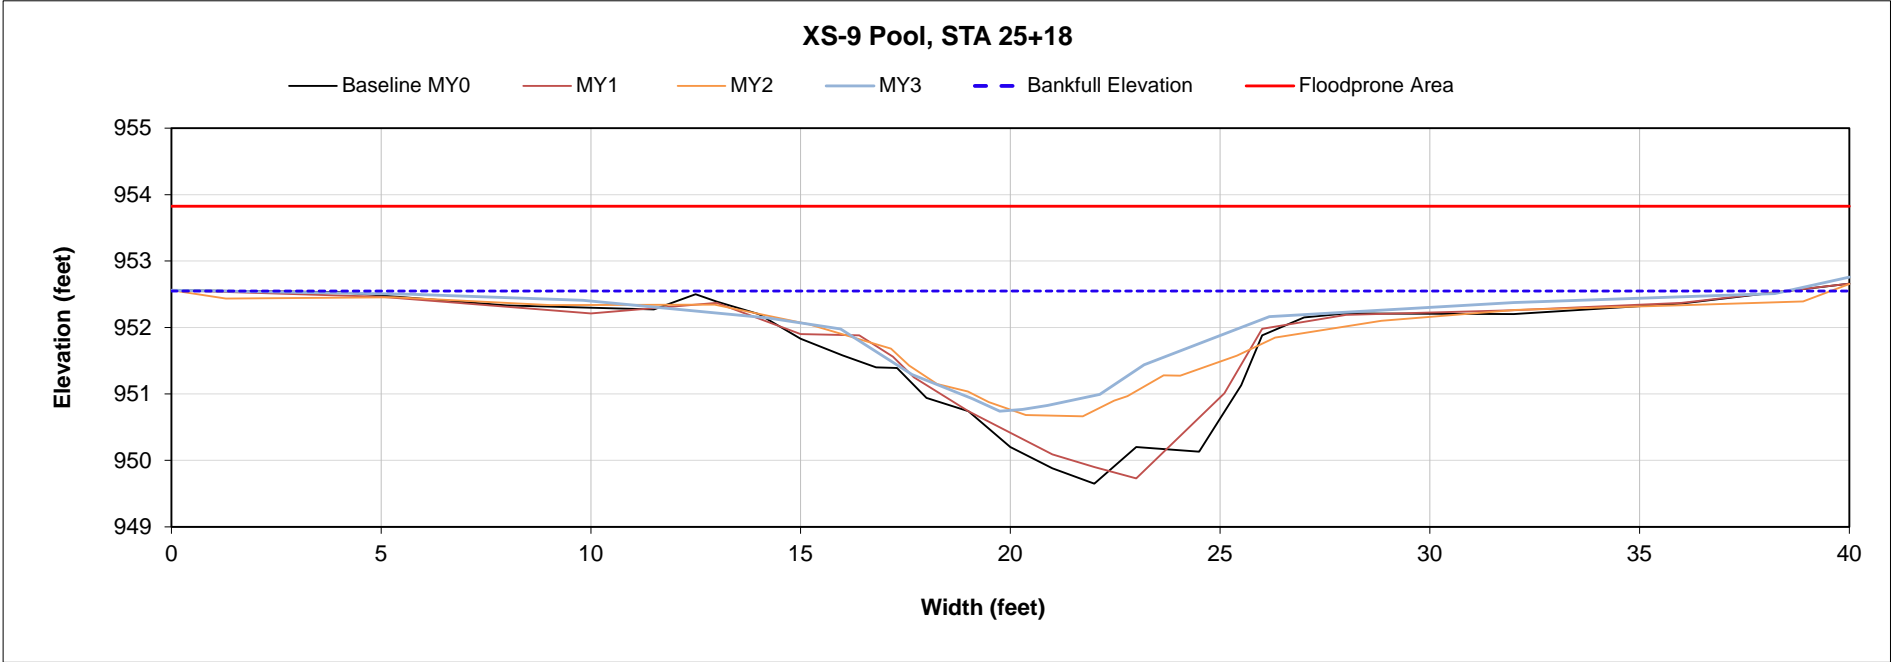
Project Name	Horne Creek Tributaries Mitigation Project
Project ID	100026
Reach ID	R5
Cross Section ID	XS-9
Field Crew	K. Obermiller, E. Dunnigan

Dimension Data Summary: MY3 2022	
Bankfull Elevation (ft)	952.6
Low Bank Height Elevation (ft)	952.1
Bankfull Max Depth (ft)	1.8
Low Bank Height (ft)	1.4
Bank Height Ratio	0.81
Bankfull X-section Area (ft²)	16.8
% Change Bank Height Ratio	22.0%

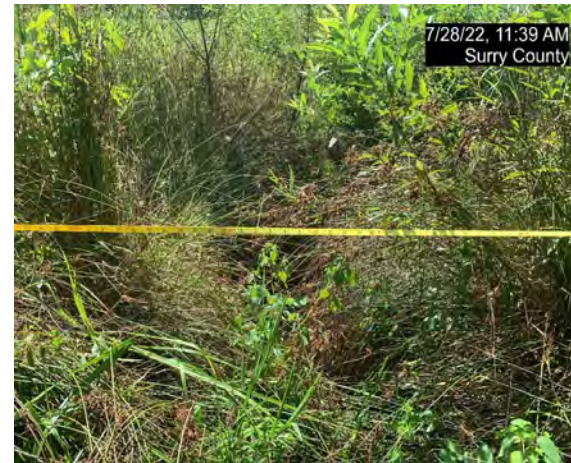
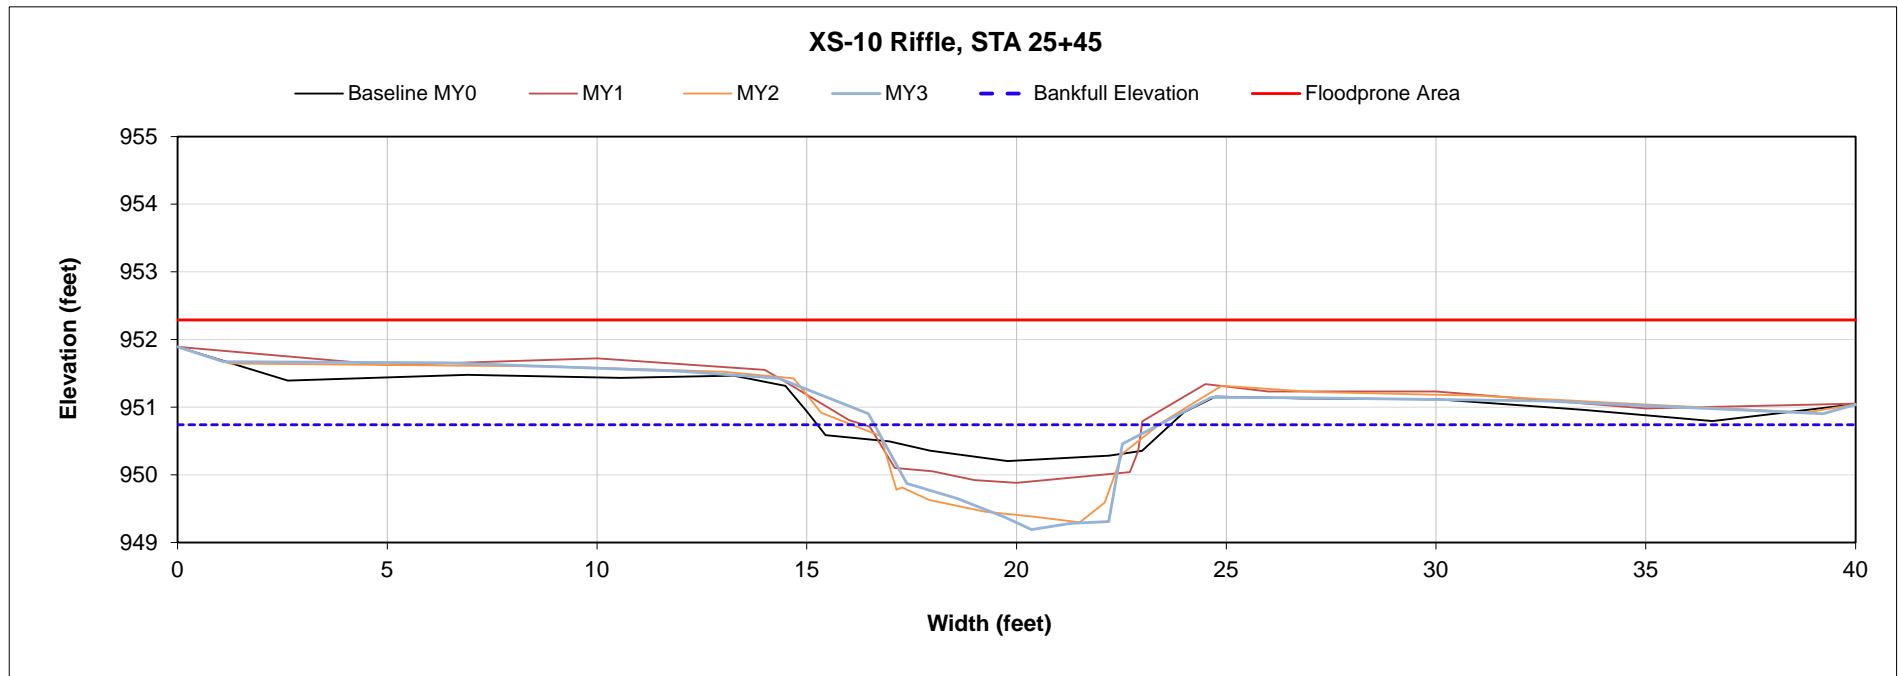
Project Name	Horne Creek Tributaries Mitigation Project
Project ID	100026
Reach ID	R5
Cross Section ID	XS-10
Field Crew	K. Obermiller, E. Dunnigan

The MY3 channel dimensions generally match the design parameters and are within acceptable and stable ranges of tolerance. Data for the 16 cross-sections (eight riffle and eight pool) can be found in Appendix D. It is expected over time that some pools may accumulate fine sediment and organic matter, however, this is not an indicator of channel instability. Maximum riffle depths are also expected to fluctuate throughout the monitoring period as the channels adjust to the new flow regime. Of the eight riffle cross-sections, four experienced minor changes in bank height ratio (BHR) from MY0 to MY3. Two of the eight riffle cross-sections (XS-10 and XS-12) have decreased BHRs from MY2, but still have BHRs above 1.2. One riffle cross-section, XS-15 on R5, experienced minor aggradation due to sediment migration and thick herbaceous vegetation occurring during MY3. The cross-section is stable and shows minimal change from MY1. Three riffle cross sections, XS-10, XS-12, and XS-14 on R5, experienced degradation. XS-10 and XS-12 on R5, experienced degradation due to bed material entrainment from the riffles during MY2 storm events. Both riffles adjusted to be shorter and migrated slightly downstream, resulting in apparent degradation. R5 is stable above and below both cross-sections. XS-10 and XS-12 were re-surveyed in

Dimension Data Summary: MY3 2022	
Bankfull Elevation (ft)	950.7
Low Bank Height Elevation (ft)	951.1
Bankfull Max Depth (ft)	1.5
Low Bank Height (ft)	2.0
Bank Height Ratio	1.26
Bankfull X-section Area (ft²)	6.9
% Change Bank Height Ratio	26.0%

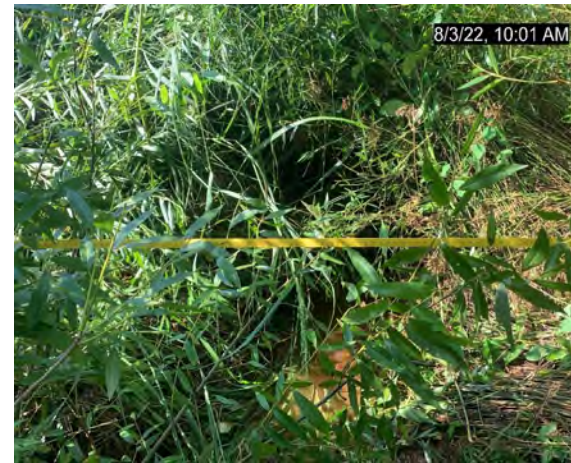
Project Name	Horne Creek Tributaries Mitigation Project
Project ID	100026
Reach ID	R5
Cross Section ID	XS-11
Field Crew	E. Dunnigan, C. Durham

Dimension Data Summary: MY3 2022	
Bankfull Elevation (ft)	937.3
Low Bank Height Elevation (ft)	936.9
Bankfull Max Depth (ft)	2.2
Low Bank Height (ft)	1.8
Bank Height Ratio	0.84
Bankfull X-section Area (ft²)	23.6
% Change Bank Height Ratio	16.0%

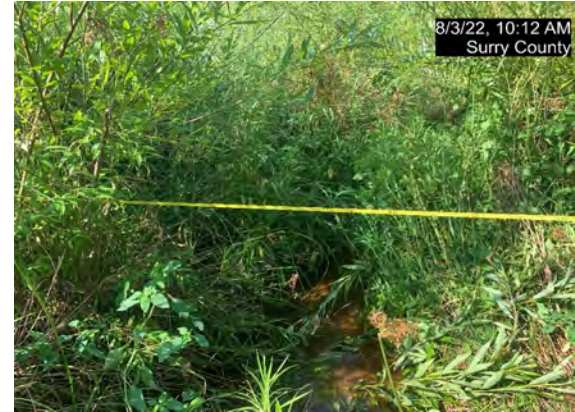
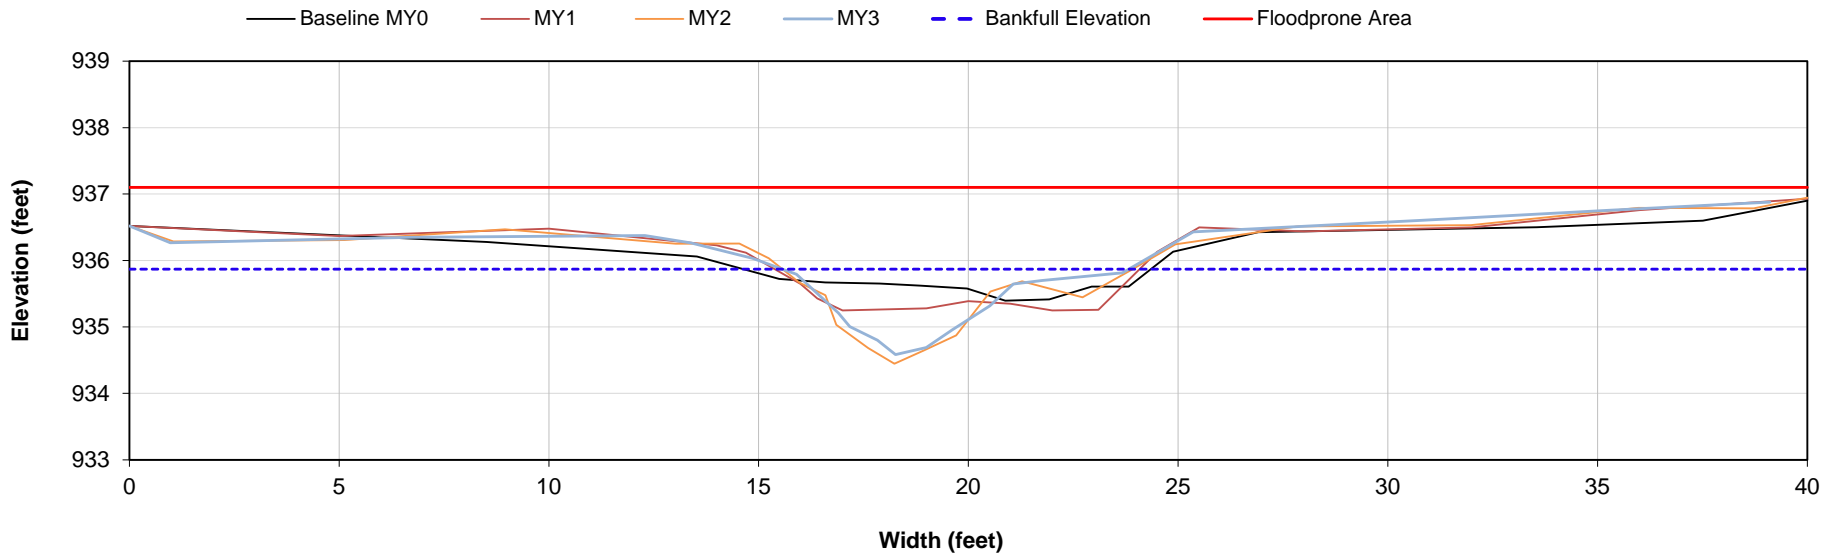
XS-12 Riffle, STA 32+88

Dimension Data Summary: MY3 2022	
Bankfull Elevation (ft)	935.9
Low Bank Height Elevation (ft)	936.3
Bankfull Max Depth (ft)	1.3
Low Bank Height (ft)	1.7
Bank Height Ratio	1.31
Bankfull X-section Area (ft²)	4.5
% Change Bank Height Ratio	31.0%

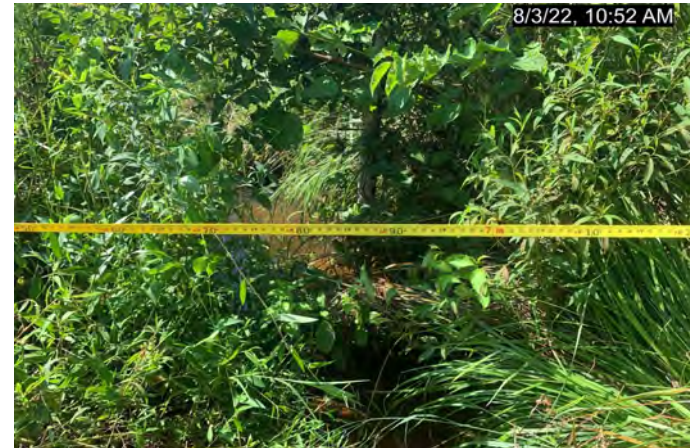
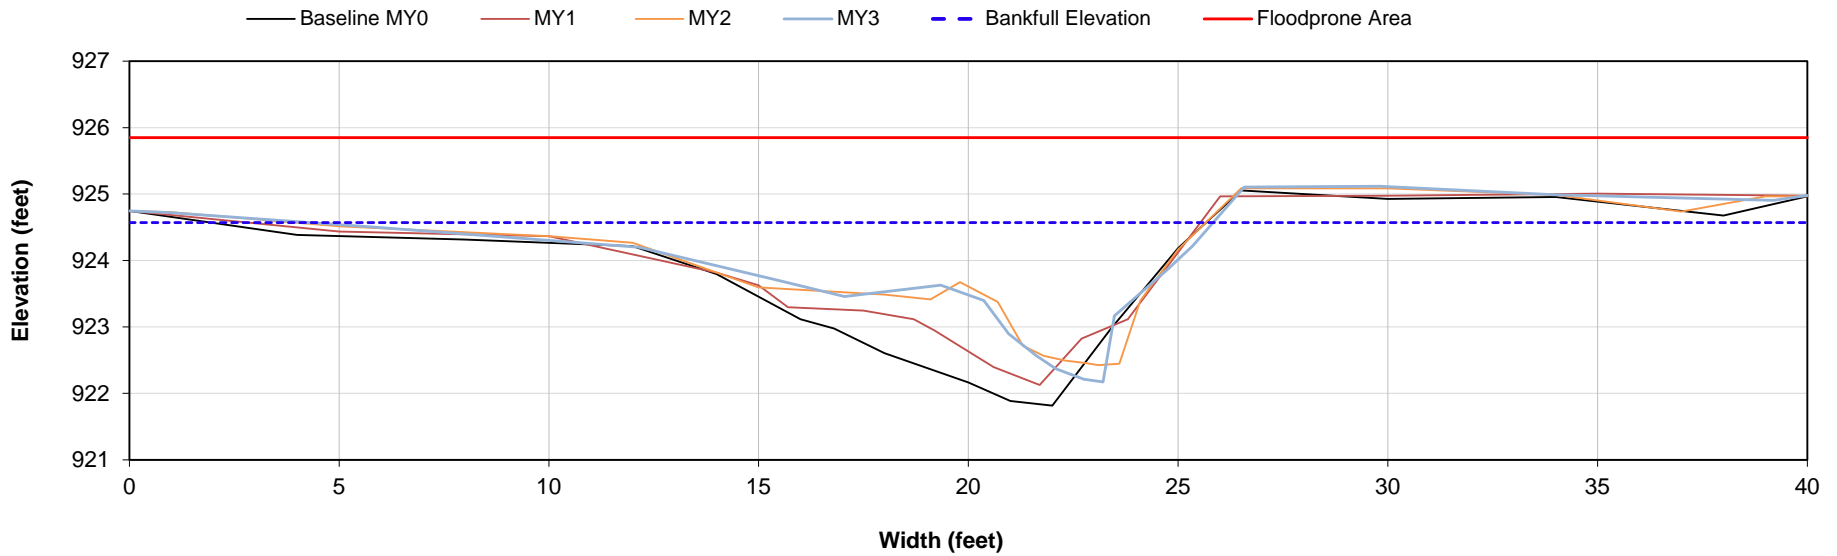
XS-13 Pool, STA 38+48

Dimension Data Summary: MY3 2022	
Bankfull Elevation (ft)	924.6
Low Bank Height Elevation (ft)	924.5
Bankfull Max Depth (ft)	2.4
Low Bank Height (ft)	2.3
Bank Height Ratio	0.97
*Bankfull X-section Area (ft²)	16.4
% Change Bank Height Ratio	3.0%

*Due to a calculation error MY0 bankfull was corrected from 19.9 to 16.4

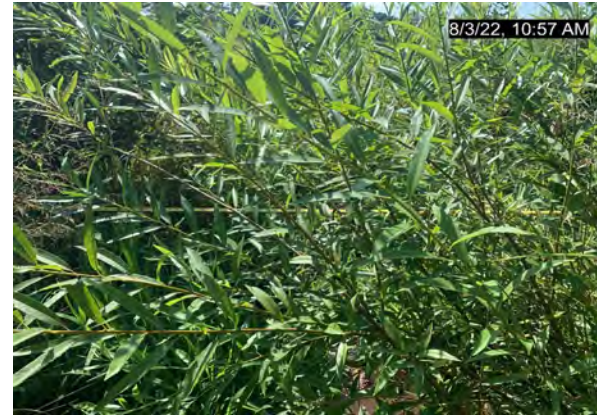
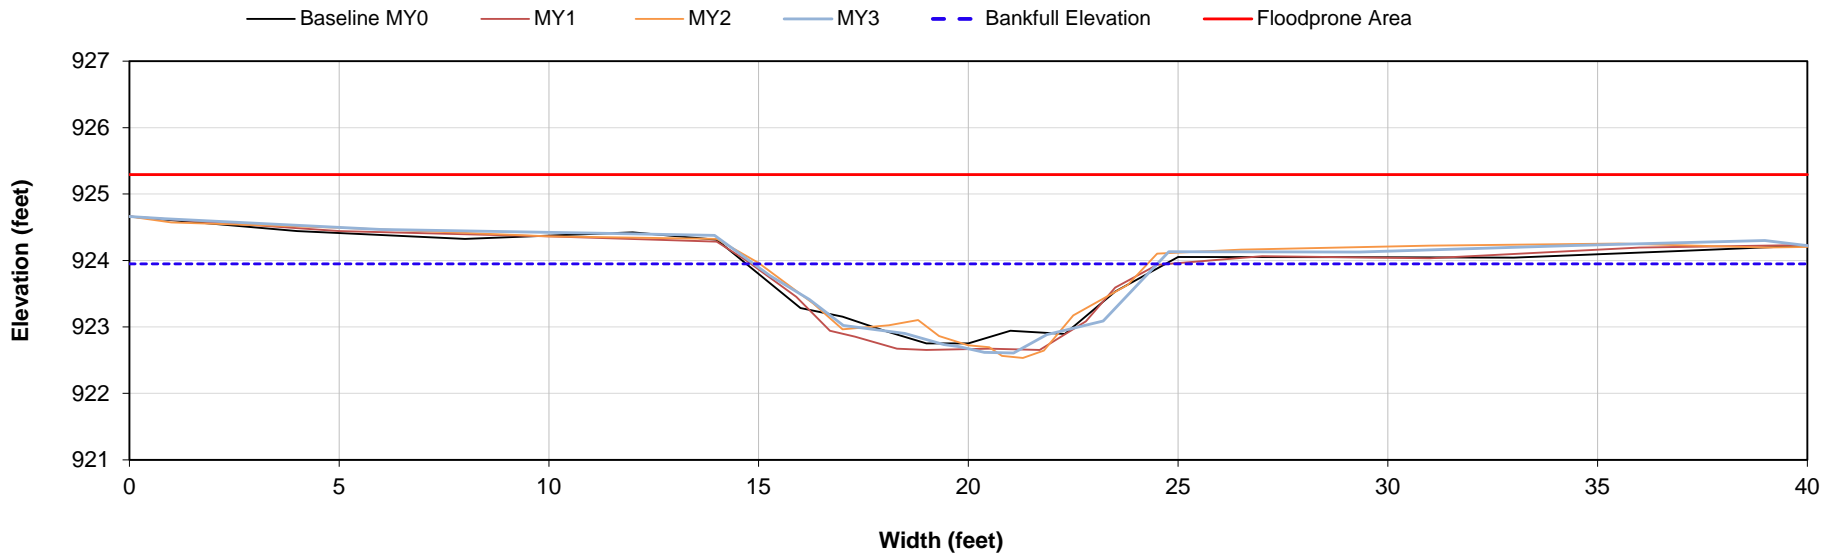
XS-14 Riffle, STA 38+75

Dimension Data Summary: MY3 2022	
Bankfull Elevation (ft)	924.0
Low Bank Height Elevation (ft)	924.1
Bankfull Max Depth (ft)	1.3
Low Bank Height (ft)	1.5
Bank Height Ratio	1.14
Bankfull X-section Area (ft²)	8.4
% Change Bank Height Ratio	14.0%

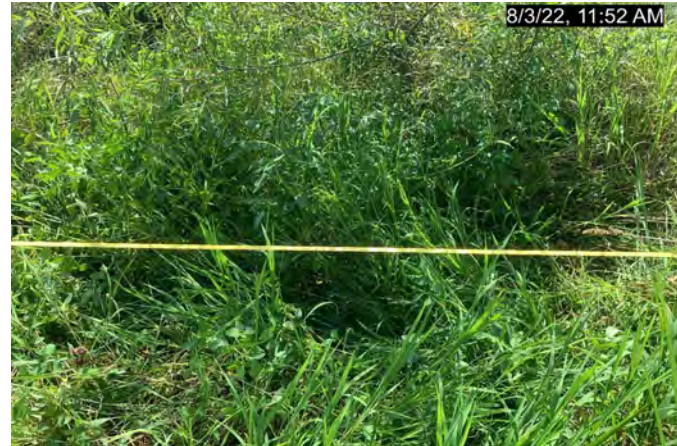
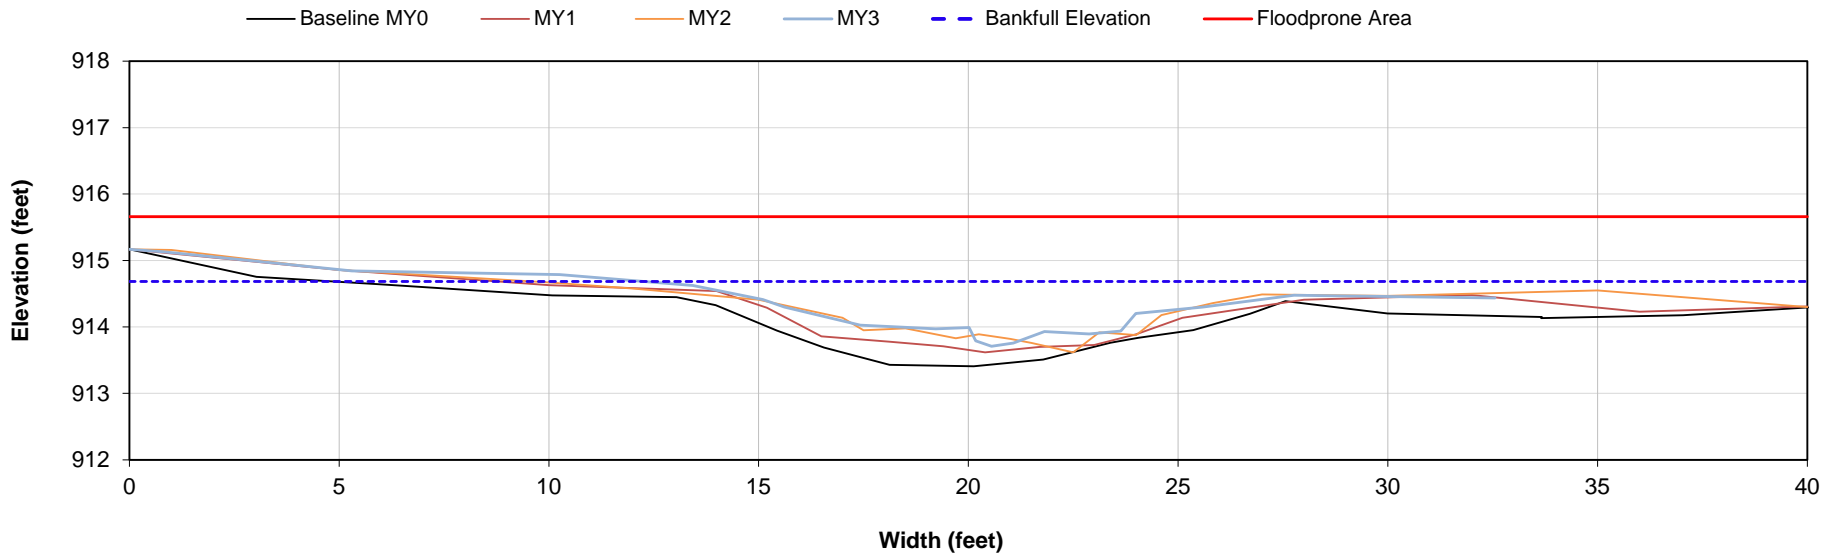
XS-15 Riffle, STA 44+19

Dimension Data Summary: MY3 2022	
Bankfull Elevation (ft)	914.7
Low Bank Height Elevation (ft)	914.5
Bankfull Max Depth (ft)	1.0
Low Bank Height (ft)	0.8
Bank Height Ratio	0.79
Bankfull X-section Area (ft²)	7.7
% Change Bank Height Ratio	21.0%
