Monitoring Report
FINAL VERSION
Horne Creek Tributaries Mitigation Project
Monitoring Year 3
Calendar Year of Data Collection: 2022

NCDEQ DMS Project Identification # 100026
NCDEQ DMS Contract # 7181
Yadkin River Basin (Cataloging Unit 03040101)
USACE Action ID Number: SAW-2017-01510
NCDEQ DWR Project # 2017-1156
Surry County, NC
Contracted Under RFP # 16-006993, Date of Issue: August 16, 2016
Data Collection Period: July - October 2022
Submission Date: November 2022

RE: WLS Responses to NCDEQ DMS Review Comments for Task 9 Submittal, Monitoring Year 3 Report for the Horne Creek Tributaries Mitigation Project, DMS Full-Delivery Project ID #100026, Contract #7181, Yadkin River Basin, Cataloging Unit 03040101, Surry County, NC

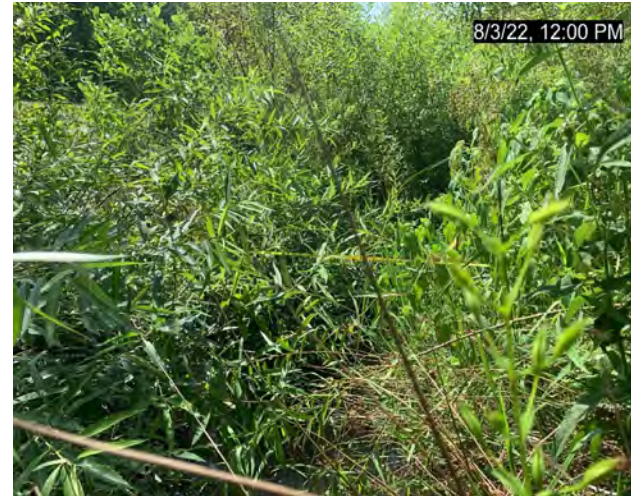
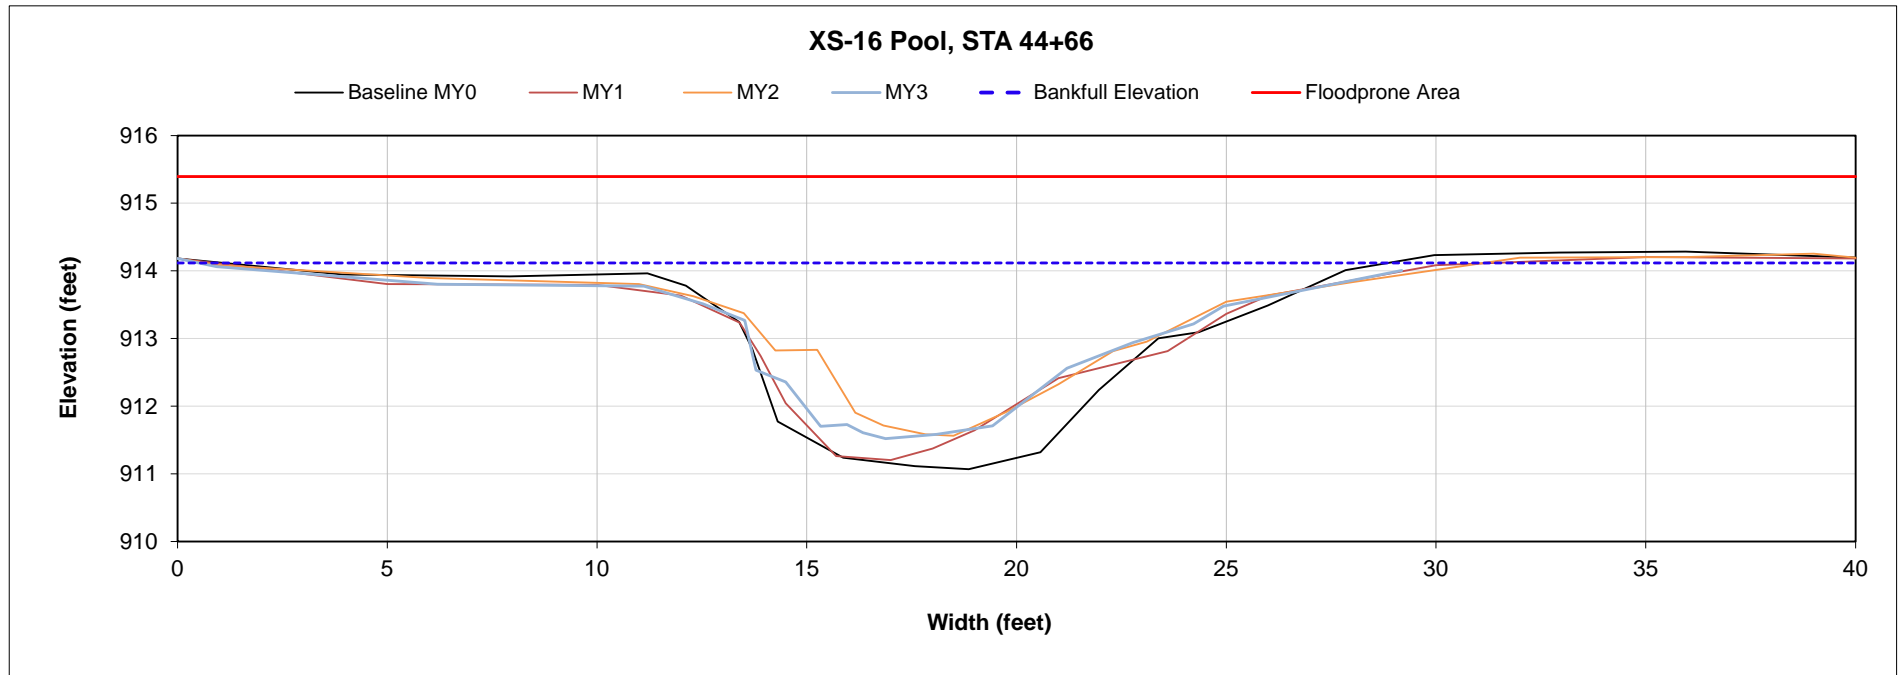
Project Name	Horne Creek Tributaries Mitigation Project
Project ID	100026
Reach ID	R5
Cross Section ID	XS-16
Field Crew	E. Dunnigan, C. Durham

Dimension Data Summary: MY3 2022	
Bankfull Elevation (ft)	914.1
Low Bank Height Elevation (ft)	913.8
Bankfull Max Depth (ft)	2.6
Low Bank Height (ft)	2.3
Bank Height Ratio	0.87
Bankfull X-section Area (ft²)	27.1
% Change Bank Height Ratio	13.0%

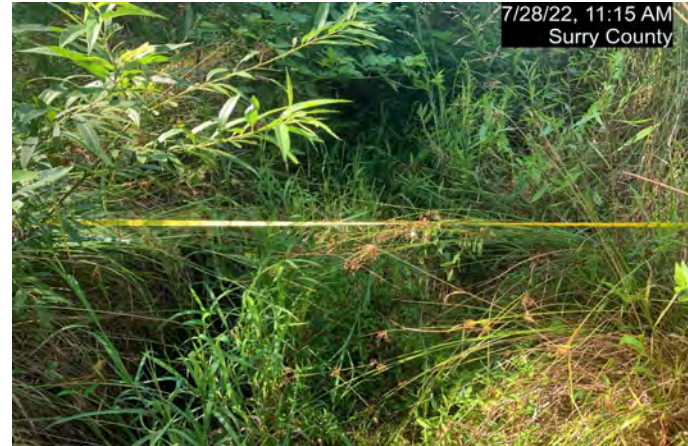
SPA-8 (Riffle), STA 21+15

Dimension Data Summary: MY3 2022	
Bankfull Elevation (ft)	961.9
Low Bank Height Elevation (ft)	962.5
Bankfull Max Depth (ft)	1.4
Low Bank Height (ft)	2.1
Bank Height Ratio	1.45
Bankfull X-section Area (ft²)	*4.9

*SPA-8 Bankfull area was estimated off design parameters for constructed rock riffles on R4
