Monitoring Report
FINAL VERSION
Horne Creek Tributaries Mitigation Project
Monitoring Year 1
Calendar Year of Data Collection: 2020

NCDEQ DMS Project Identification # 100026
NCDEQ DMS Contract # 7181
Yadkin River Basin (Cataloging Unit 03040101)
USACE Action ID Number: SAW-2017-01510
NCDEQ DWR Project # 2017-1156
Surry County, NC
Contracted Under RFP # 16-006993
Data Collection Period: November 2020
Submission Date: December 2020

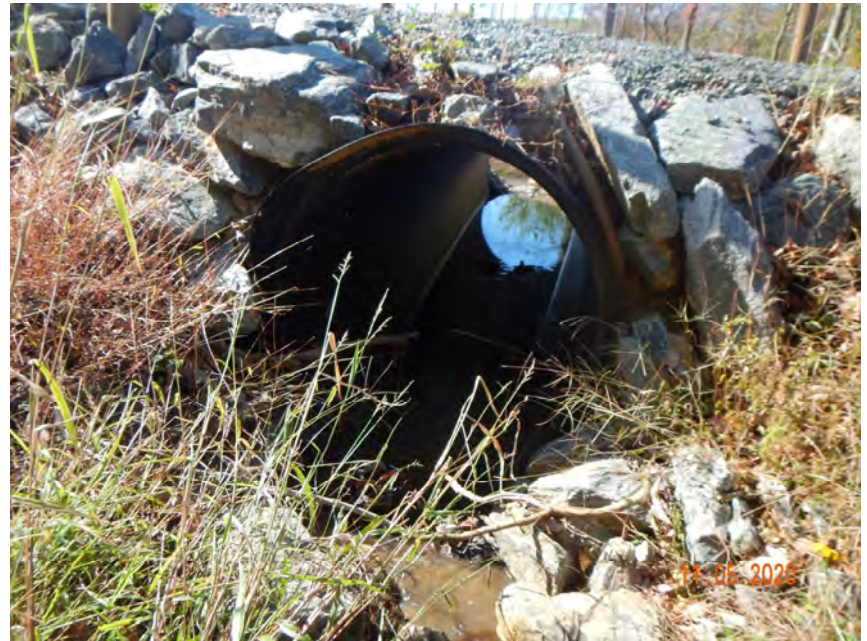
PS-3, R4, Culvert Crossing, Downstream (MY-00)

14. Todd Tugwell noted that the invert of the downstream pipe on R4 was too high. Kayne VanStell agreed and said WLS will monitor and lower the invert (bury the pipe) or raise the downstream rifle invert elevation if needed.

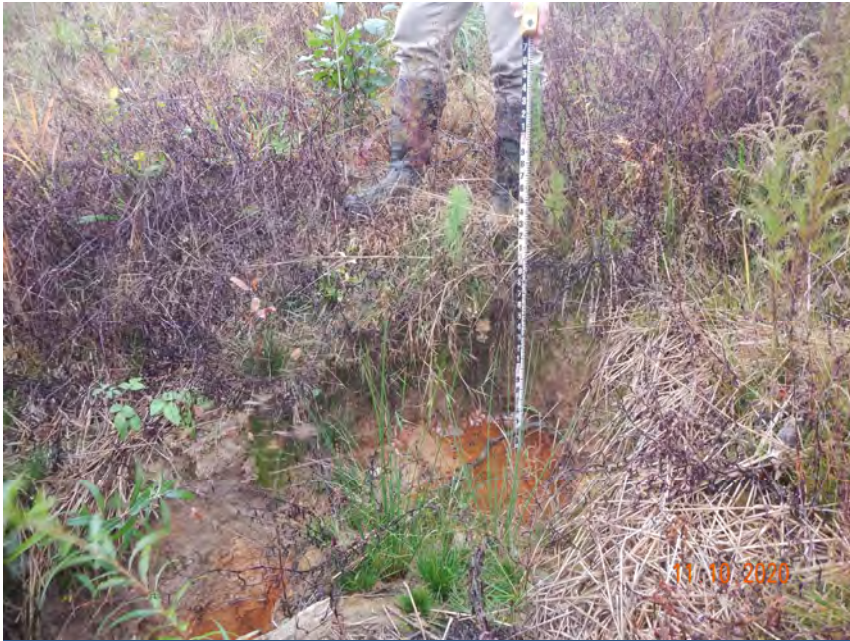
SPA1, R1 Right Floodplain, Minor Slumping (MY-01)

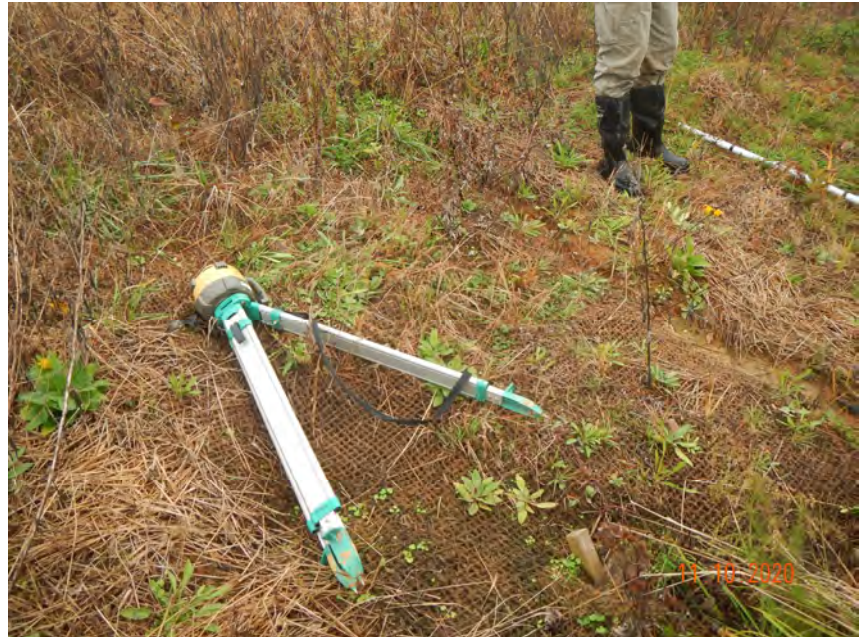
SPA2, R1 Left Floodplain, Minor Erosion (MY-01)

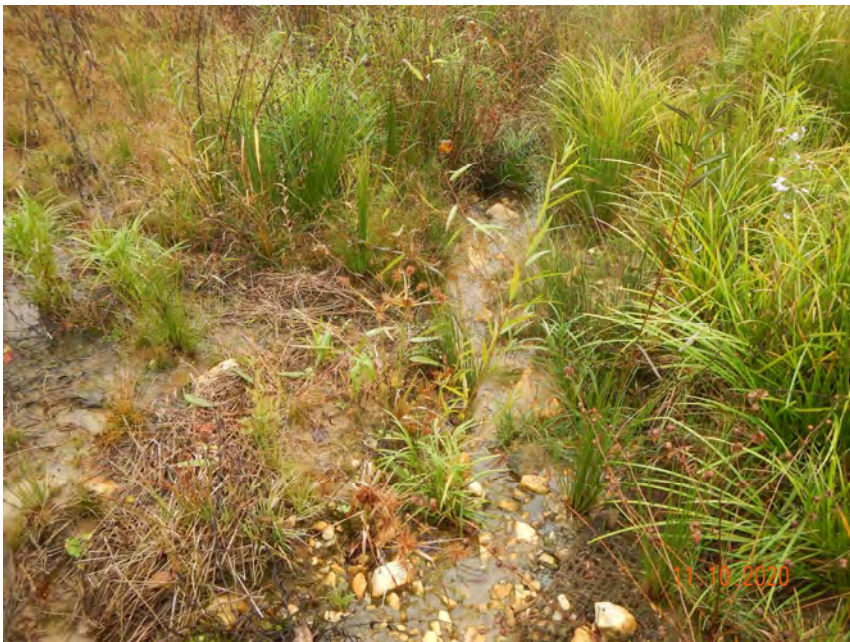
SPA3, R1 Left Floodplain, Minor Avulsion (MY-01)

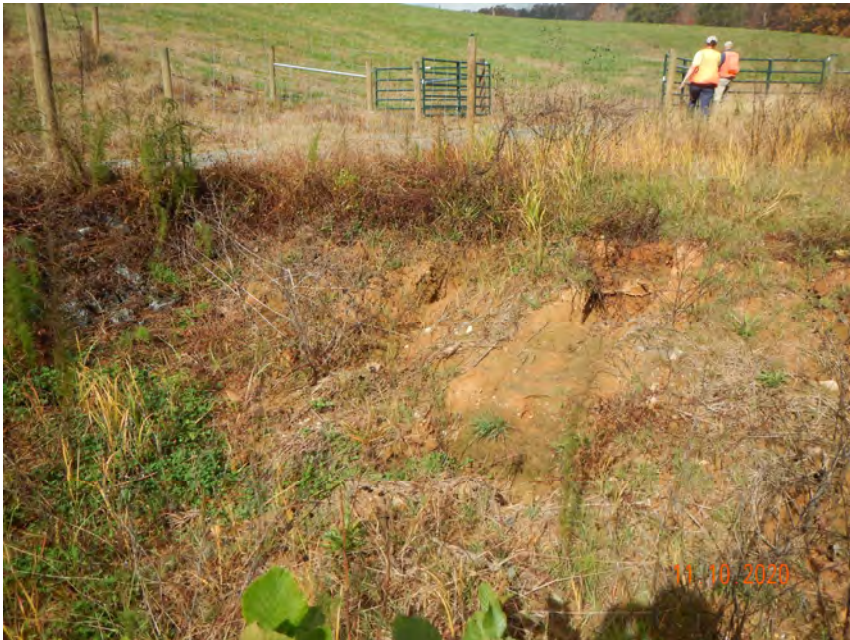
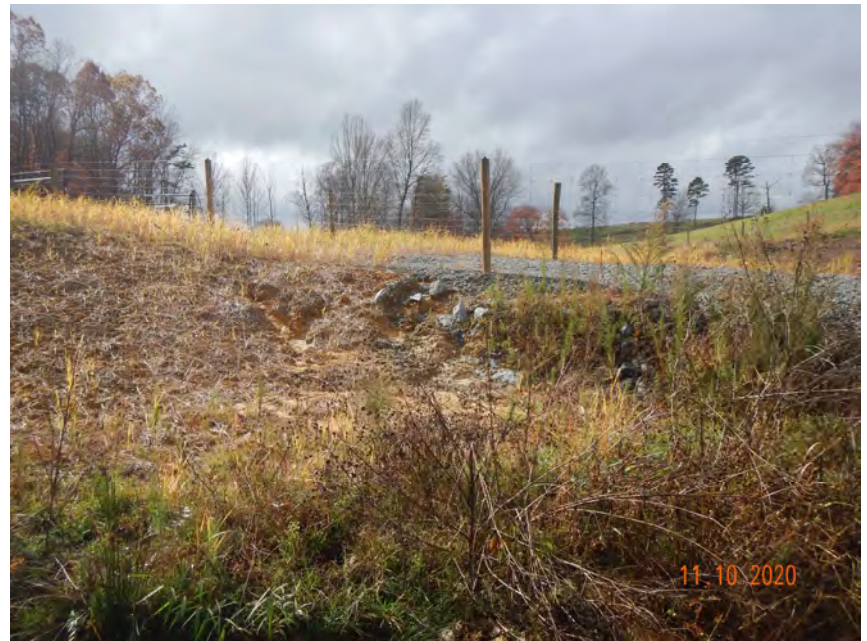
- **SPA4-** On R4, minor erosion was observed on both the right and left bank side slopes at approximate station 15+75, above the culvert crossing. This area will be closely monitored during MY2.
- **SPA5-** On R5, in the left floodplain area: minor erosion is occurring adjacent to station 32+60. WLS will monitor this area during MY2.
- **SPA6-** On R5, adjacent to vegetation plot 10 near station 43+50: a small secondary channel has formed in the right floodplain between the floodplain depressions. This area and drainage pattern will be closely monitored during MY2.
- **SPA7-** On R5, at the meander bend located at station 47+00: the left bank is at risk of eroding. The bank is currently functioning, but WLS will install additional live stakes in the meander to ensure stability in MY2. Any remedial action taken during MY2 will be photographed and documented in the MY2 report.

SPA4, R2 Left Floodplain, Minor Erosion (MY-01)

SPA4, R2 Right Floodplain, Minor Erosion (MY-01)

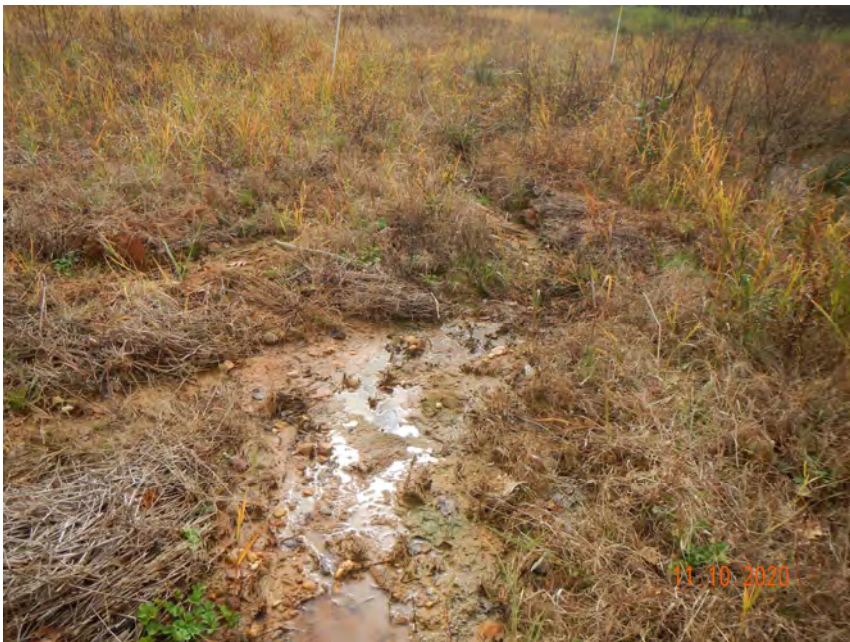
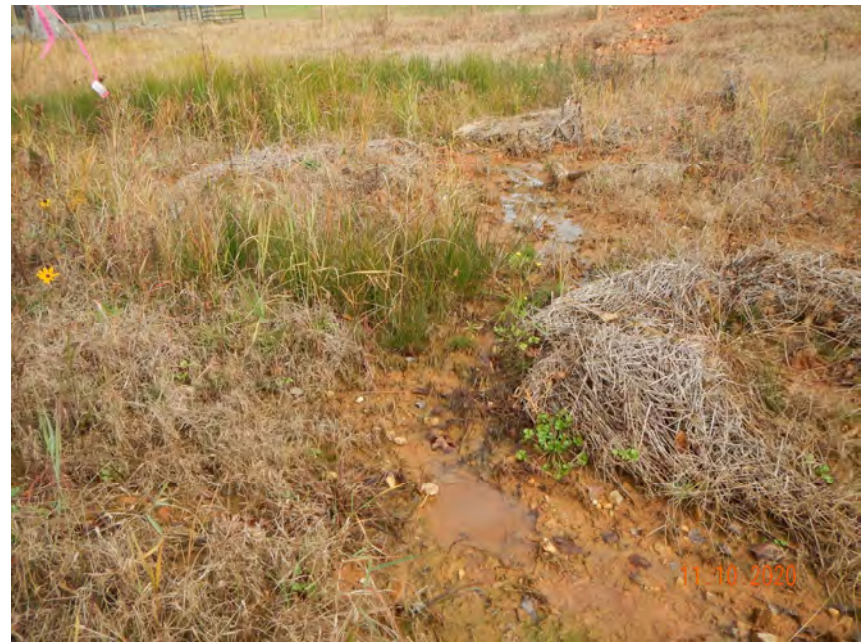
SPA5, R5 Left Floodplain, Minor Erosion (MY-01)

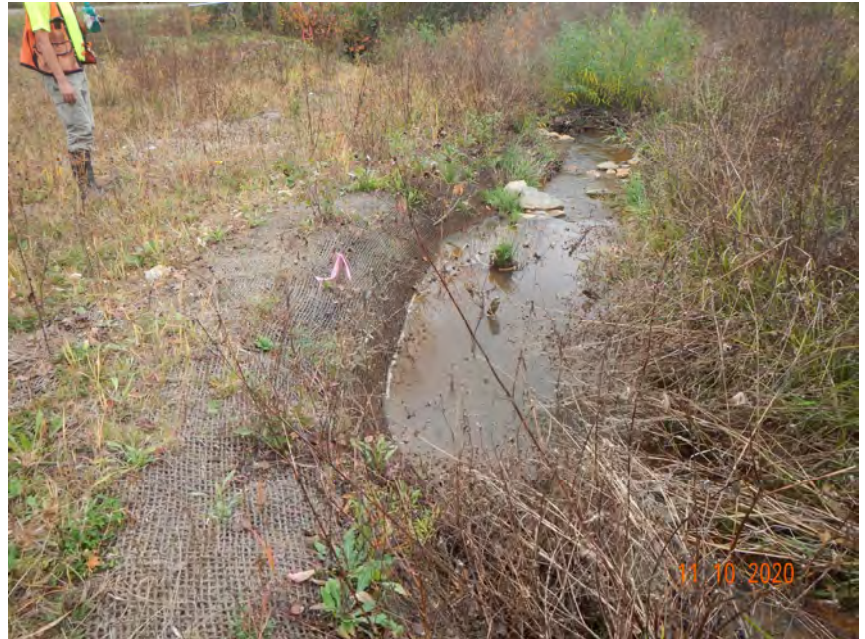
SPA7, R5 Left Bank, Functioning at Risk (MY-01)
