MY1 FINAL MONITORING REPORT
Hornpipe Branch Tributaries Mitigation Project
Lenoir County
Neuse River Basin
CU 03020202

DMS Project # 100076
DMS Contract # 7605
Contracted RFP # 16-007401
USACE Action ID Number: SAW-2018-01762
DWR Project # 2018-1155

Calendar Year of Data Collection: 2021

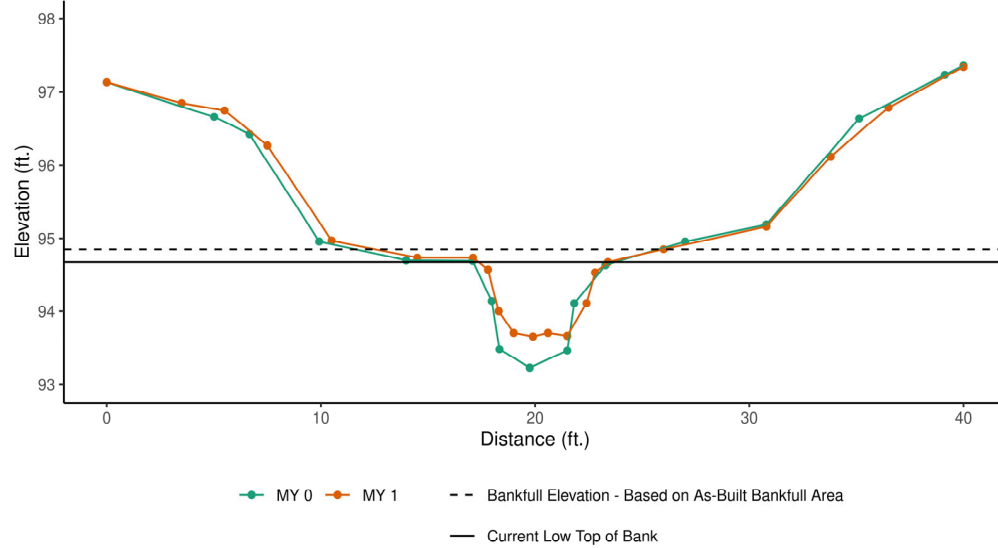
Cross-Section 1 (MS1 - Pool) MY1

MY0	MY1	MY2	MY3	MY4	MY5	MY6	MY7
Bankfull Elevation - Based on As-Built Bankfull Area	94.63	94.85						
Bank Height Ratio - Based on As-Built Bankfull Area	1.00	0.85						
Thalweg Elevation	93.23	93.66						
LTOB Elevation	94.63	94.67						
LTOB Max Depth	1.401	1.01						
LTOB Cross Sectional Area	5.20	4.13

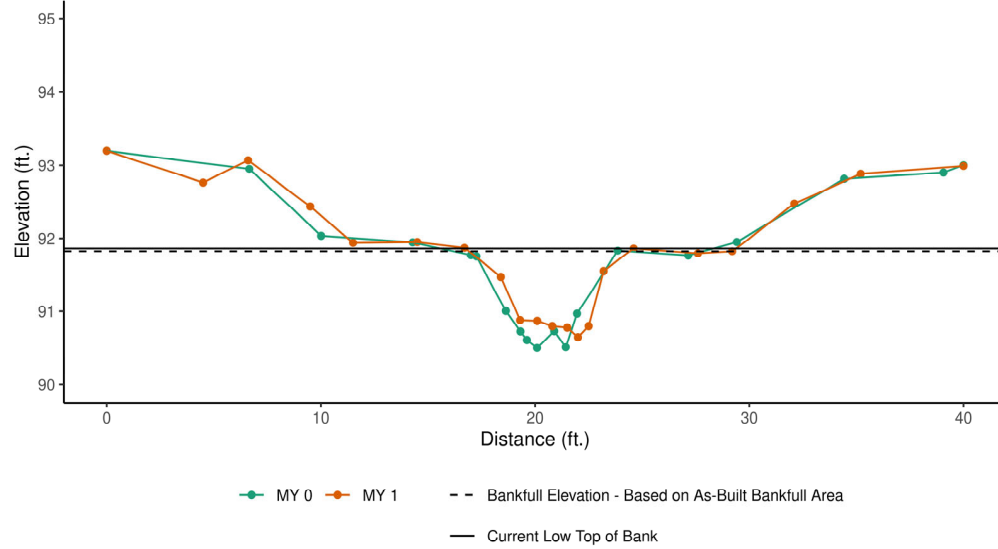
Cross-Section 2 (MS1 - Riffle) MY1

MY0	MY1	MY2	MY3	MY4	MY5	MY6	MY7
Bankfull Elevation - Based on As-Built Bankfull Area	91.75	91.82						
Bank Height Ratio - Based on As-Built Bankfull Area	1.00	1.03						
Thalweg Elevation	90.51	90.65						
LTOB Elevation	91.75	91.86						
LTOB Max Depth	1.245	1.21						
LTOB Cross Sectional Area	4.72	5.03

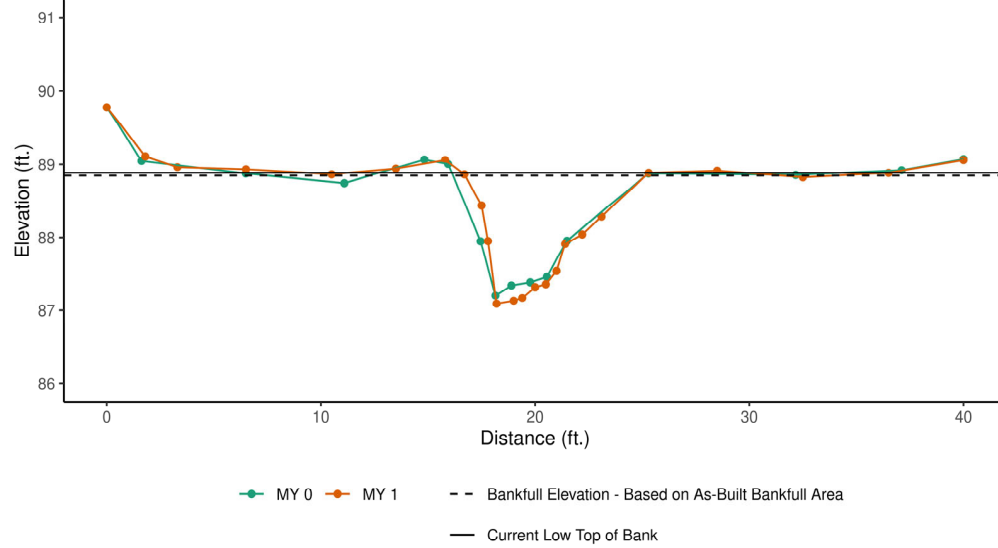
Cross-Section 3 (MS2 - Pool) MY1

MY0	MY1	MY2	MY3	MY4	MY5	MY6	MY7
Bankfull Elevation - Based on As-Built Bankfull Area	88.87	88.84						
Bank Height Ratio - Based on As-Built Bankfull Area	1.00	1.02						
Thalweg Elevation	87.34	87.09						
LTOB Elevation	88.87	88.88						
LTOB Max Depth	1.529	1.79						
LTOB Cross Sectional Area	7.68	8.01

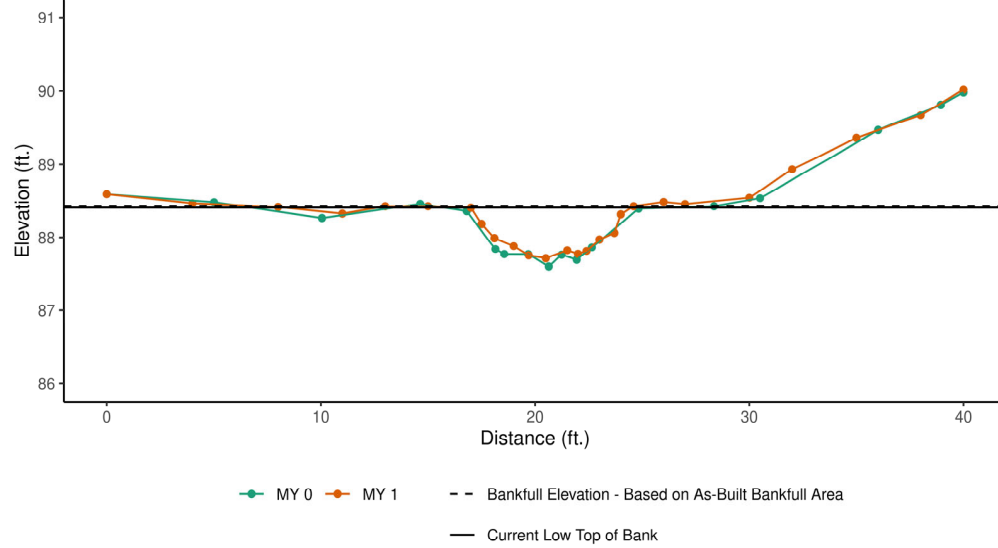
Cross-Section 4 (MS2 - Riffle) MY1

MY0	MY1	MY2	MY3	MY4	MY5	MY6	MY7
Bankfull Elevation - Based on As-Built Bankfull Area	88.35	88.43						
Bank Height Ratio - Based on As-Built Bankfull Area	1.00	0.97						
Thalweg Elevation	87.60	87.71						
LTOB Elevation	88.35	88.40						
LTOB Max Depth	0.755	0.69						
LTOB Cross Sectional Area	3.64	3.45

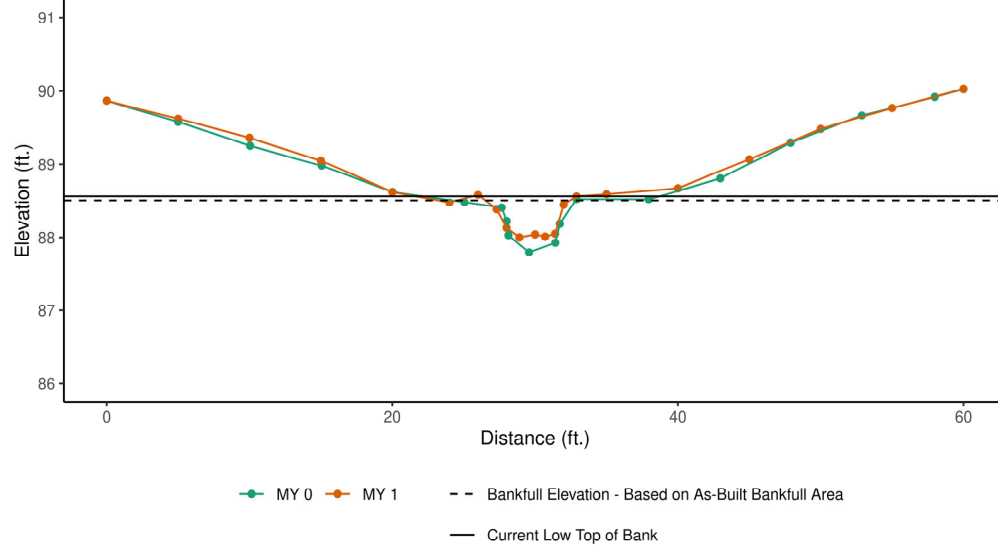
Cross-Section 5 (UT2 - Headwater) MY1

MY0	MY1	MY2	MY3	MY4	MY5	MY6	MY7
Bankfull Elevation - Based on As-Built Bankfull Area	88.40	88.50						
Bank Height Ratio - Based on As-Built Bankfull Area	1.00	1.12						
Thalweg Elevation	87.79	88.00						
LTOB Elevation	88.40	88.56						
LTOB Max Depth	0.609	0.56						
LTOB Cross Sectional Area	1.96	2.35

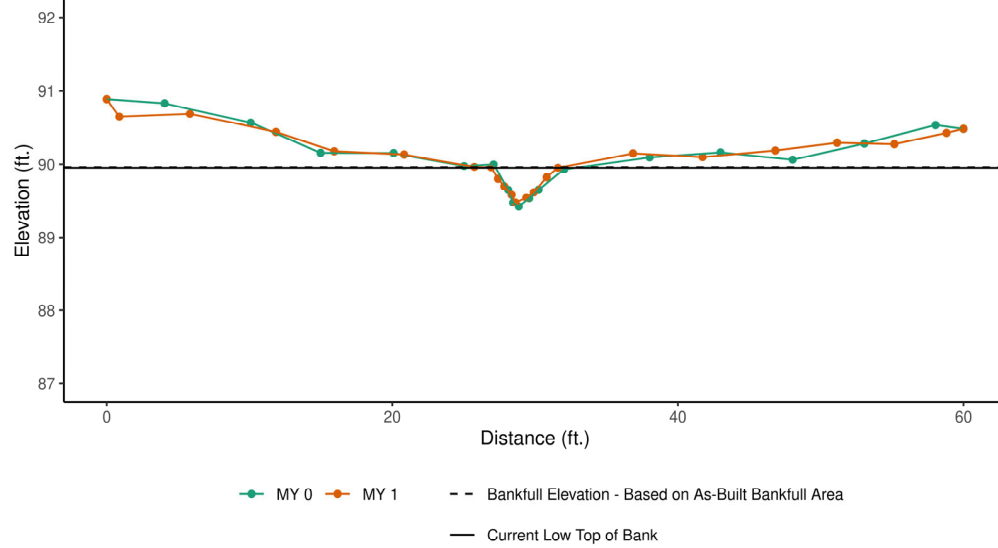
Cross-Section 6 (UT1 - Headwater) MY1

MY0	MY1	MY2	MY3	MY4	MY5	MY6	MY7
Bankfull Elevation - Based on As-Built Bankfull Area	89.93	89.96						
Bank Height Ratio - Based on As-Built Bankfull Area	1.00	0.98						
Thalweg Elevation	89.42	89.47						
LTOB Elevation	89.93	89.95						
LTOB Max Depth	0.511	0.477						
LTOB Cross Sectional Area	1.23	1.19

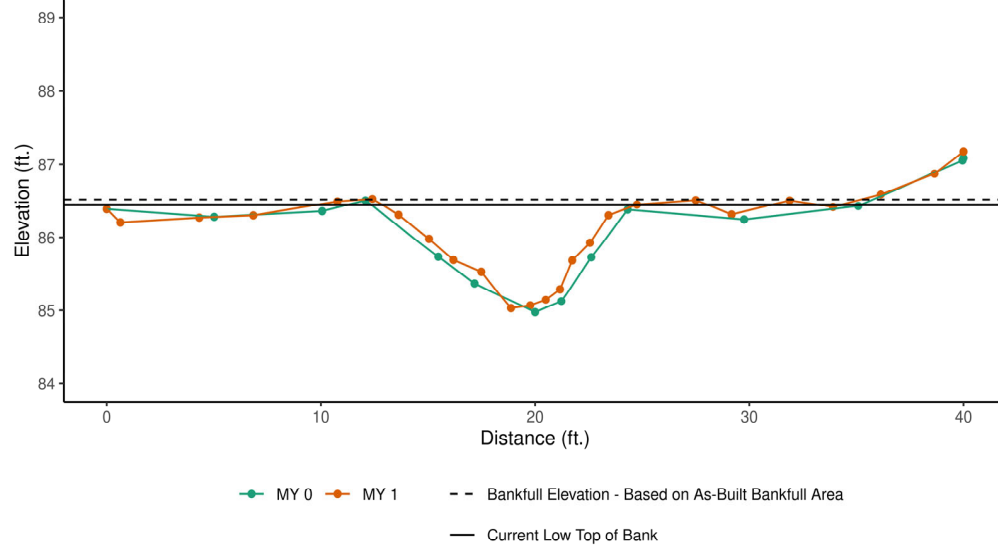
Cross-Section 7 (MS3 - Pool) MY1

MY0	MY1	MY2	MY3	MY4	MY5	MY6	MY7
Bankfull Elevation - Based on As-Built Bankfull Area	86.37	86.51						
Bank Height Ratio - Based on As-Built Bankfull Area	1.00	0.95						
Thalweg Elevation	84.98	85.03						
LTOB Elevation	86.37	86.44						
LTOB Max Depth	1.398	1.413						
LTOB Cross Sectional Area	9.20	8.37

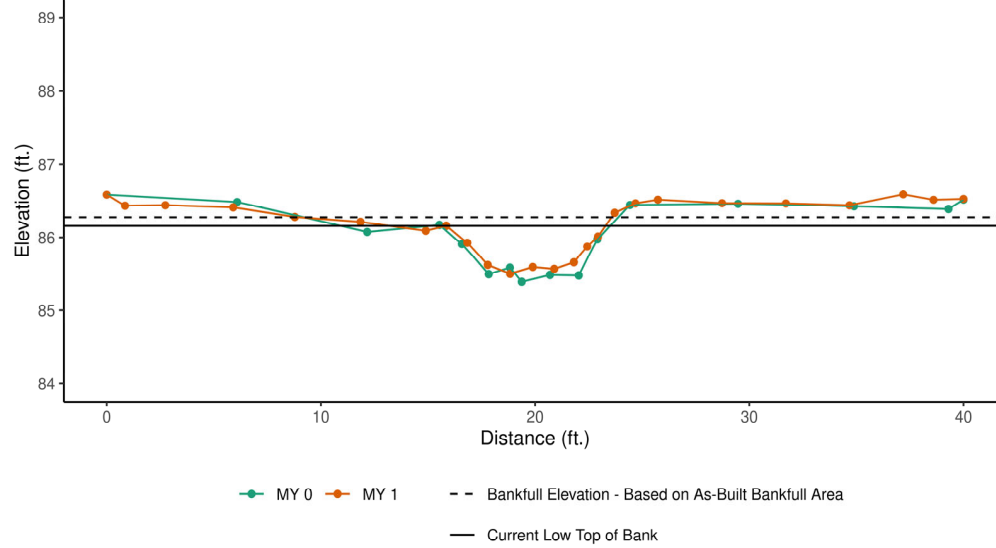
Cross-Section 8 (MS3 - Riffle) MY1

MY0	MY1	MY2	MY3	MY4	MY5	MY6	MY7
Bankfull Elevation - Based on As-Built Bankfull Area	86.17	86.27						
Bank Height Ratio - Based on As-Built Bankfull Area	1.00	0.85						
Thalweg Elevation	85.40	85.50						
LTOB Elevation	86.17	86.16						
LTOB Max Depth	0.773	0.655						
LTOB Cross Sectional Area	4.04	3.20

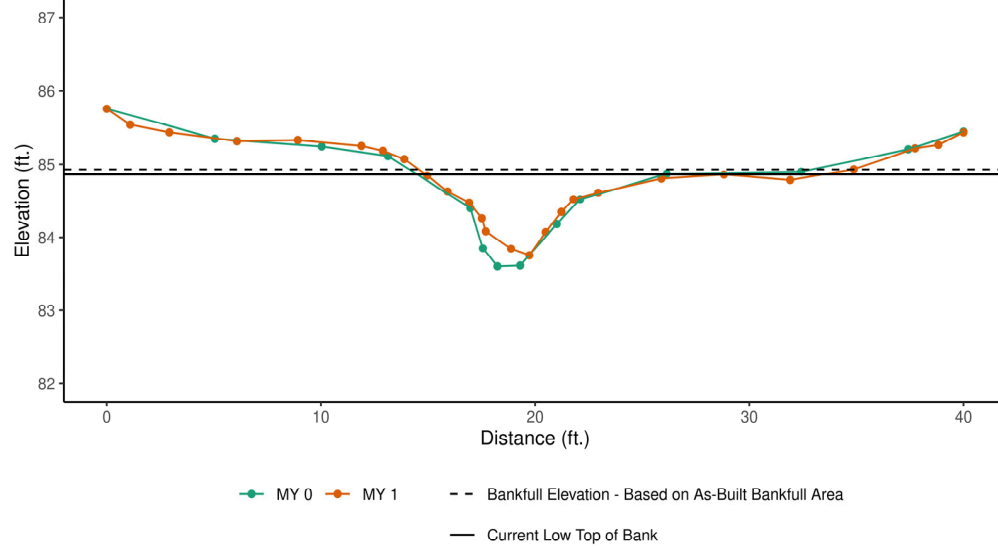
Cross-Section 9 (MS3 - Pool) MY1

MY0	MY1	MY2	MY3	MY4	MY5	MY6	MY7
Bankfull Elevation - Based on As-Built Bankfull Area	84.87	84.93						
Bank Height Ratio - Based on As-Built Bankfull Area	1.00	0.94						
Thalweg Elevation	83.60	83.75						
LTOB Elevation	84.87	84.86						
LTOB Max Depth	1.265	1.107						
LTOB Cross Sectional Area	6.09	5.12

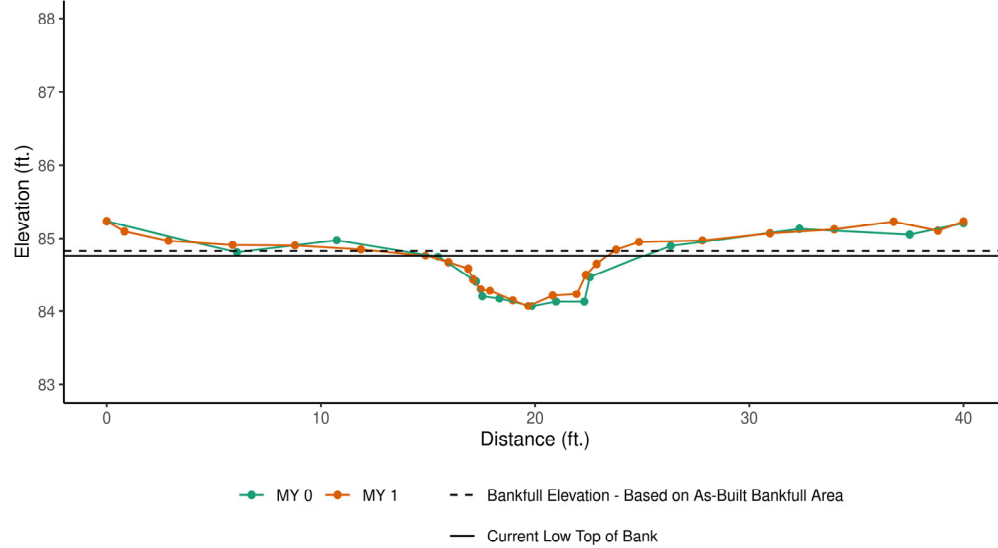
Cross-Section 10 (MS3 - Riffle) MY1

MY0	MY1	MY2	MY3	MY4	MY5	MY6	MY7
Bankfull Elevation - Based on As-Built Bankfull Area	84.74	84.83						
Bank Height Ratio - Based on As-Built Bankfull Area	1.00	0.91						
Thalweg Elevation	84.07	84.07						
LTOB Elevation	84.74	84.76						
LTOB Max Depth	0.674	0.686						
LTOB Cross Sectional Area	3.77	3.18

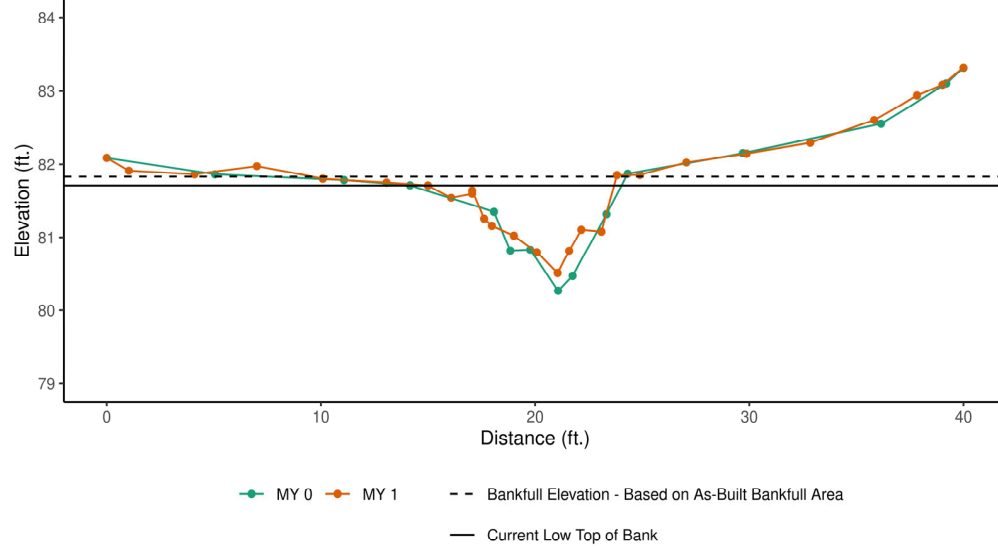
Cross-Section 11 (MS3 - Pool) MY1

MY0	MY1	MY2	MY3	MY4	MY5	MY6	MY7
Bankfull Elevation - Based on As-Built Bankfull Area	81.71	81.83						
Bank Height Ratio - Based on As-Built Bankfull Area	1.00	0.91						
Thalweg Elevation	80.27	80.51						
LTOB Elevation	81.71	81.71						
LTOB Max Depth	1.437	1.196						
LTOB Cross Sectional Area	5.88	4.84

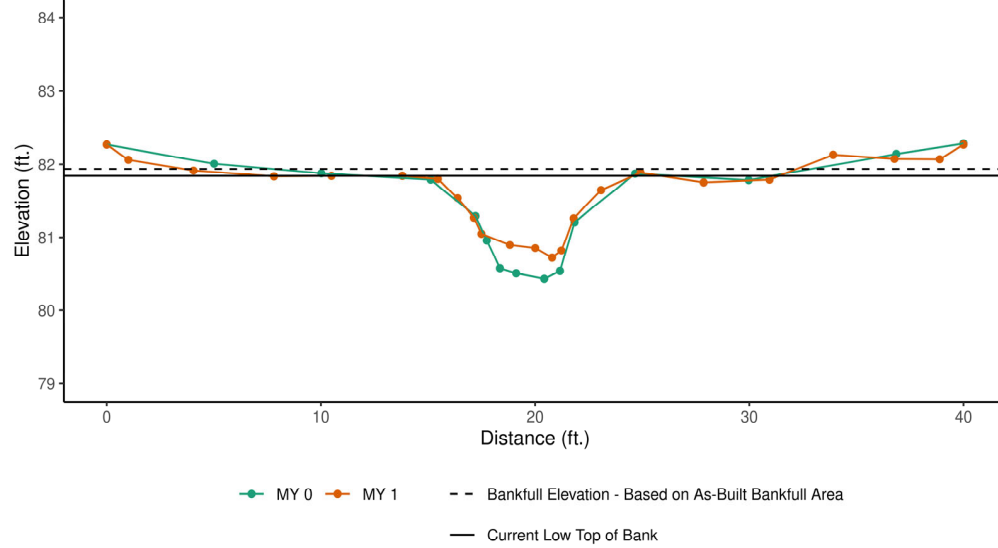
Cross-Section 12 (MS3 - Riffle) MY1

MY0	MY1	MY2	MY3	MY4	MY5	MY6	MY7
Bankfull Elevation - Based on As-Built Bankfull Area	81.79	81.93						
Bank Height Ratio - Based on As-Built Bankfull Area	1.00	0.92						
Thalweg Elevation	80.43	80.72						
LTOB Elevation	81.79	81.84						
LTOB Max Depth	1.354	1.121						
LTOB Cross Sectional Area	6.47	5.46

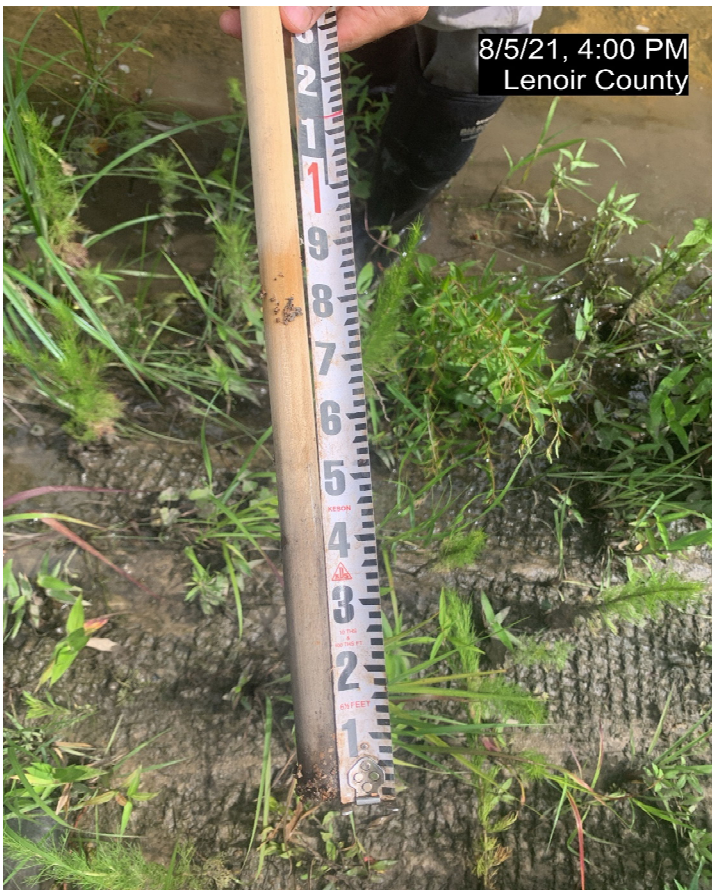
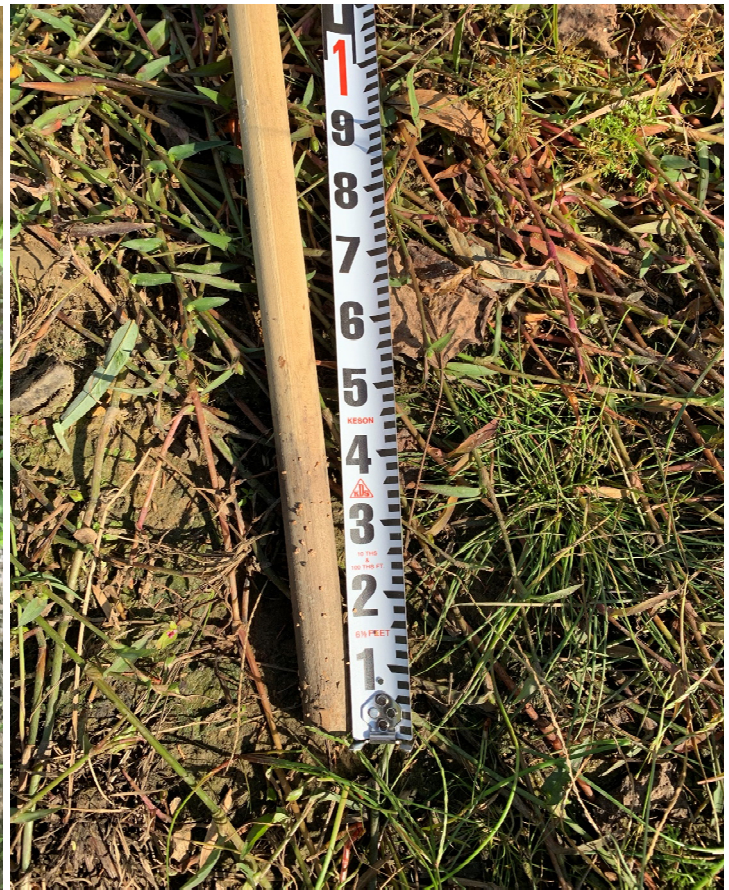
Date of Collection	Date of Occurrence	Method	Notes	Measurement Above Bankfull (feet)
MY1	4/7/2021	3/27/2021 - 3/28/2021	Pressure Transducer	Bankfull due to rainfall event	0.411
	4/7/2021	4/1/2021	Pressure Transducer	Bankfull due to rainfall event	0.488
	8/5/2021	unknown	Cork Gauge	Evidence of bankfull on traditional cork gauge	0.85
	10/19/2021	unknown	Cork Gauge	Evidence of bankfull on traditional cork gauge	0.45

*Data lost due to a pressure transducer malfunction from 6/6/2021 - 10/19/2021

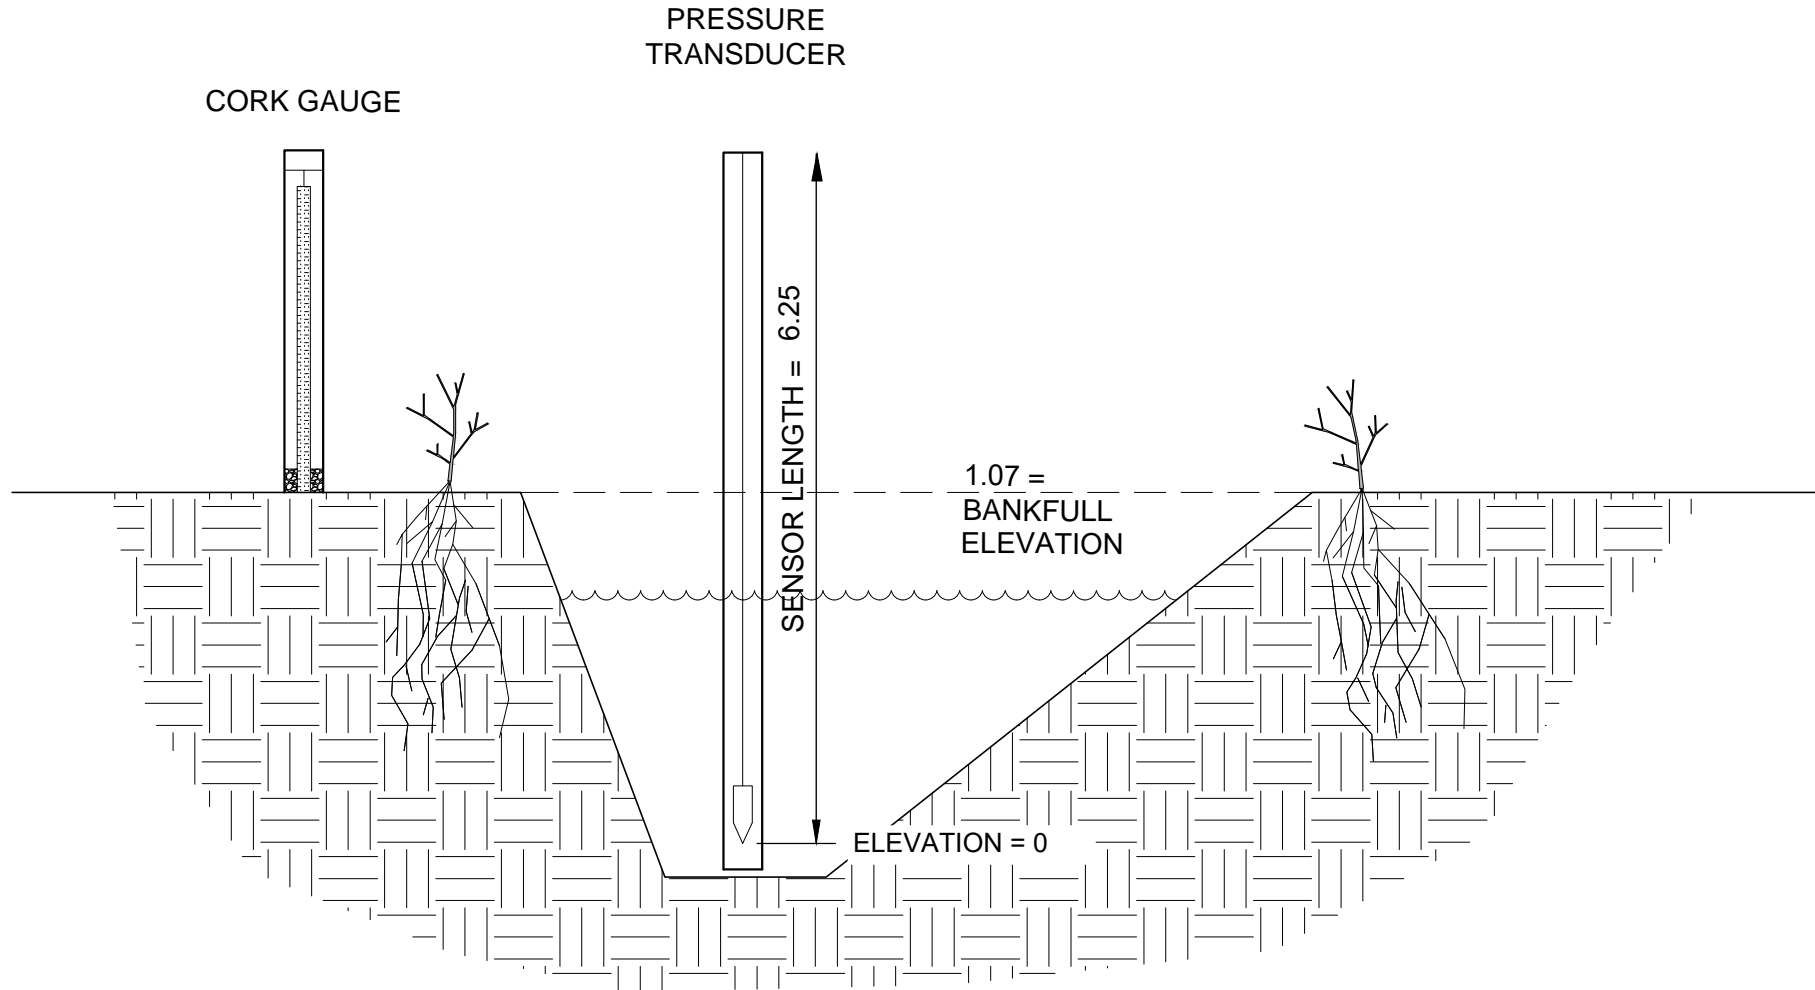
Crest Gauge CG-1 (MS-3)

During MY1, bankfull events were recorded on the pressure transducer crest gauge. CG-1 recorded 2 events with a maximum event of 0.488' above bankfull on April 1, 2021. The CG-1 pressure transducer malfunctioned on June 6, 2021 and was replaced during MY1 activities on October 19, 2021. Additionally, the cork crest gauge located adjacent to CG-1 recorded 2 bankfull events with a maximum event of 0.85' above bankfull. Associated data and photographs are located in Appendix D.

Bankfull Event Depth = 1.07 feet
