MY2 FINAL MONITORING REPORT
Hornpipe Branch Tributaries Mitigation Project
Lenoir County
Neuse River Basin
CU 03020202

DMS Project # 100076
DMS Contract # 7605
Contracted RFP # 16-007401
USACE Action ID Number: SAW-2018-01762
DWR Project # 2018-1155

Calendar Year of Data Collection: 2022

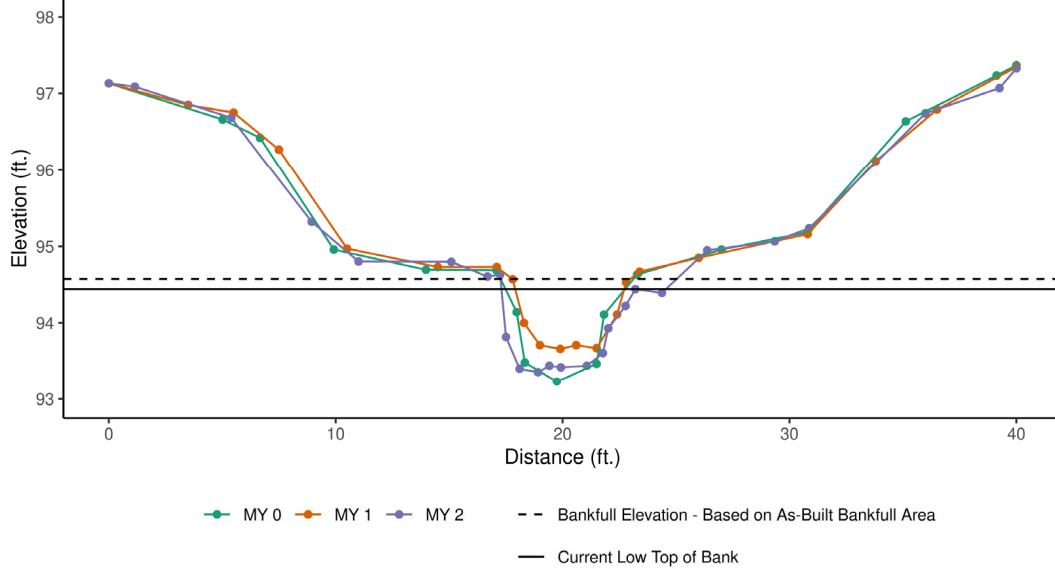
Cross-Section 1 (MS1 - Pool) MY2

MY0	MY1	MY2	MY3	MY4	MY5	MY6	MY7
Bankfull Elevation - Based on As-Built Bankfull Area	94.63	94.85	94.57					
Bank Height Ratio - Based on As-Built Bankfull Area	1.00	0.85	0.89					
Thalweg Elevation	93.23	93.66	93.42					
LTOB Elevation	94.63	94.67	94.44					
LTOB Max Depth	1.401	1.01	1.023					
LTOB Cross Sectional Area	5.20	4.13	4.43

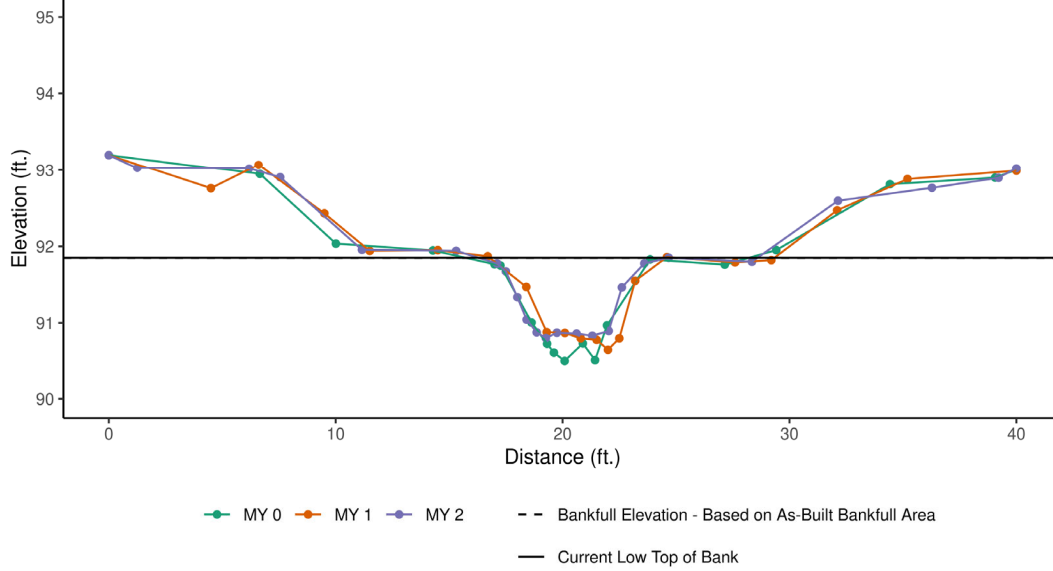
Cross-Section 2 (MS1 - Riffle) MY2

MY0	MY1	MY2	MY3	MY4	MY5	MY6	MY7
Bankfull Elevation - Based on As-Built Bankfull Area	91.75	91.82	91.85					
Bank Height Ratio - Based on As-Built Bankfull Area	1.00	1.03	1.00					
Thalweg Elevation	90.51	90.65	90.80					
LTOB Elevation	91.75	91.86	91.85					
LTOB Max Depth	1.245	1.21	1.048					
LTOB Cross Sectional Area	4.72	5.03	4.74

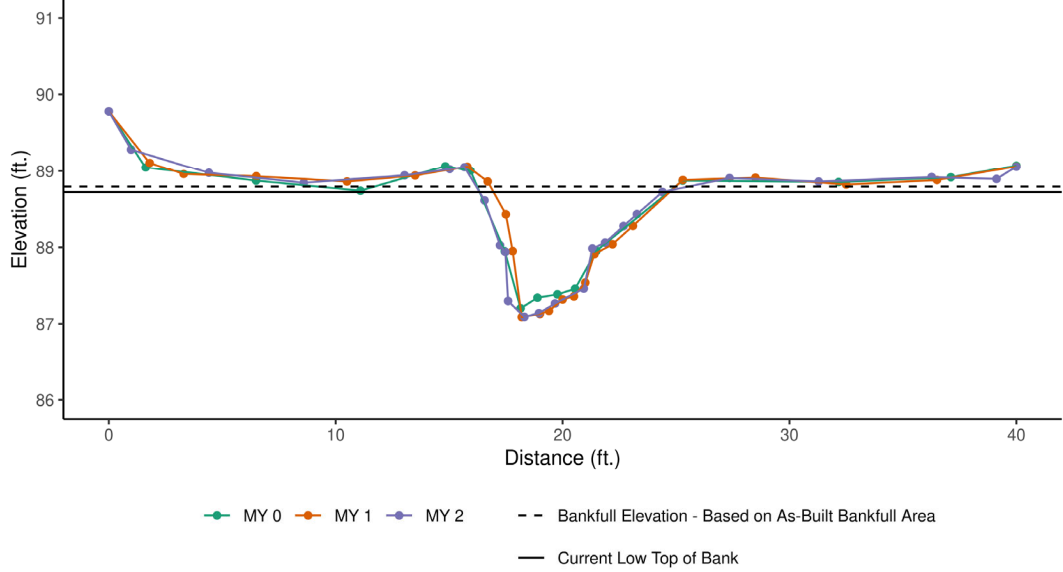
Cross-Section 3 (MS2 - Pool) MY2

MY0	MY1	MY2	MY3	MY4	MY5	MY6	MY7
Bankfull Elevation - Based on As-Built Bankfull Area	88.87	88.84	88.79					
Bank Height Ratio - Based on As-Built Bankfull Area	1.00	1.02	0.96					
Thalweg Elevation	87.34	87.09	87.09					
LTOB Elevation	88.87	88.88	88.72					
LTOB Max Depth	1.529	1.79	1.632					
LTOB Cross Sectional Area	7.68	8.01	7.12

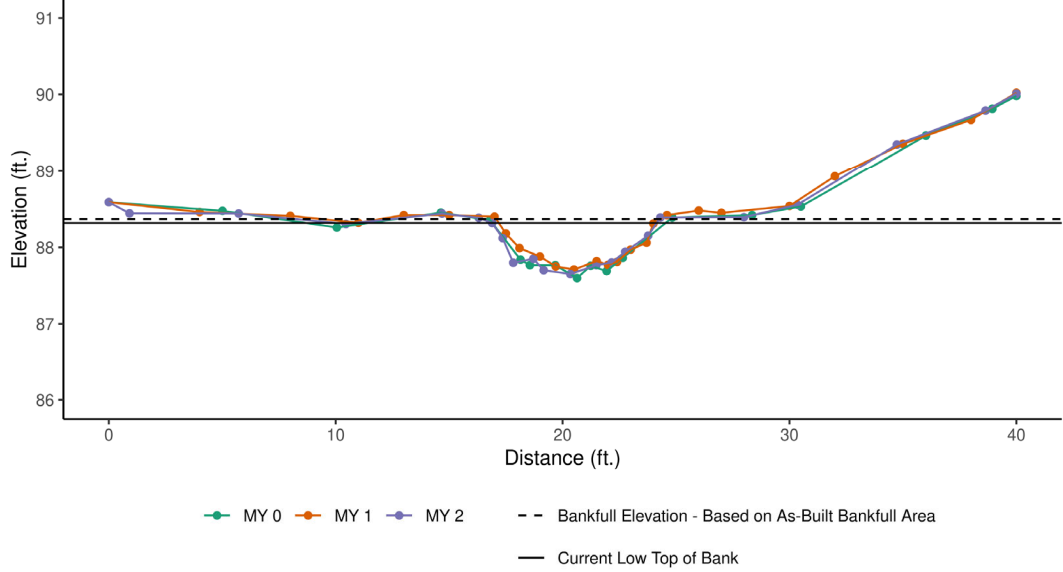
Cross-Section 4 (MS2 - Riffle) MY2

MY0	MY1	MY2	MY3	MY4	MY5	MY6	MY7
Bankfull Elevation - Based on As-Built Bankfull Area	88.35	88.43	88.37					
Bank Height Ratio - Based on As-Built Bankfull Area	1.00	0.97	0.93					
Thalweg Elevation	87.60	87.71	87.65					
LTOB Elevation	88.35	88.40	88.32					
LTOB Max Depth	0.755	0.69	0.665					
LTOB Cross Sectional Area	3.64	3.45	3.27

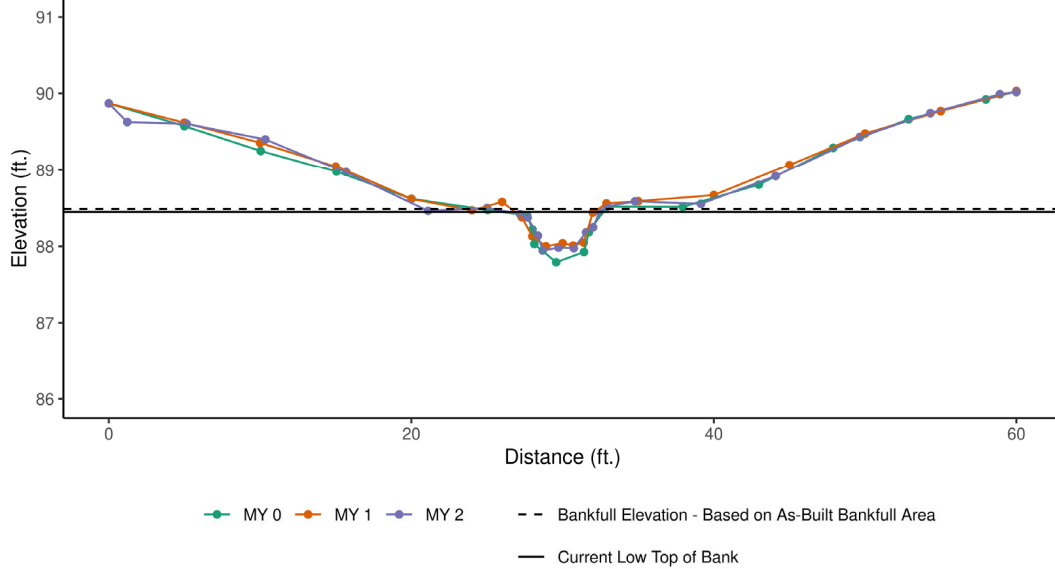
Cross-Section 5 (UT2 - Headwater) MY2

MY0	MY1	MY2	MY3	MY4	MY5	MY6	MY7
Bankfull Elevation - Based on As-Built Bankfull Area	88.40	88.50	88.49					
Bank Height Ratio - Based on As-Built Bankfull Area	1.00	1.12	0.93					
Thalweg Elevation	87.79	88.00	87.95					
LTOB Elevation	88.40	88.56	88.45					
LTOB Max Depth	0.609	0.56	0.504					
LTOB Cross Sectional Area	1.96	2.35	1.73

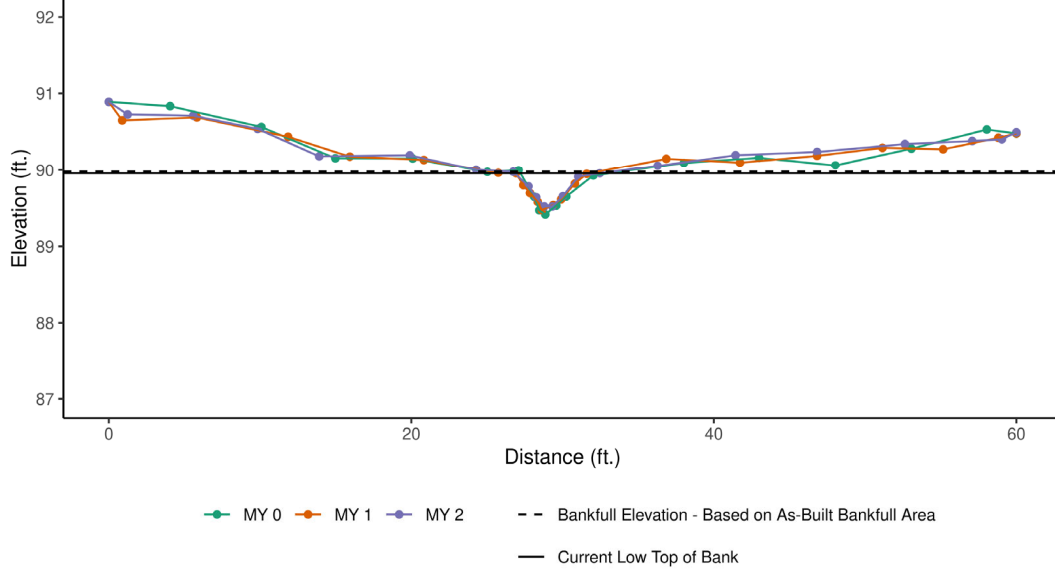
Cross-Section 6 (UT1 - Headwater) MY2

MY0	MY1	MY2	MY3	MY4	MY5	MY6	MY7
Bankfull Elevation - Based on As-Built Bankfull Area	89.93	89.96	89.98					
Bank Height Ratio - Based on As-Built Bankfull Area	1.00	0.98	0.95					
Thalweg Elevation	89.42	89.47	89.52					
LTOB Elevation	89.93	89.95	89.96					
LTOB Max Depth	0.511	0.477	0.437					
LTOB Cross Sectional Area	1.23	1.19	1.10

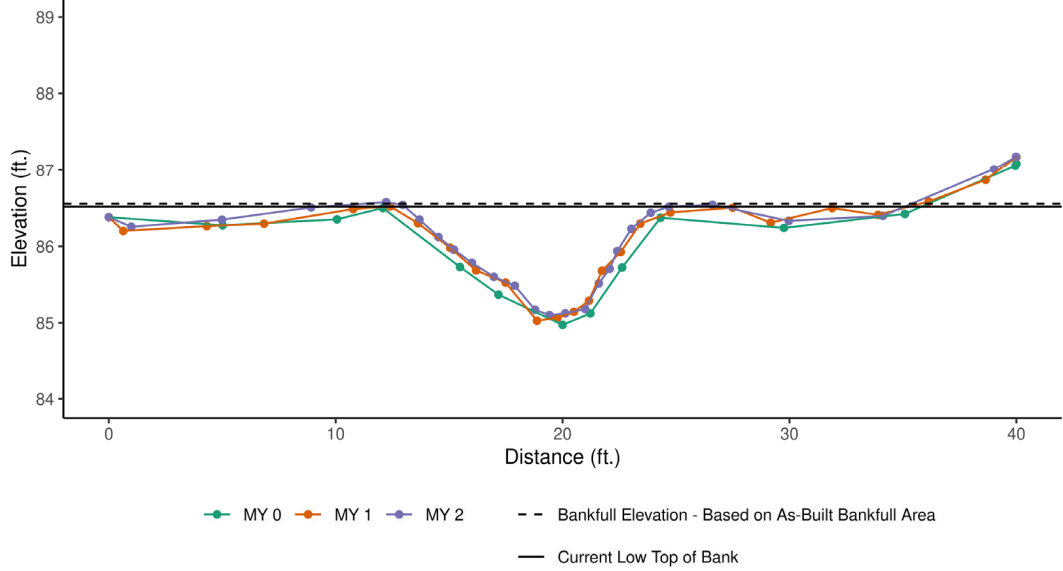
Cross-Section 7 (MS3 - Pool) MY2

MY0	MY1	MY2	MY3	MY4	MY5	MY6	MY7
Bankfull Elevation - Based on As-Built Bankfull Area	86.37	86.51	86.56					
Bank Height Ratio - Based on As-Built Bankfull Area	1.00	0.95	0.97					
Thalweg Elevation	84.98	85.03	85.10					
LTOB Elevation	86.37	86.44	86.52					
LTOB Max Depth	1.398	1.413	1.414					
LTOB Cross Sectional Area	9.20	8.37	8.75

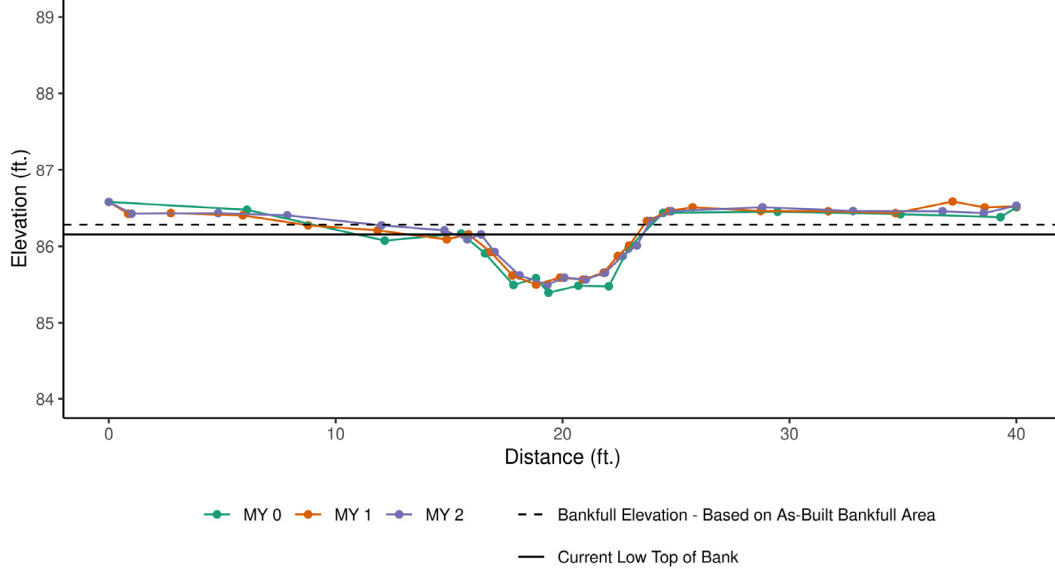
Cross-Section 8 (MS3 - Riffle) MY2

MY0	MY1	MY2	MY3	MY4	MY5	MY6	MY7
Bankfull Elevation - Based on As-Built Bankfull Area	86.17	86.27	86.28					
Bank Height Ratio - Based on As-Built Bankfull Area	1.00	0.85	0.84					
Thalweg Elevation	85.40	85.50	85.50					
LTOB Elevation	86.17	86.16	86.16					
LTOB Max Depth	0.773	0.655	0.655					
LTOB Cross Sectional Area	4.04	3.20	3.14

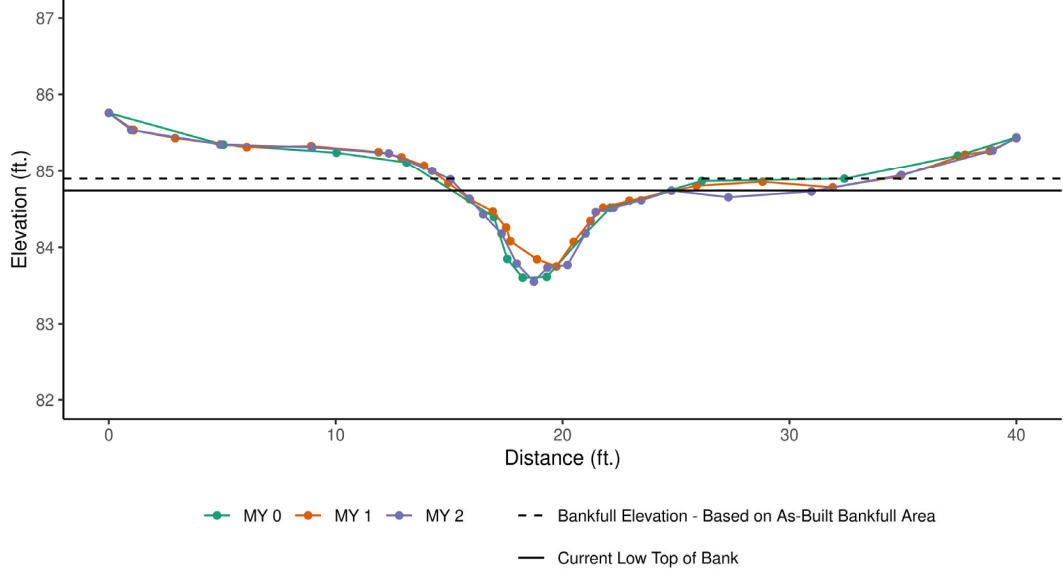
Cross-Section 9 (MS3 - Pool) MY2

MY0	MY1	MY2	MY3	MY4	MY5	MY6	MY7
Bankfull Elevation - Based on As-Built Bankfull Area	84.87	84.93	84.90					
Bank Height Ratio - Based on As-Built Bankfull Area	1.00	0.94	0.88					
Thalweg Elevation	83.60	83.75	83.55					
LTOB Elevation	84.87	84.86	84.74					
LTOB Max Depth	1.265	1.107	1.188					
LTOB Cross Sectional Area	6.09	5.12	4.63

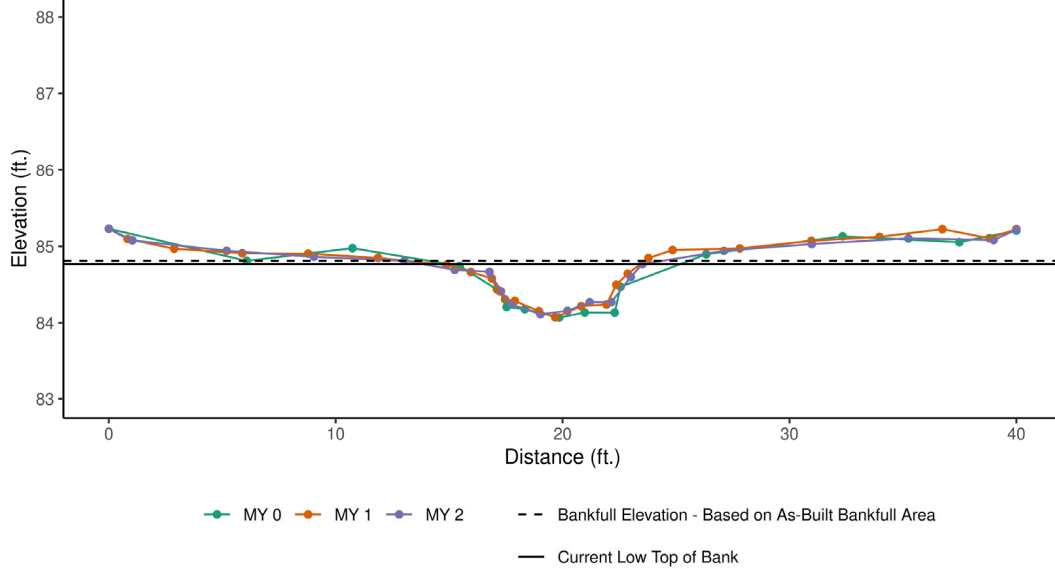
Cross-Section 10 (MS3 - Riffle) MY2

MY0	MY1	MY2	MY3	MY4	MY5	MY6	MY7
Bankfull Elevation - Based on As-Built Bankfull Area	84.74	84.83	84.81					
Bank Height Ratio - Based on As-Built Bankfull Area	1.00	0.91	0.94					
Thalweg Elevation	84.07	84.07	84.11					
LTOB Elevation	84.74	84.76	84.77					
LTOB Max Depth	0.674	0.686	0.655					
LTOB Cross Sectional Area	3.77	3.18	3.36

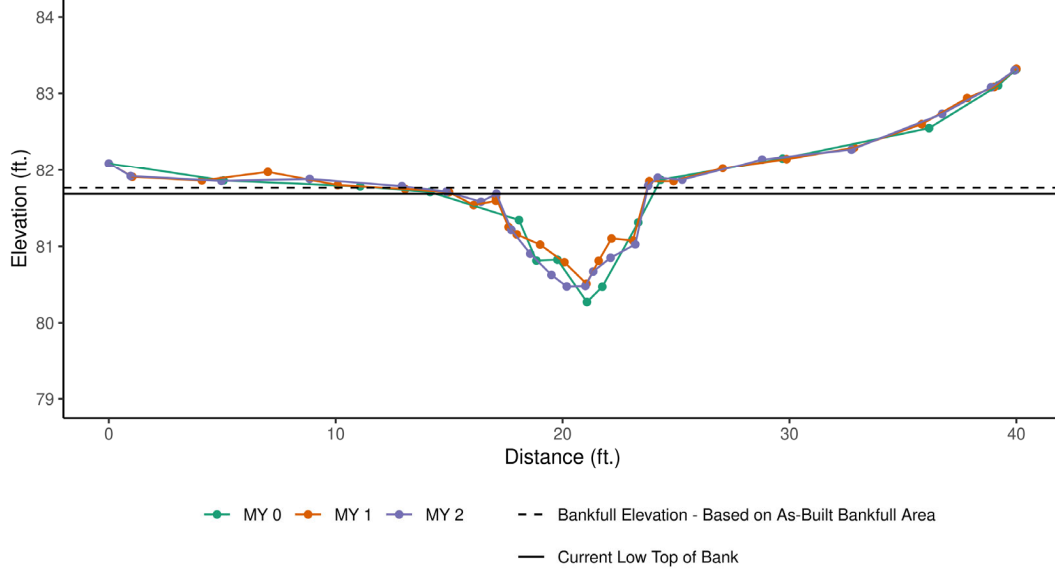
Cross-Section 11 (MS3 - Pool) MY2

MY0	MY1	MY2	MY3	MY4	MY5	MY6	MY7
Bankfull Elevation - Based on As-Built Bankfull Area	81.71	81.83	81.77					
Bank Height Ratio - Based on As-Built Bankfull Area	1.00	0.91	0.94					
Thalweg Elevation	80.27	80.51	80.48					
LTOB Elevation	81.71	81.71	81.69					
LTOB Max Depth	1.437	1.196	1.211					
LTOB Cross Sectional Area	5.88	4.84	5.37

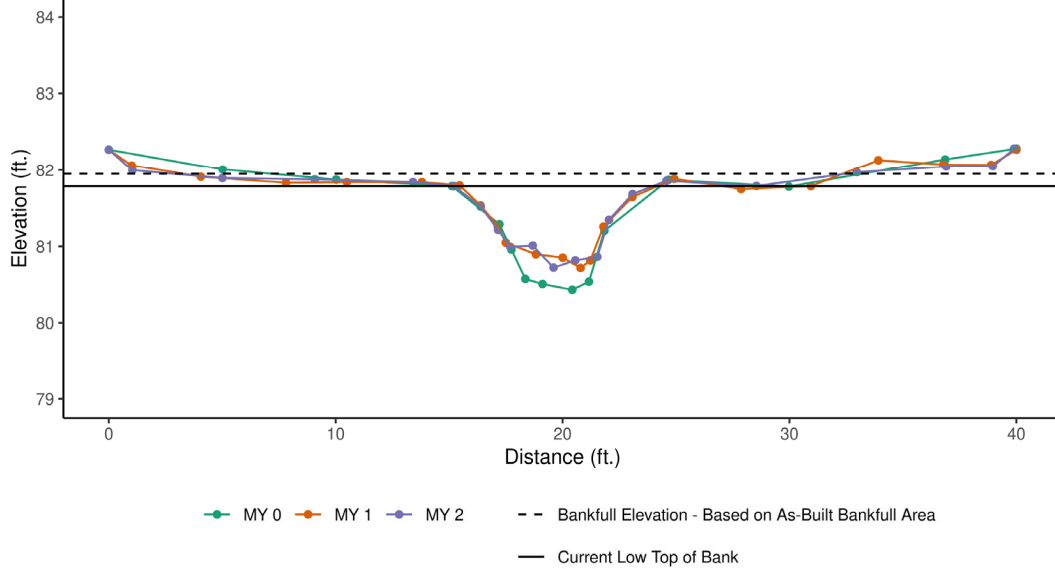
Cross-Section 12 (MS3 - Riffle) MY2

MY0	MY1	MY2	MY3	MY4	MY5	MY6	MY7
Bankfull Elevation - Based on As-Built Bankfull Area	81.79	81.93	81.95					
Bank Height Ratio - Based on As-Built Bankfull Area	1.00	0.92	0.87					
Thalweg Elevation	80.43	80.72	80.72					
LTOB Elevation	81.79	81.84	81.79					
LTOB Max Depth	1.354	1.121	1.064					
LTOB Cross Sectional Area	6.47	5.46	5.04

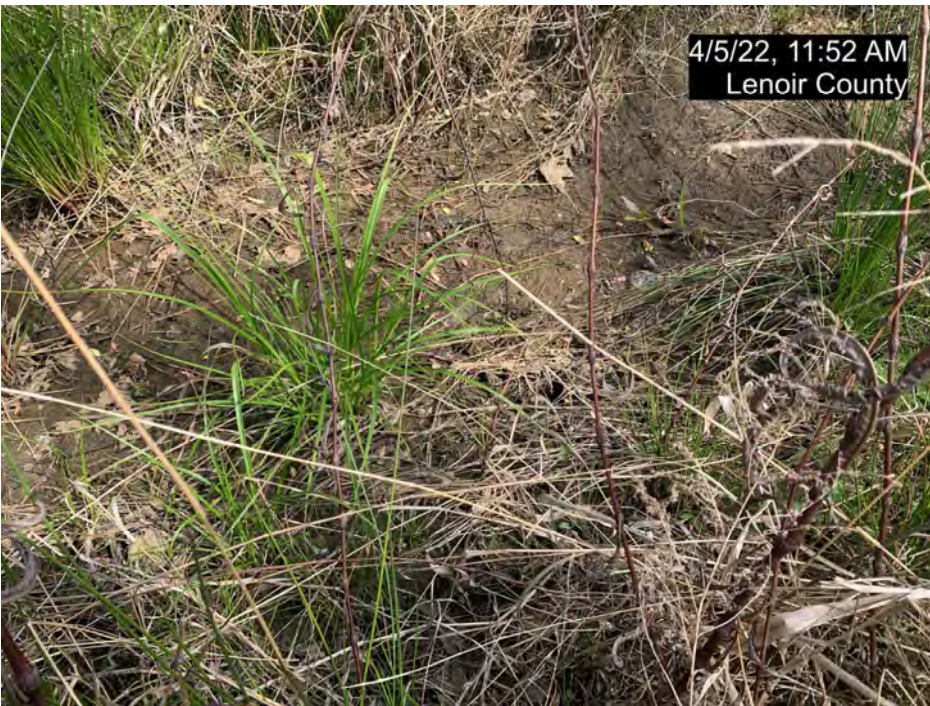
UT1, vegetation matted outside of channel

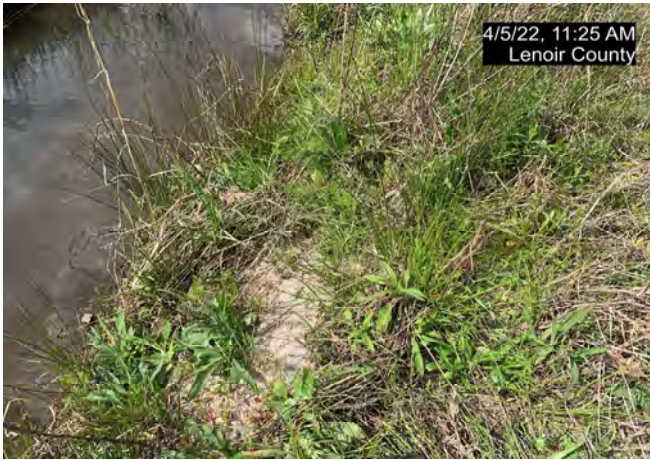
Alluvial Deposit

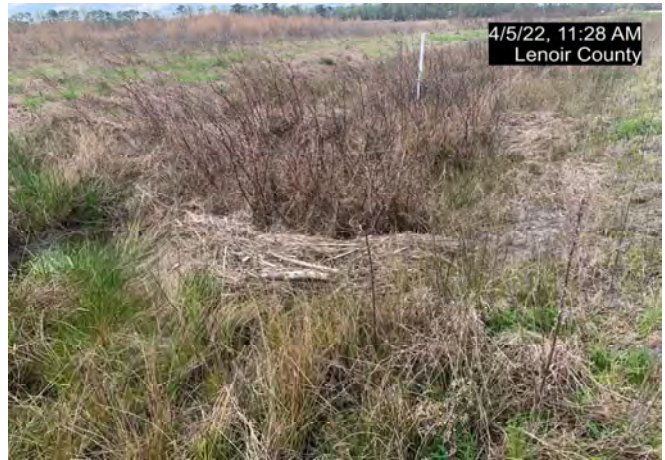
Wrack line

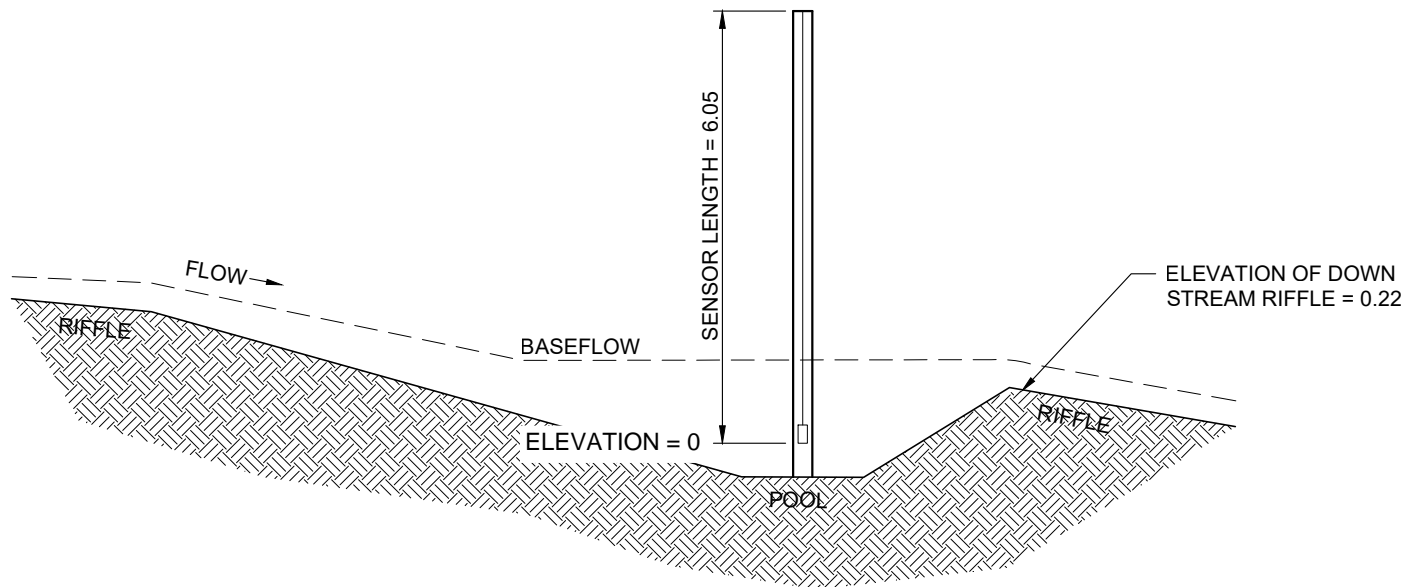
FLOW GAUGE #1 - MS1

Flow Depth = 0.22 feet

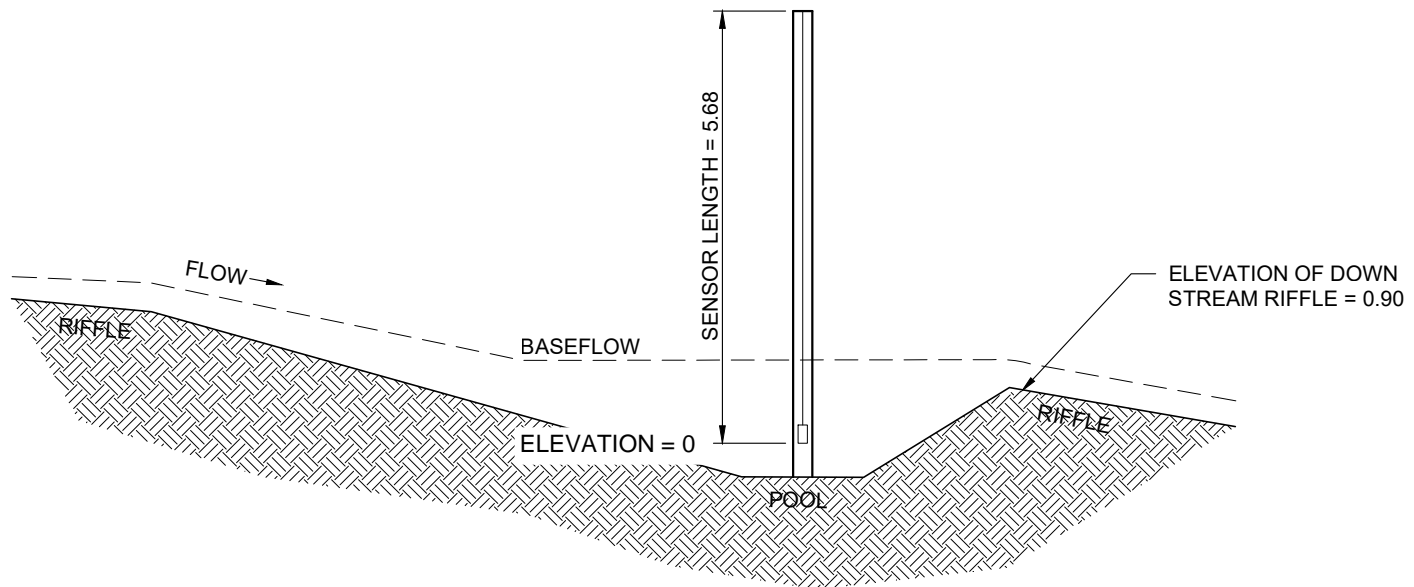
FLOW GAUGE #2 - UT1

Flow Depth = 0.90 feet

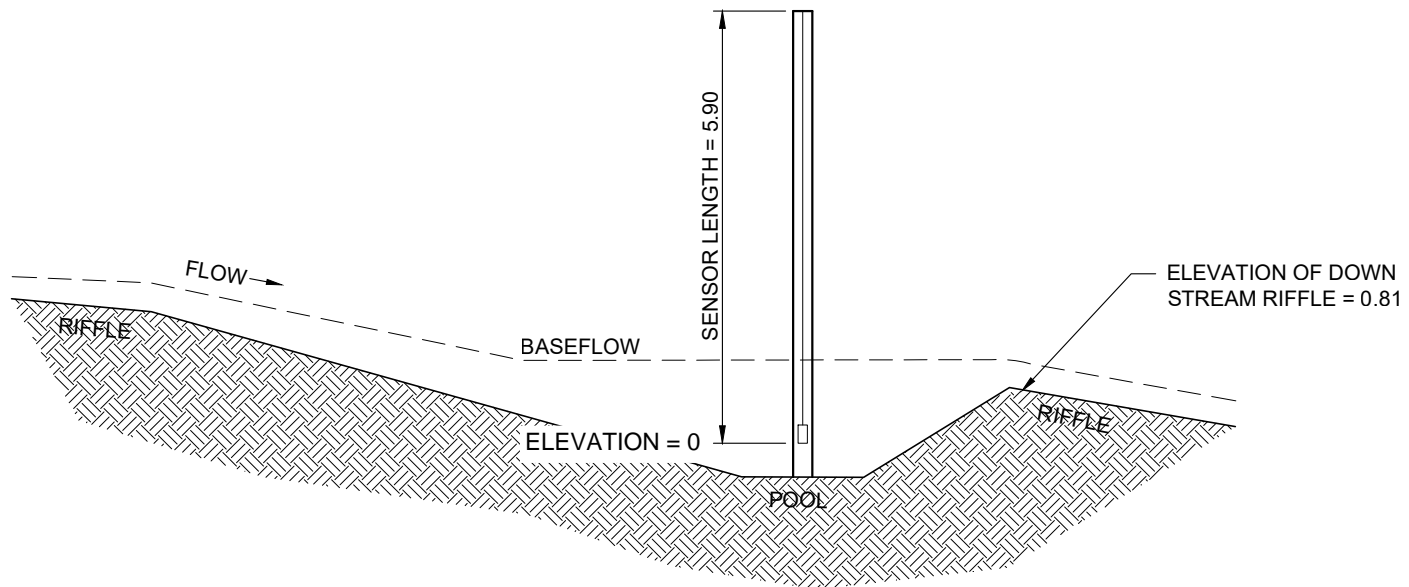
FLOW GAUGE #3 - UT2

Flow Depth = 0.81 feet

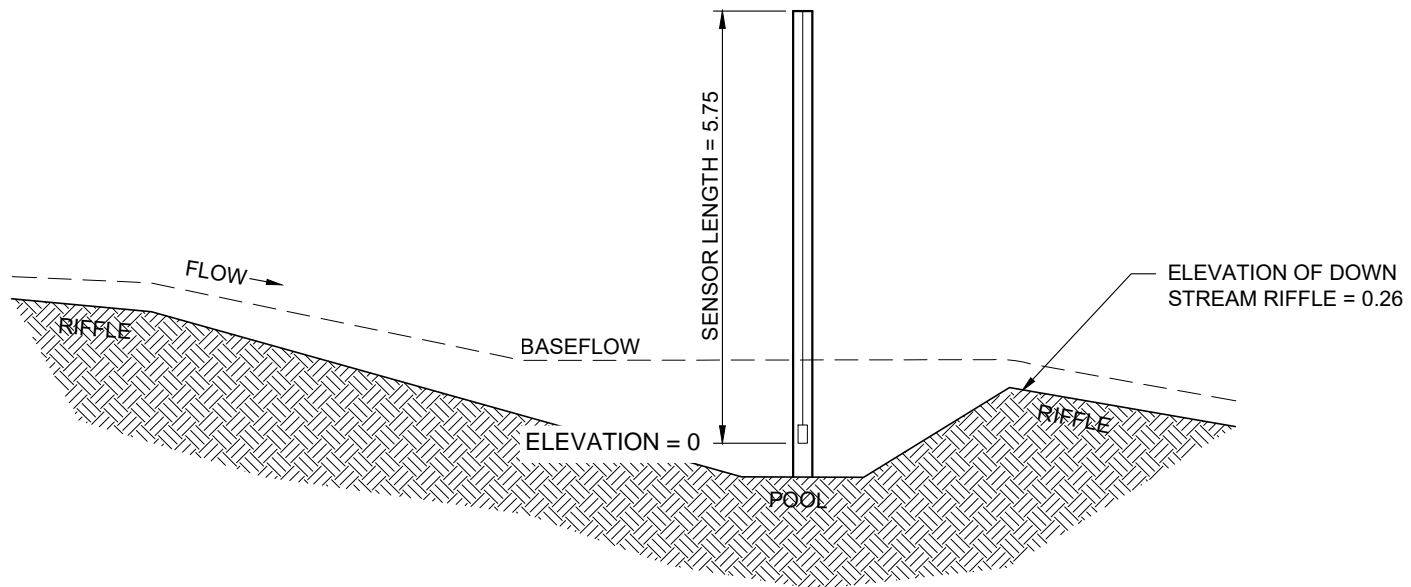
FLOW GAUGE #4 - Reference Reach

Flow Depth = 0.26 feet
