MY3 FINAL MONITORING REPORT
Hornpipe Branch Tributaries Mitigation Project
Lenoir County
Neuse River Basin
CU 03020202

DMS Project # 100076
DMS Contract # 7605
Contracted RFP # 16-007401
USACE Action ID Number: SAW-2018-01762
DWR Project # 2018-1155

Calendar Year of Data Collection: 2023

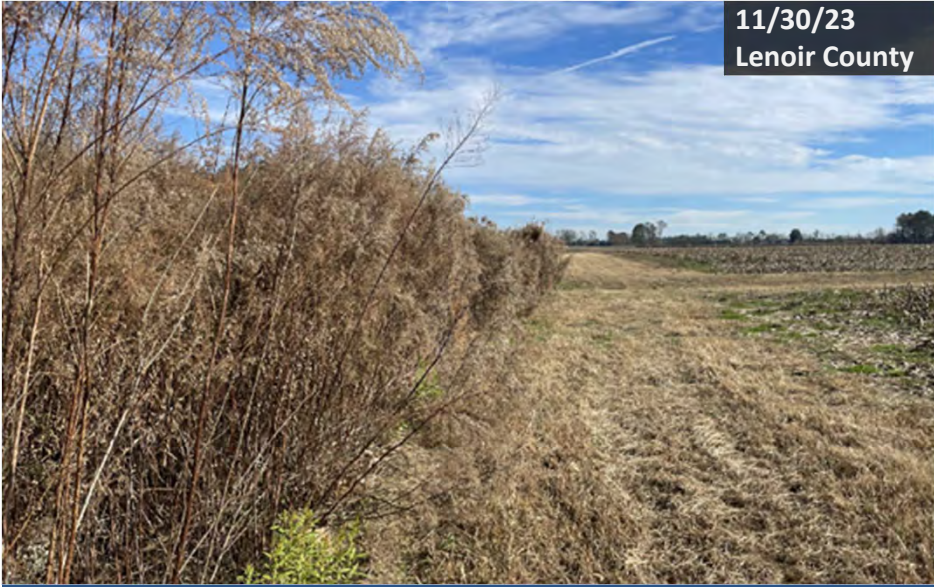
Encroachment Area 1, MS1, near STA 13+00 (MY-03)

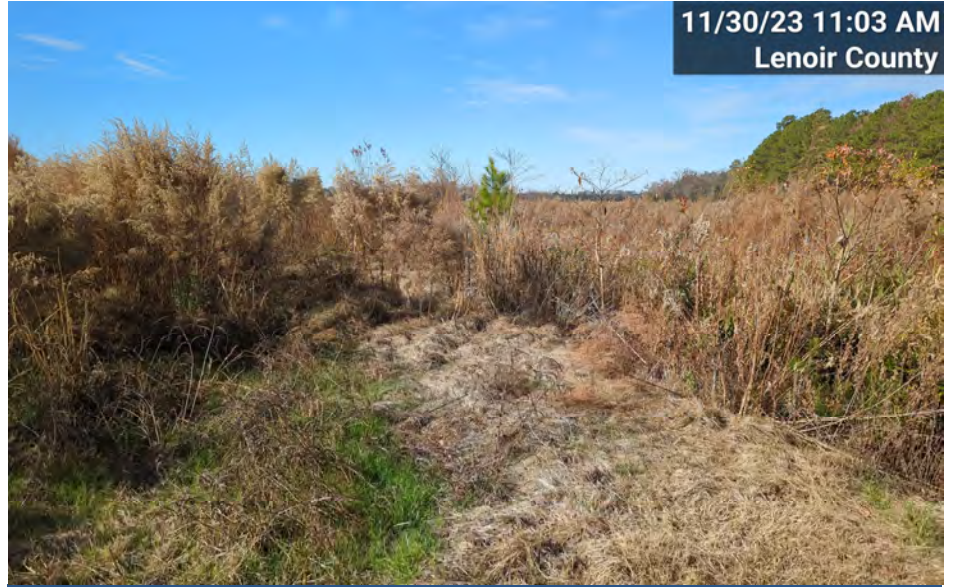
Encroachment Area 2, MS1, near STA 10+00 (MY-03)

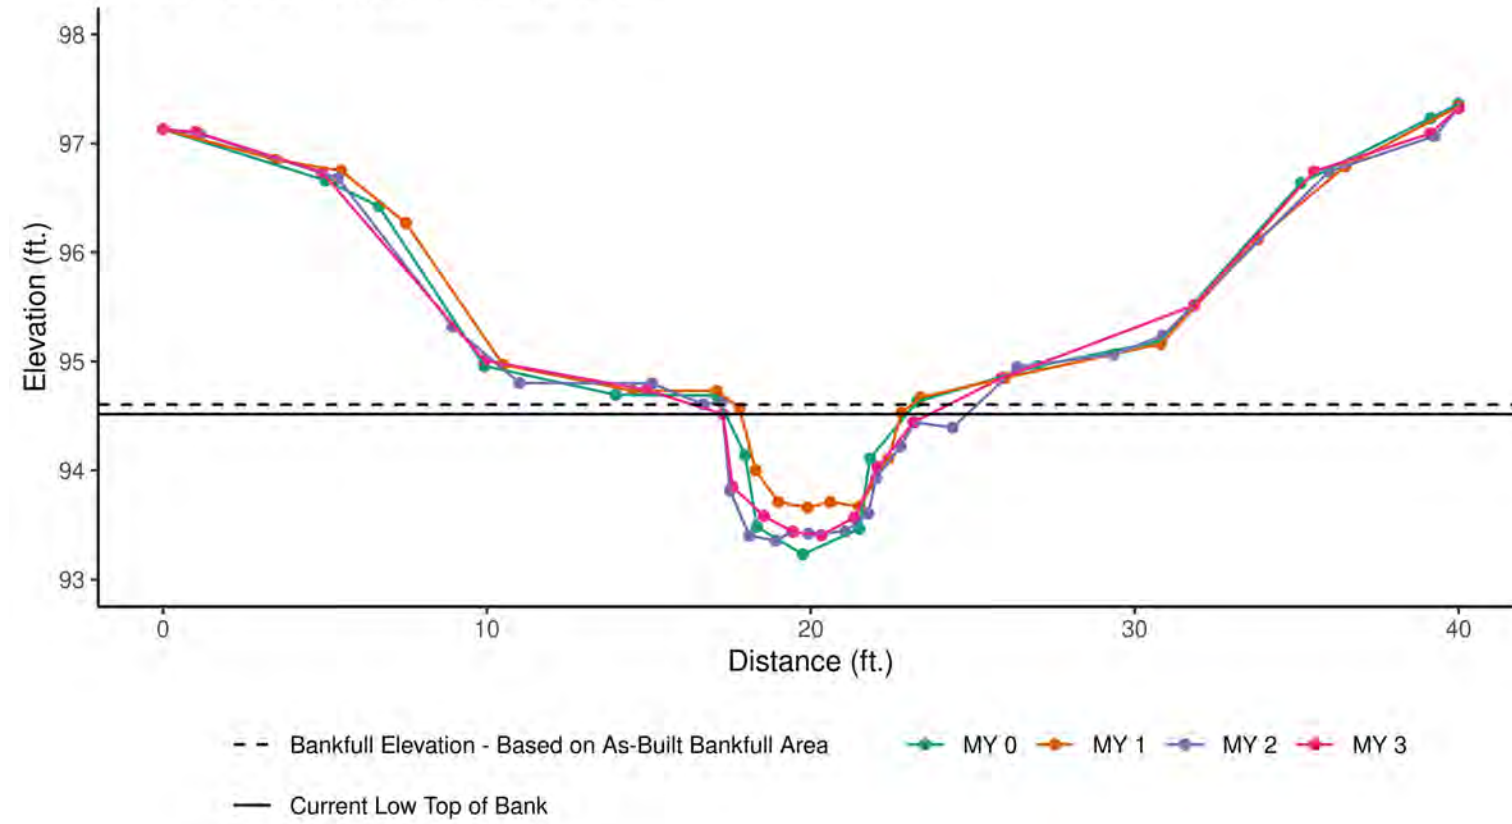
Cross-Section 1 (MS1 - Pool) MY3

MY0	MY1	MY2	MY3	MY4	MY5	MY6	MY7
Bankfull Elevation - Based on As-Built Bankfull Area	94.63	94.85	94.57	94.61				
Bank Height Ratio - Based on As-Built Bankfull Area	1.00	0.85	0.89	0.93				
Thalweg Elevation	93.23	93.66	93.42	93.41				
LTOB Elevation	94.63	94.67	94.44	94.52				
LTOB Max Depth	1.401	1.01	1.023	1.112				
LTOB Cross Sectional Area	5.20	4.13	4.43	4.64

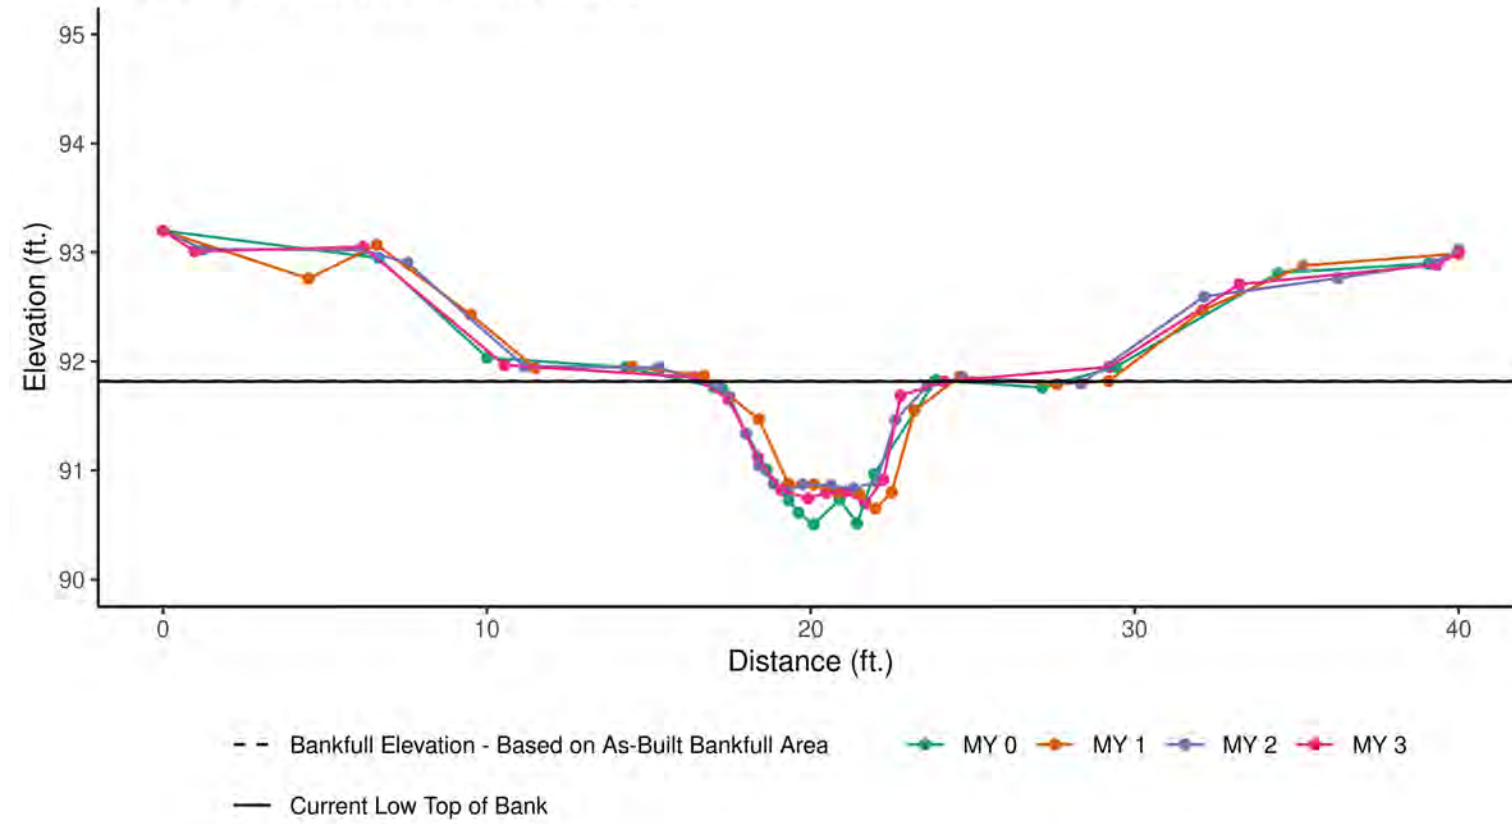
Cross-Section 2 (MS1 - Riffle) MY3

MY0	MY1	MY2	MY3	MY4	MY5	MY6	MY7
Bankfull Elevation - Based on As-Built Bankfull Area	91.75	91.82	91.85	91.82				
Bank Height Ratio - Based on As-Built Bankfull Area	1.00	1.03	1.00	1.00				
Thalweg Elevation	90.51	90.65	90.80	90.70				
LTOB Elevation	91.75	91.86	91.85	91.82				
LTOB Max Depth	1.245	1.21	1.048	1.119				
LTOB Cross Sectional Area	4.72	5.03	4.74	4.69

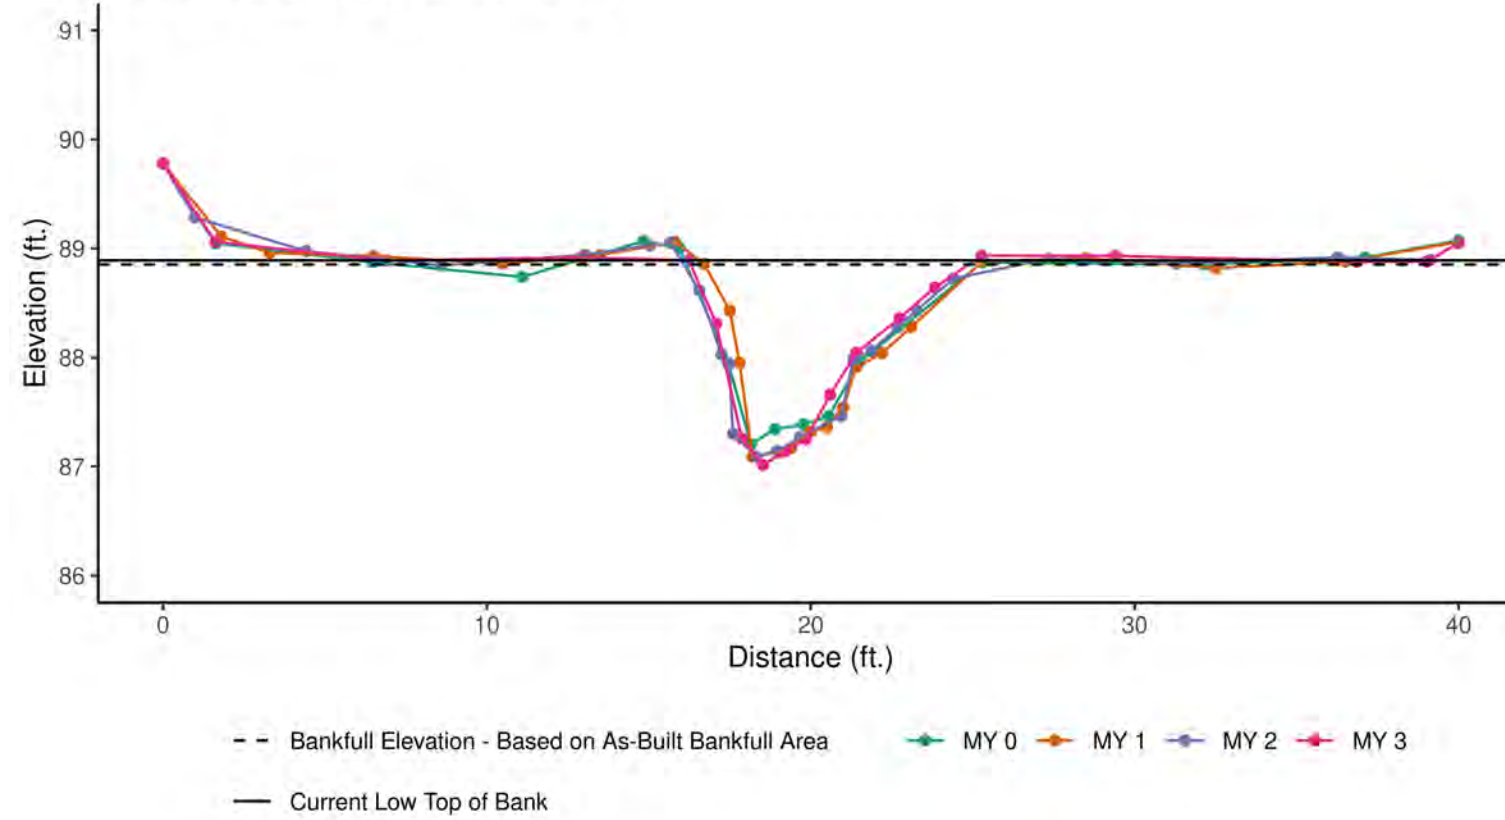
Cross-Section 3 (MS2 - Pool) MY3

MY0	MY1	MY2	MY3	MY4	MY5	MY6	MY7
Bankfull Elevation - Based on As-Built Bankfull Area	88.87	88.84	88.79	88.85				
Bank Height Ratio - Based on As-Built Bankfull Area	1.00	1.02	0.96	1.02				
Thalweg Elevation	87.34	87.09	87.09	87.01				
LTOB Elevation	88.87	88.88	88.72	88.89				
LTOB Max Depth	1.529	1.79	1.632	1.877				
LTOB Cross Sectional Area	7.68	8.01	7.12	8.01

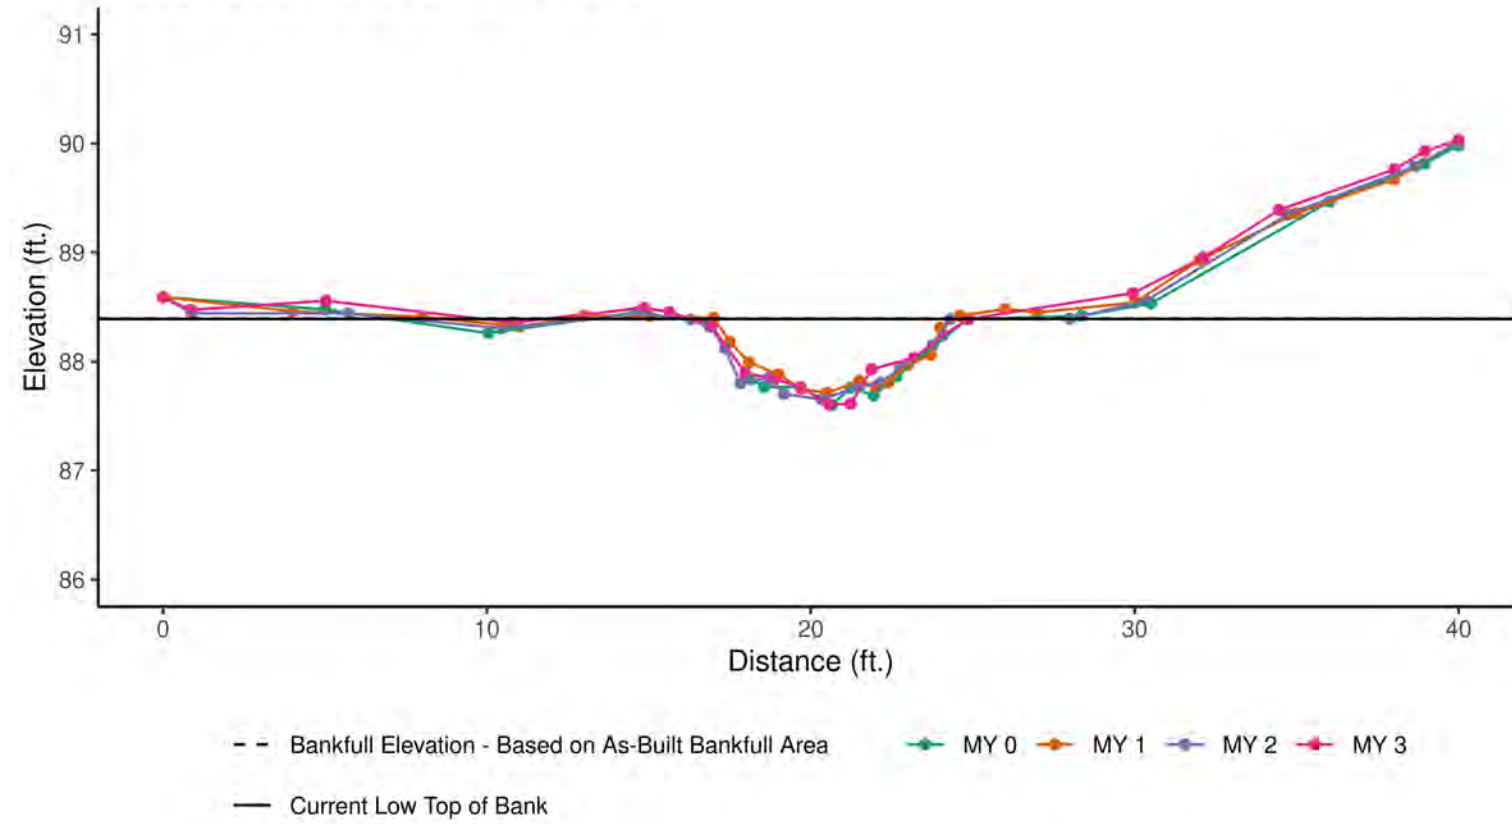
Cross-Section 4 (MS2 - Riffle) MY3

MY0	MY1	MY2	MY3	MY4	MY5	MY6	MY7
Bankfull Elevation - Based on As-Built Bankfull Area	88.35	88.43	88.37	88.39				
Bank Height Ratio - Based on As-Built Bankfull Area	1.00	0.97	0.93	1.00				
Thalweg Elevation	87.60	87.71	87.65	87.61				
LTOB Elevation	88.35	88.40	88.32	88.39				
LTOB Max Depth	0.755	0.69	0.665	0.784				
LTOB Cross Sectional Area	3.64	3.45	3.27	3.62

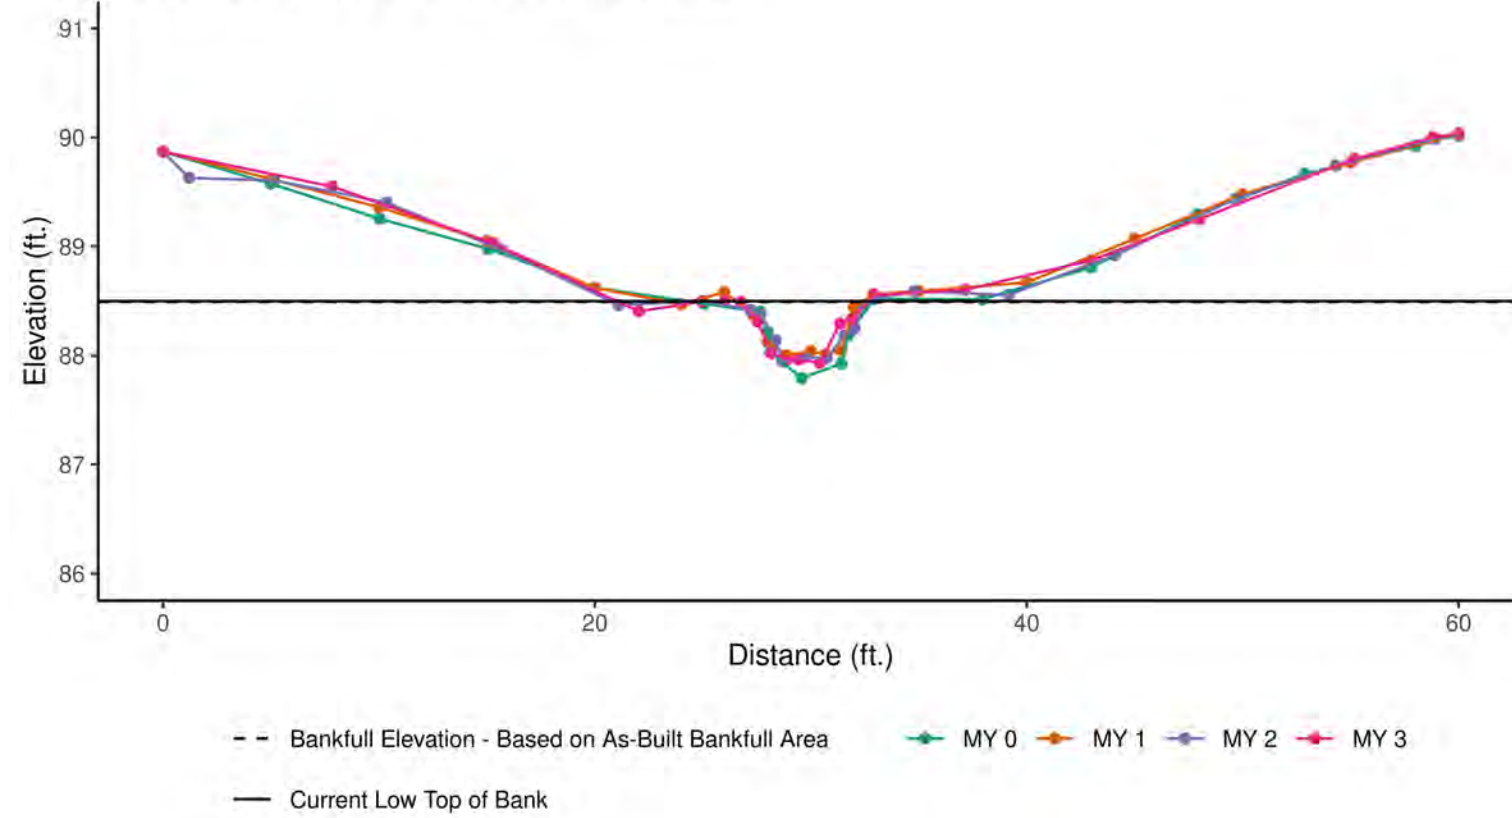
Cross-Section 5 (UT2 - Headwater) MY3

MY0	MY1	MY2	MY3	MY4	MY5	MY6	MY7
Bankfull Elevation - Based on As-Built Bankfull Area	88.40	88.50	88.49	88.49				
Bank Height Ratio - Based on As-Built Bankfull Area	1.00	1.12	0.93	1.01				
Thalweg Elevation	87.79	88.00	87.95	87.93				
LTOB Elevation	88.40	88.56	88.45	88.50				
LTOB Max Depth	0.609	0.56	0.504	0.565				
LTOB Cross Sectional Area	1.96	2.35	1.73	2.01

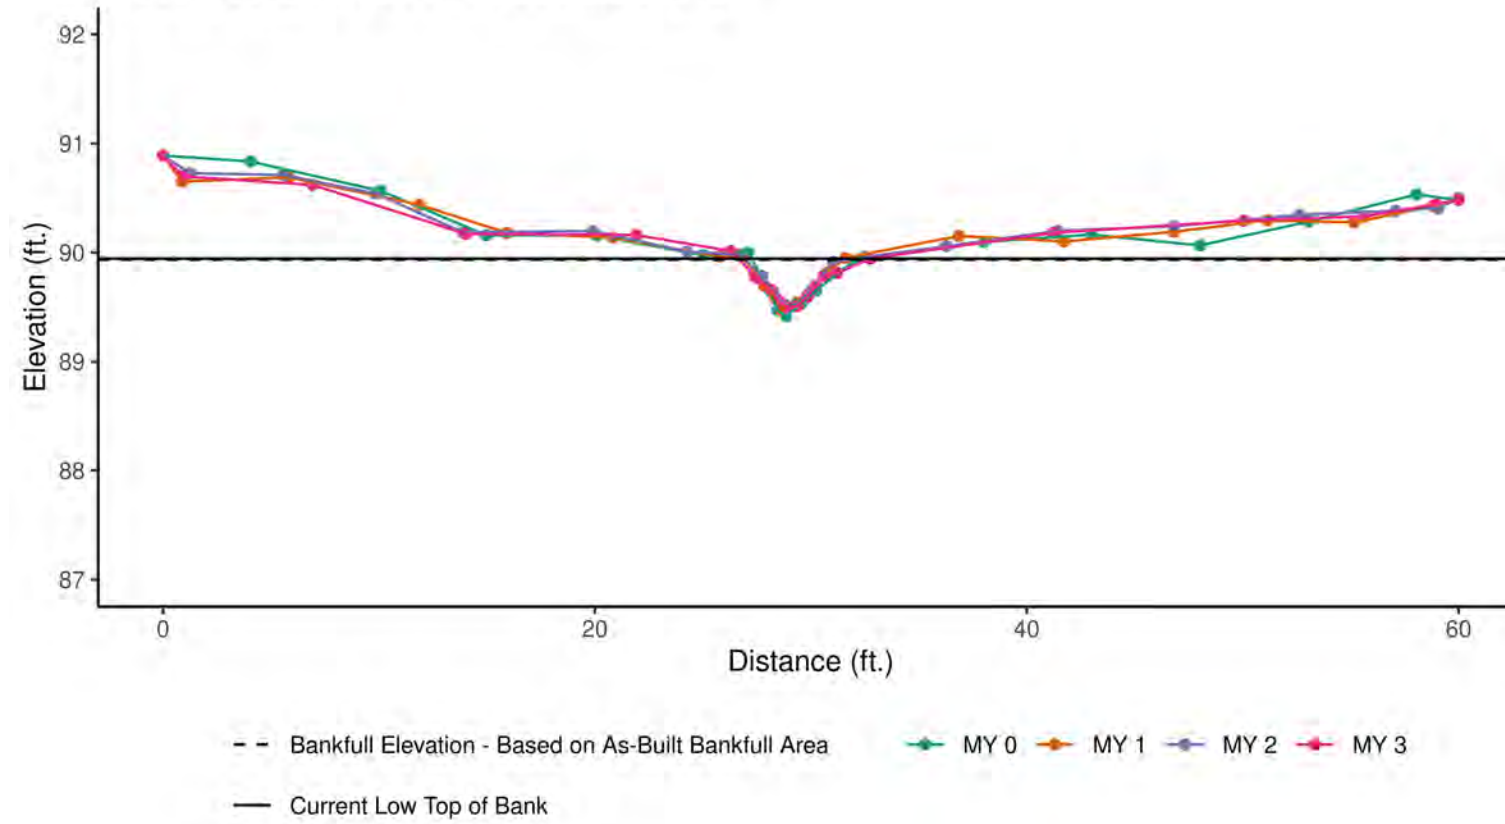
Cross-Section 6 (UT1 - Headwater) MY3

MY0	MY1	MY2	MY3	MY4	MY5	MY6	MY7
Bankfull Elevation - Based on As-Built Bankfull Area	89.93	89.96	89.98	89.93				
Bank Height Ratio - Based on As-Built Bankfull Area	1.00	0.98	0.95	1.02				
Thalweg Elevation	89.42	89.47	89.52	89.49				
LTOB Elevation	89.93	89.95	89.96	89.94				
LTOB Max Depth	0.511	0.477	0.437	0.453				
LTOB Cross Sectional Area	1.23	1.19	1.10	1.29

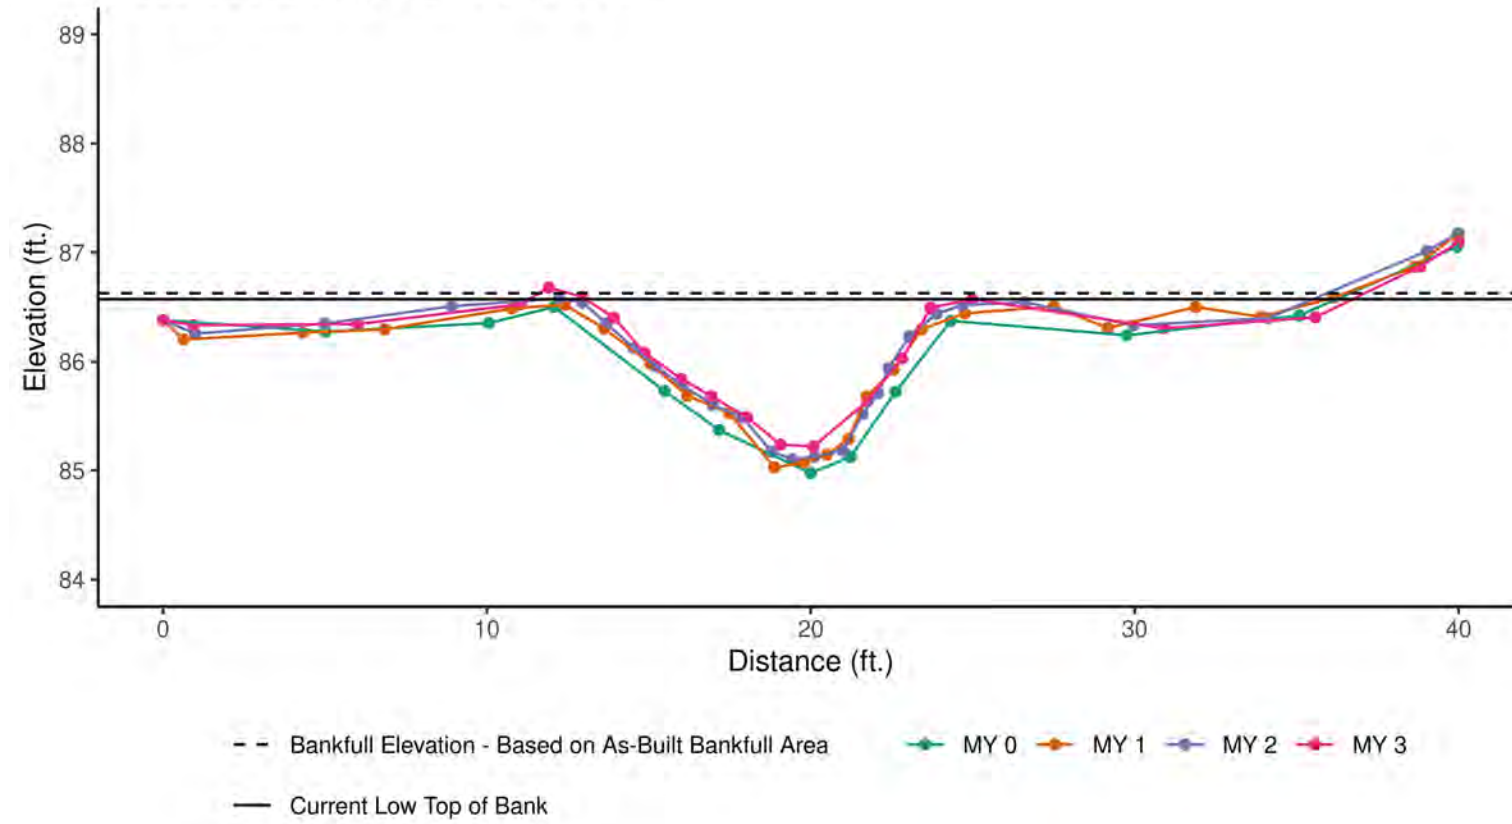
Cross-Section 7 (MS3 - Pool) MY3

MY0	MY1	MY2	MY3	MY4	MY5	MY6	MY7
Bankfull Elevation - Based on As-Built Bankfull Area	86.37	86.51	86.56	86.63				
Bank Height Ratio - Based on As-Built Bankfull Area	1.00	0.95	0.97	0.96				
Thalweg Elevation	84.98	85.03	85.10	85.22				
LTOB Elevation	86.37	86.44	86.52	86.57				
LTOB Max Depth	1.398	1.413	1.414	1.351				
LTOB Cross Sectional Area	9.20	8.37	8.75	8.55

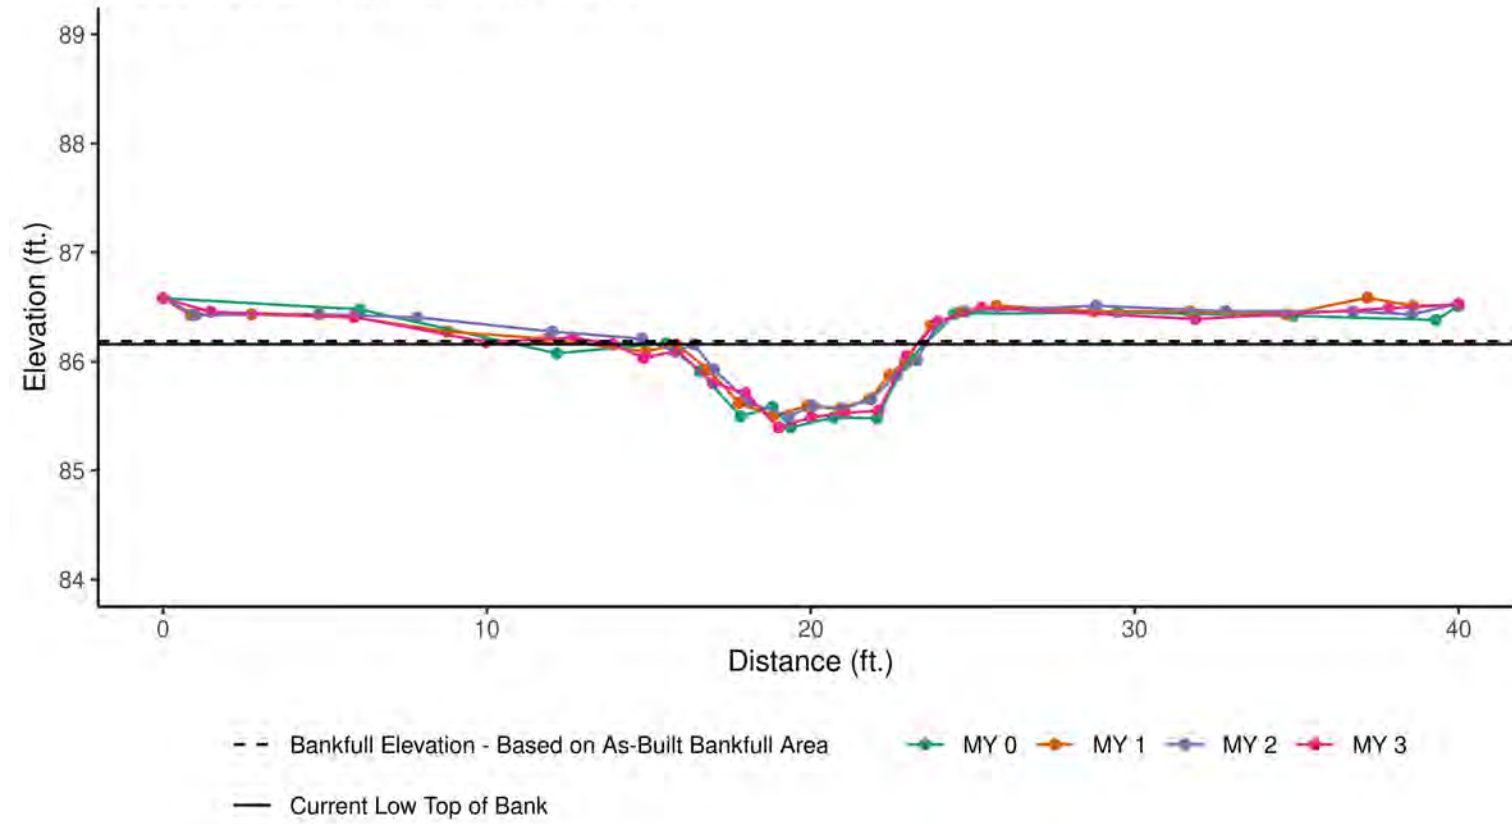
Cross-Section 8 (MS3 - Riffle) MY3

MY0	MY1	MY2	MY3	MY4	MY5	MY6	MY7
Bankfull Elevation - Based on As-Built Bankfull Area	86.17	86.27	86.28	86.19				
Bank Height Ratio - Based on As-Built Bankfull Area	1.00	0.85	0.84	0.96				
Thalweg Elevation	85.40	85.50	85.50	85.39				
LTOB Elevation	86.17	86.16	86.16	86.16				
LTOB Max Depth	0.773	0.655	0.655	0.764				
LTOB Cross Sectional Area	4.04	3.20	3.14	3.78

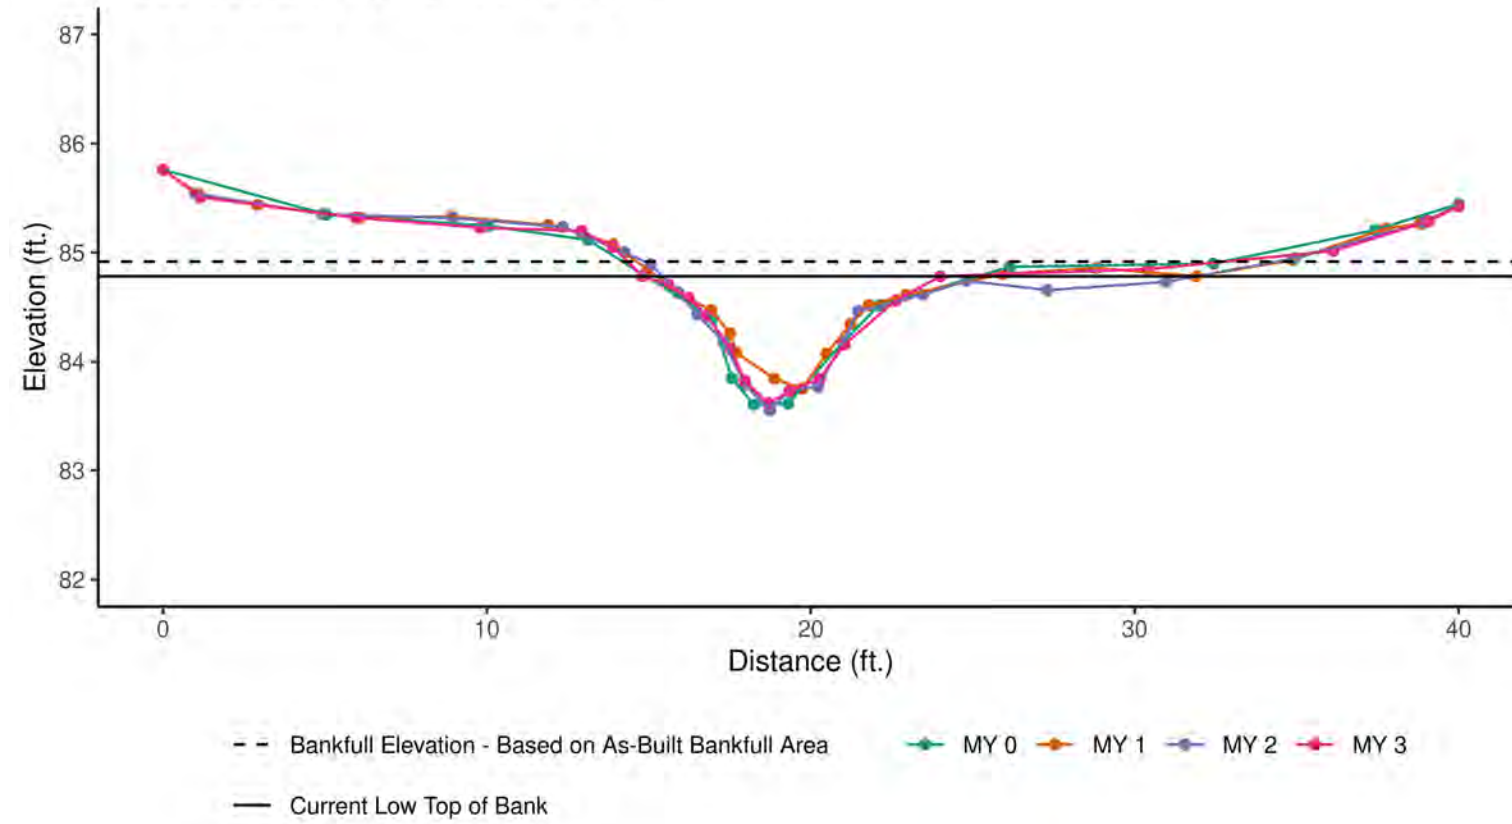
Cross-Section 9 (MS3 - Pool) MY3

MY0	MY1	MY2	MY3	MY4	MY5	MY6	MY7
Bankfull Elevation - Based on As-Built Bankfull Area	84.87	84.93	84.90	84.92				
Bank Height Ratio - Based on As-Built Bankfull Area	1.00	0.94	0.88	0.90				
Thalweg Elevation	83.60	83.75	83.55	83.62				
LTOB Elevation	84.87	84.86	84.74	84.78				
LTOB Max Depth	1.265	1.107	1.188	1.166				
LTOB Cross Sectional Area	6.09	5.12	4.63	4.85

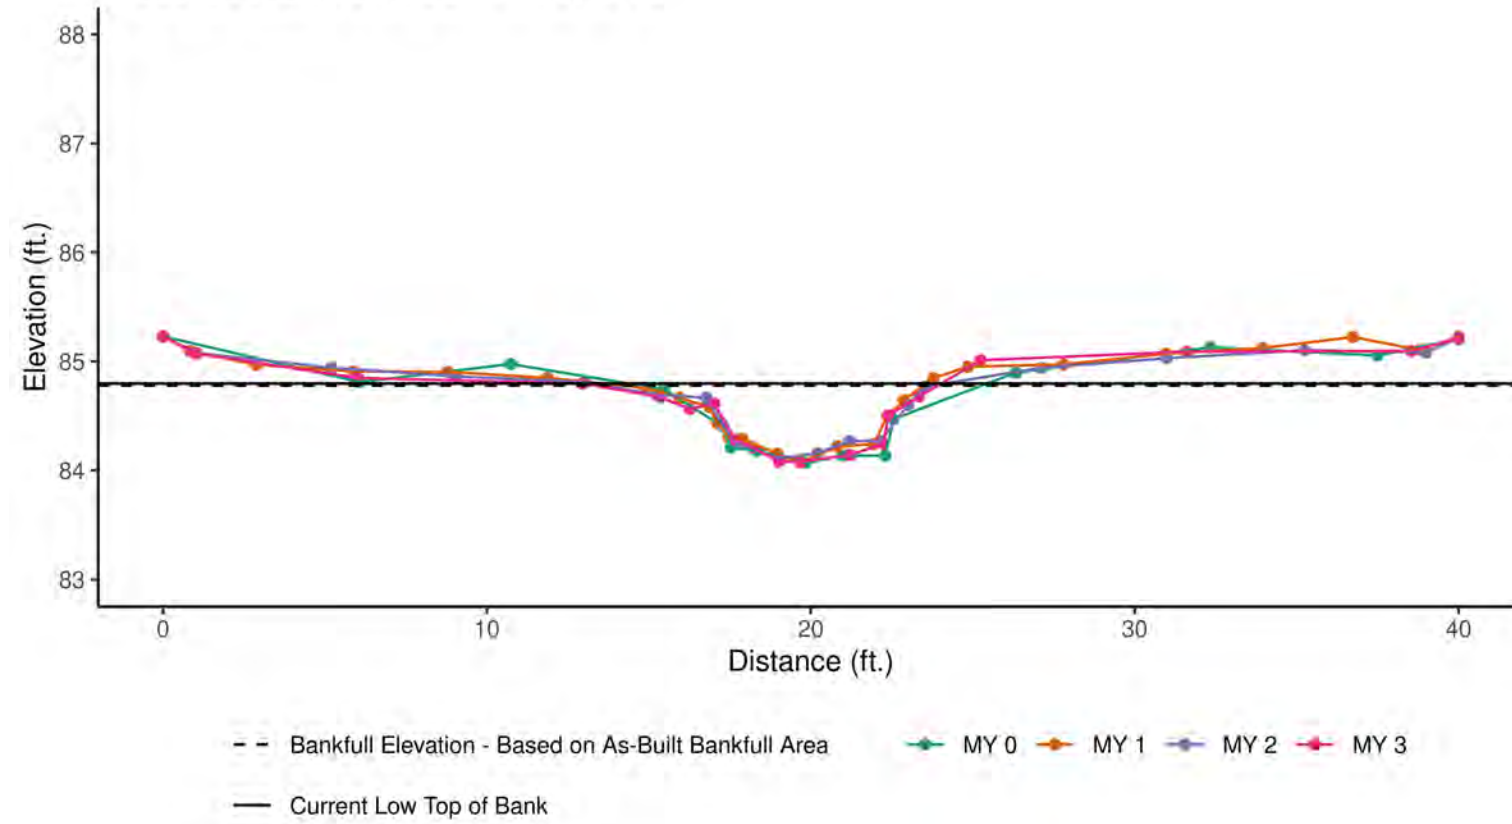
Cross-Section 10 (MS3 - Riffle) MY3

MY0	MY1	MY2	MY3	MY4	MY5	MY6	MY7
Bankfull Elevation - Based on As-Built Bankfull Area	84.74	84.83	84.81	84.78				
Bank Height Ratio - Based on As-Built Bankfull Area	1.00	0.91	0.94	1.03				
Thalweg Elevation	84.07	84.07	84.11	84.08				
LTOB Elevation	84.74	84.76	84.77	84.80				
LTOB Max Depth	0.674	0.686	0.655	0.718				
LTOB Cross Sectional Area	3.77	3.18	3.36	3.97

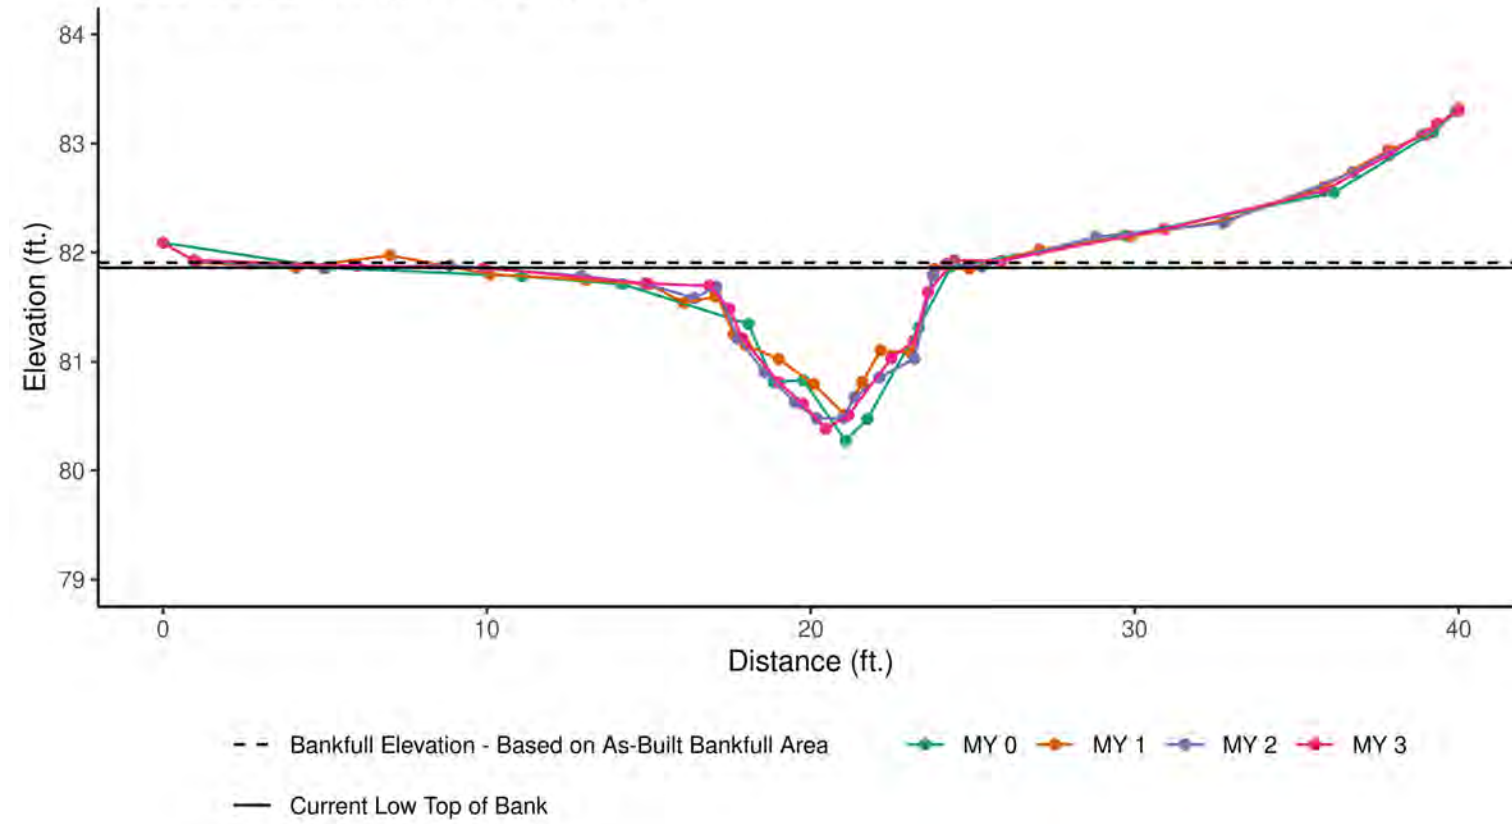
Cross-Section 11 (MS3 - Pool) MY3

MY0	MY1	MY2	MY3	MY4	MY5	MY6	MY7
Bankfull Elevation - Based on As-Built Bankfull Area	81.71	81.83	81.77	81.91				
Bank Height Ratio - Based on As-Built Bankfull Area	1.00	0.91	0.94	0.95				
Thalweg Elevation	80.27	80.51	80.48	81.03				
LTOB Elevation	81.71	81.71	81.69	81.86				
LTOB Max Depth	1.437	1.196	1.211	0.831				
LTOB Cross Sectional Area	5.88	4.84	5.37	5.23

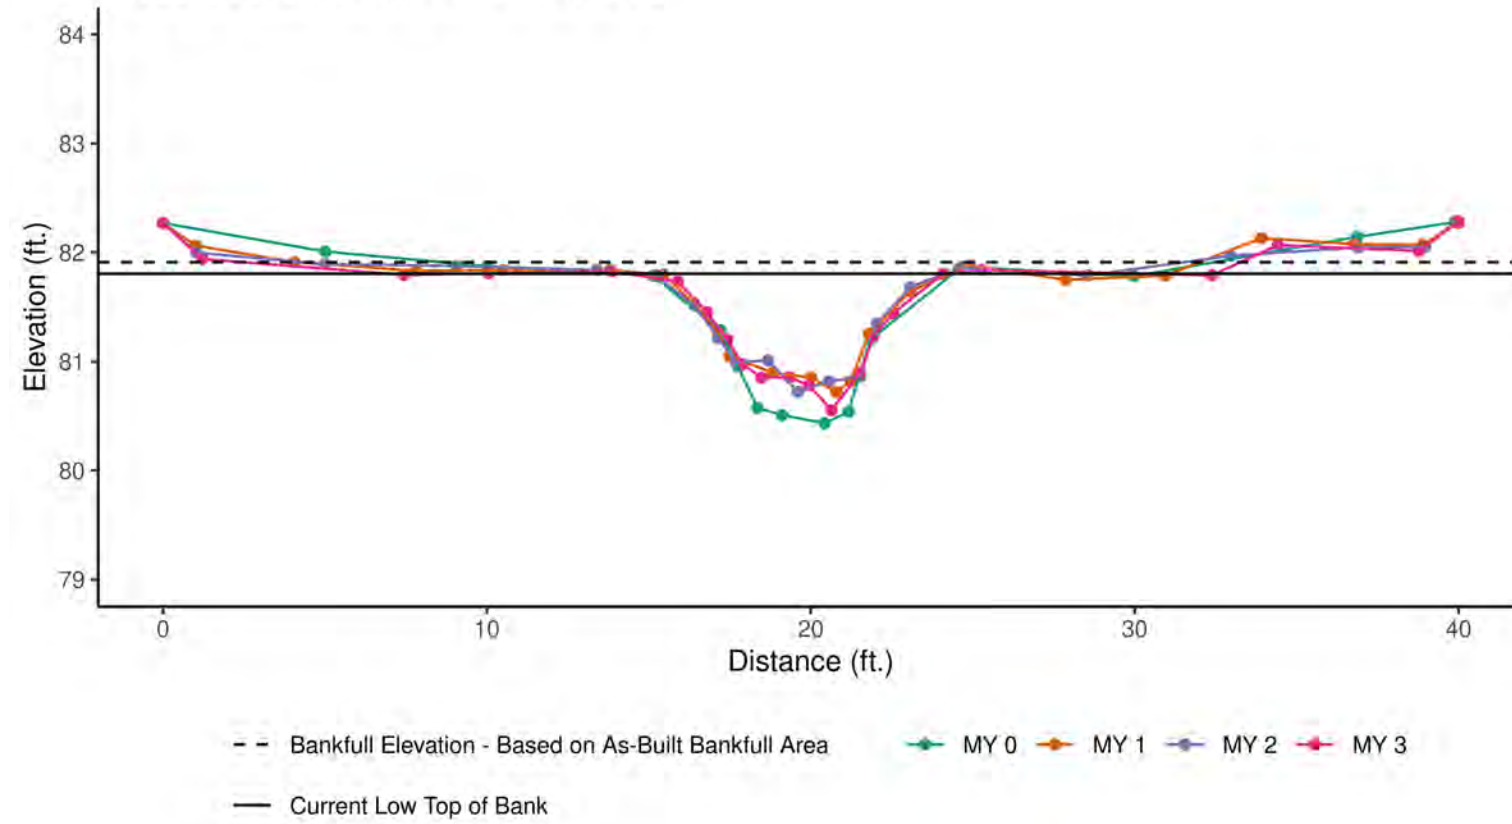
Cross-Section 12 (MS3 - Riffle) MY3

MY0	MY1	MY2	MY3	MY4	MY5	MY6	MY7
Bankfull Elevation - Based on As-Built Bankfull Area	81.79	81.93	81.95	81.91				
Bank Height Ratio - Based on As-Built Bankfull Area	1.00	0.92	0.87	0.92				
Thalweg Elevation	80.43	80.72	80.72	80.55				
LTOB Elevation	81.79	81.84	81.79	81.81				
LTOB Max Depth	1.354	1.121	1.064	1.253				
LTOB Cross Sectional Area	6.47	5.46	5.04	5.44

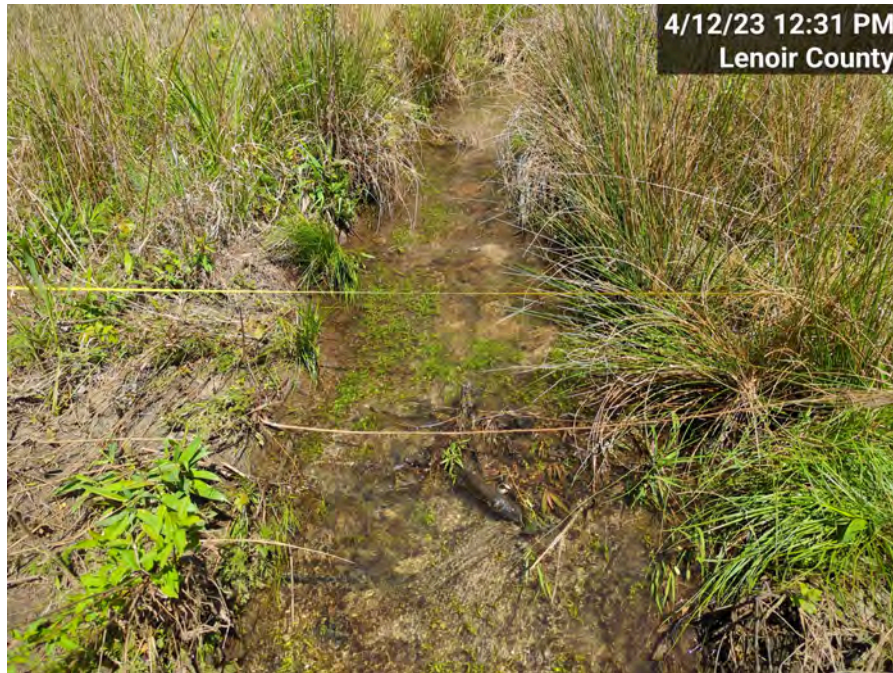
MY3 - View Upstream

MS3 - Hornpipe Branch Tributaries Mitigation Site			
Monitoring Year	MY0	MY3	
Biotic Index Score	NA*	7.72	
Water Quality Level	NA*	Poor
