Year 1 Monitoring Report FINAL

Hudson Property

DMS Project ID #: 95361

Beaufort County, North Carolina

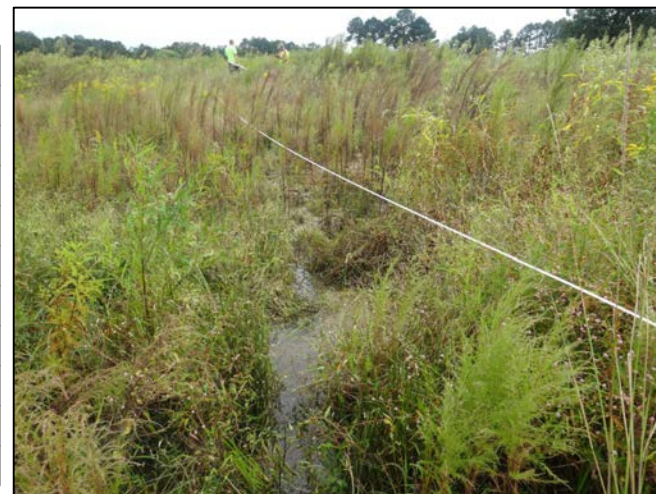
YEAR 1 MONITORING XS 1
PROJECT # 95361
BEAUFORT COUNTY, NORTH CAROLINA

SUMMARY DATA (FT)	
BANKFULL ELEVATION:	37.57
BANKFULL CROSS SECTIONAL AREA:	2.17
BANKFULL WIDTH:	10.63
FLOOD PRONE AREA ELEVATION:	38.16
FLOOD PRONE WIDTH:	24.55
MAX DEPTH AT BANKFULL:	0.52
MEAN DEPTH AT BANKFULL:	0.20
W/D RATIO:	NA
ENTRENCHMENT RATIO:	NA
BANK HEIGHT RATIO:	1

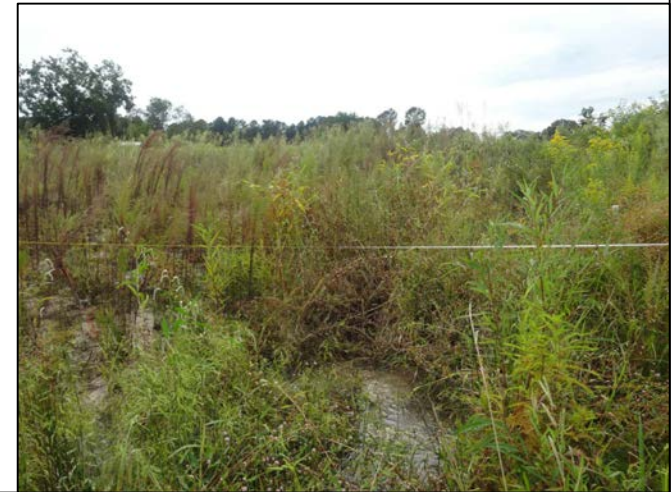
YEAR 1 MONITORING XS 2

SUMMARY DATA (FT)	
BANKFULL ELEVATION:	36.40
BANKFULL CROSS SECTIONAL AREA:	16.24
BANKFULL WIDTH:	14.44
FLOOD PRONE AREA ELEVATION:	37.35
FLOOD PRONE WIDTH:	36.68
MAX DEPTH AT BANKFULL:	0.96
MEAN DEPTH AT BANKFULL:	0.48
W/D RATIO:	69.34
ENTRENCHMENT RATIO:	2.53
BANK HEIGHT RATIO:	1

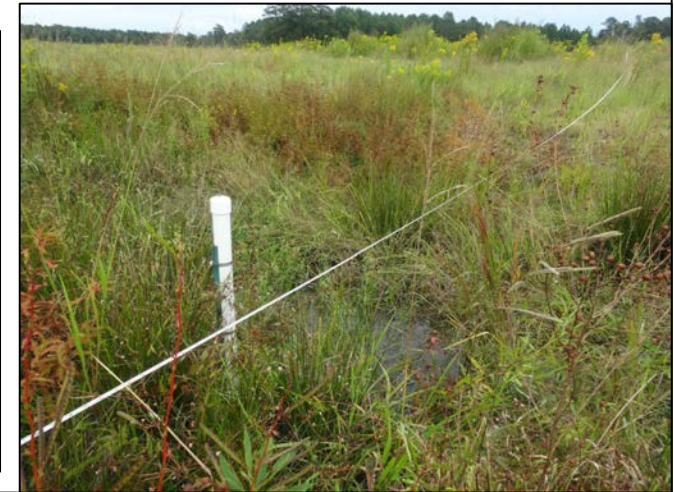
YEAR 1 MONITORING XS 3
PROJECT # 95361
BEAUFORT COUNTY, NORTH CAROLINA

SUMMARY DATA (FT)	
BANKFULL ELEVATION:	34.50
BANKFULL CROSS SECTIONAL AREA:	4.31
BANKFULL WIDTH:	8.27
FLOOD PRONE AREA ELEVATION:	36.14
FLOOD PRONE WIDTH:	57.96
MAX DEPTH AT BANKFULL:	1.62
MEAN DEPTH AT BANKFULL:	0.52
W/D RATIO:	15.86
ENTRENCHMENT RATIO:	7.01
BANK HEIGHT RATIO:	1

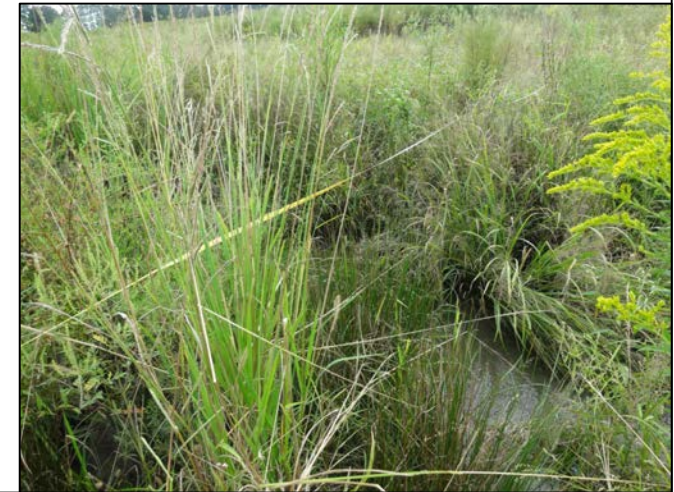
YEAR 1 MONITORING XS 4
PROJECT # 95361
BEAUFORT COUNTY, NORTH CAROLINA

SUMMARY DATA (FT)	
BANKFULL ELEVATION:	33.60
BANKFULL CROSS SECTIONAL AREA:	2.36
BANKFULL WIDTH:	7.03
FLOOD PRONE AREA ELEVATION:	34.28
FLOOD PRONE WIDTH:	30.15
MAX DEPTH AT BANKFULL:	0.68
MEAN DEPTH AT BANKFULL:	0.34
W/D RATIO:	NA
ENTRENCHMENT RATIO:	NA
BANK HEIGHT RATIO:	1

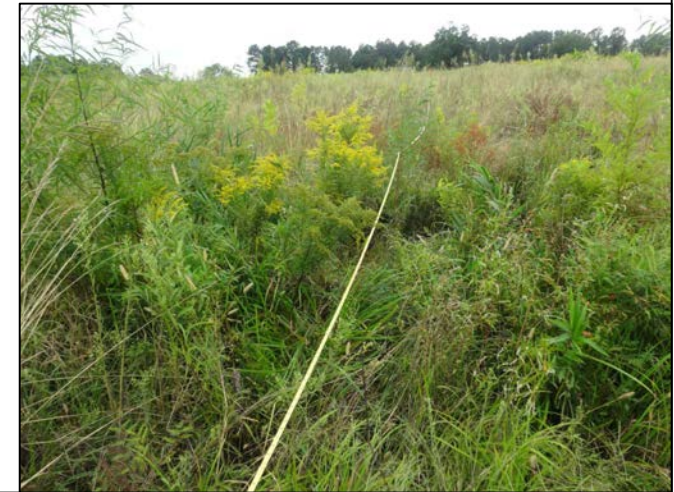
YEAR 1 MONITORING XS 5

SUMMARY DATA (FT)	
BANKFULL ELEVATION:	35.46
BANKFULL CROSS SECTIONAL AREA:	2.83
BANKFULL WIDTH:	7.58
FLOOD PRONE AREA ELEVATION:	36.15
FLOOD PRONE WIDTH:	24.33
MAX DEPTH AT BANKFULL:	0.69
MEAN DEPTH AT BANKFULL:	0.37
W/D RATIO:	NA
ENTRENCHMENT RATIO:	NA
BANK HEIGHT RATIO:	1

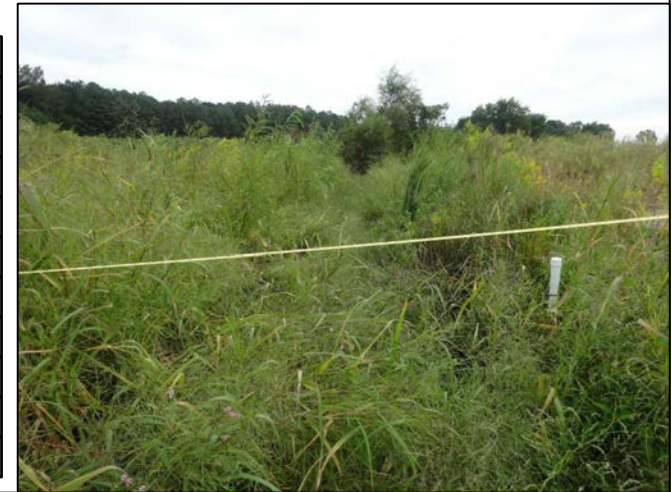
YEAR 1 MONITORING XS 6
PROJECT # 95361
BEAUFORT COUNTY, NORTH CAROLINA

SUMMARY DATA (FT)	
BANKFULL ELEVATION:	36.78
BANKFULL CROSS SECTIONAL AREA:	1.39
BANKFULL WIDTH:	12.51
FLOOD PRONE AREA ELEVATION:	37.13
FLOOD PRONE WIDTH:	25.00
MAX DEPTH AT BANKFULL:	0.21
MEAN DEPTH AT BANKFULL:	0.11
W/D RATIO:	112.26
ENTRENCHMENT RATIO:	2.00
BANK HEIGHT RATIO:	1

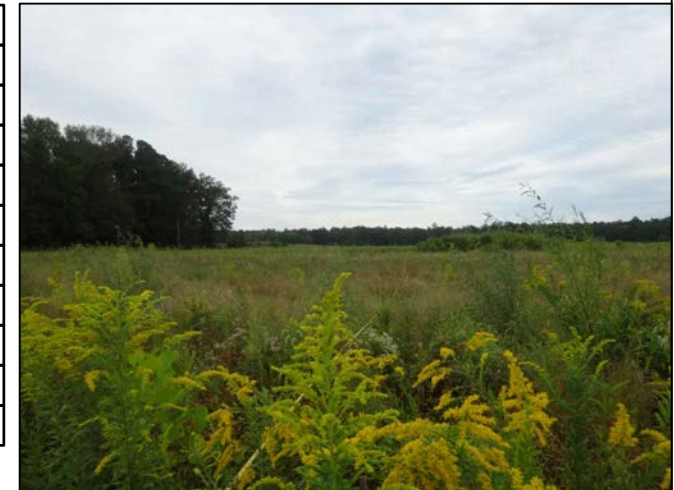
YEAR 1 MONITORING XS 7

SUMMARY DATA (FT)	
BANKFULL ELEVATION:	36.56
BANKFULL CROSS SECTIONAL AREA:	2.47
BANKFULL WIDTH:	6.81
FLOOD PRONE AREA ELEVATION:	37.21
FLOOD PRONE WIDTH:	71.00
MAX DEPTH AT BANKFULL:	0.69
MEAN DEPTH AT BANKFULL:	0.36
W/D RATIO:	NA
ENTRENCHMENT RATIO:	NA
BANK HEIGHT RATIO:	1

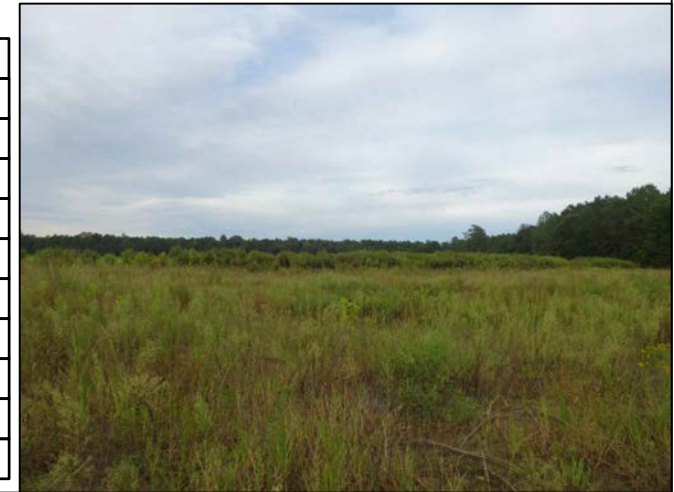
YEAR 1 MONITORING XS 8
PROJECT # 95361
BEAUFORT COUNTY, NORTH CAROLINA

SUMMARY DATA (FT)	
BANKFULL ELEVATION:	37.91
BANKFULL CROSS SECTIONAL AREA:	4.77
BANKFULL WIDTH:	20.00
FLOOD PRONE AREA ELEVATION:	38.41
FLOOD PRONE WIDTH:	86.26
MAX DEPTH AT BANKFULL:	0.50
MEAN DEPTH AT BANKFULL:	0.24
W/D RATIO:	83.95
ENTRENCHMENT RATIO:	4.31
BANK HEIGHT RATIO:	1

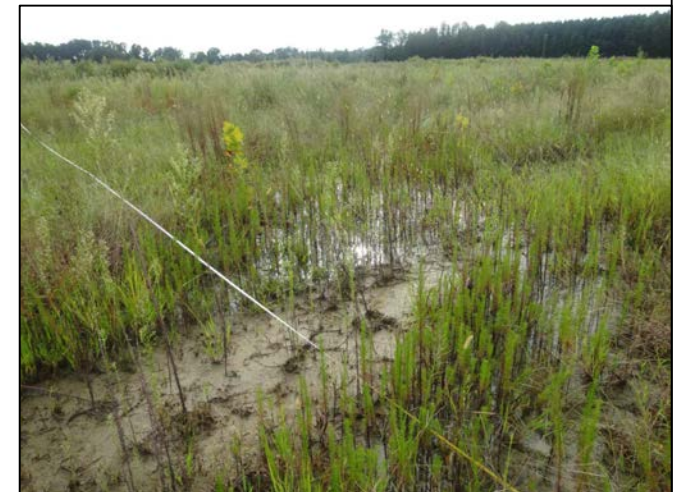
YEAR 1 MONITORING XS 9
PROJECT # 95361
BEAUFORT COUNTY, NORTH CAROLINA

SUMMARY DATA (FT)	
BANKFULL ELEVATION:	39.00
BANKFULL CROSS SECTIONAL AREA:	2.21
BANKFULL WIDTH:	8.61
FLOOD PRONE AREA ELEVATION:	39.68
FLOOD PRONE WIDTH:	49.57
MAX DEPTH AT BANKFULL:	0.68
MEAN DEPTH AT BANKFULL:	0.26
W/D RATIO:	NA
ENTRENCHMENT RATIO:	NA
BANK HEIGHT RATIO:	1

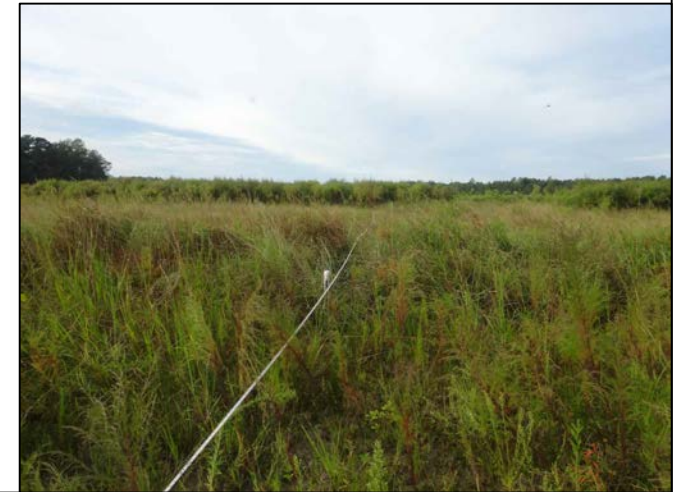
YEAR 1 MONITORING XS 10
PROJECT # 95361
BEAUFORT COUNTY, NORTH CAROLINA

SUMMARY DATA (FT)	
BANKFULL ELEVATION:	40.26
BANKFULL CROSS SECTIONAL AREA:	3.25
BANKFULL WIDTH:	11.46
FLOOD PRONE AREA ELEVATION:	40.72
FLOOD PRONE WIDTH:	58.28
MAX DEPTH AT BANKFULL:	0.49
MEAN DEPTH AT BANKFULL:	0.28
W/D RATIO:	40.49
ENTRENCHMENT RATIO:	5.08
BANK HEIGHT RATIO:	1

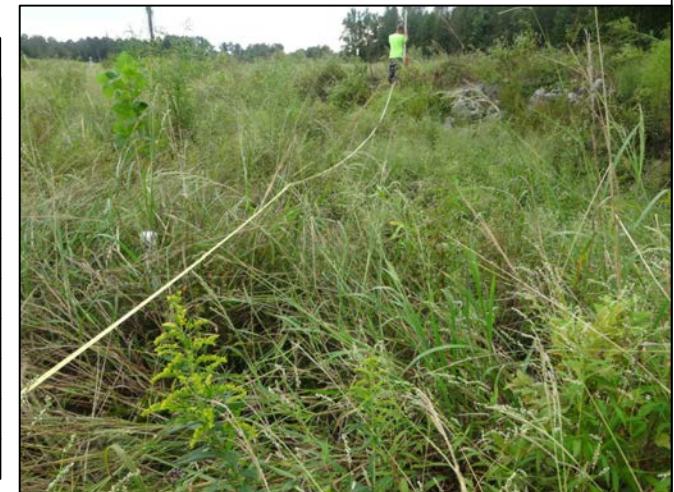
YEAR 1 MONITORING XS 11

SUMMARY DATA (FT)	
BANKFULL ELEVATION:	33.42
BANKFULL CROSS SECTIONAL AREA:	22.13
BANKFULL WIDTH:	31.88
FLOOD PRONE AREA ELEVATION:	34.94
FLOOD PRONE WIDTH:	59.59
MAX DEPTH AT BANKFULL:	1.51
MEAN DEPTH AT BANKFULL:	0.69
W/D RATIO:	NA
ENTRENCHMENT RATIO:	NA
BANK HEIGHT RATIO:	1

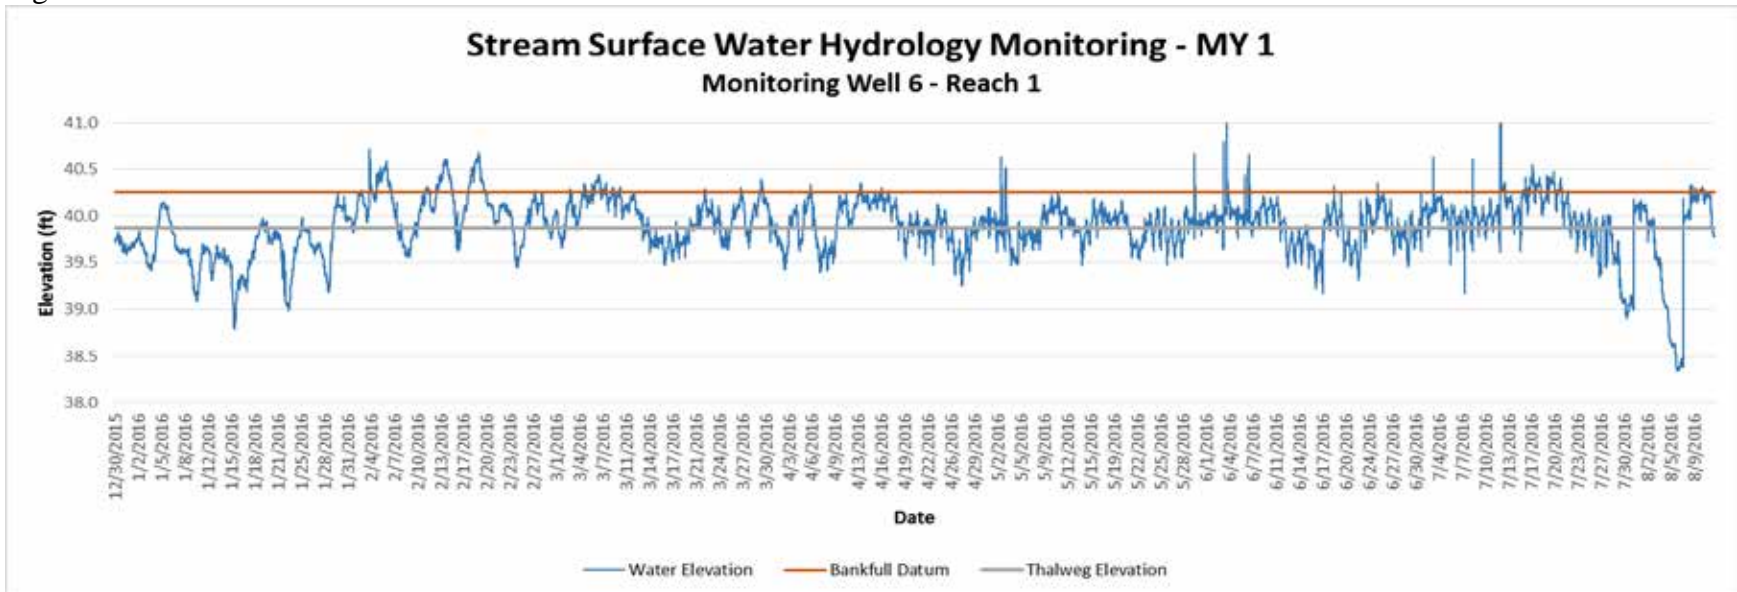
Figure 8

Well (Reach)	Dates of Occurrence	30 Consecutive Days Minimum Flow Requirement Met?	Notes
1 (Reach 3)	1/29/16 - 4/2/16	Y	
2 (Reach 3)	1/29/16 – 4/27/16	Y	
3 (Reach 4)	12/30/15 – 8/11/16	Y	
4 (Confluence R1&4)	1/29/16 – 5/27/16	Y	
5 (Reach 1)	1/29/16 - 4/19/16	Y	
6 (Reach 1)	2/16/16 - 3/14/16	N	Head of Reach 1
7 (Reach 2)	1/29/16 - 3/14/16	Y	
8 (Reach 5)	12/30/15 – 6/15/16	Y	
9 (Reach 5)	12/30/15 – 8/11/16	Y	
10 (Reach 5)	12/30/15 – 8/11/16	Y
