Year 2 Monitoring Report Final

Hudson Property

DMS Project ID #: 95361

Beaufort County, North Carolina

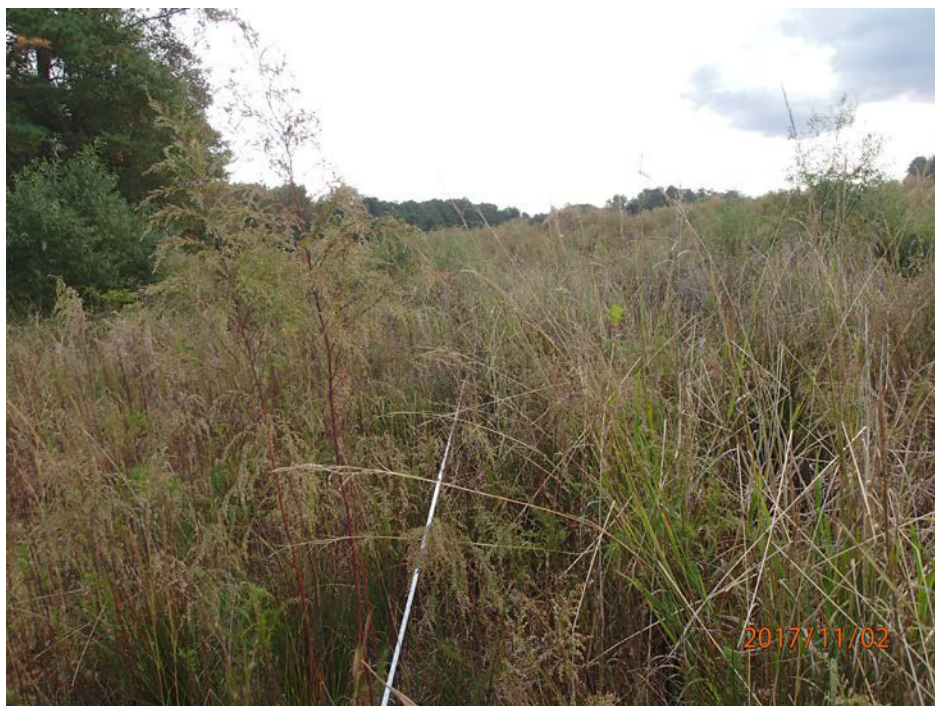
Photo 2: View Upstream on Reach 3

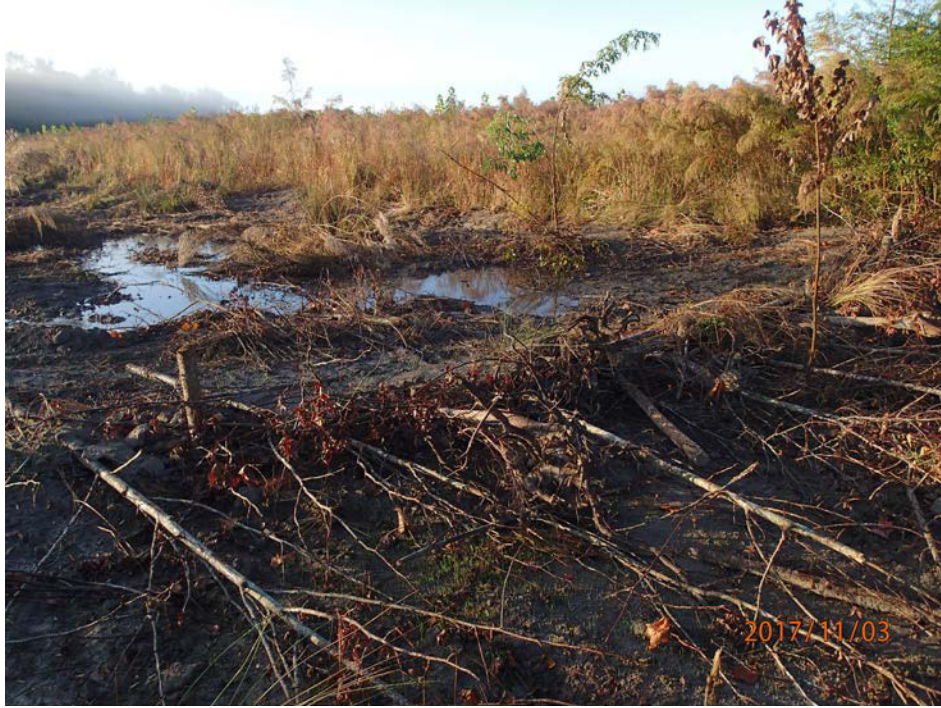
Photo 3: View of Reach 5 upstream

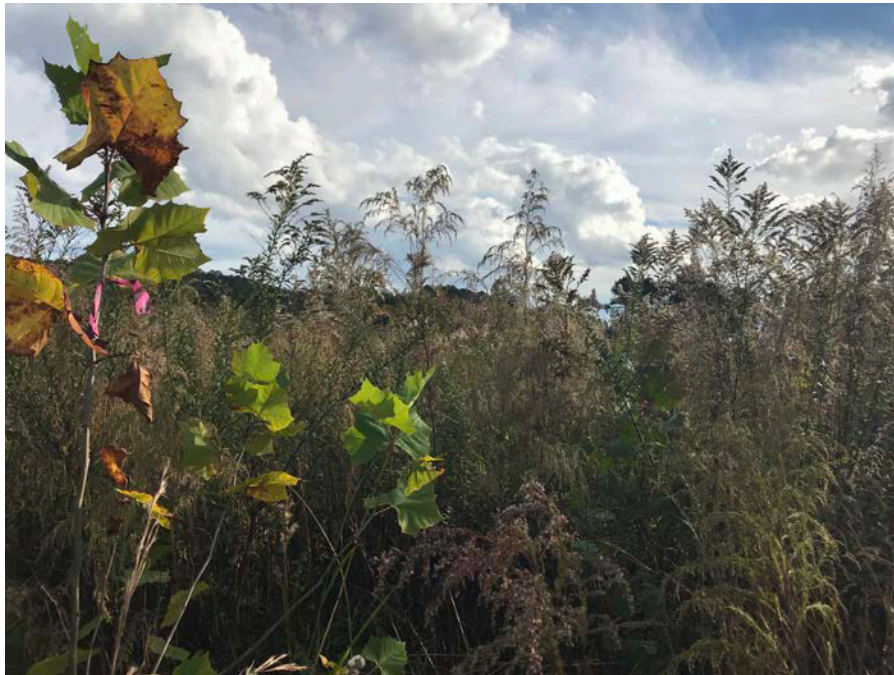
Photo 4: View of vegetation plot

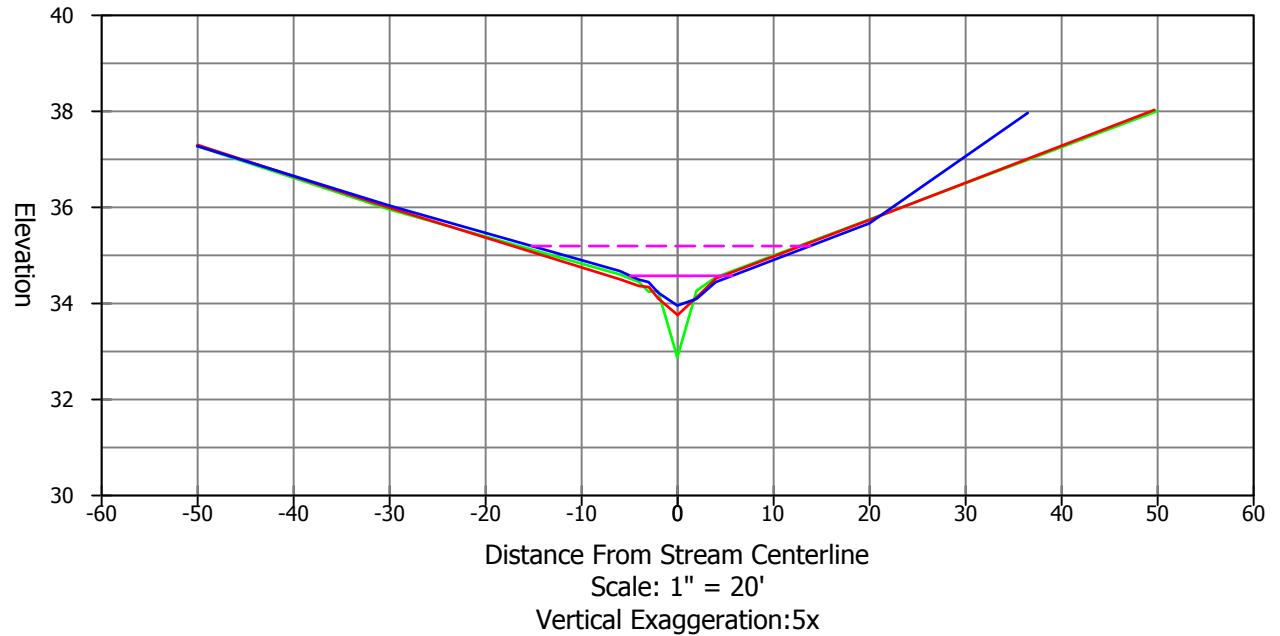
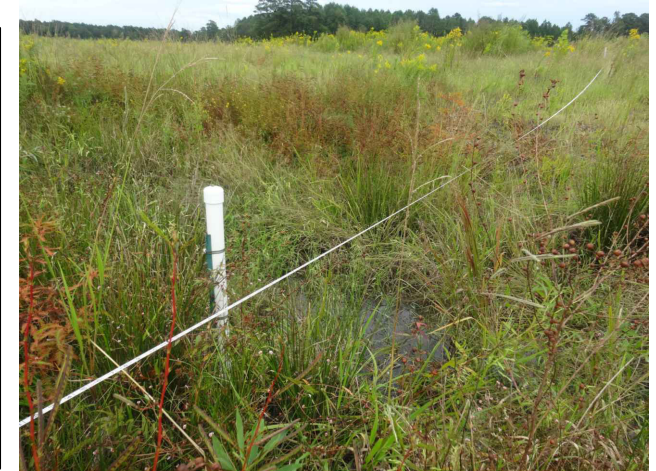
Monitoring XS 3 (Riffle) - REACH 4 STA 0+24

SUMMARY DATA (FT)	
BANKFULL ELEVATION:	34.58
BANKFULL CROSS SECTIONAL AREA:	3.17
BANKFULL WIDTH:	10.59
FLOOD PRONE AREA ELEVATION:	35.18
FLOOD PRONE WIDTH:	29.01
MAX DEPTH AT BANKFULL:	0.62
MEAN DEPTH AT BANKFULL:	0.30
W/D RATIO:	35.39
ENTRENCHMENT RATIO:	5.47
BANK HEIGHT RATIO:	1

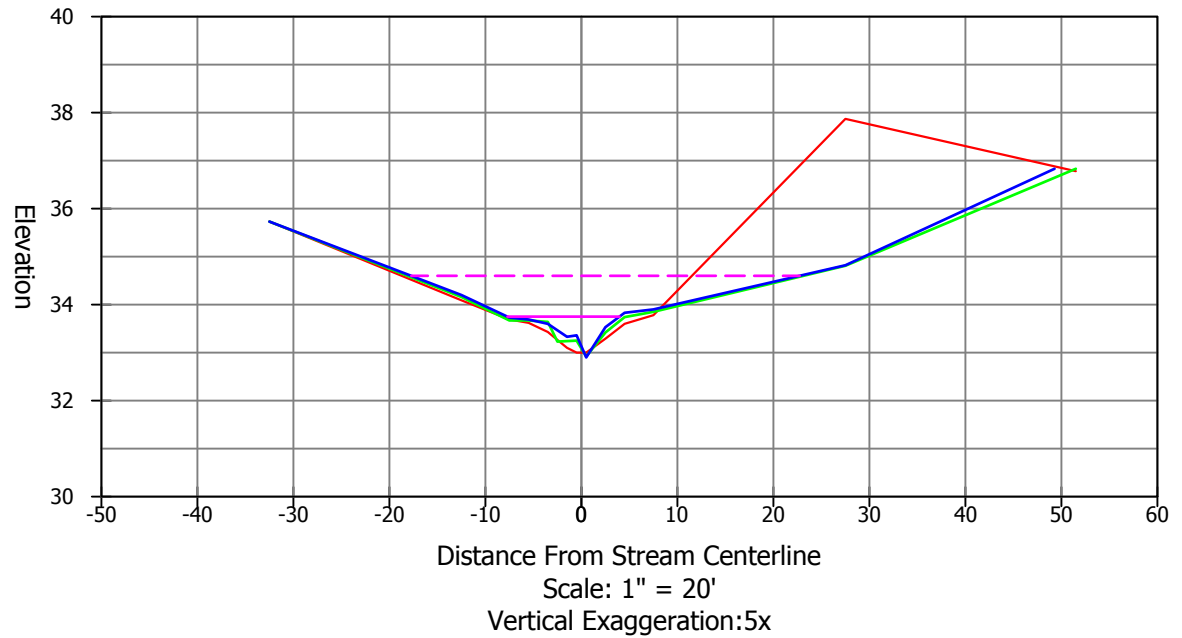
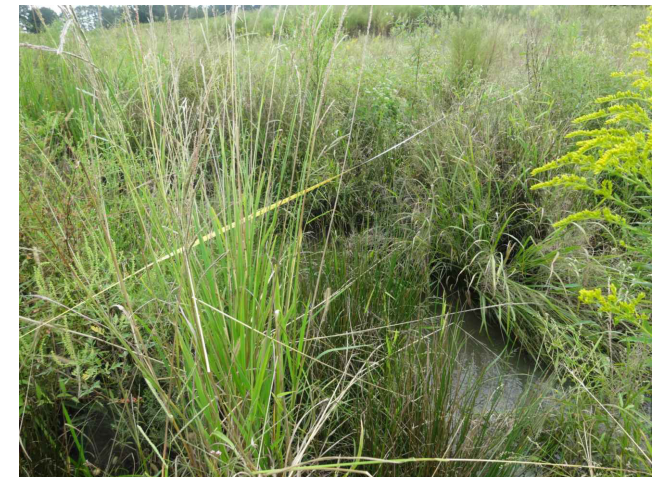
Monitoring XS 4 (Pool) - REACH 4 STA 2+69

SUMMARY DATA (FT)	
BANKFULL ELEVATION:	33.75
BANKFULL CROSS SECTIONAL AREA:	3.19
BANKFULL WIDTH:	11.61
FLOOD PRONE AREA ELEVATION:	34.6
FLOOD PRONE WIDTH:	40.4
MAX DEPTH AT BANKFULL:	0.85
MEAN DEPTH AT BANKFULL:	0.27
W/D RATIO:	NA
ENTRENCHMENT RATIO:	NA
BANK HEIGHT RATIO:	0.99

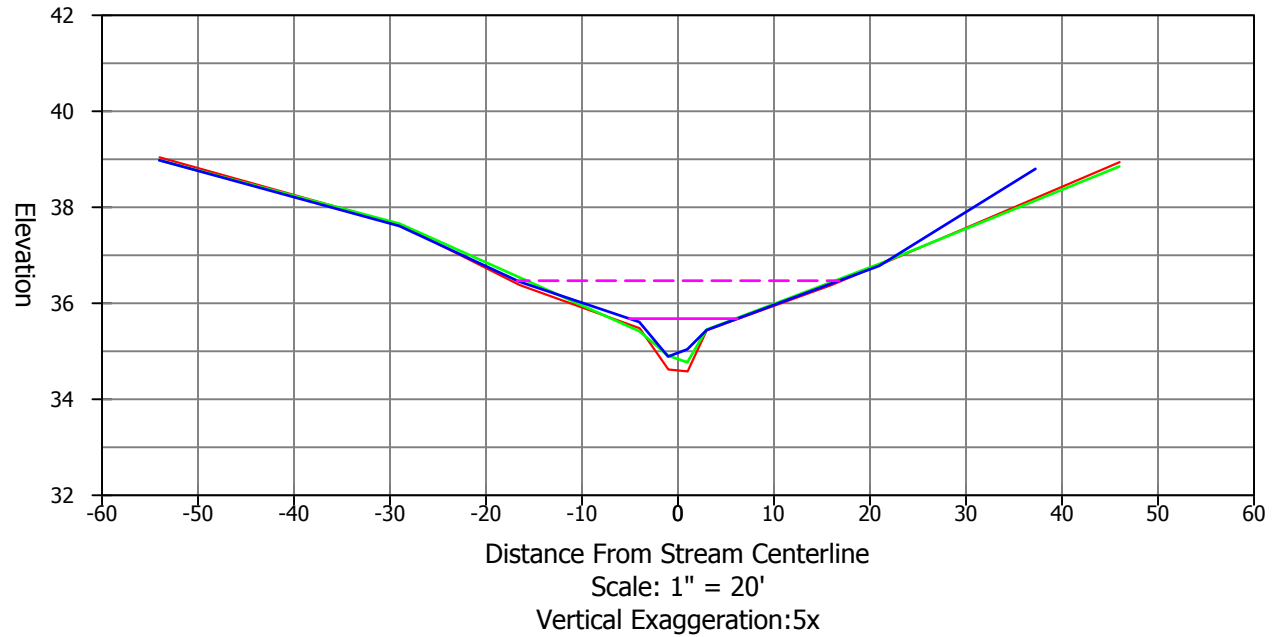
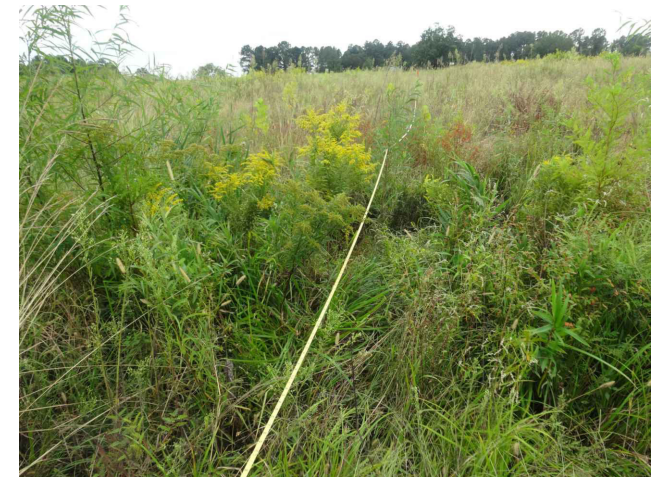
Monitoring XS 5 (Pool) - REACH 2 STA 3+95

SUMMARY DATA (FT)	
BANKFULL ELEVATION:	35.68
BANKFULL CROSS SECTIONAL AREA:	4.00
BANKFULL WIDTH:	11.04
FLOOD PRONE AREA ELEVATION:	36.38
FLOOD PRONE WIDTH:	33.5
MAX DEPTH AT BANKFULL:	0.79
MEAN DEPTH AT BANKFULL:	0.36
W/D RATIO:	NA
ENTRENCHMENT RATIO:	NA
BANK HEIGHT RATIO:	1

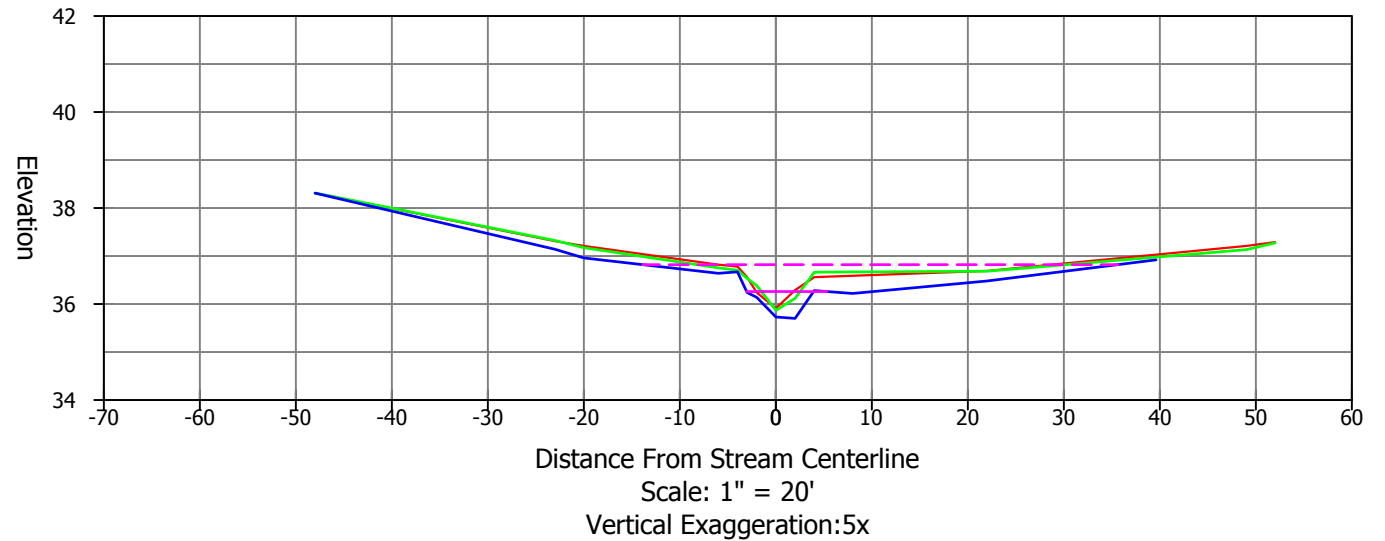
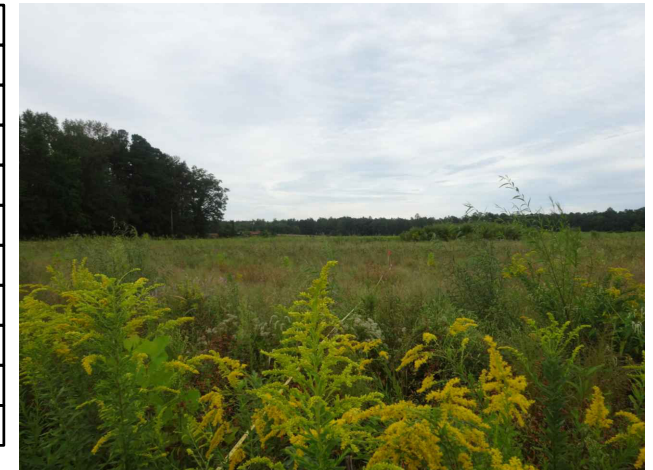
Monitoring XS 7 (Pool) - REACH 1 STA 6+47

SUMMARY DATA (FT)	
BANKFULL ELEVATION:	36.26
BANKFULL CROSS SECTIONAL AREA:	2.37
BANKFULL WIDTH:	6.99
FLOOD PRONE AREA ELEVATION:	36.82
FLOOD PRONE WIDTH:	49.4
MAX DEPTH AT BANKFULL:	0.56
MEAN DEPTH AT BANKFULL:	0.34
W/D RATIO:	NA
ENTRENCHMENT RATIO:	NA
BANK HEIGHT RATIO:	0.99

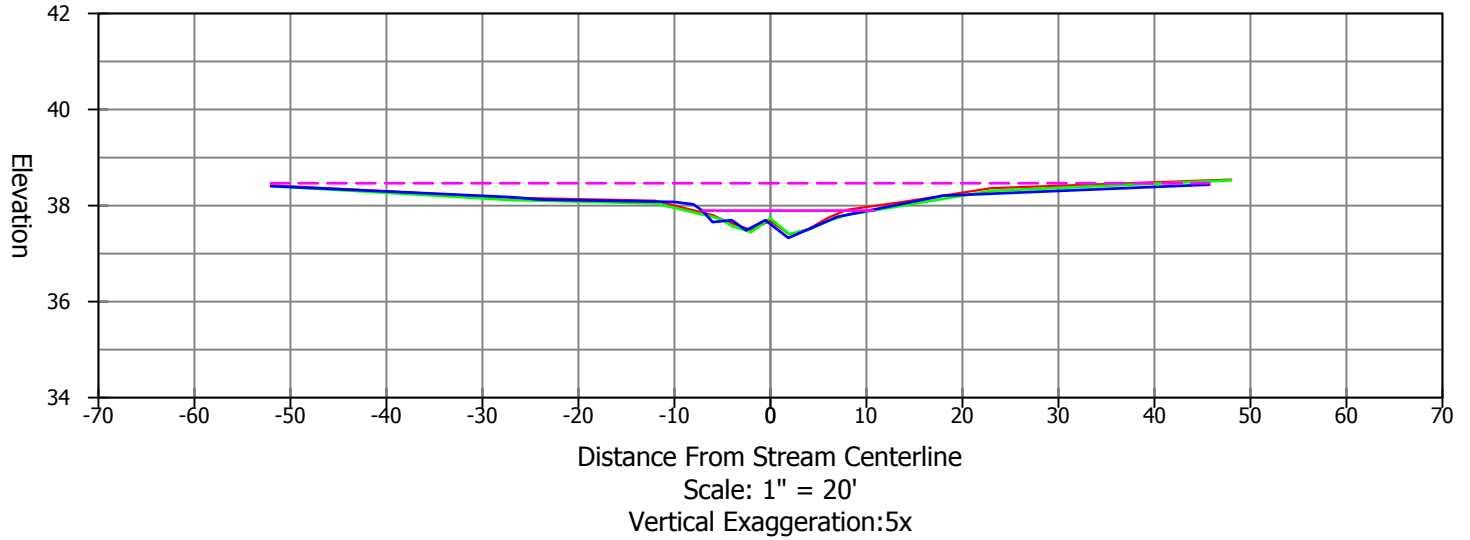
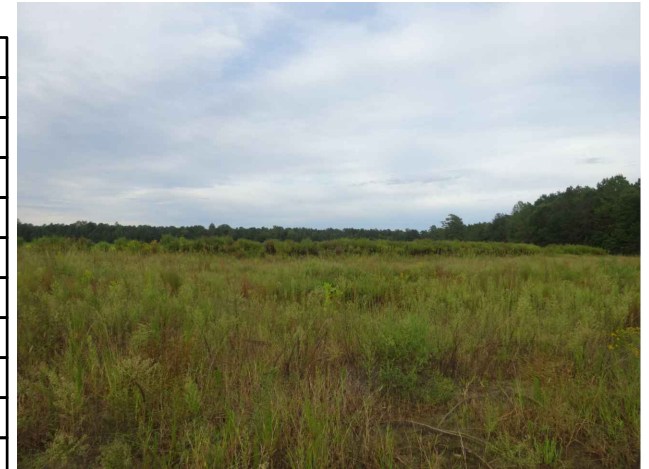
Monitoring XS 8 (Riffle) - REACH 1 STA 4+43

SUMMARY DATA (FT)	
BANKFULL ELEVATION:	37.9
BANKFULL CROSS SECTIONAL AREA:	4.26
BANKFULL WIDTH:	16.10
FLOOD PRONE AREA ELEVATION:	38.46
FLOOD PRONE WIDTH:	97.7
MAX DEPTH AT BANKFULL:	0.57
MEAN DEPTH AT BANKFULL:	0.26
W/D RATIO:	60.83
ENTRENCHMENT RATIO:	5.36
BANK HEIGHT RATIO:	0.88

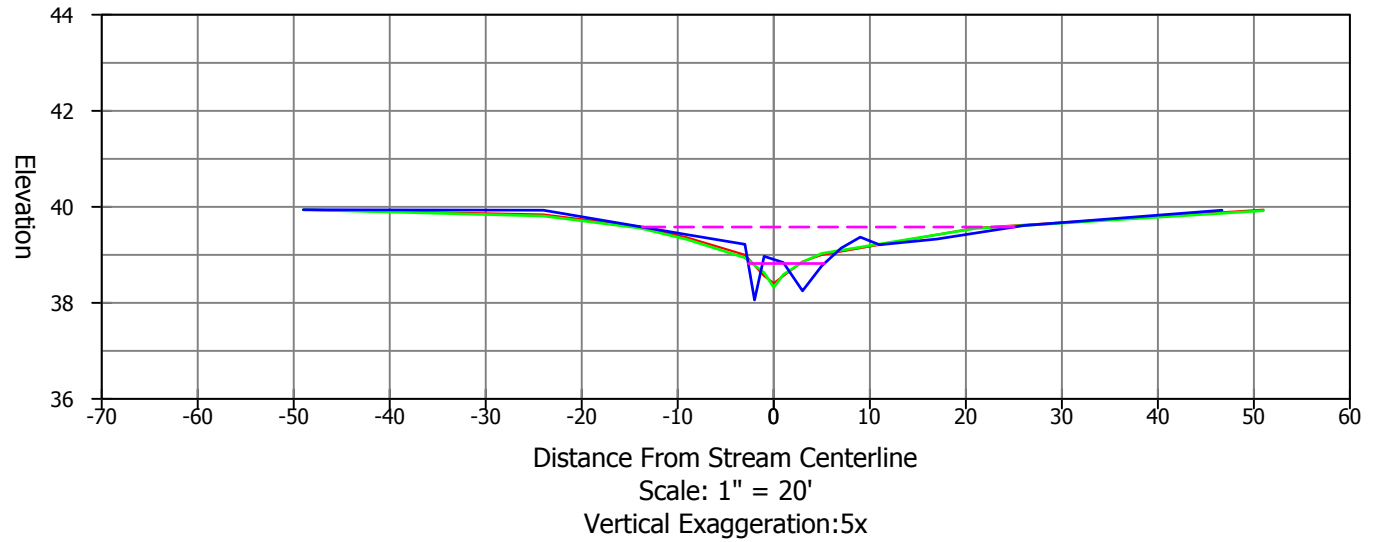
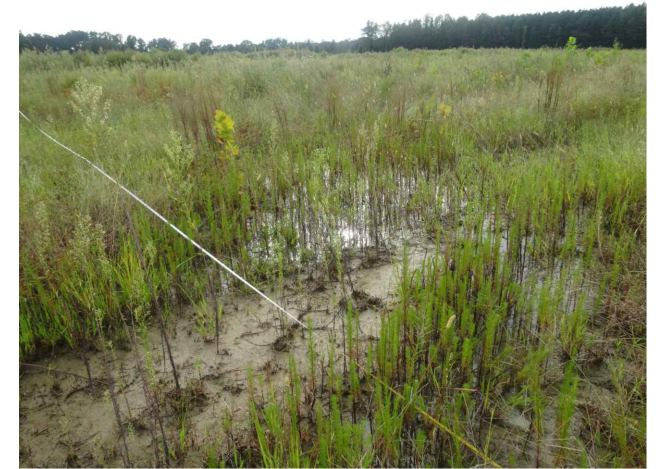
Monitoring XS 9 (Pool) - REACH 1 STA 2+73

SUMMARY DATA (FT)	
BANKFULL ELEVATION:	39.00
BANKFULL CROSS SECTIONAL AREA:	2.19
BANKFULL WIDTH:	7.30
FLOOD PRONE AREA ELEVATION:	39.58
FLOOD PRONE WIDTH:	38.7
MAX DEPTH AT BANKFULL:	0.76
MEAN DEPTH AT BANKFULL:	0.30
W/D RATIO:	NA
ENTRENCHMENT RATIO:	NA
BANK HEIGHT RATIO:	1.01

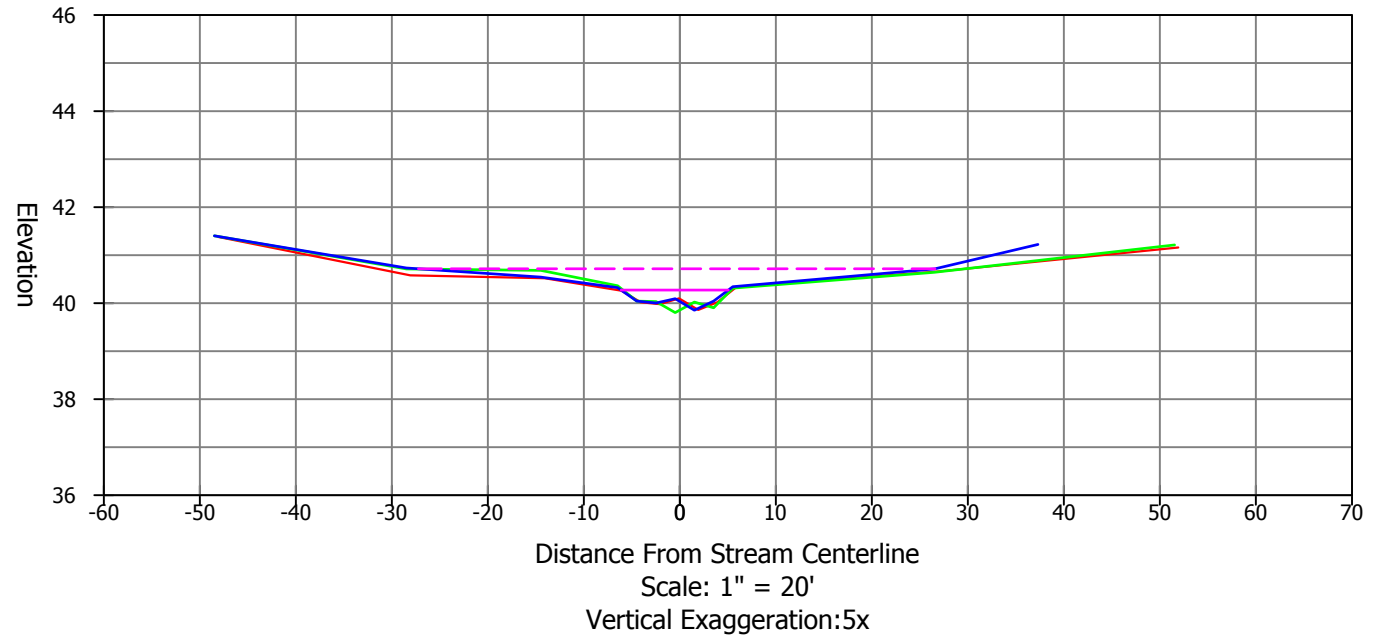
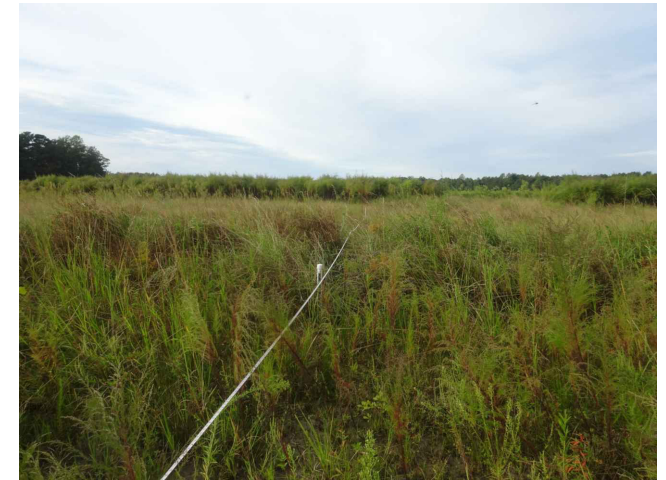
Monitoring XS 10 (Riffle) - REACH 1 STA 0+64

SUMMARY DATA (FT)	
BANKFULL ELEVATION:	40.24
BANKFULL CROSS SECTIONAL AREA:	2.58
BANKFULL WIDTH:	11.19
FLOOD PRONE AREA ELEVATION:	40.7
FLOOD PRONE WIDTH:	53.8
MAX DEPTH AT BANKFULL:	0.42
MEAN DEPTH AT BANKFULL:	0.23
W/D RATIO:	48.60
ENTRENCHMENT RATIO:	5.21
BANK HEIGHT RATIO:	1.12

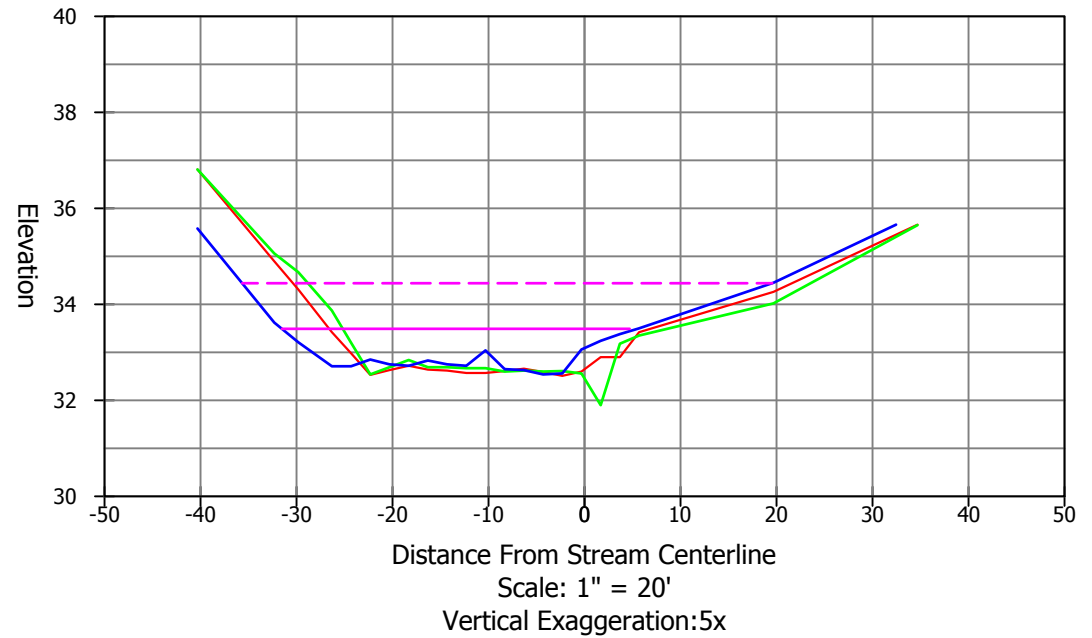
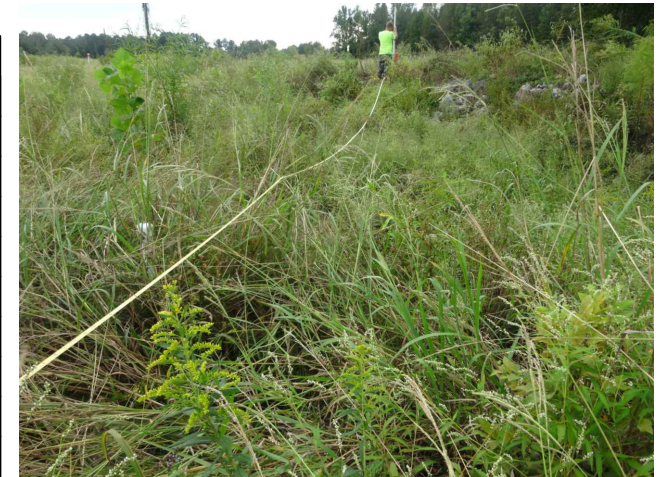
Monitoring XS 11 REACH 1 STA 8+14 & Reach 4 (Station 4+28)

SUMMARY DATA (FT)	
BANKFULL ELEVATION:	33.49
BANKFULL CROSS SECTIONAL AREA:	22.54
BANKFULL WIDTH:	36.94
FLOOD PRONE AREA ELEVATION:	34.44
FLOOD PRONE WIDTH:	55.1
MAX DEPTH AT BANKFULL:	0.95
MEAN DEPTH AT BANKFULL:	0.61
W/D RATIO:	NA
ENTRENCHMENT RATIO:	NA
BANK HEIGHT RATIO:	1
