Year 3 Monitoring Report FINAL

Hudson Property

DMS Project ID #: 95361

Beaufort County, North Carolina

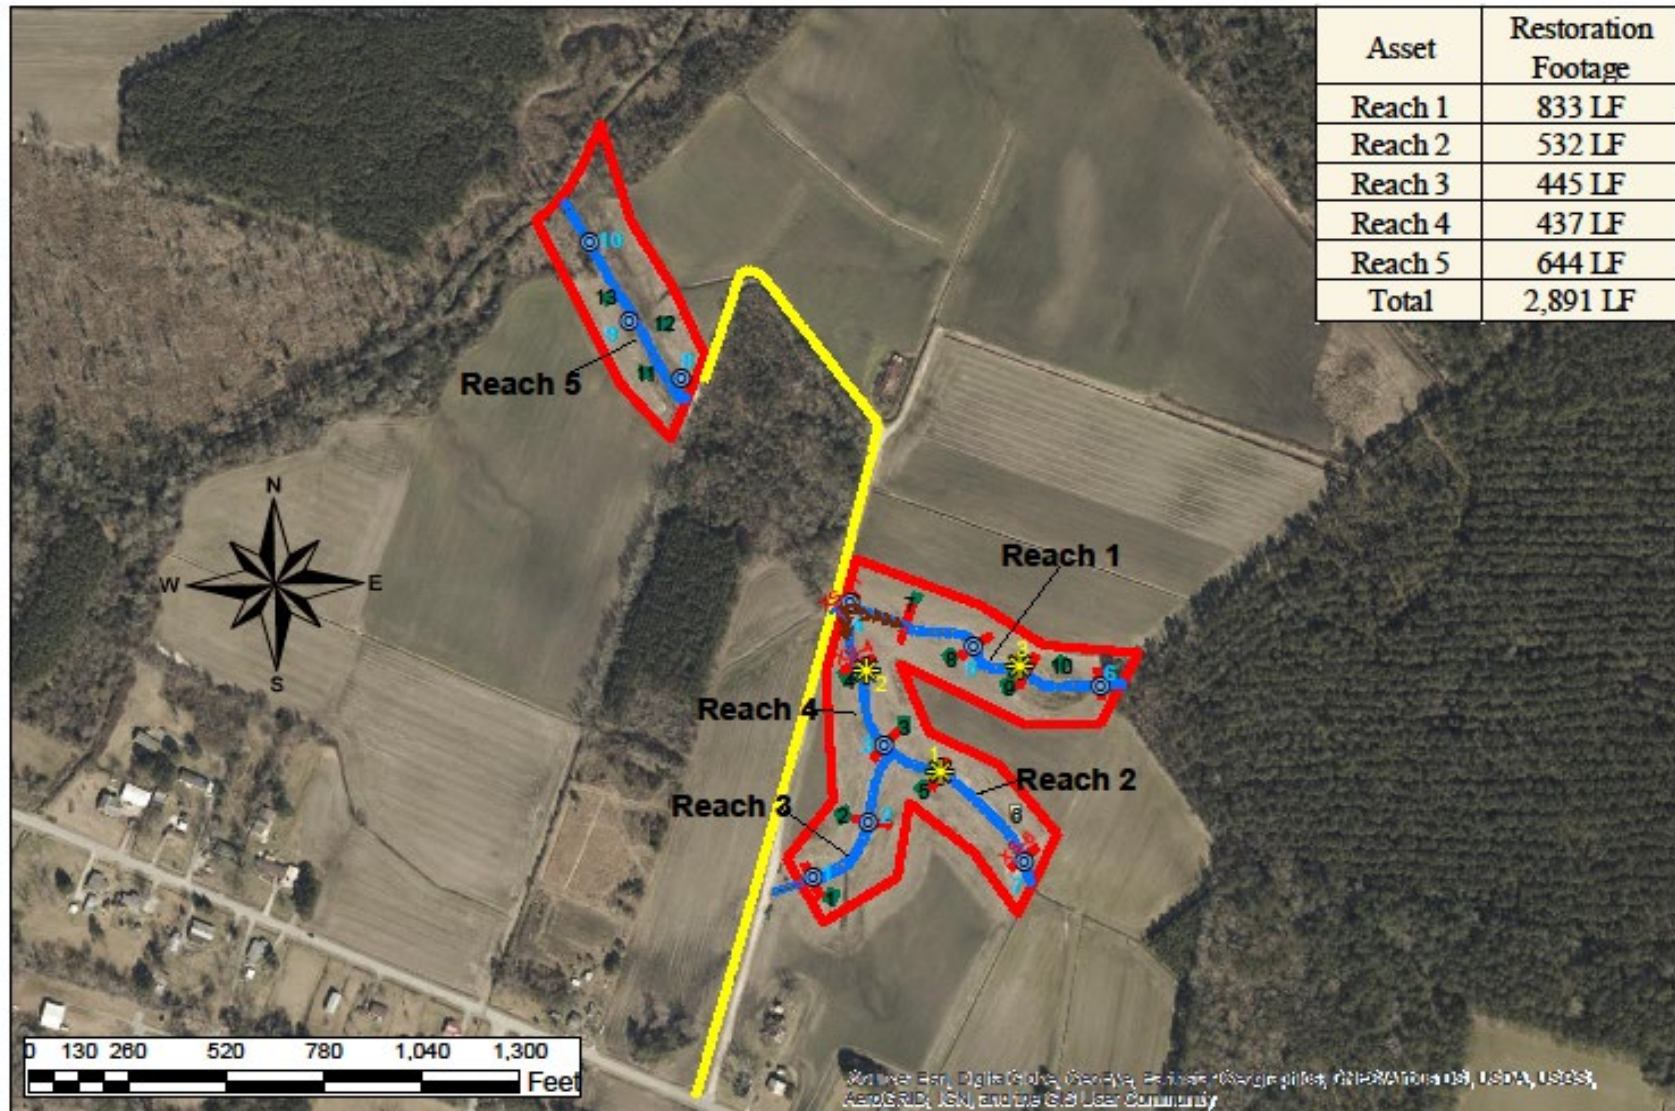
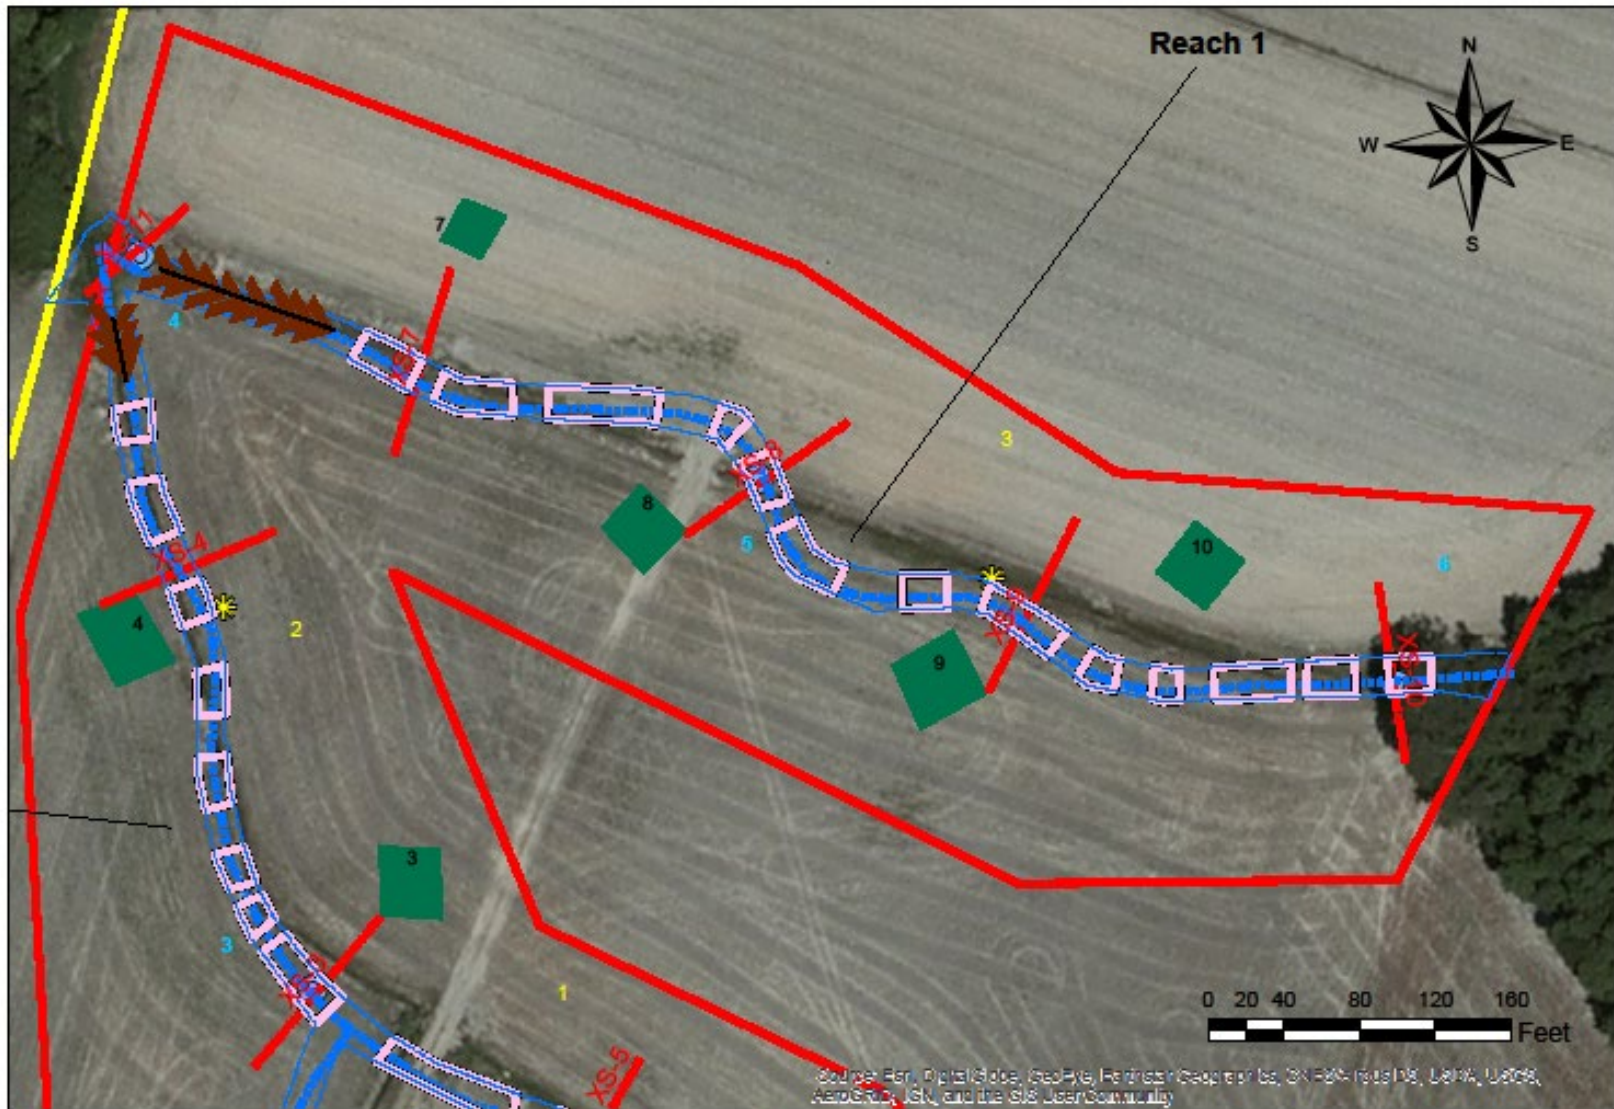
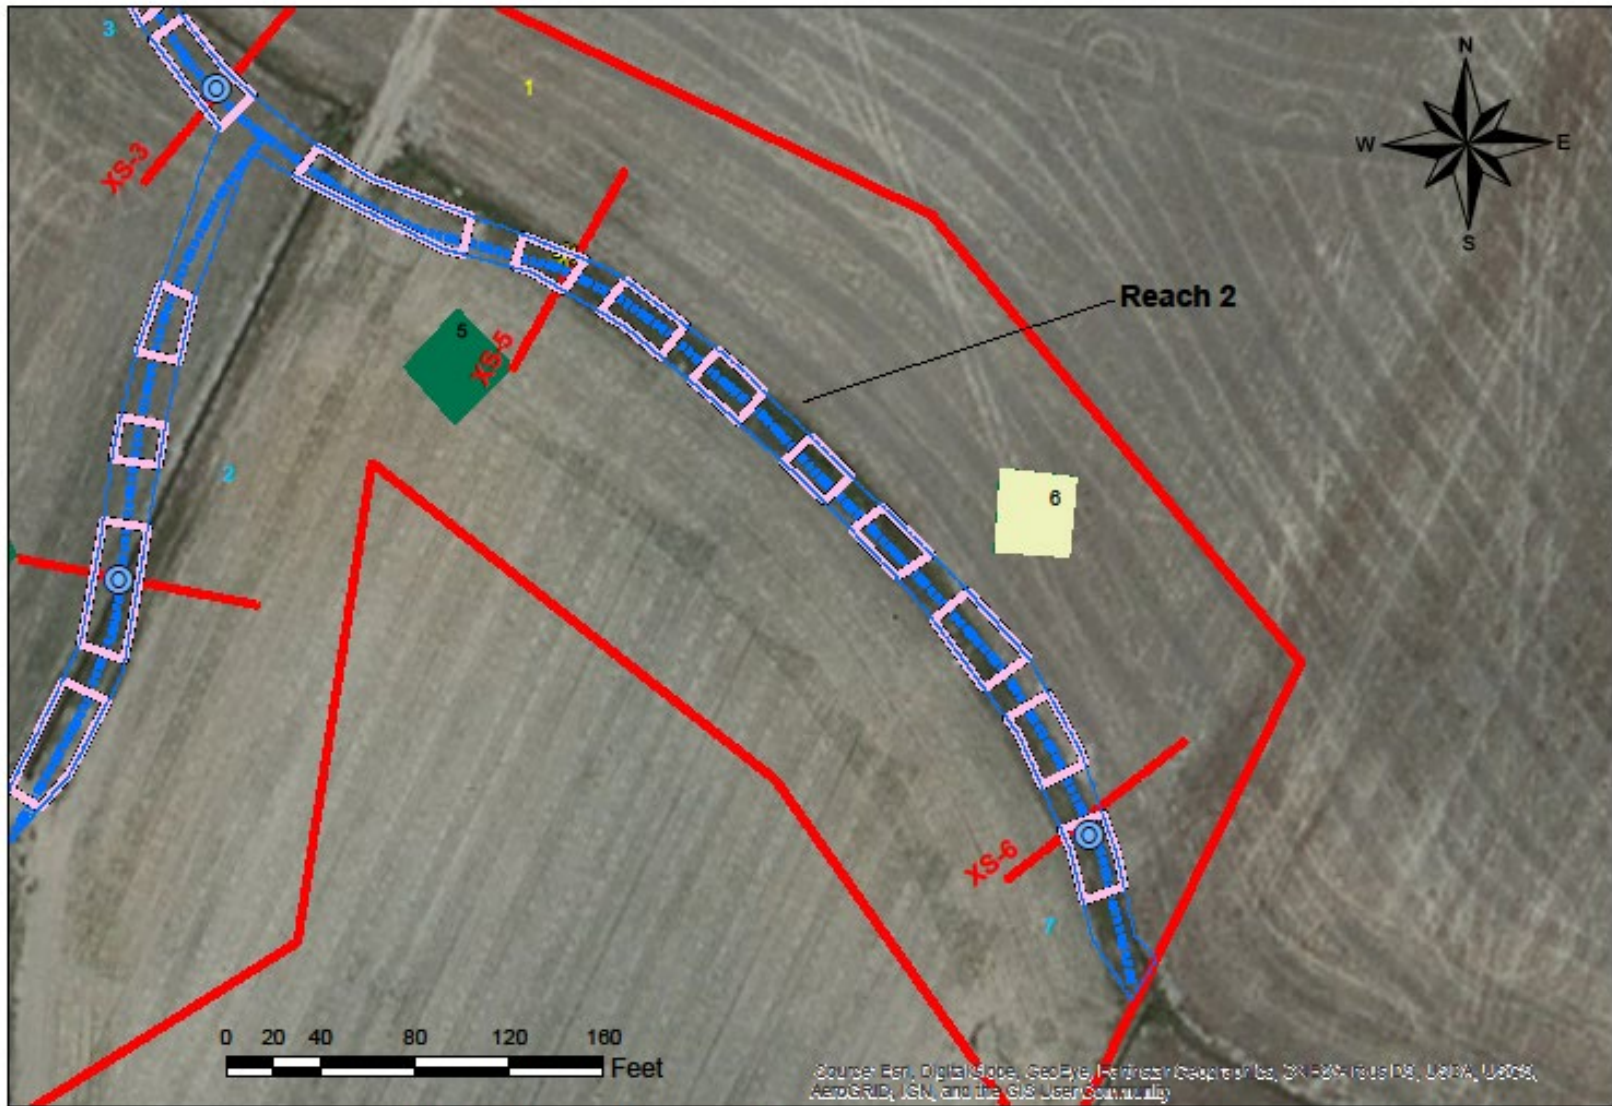
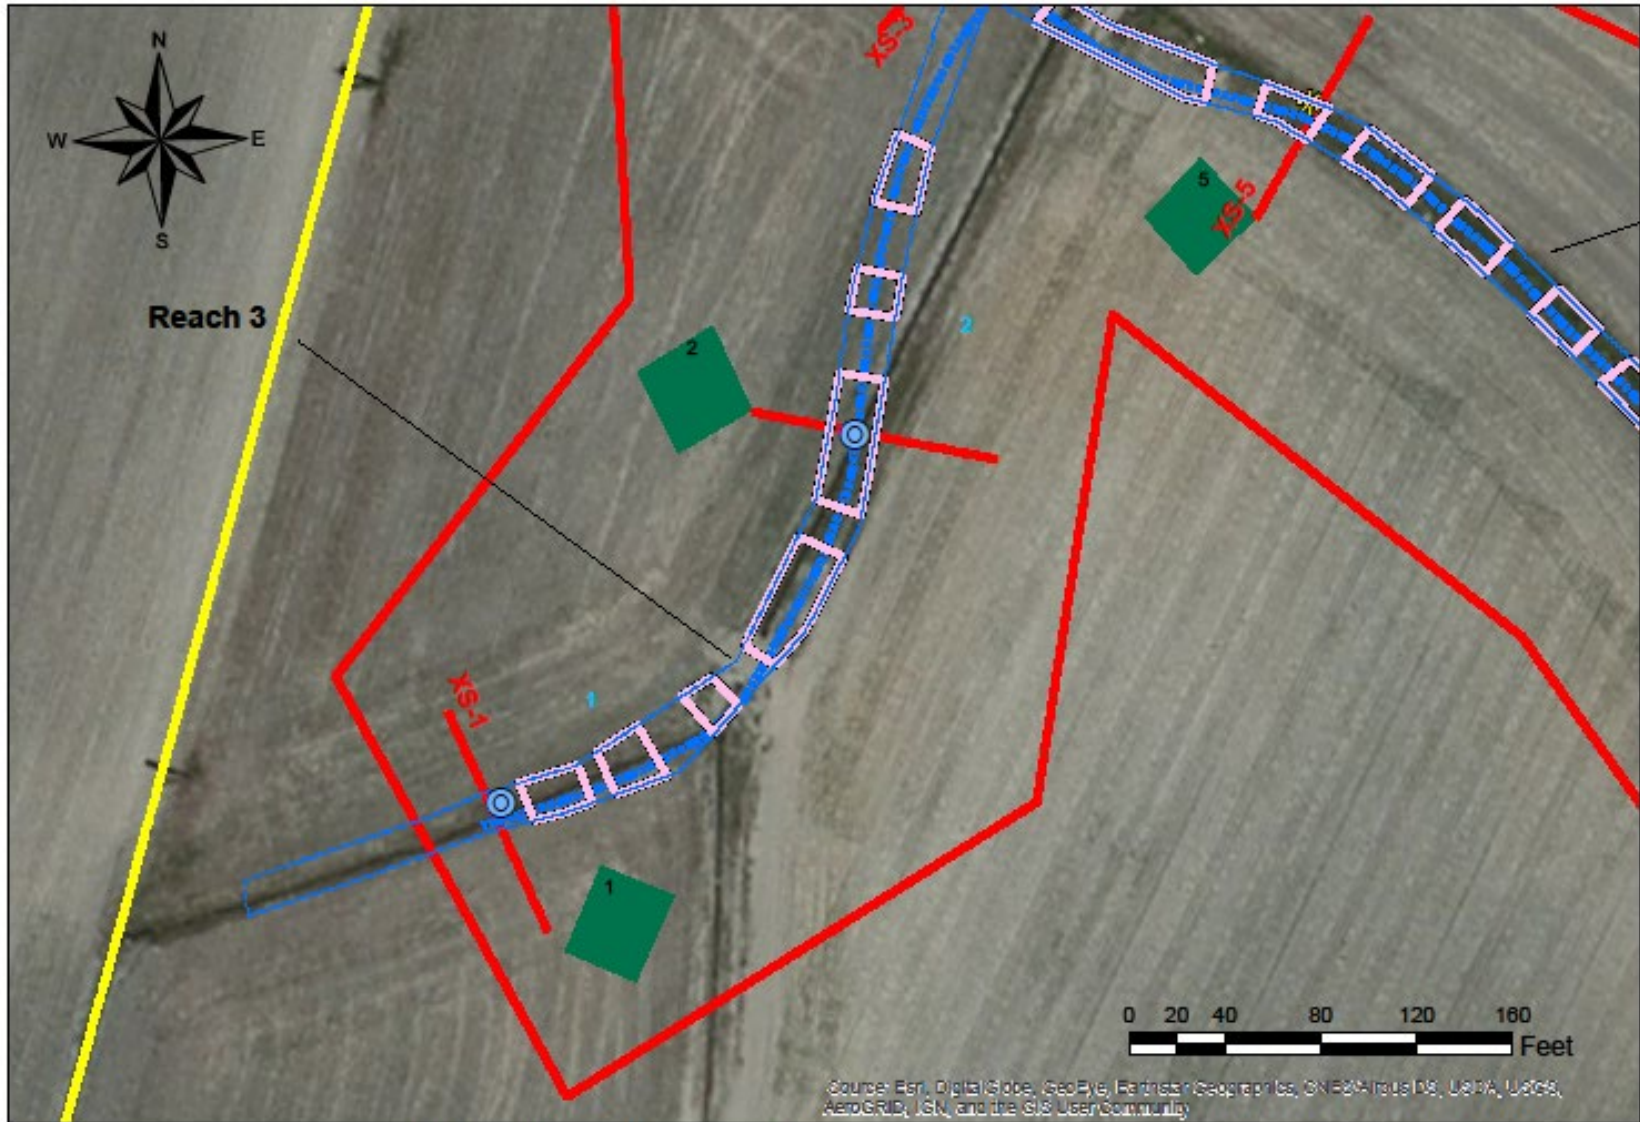
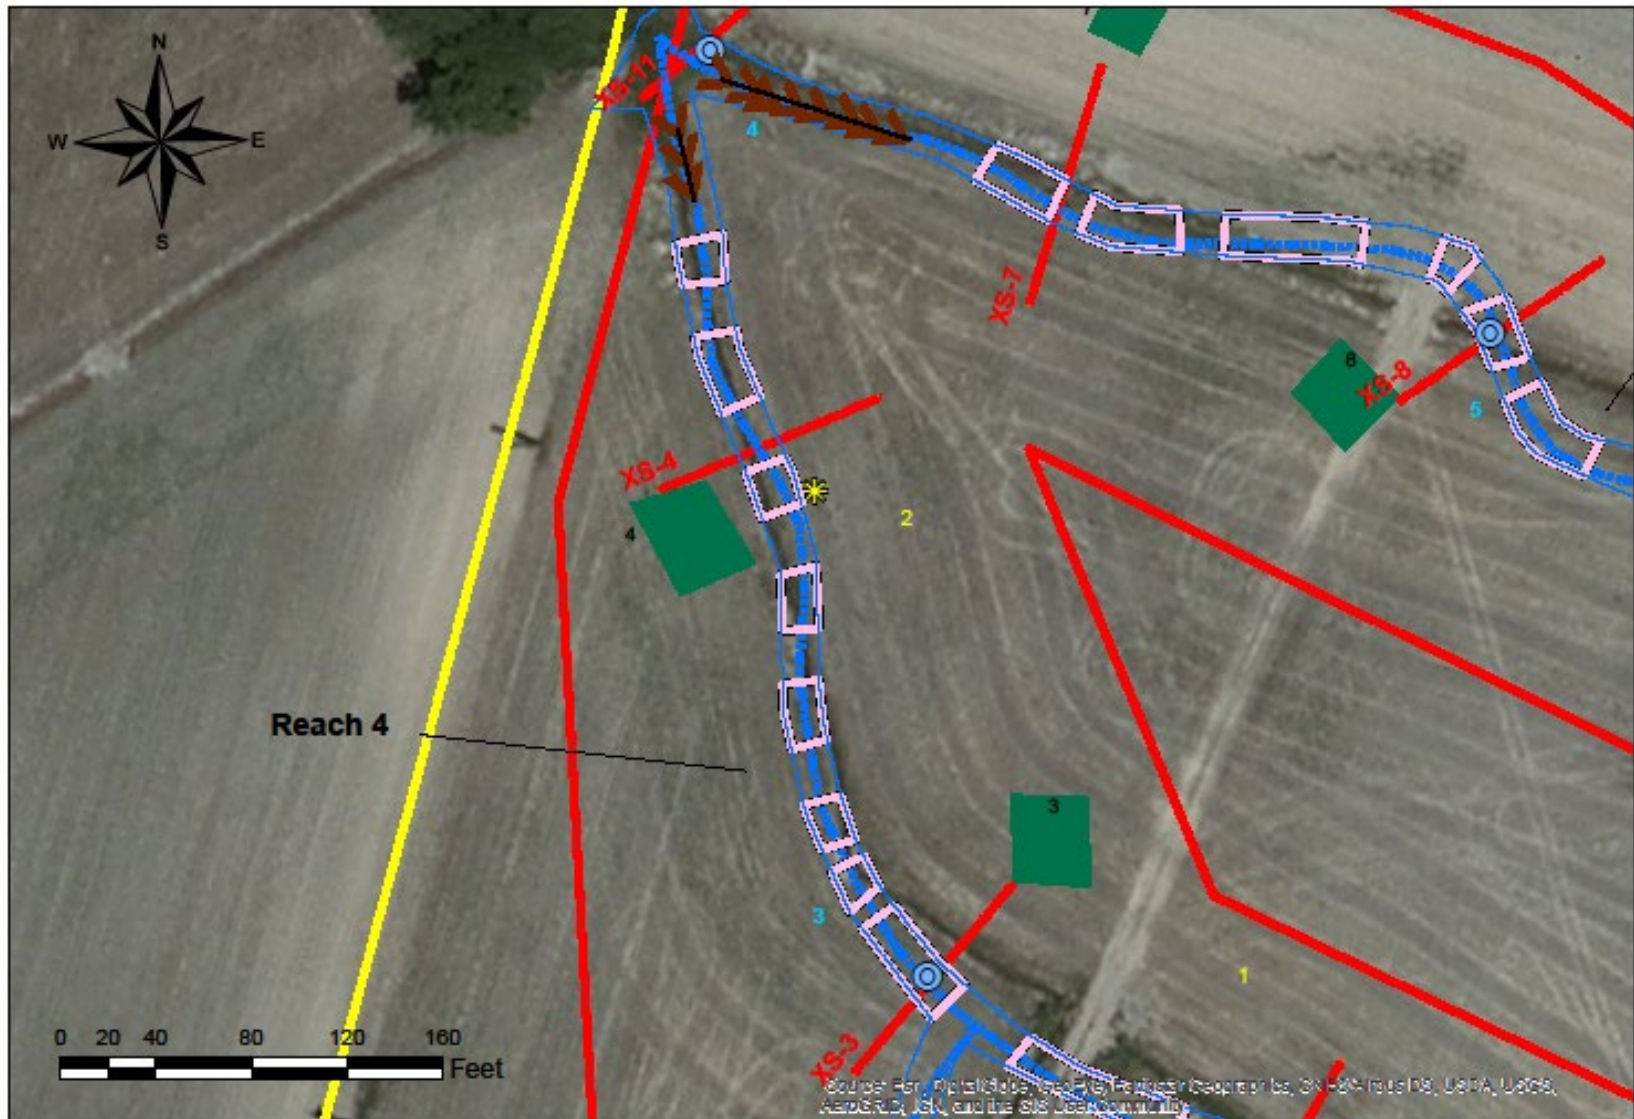
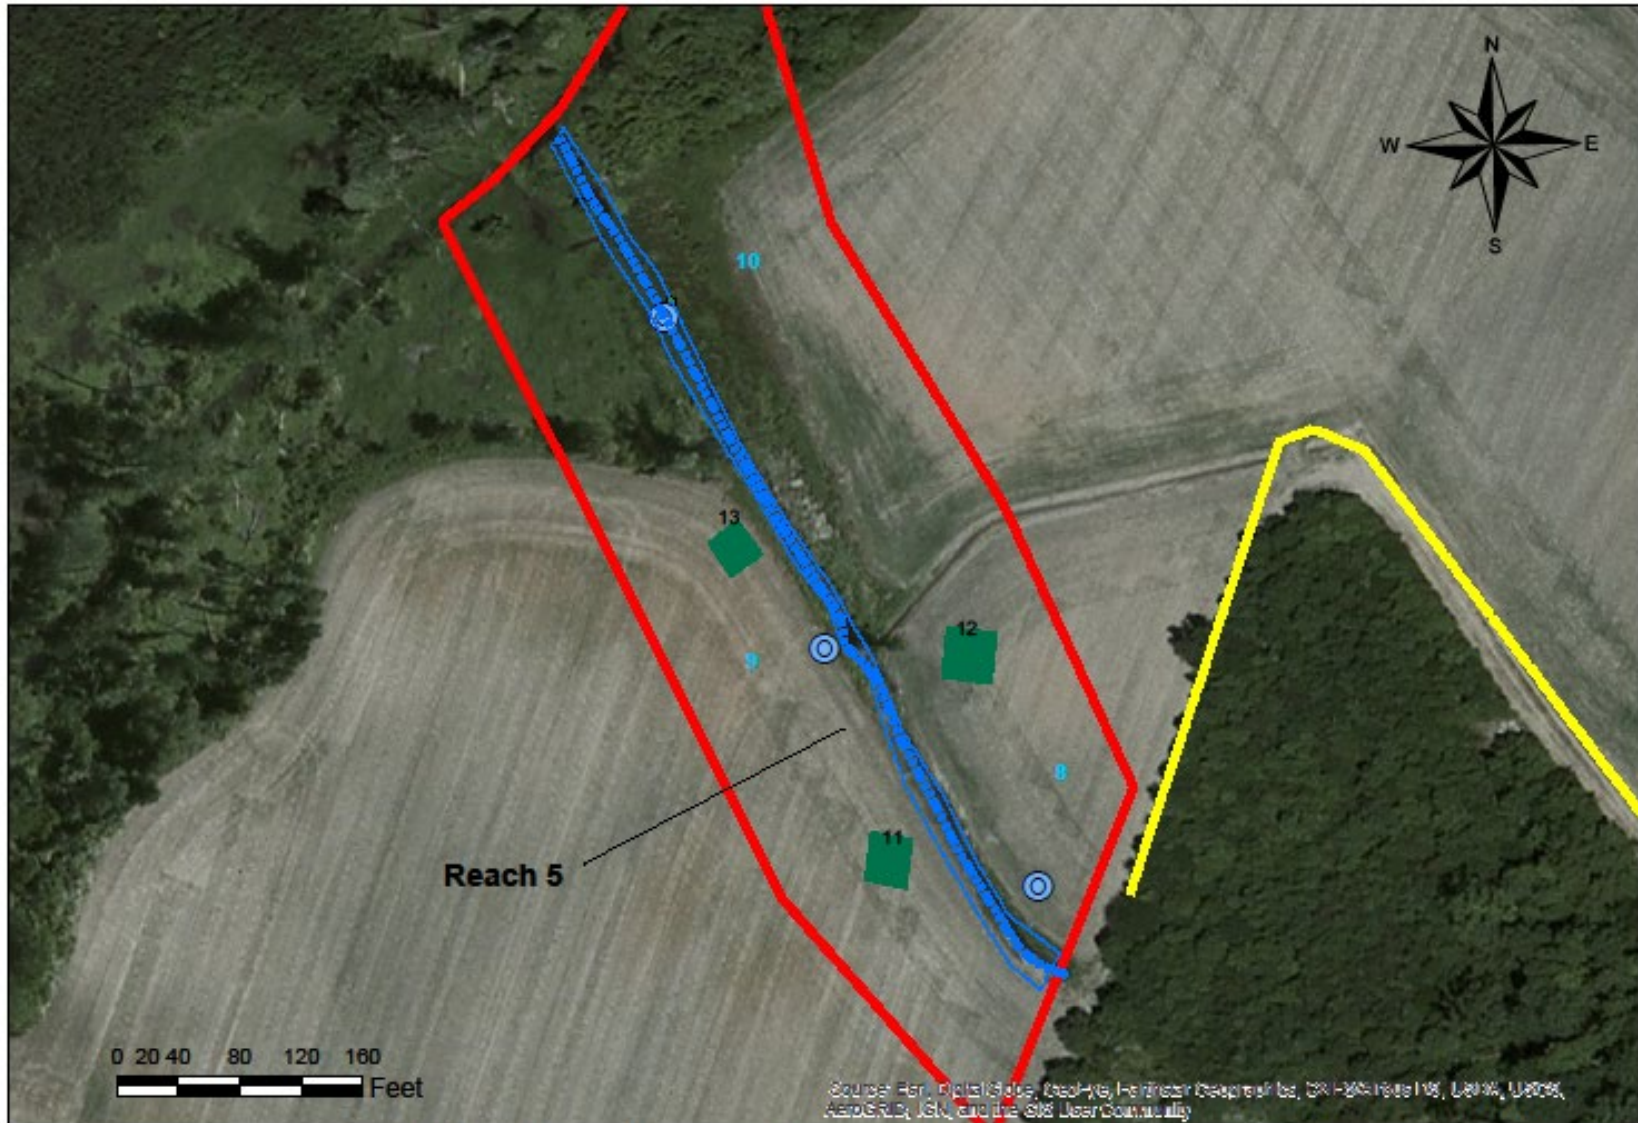
Hudson Stream Restoration Project
Current Condition Plan View
 Project # 95361
 November 2, 2018

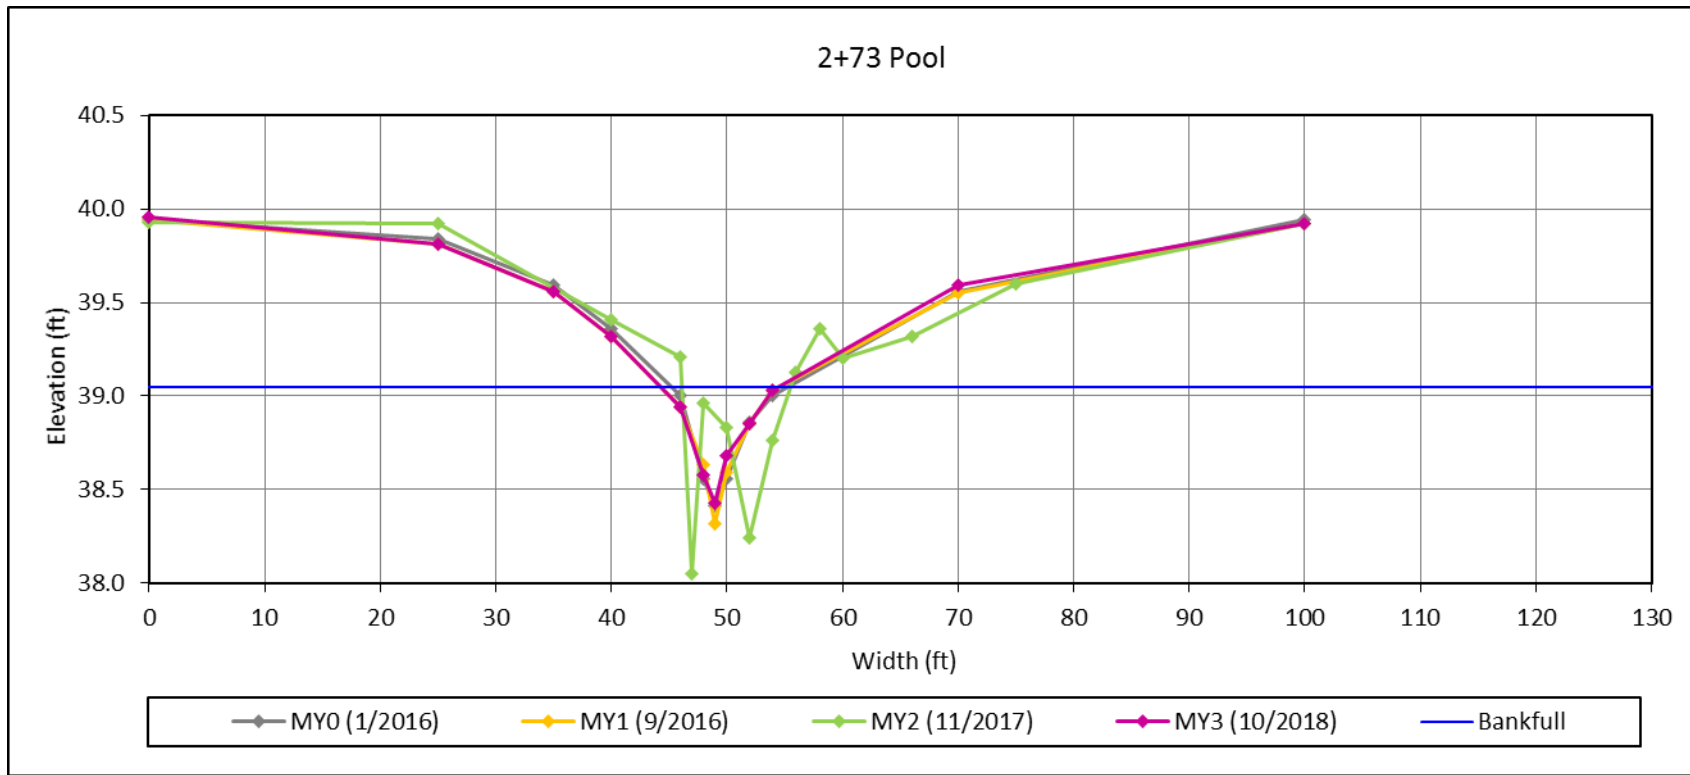
Cross Section 9 – Reach 1

Photo 2: View Upstream on Reach 1, Cross Section 9 – standing water and wetland vegetation in channel
