Year 4 Monitoring Report FINAL

Hudson Property

DMS Project ID #: 95361

Beaufort County, North Carolina

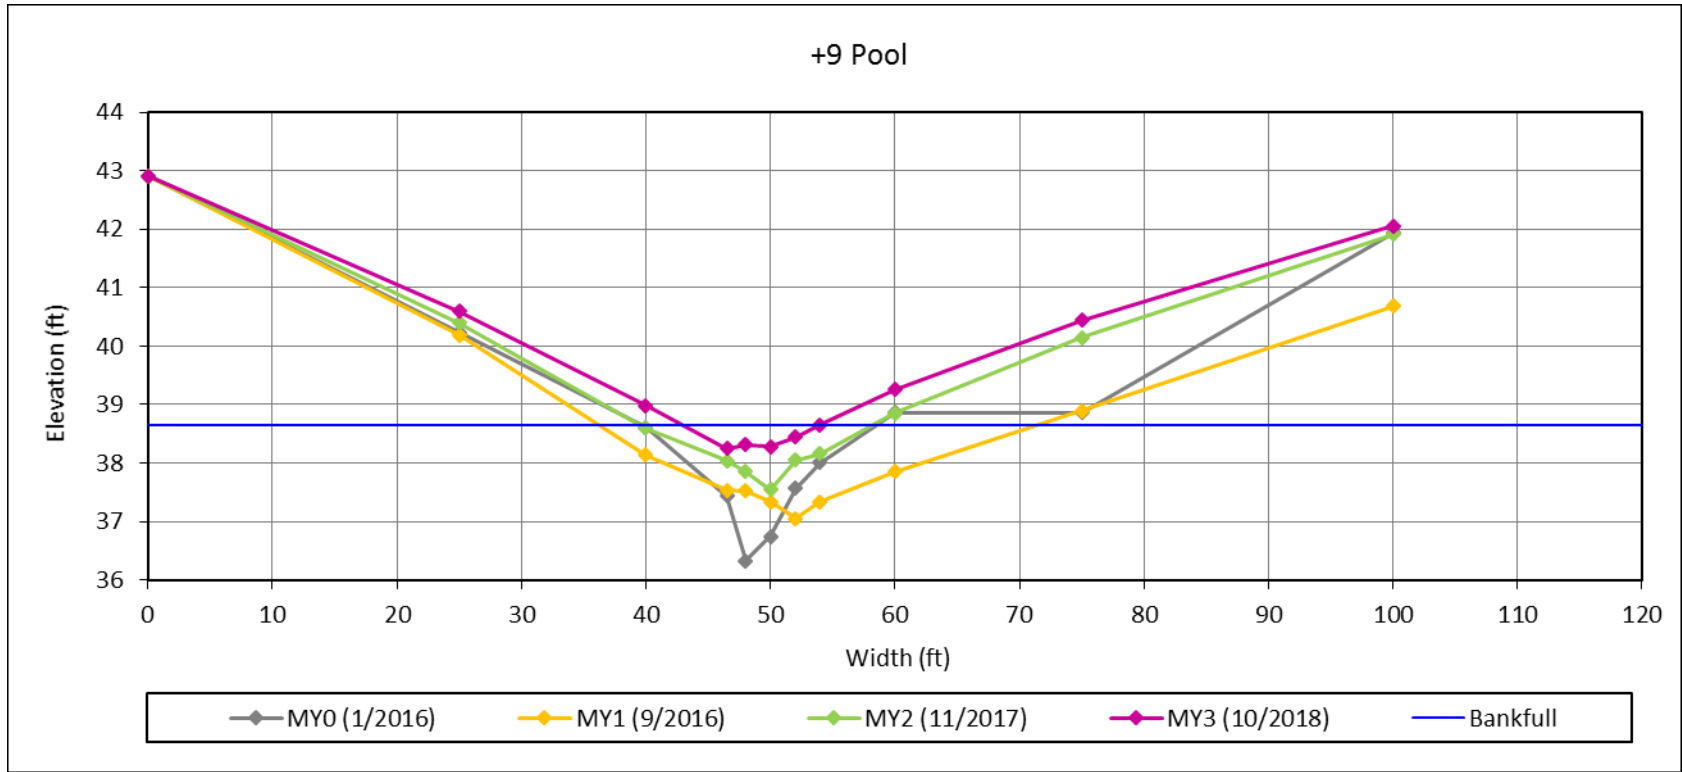
Cross Section 1 – Reach 3

Note: Year 4 Monitoring did not require Cross Section Survey. Graph is based on 2018 information.

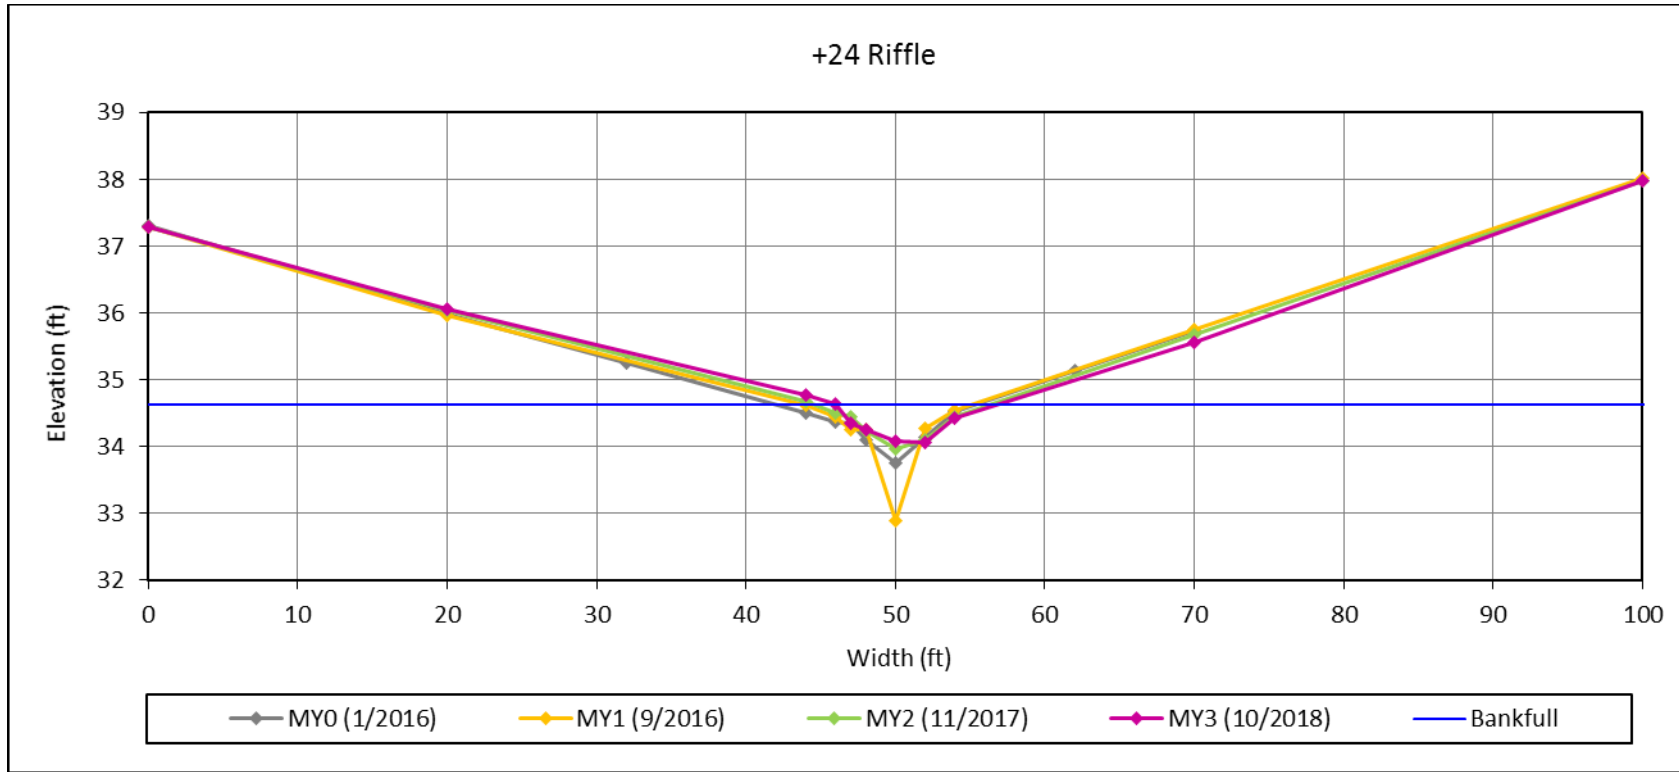
Cross Section 3 – Reach 4

Note: Year 4 Monitoring did not require Cross Section Survey. Graph is based on 2018 information.

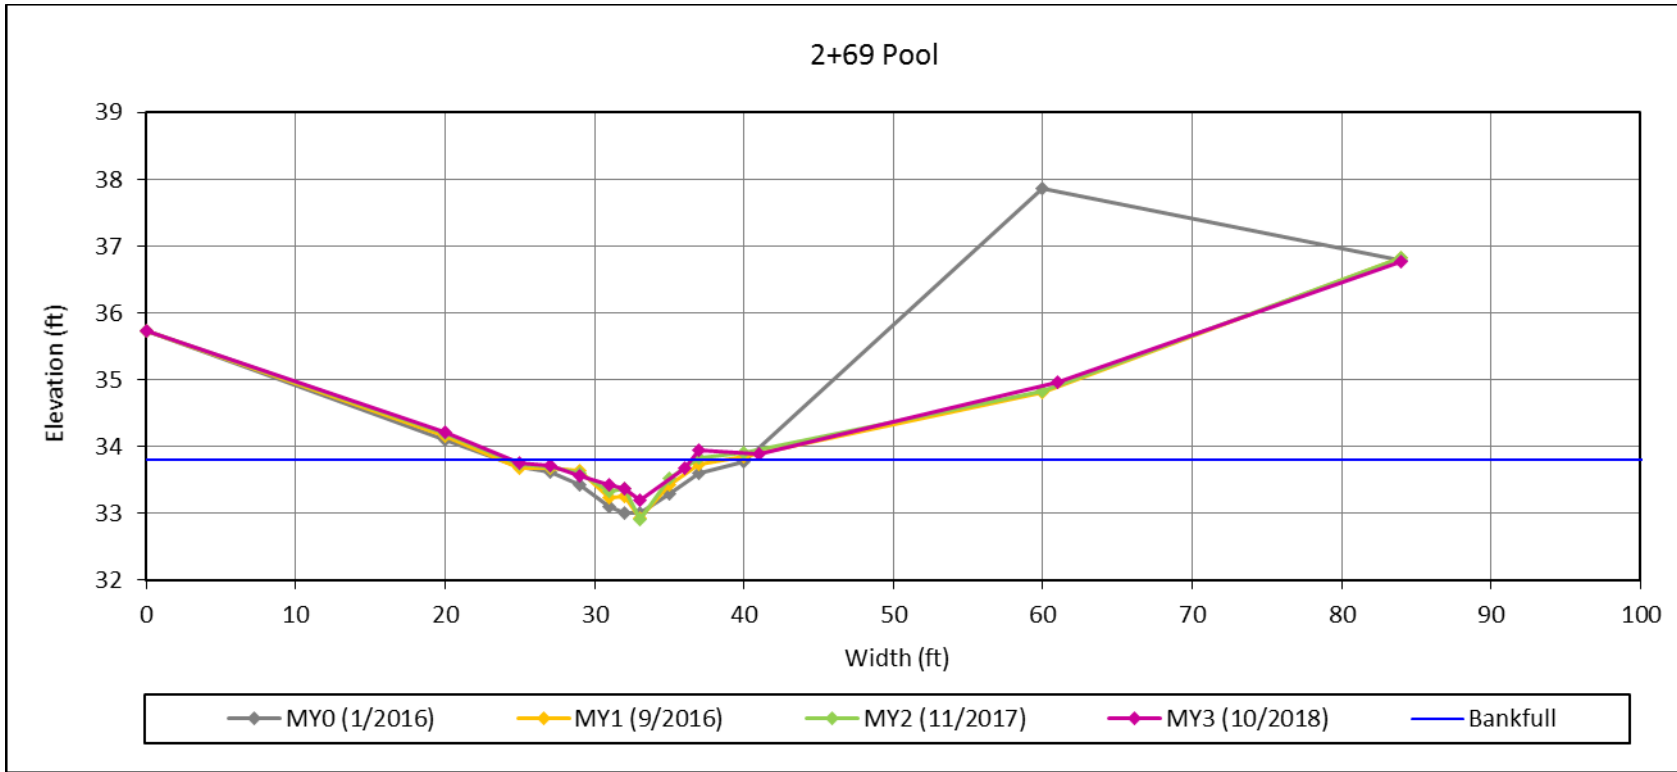
Cross Section 4 – Reach 4

Note: Year 4 Monitoring did not require Cross Section Survey. Graph is based on 2018 information.

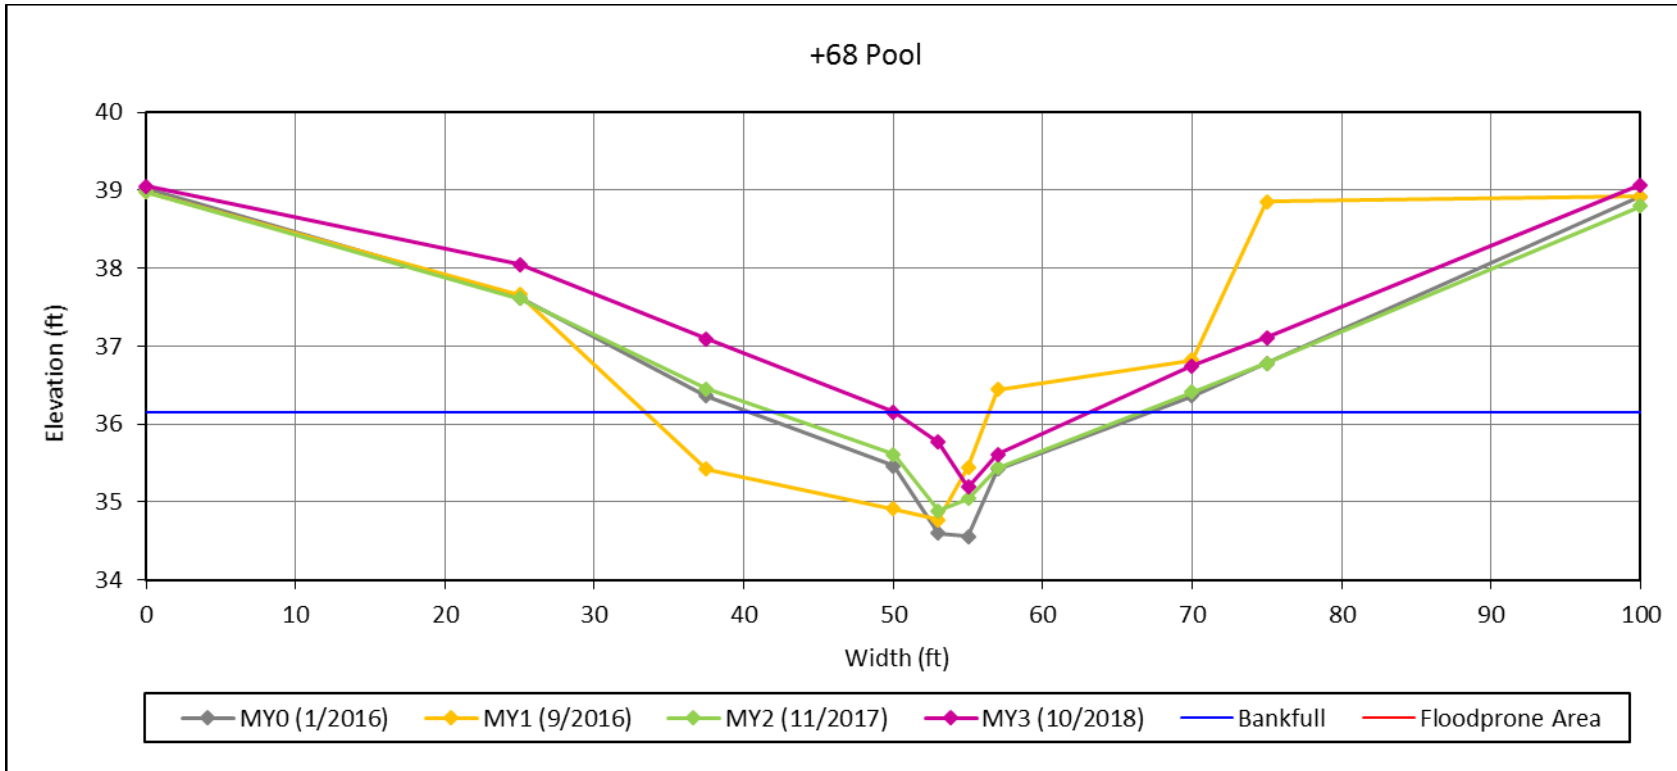
Cross Section 5 – Reach 2

Note: Year 4 Monitoring did not require Cross Section Survey. Graph is based on 2018 information.

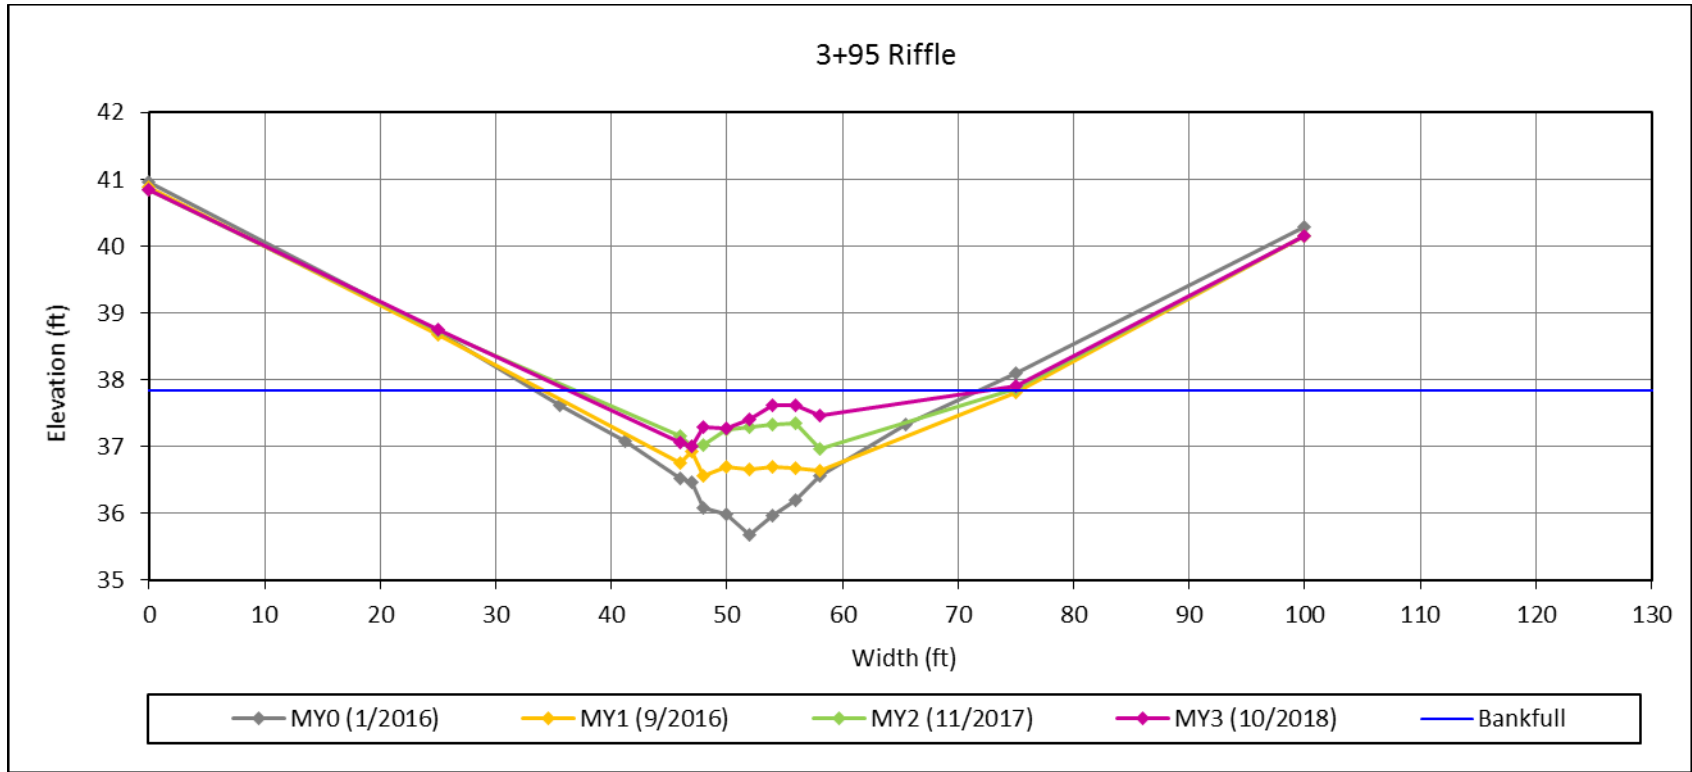
Cross Section 6 – Reach 2

Note: Year 4 Monitoring did not require Cross Section Survey. Graph is based on 2018 information.

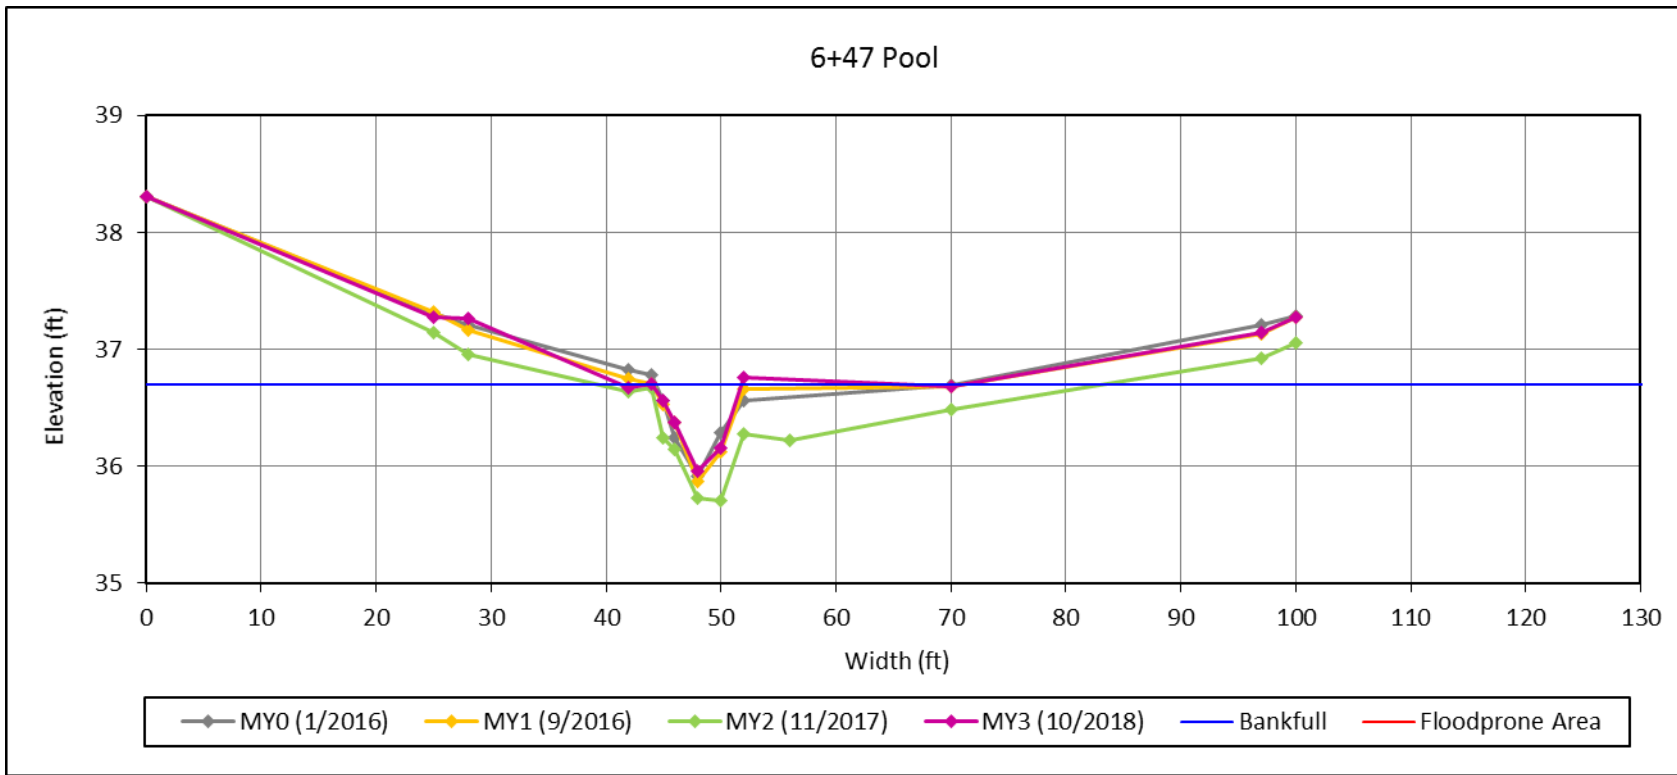
Cross Section 7 – Reach 1

Note: Year 4 Monitoring did not require Cross Section Survey. Graph is based on 2018 information.

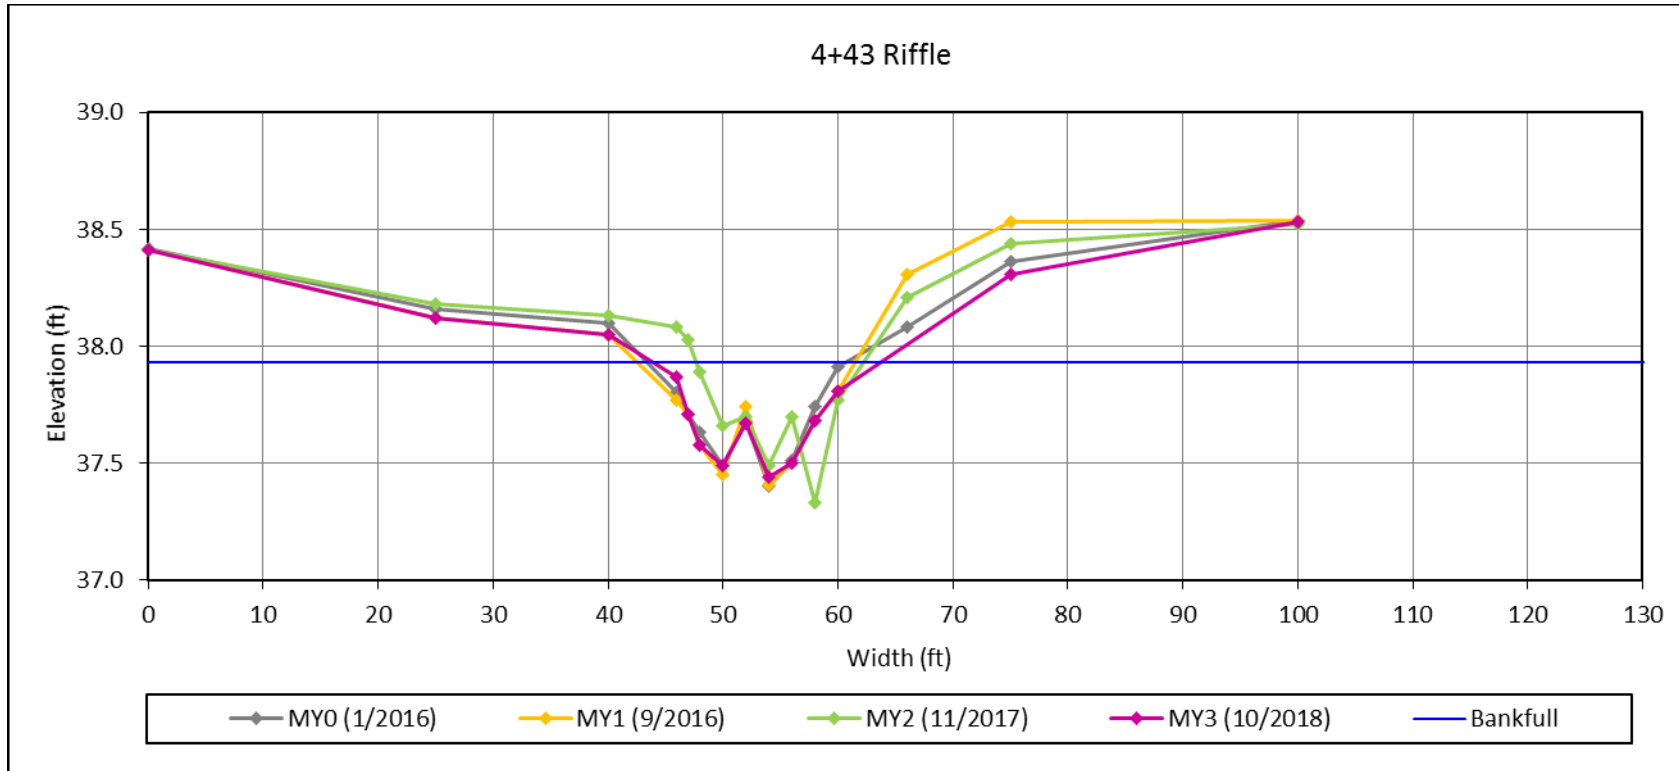
Cross Section 8 – Reach 1

Note: Year 4 Monitoring did not require Cross Section Survey. Graph is based on 2018 information.

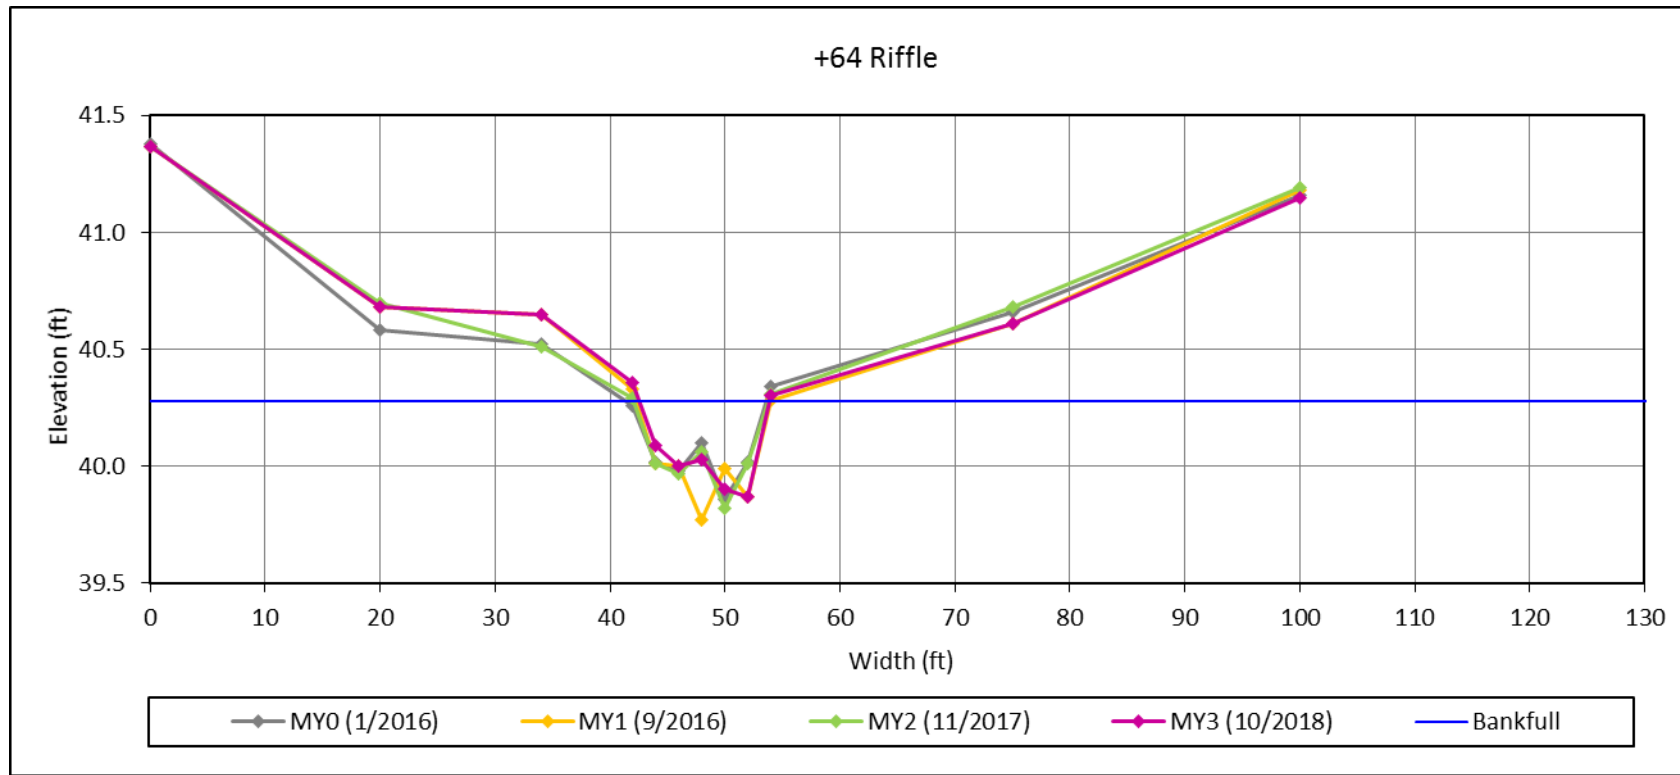
Cross Section 10 – Reach 1

Note: Year 4 Monitoring did not require Cross Section Survey. Graph is based on 2018 information.

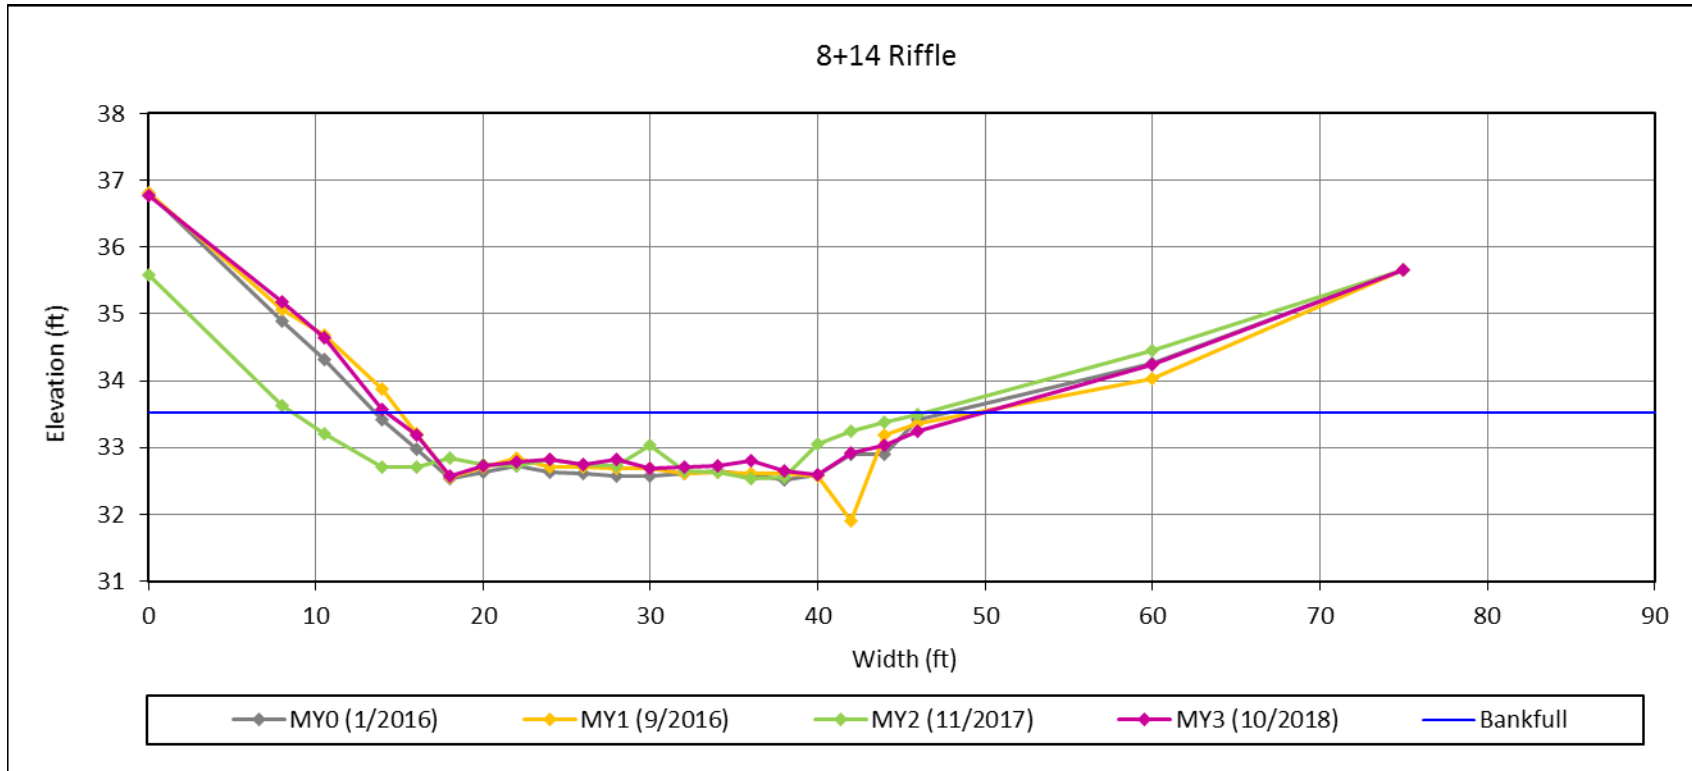
Cross Section 11 – Reach 1 & 4 Confluence

Note: Year 4 Monitoring did not require Cross Section Survey. Graph is based on 2018 information.
