MONITORING YEAR 2 ANNUAL REPORT FINAL

HUNTSMAN MITIGATION SITE

Wilkes County, NC
Yadkin River Basin
HUC 03040102

DMS Project No. 100123
DMS Contract No. 7891
DMS RFP No. 16-007728; Date of Issue: 11/13/2018
USACE Action ID No. SAW-2019-00836
DWR Project No. 20190866
Data Collection Dates: February - November 2023
Submission Date: January 2024

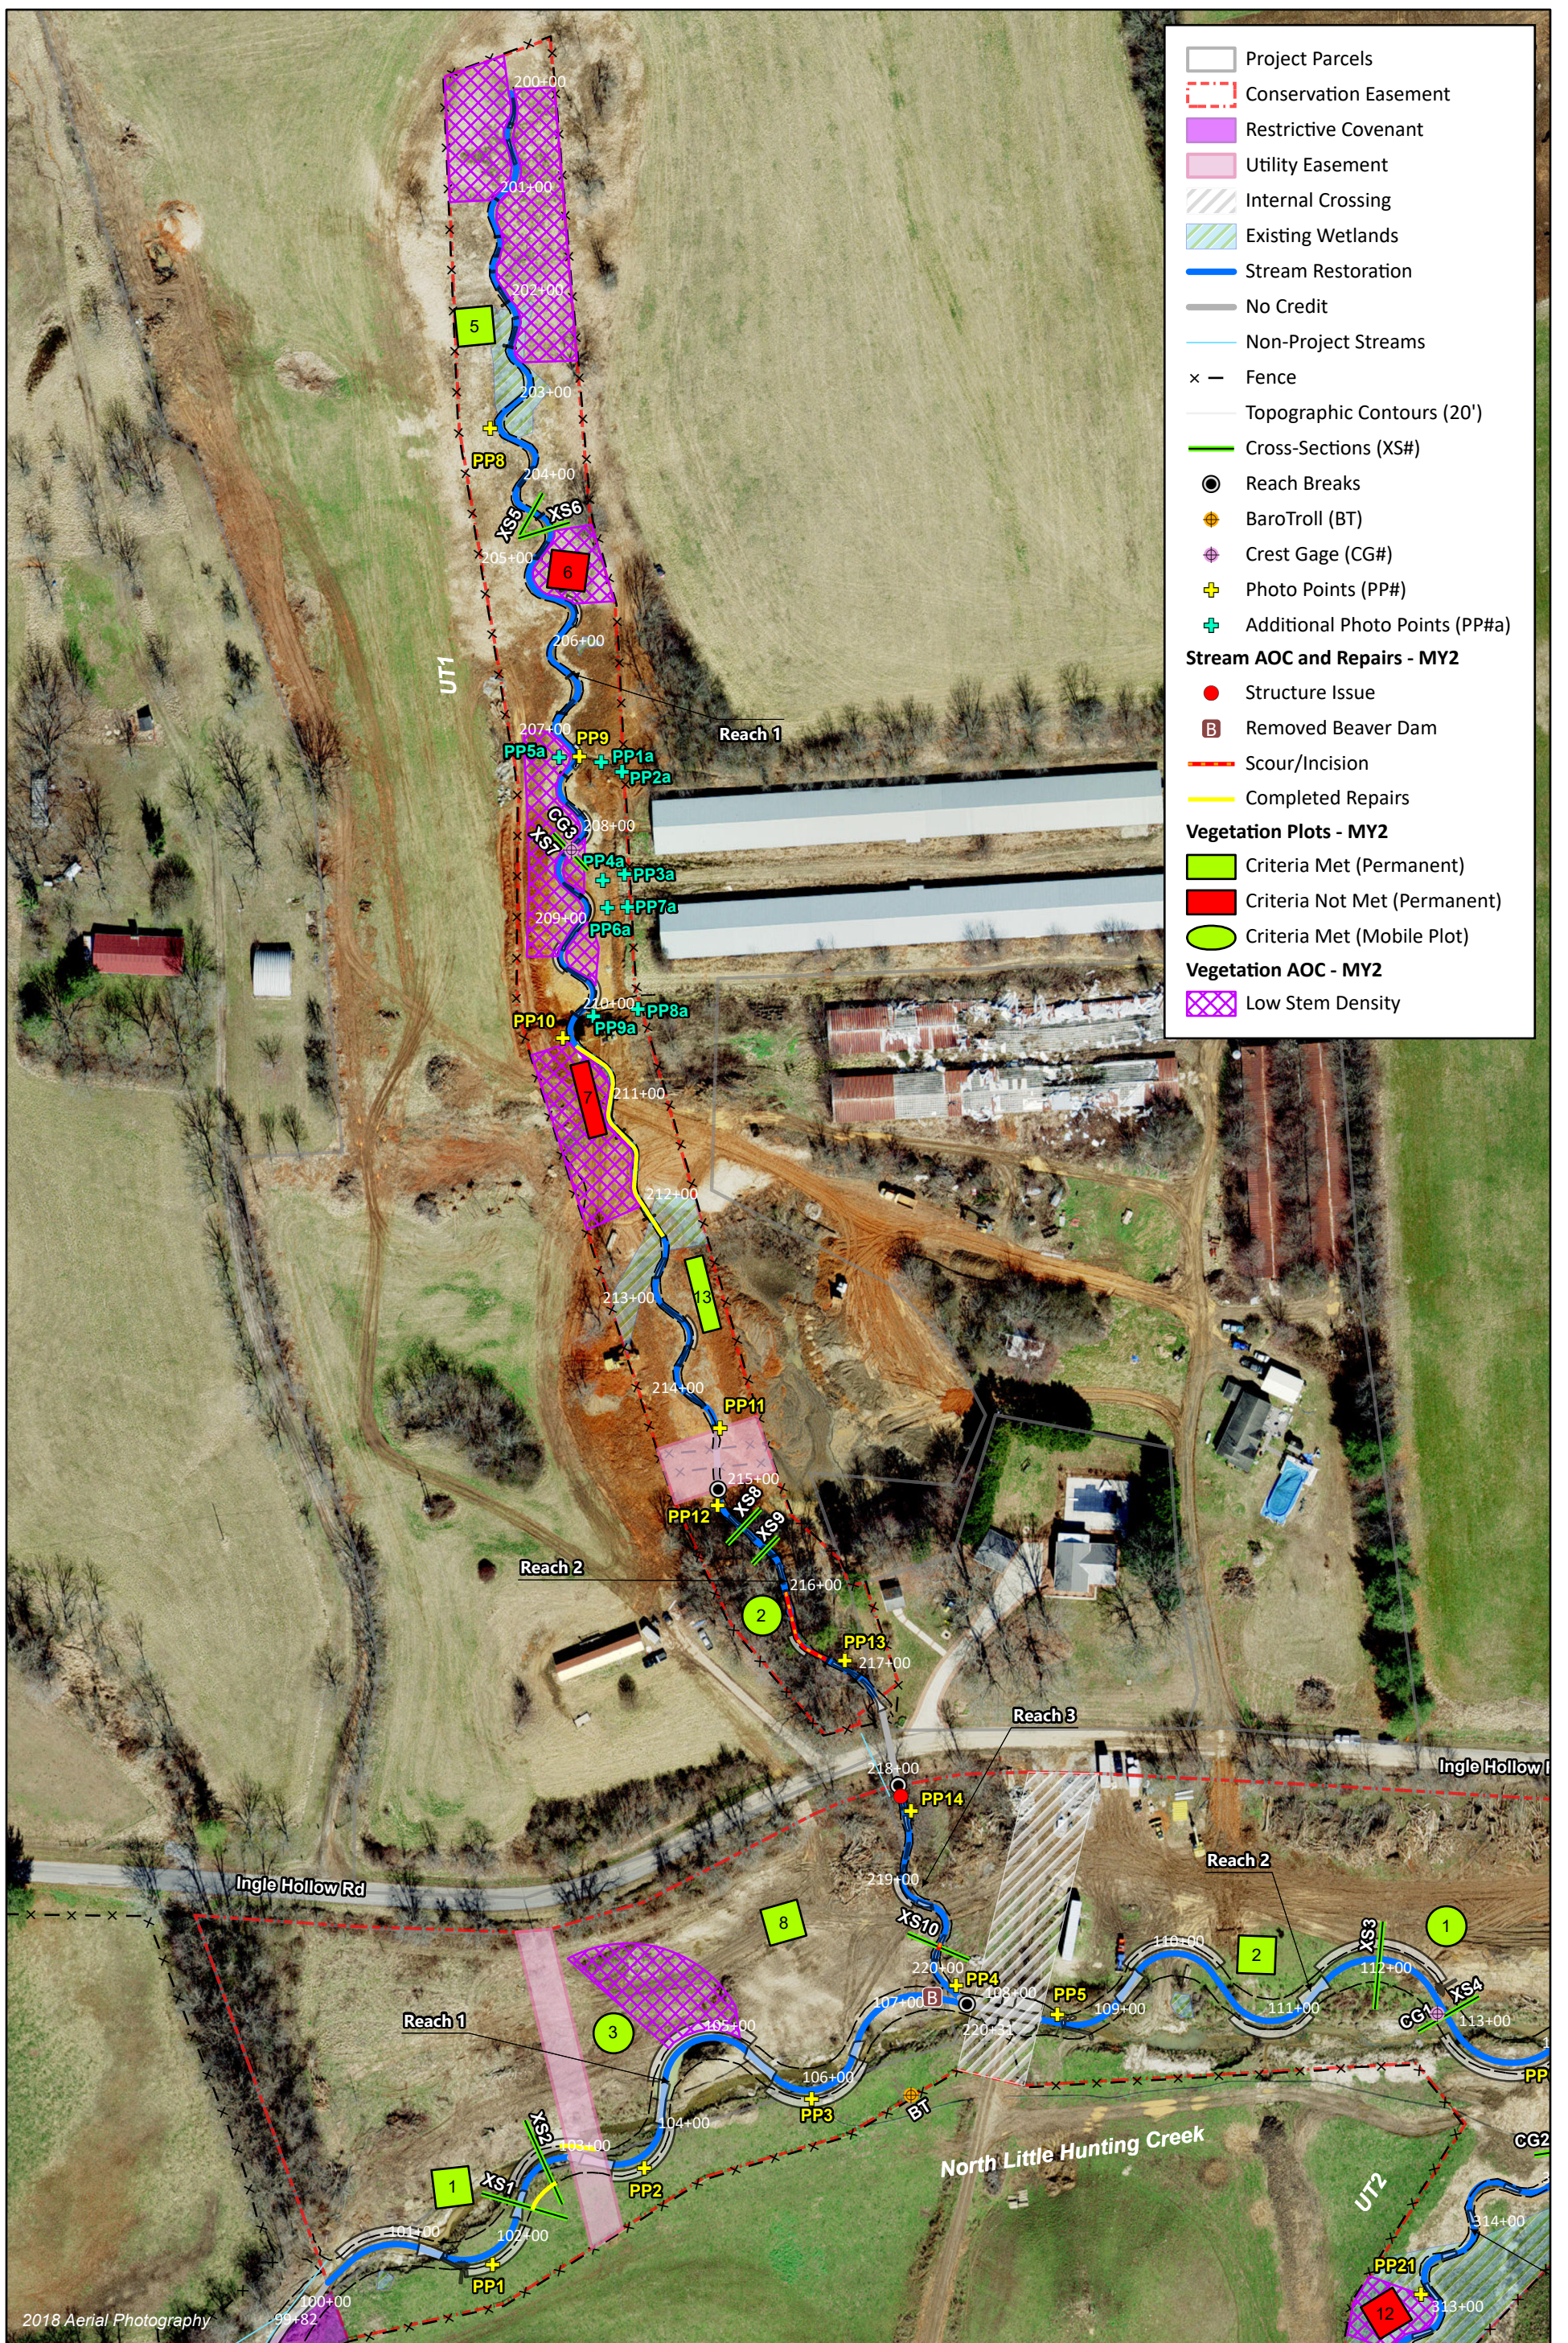
Figure 1.1 Current Condition Plan View
 Huntsman Mitigation Site
 DMS Project No. 100123
 Monitoring Year 2 - 2023
 Wilkes County, NC

Except for one small area in the left floodplain along UT1 Reach 1 near station 213+50, the bare areas have been successfully resolved in MY2. The bare area on UT1 Reach 1 is below the mapping threshold of 0.10 acres and therefore, is not depicted on the CCPV. Several areas of low stem density continue to persist on UT1 Reach 1, with localized occurrences on North Little Hunting Creek. At VP6 and the headwaters of UT1, herbaceous vegetation has outcompeted planted stems, resulting in an area of reduced stem density while poor soil conditions and moderately steep slopes have negatively affected the successful establishment of woody vegetation along mid-reach of UT1 Reach 1. Additionally, low stem density near VP7 was directly attributed to construction access during stream repairs discussed in Section 2.4. Areas of low stem density on the Site have a combined total acreage of 1.1 acres or 6.9% of

- **UT1 Reach 2: STA 216+00 to 216+75** – A lack of baseflow in this segment of stream was observed in late August. Wildlands installed a game camera in November 2023 to monitor baseflow and reassess the area in MY3.
- **UT1 Reach 3: STA 218+23** – A rock sill is piping resulting in a perched culvert. A repair was completed on this area in January 2023; however, the repair was unsuccessful, and the rock sill is piping again. To address this issue, Wildlands will repair the rock sill to backup water into the culvert in late 2023/early 2024.
- **UT1 Reach 3: STA 219+80 to 219+86** – There is localized scour on riffle XS10 resulting in undercut banks and bed scour. Wildlands will continue to monitor this area and will repair the area if needed.

the total easement acreage. Management activities are planned for winter 2023/2024 and will include supplementally planting mapped areas of low stem density with approved species from the project's Final Mitigation Plan (Wildlands, 2021). Refer to the CCPV Figures 1.0 – 1.2 and the Vegetation Condition Assessment Table. A list of the proposed plantings and quantities is included in Appendix B.

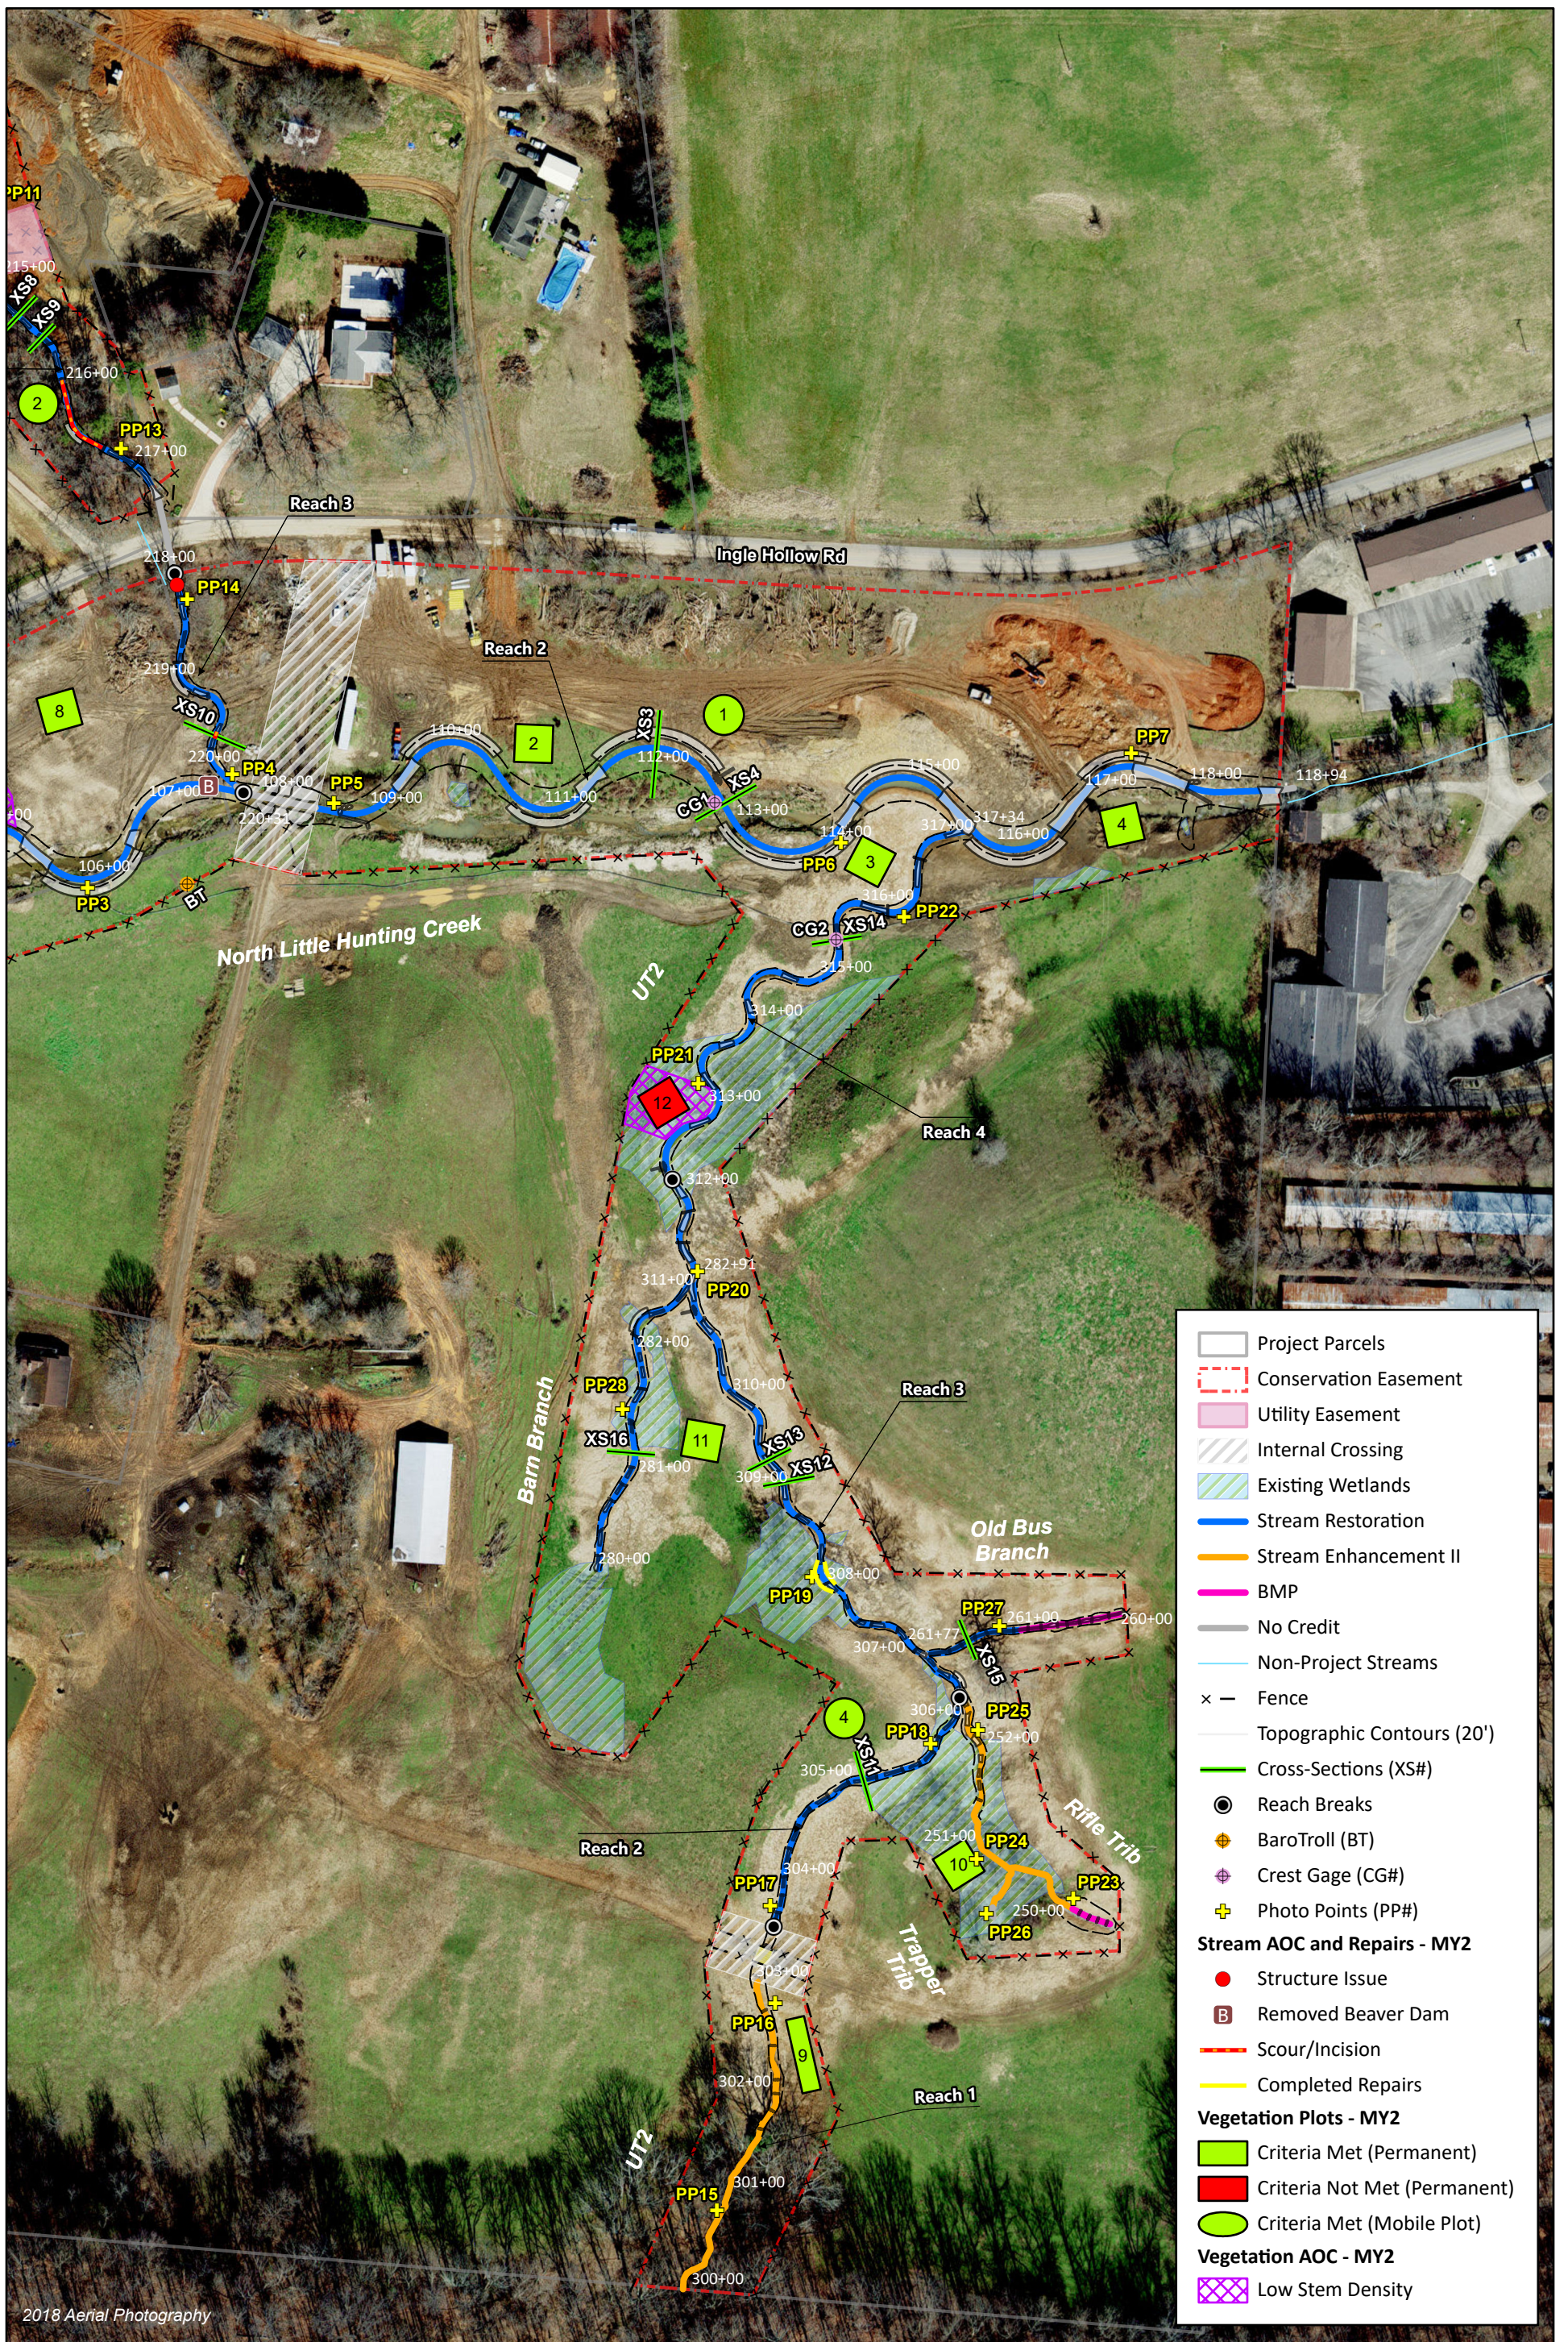
Figure 1.2 Current Condition Plan View
 Huntsman Mitigation Site
 DMS Project No. 100123
 Monitoring Year 2 - 2023
 Wilkes County, NC

- **UT1 Reach 3: STA 218+23** – A rock sill was piping resulting in a perched culvert. Wildlands added geotextile fabric and rip-rap to the back of the rock sill to backup water into the culvert for aquatic passage. Since the repair was first completed, the rip-rap has washed downstream and the culvert is once again perched.
- **UT2 Reach 3: STA 308+00 to 308+30** – Hydrological seepage from a wetland area that abuts the reach resulted in stream bank slump and scour. Wildlands re-graded both banks, installed brushtoe, and re-seeded and matted the banks and floodplain.

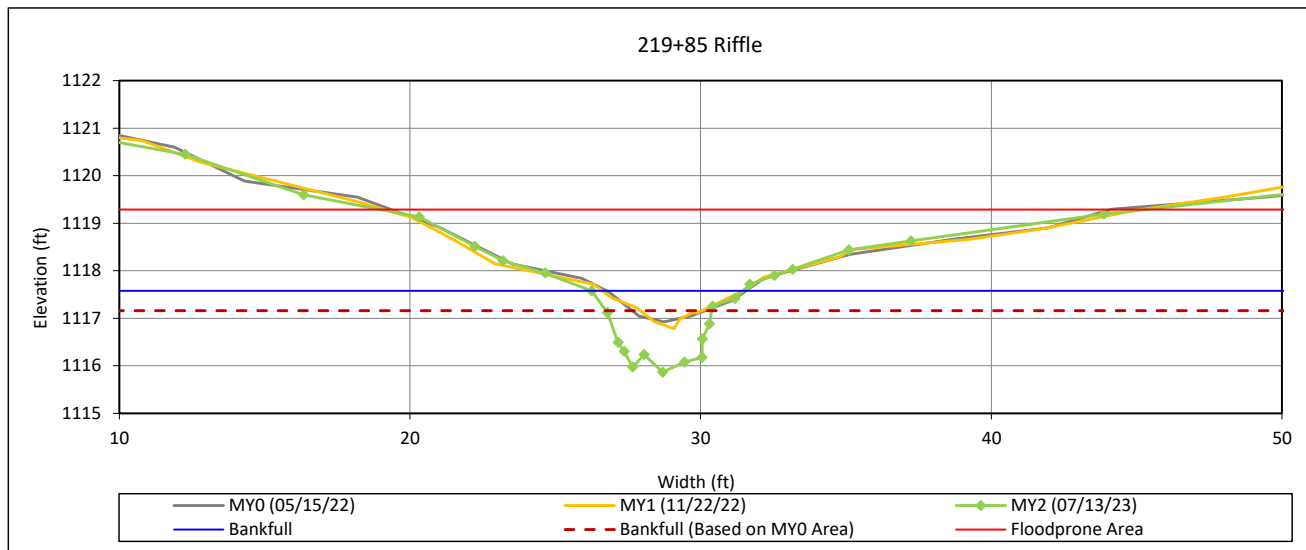
Cross-Section 10 - UT1 Reach 3

MY2-3	UT1 Reach 3	219+80 - 219+86	Localized incision on cross-section 10.	N/A	No repair needed at this time. Wildlands will continue to monitor the area of localized incision and will report on conditions in 2024.	6 LF

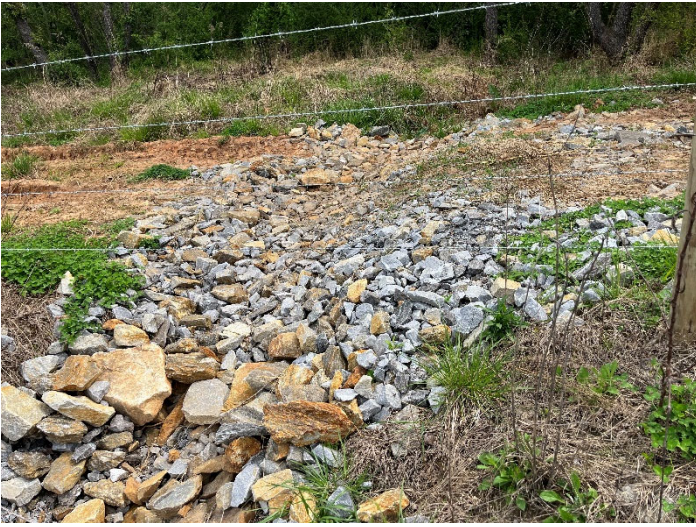
Photo Point 2a – Stabilized swale, view up valley (04/06/2023)

1. The IRT asked if the repair work to stabilize the access road near the chicken houses had been completed.
 - Yes, it has been completed. Rip rap was added to each swale within the access road to act as a "ford-type" crossing to stabilize the crossing and slow down concentrated flow to minimize an outside source sedimentation into the easement. Photos of the completed work were taken in April 2023. I have included the CCPV map of the area for reference. Please see attached pdf.
2. Casey asked if the crest gauge on UT1 had been replaced.
 - Yes, it was replaced and has been successfully recording data since 12/30/2022. The last time the gauge was downloaded was on 4/20/2023.

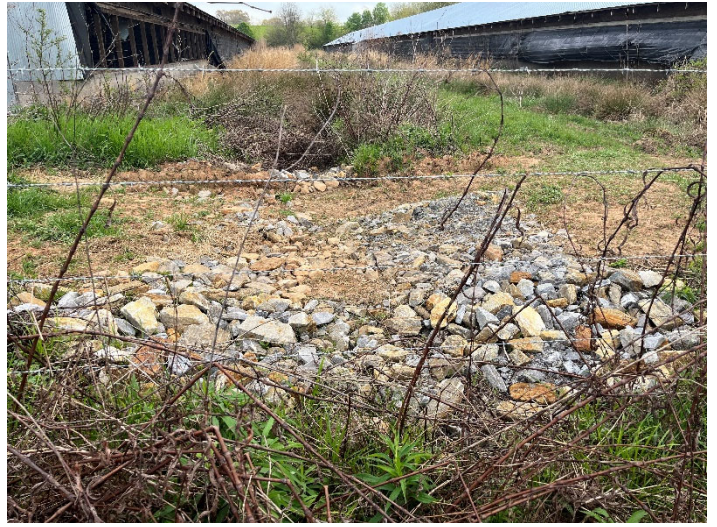
Photo Point 3a – Stabilized swale, view up valley (04/06/2023)

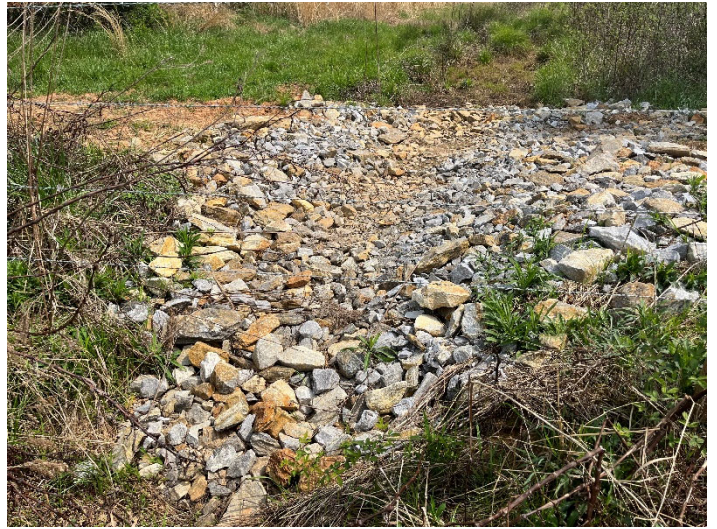
Photo Point 8a – Stabilized swale, view up valley (04/06/2023)
