Jacksonville Country Club Stream Restoration and Enhancement Project

**SCO No. 070715501
DEQ Contract No. D08049S
DMS Project No. 194
Action ID# 2006-40325-067
Onslow County, North Carolina**

**Year 2 of 5 Monitoring Report
Data Collection: January through December 2015
Submission Date: April 13, 2016**

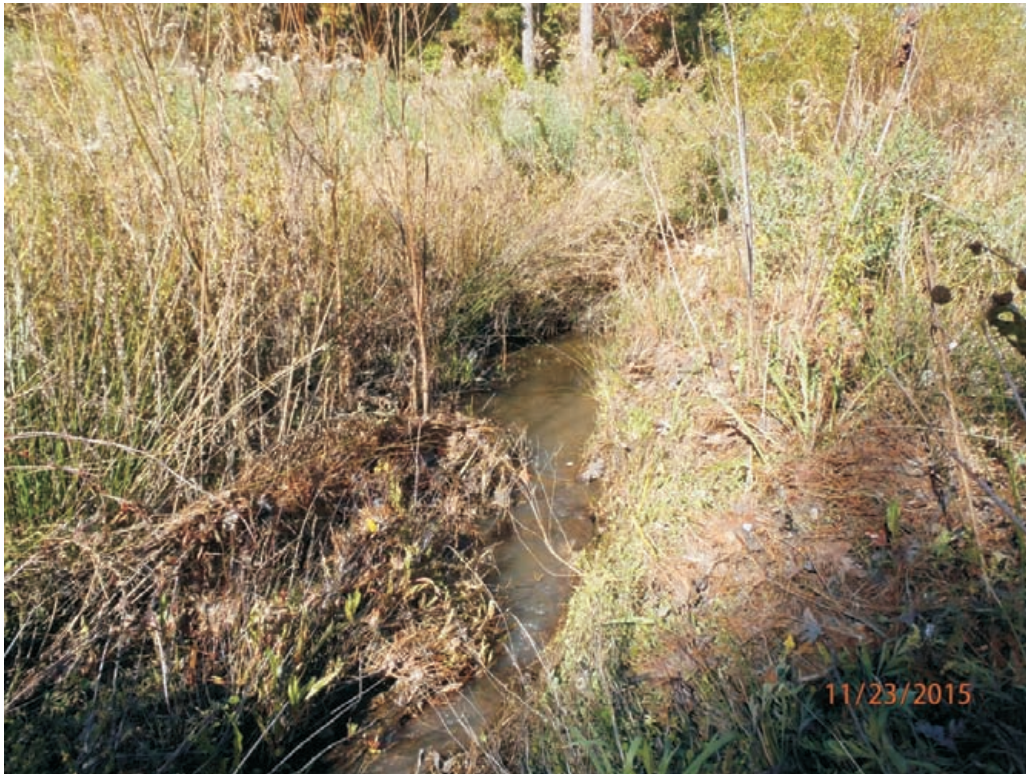
Reach 1A - Stream Problem Area #3; bank undercut

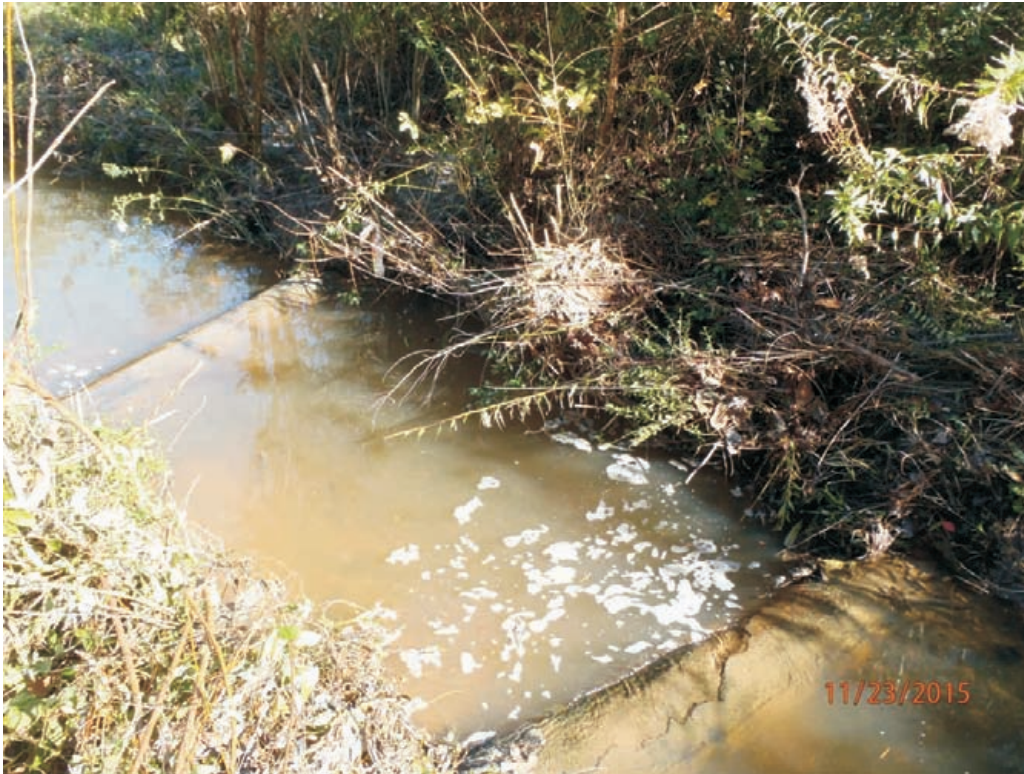
Reach 1A - Stream Problem Area #11; Log Vane Undercut

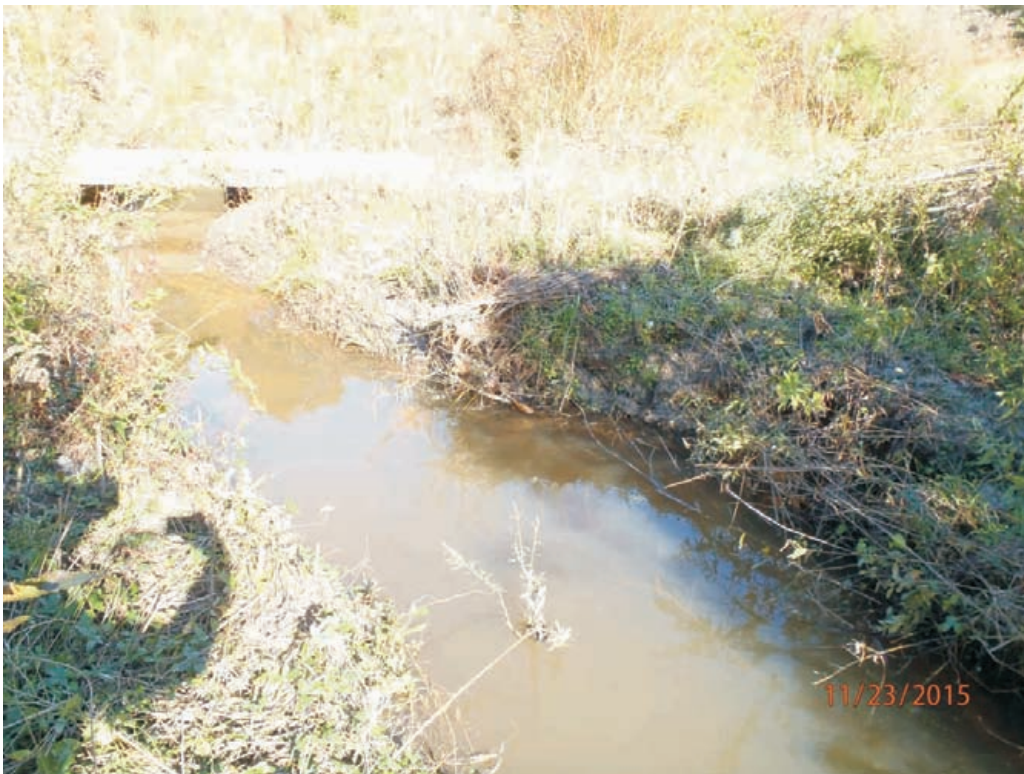
Reach 1A - Stream Problem Area #12; Scour

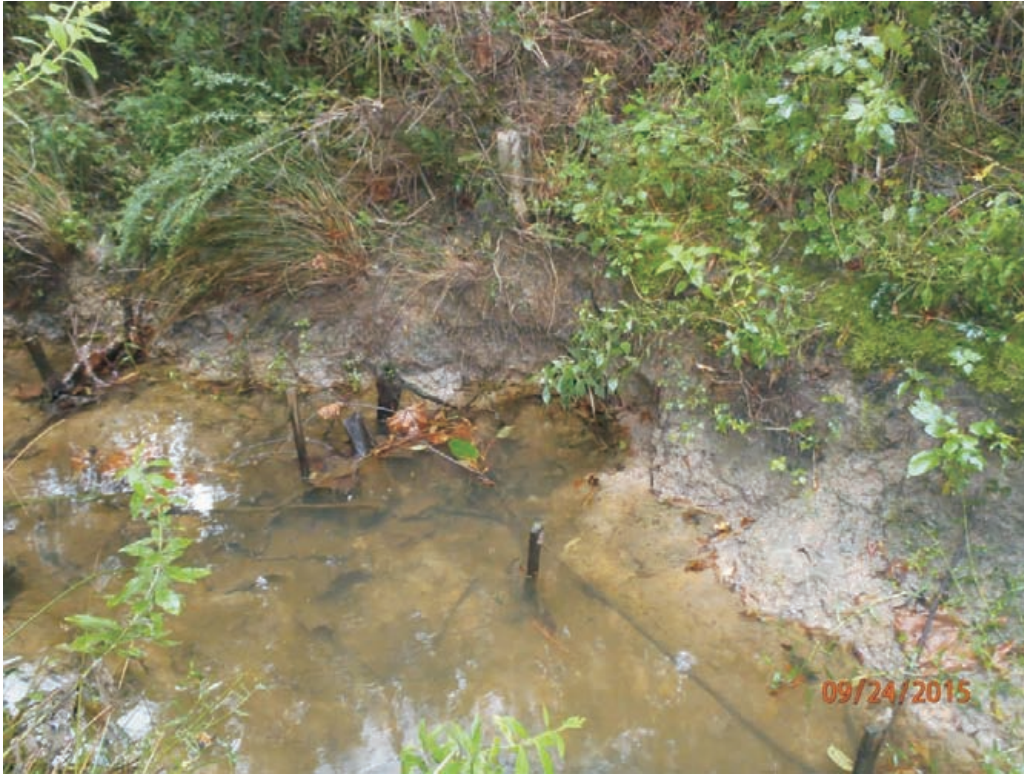
Reach 2A - Stream Problem Area #31; Scour

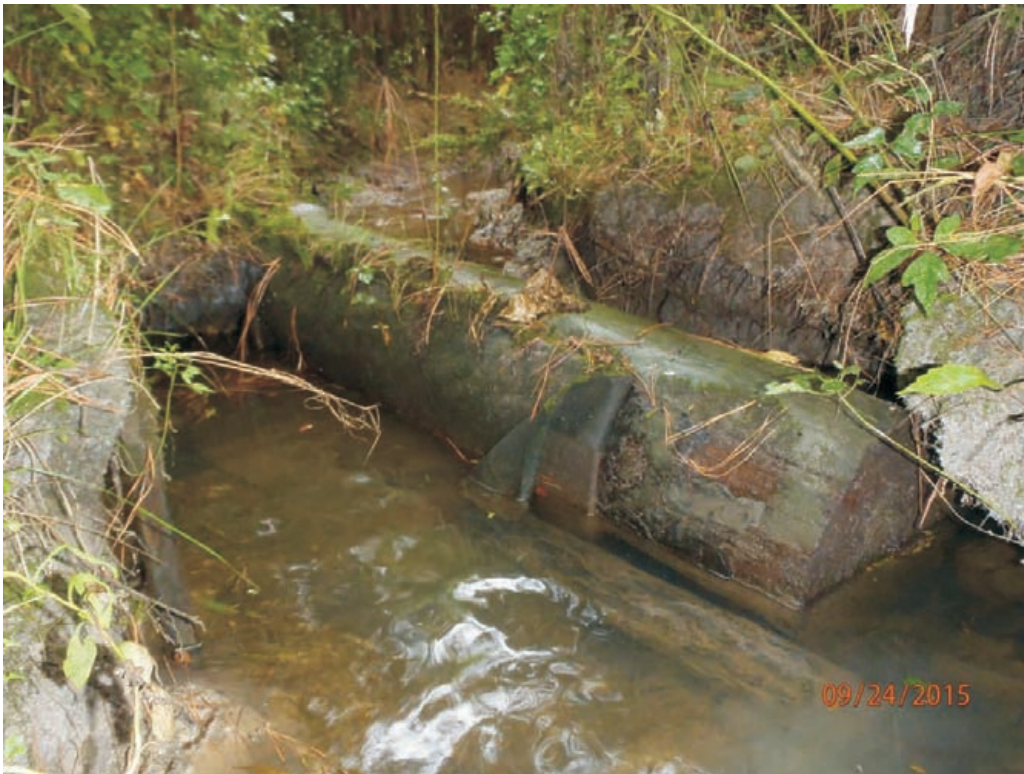
Reach 2A - Stream Problem Area #34; Log Vane Undercut

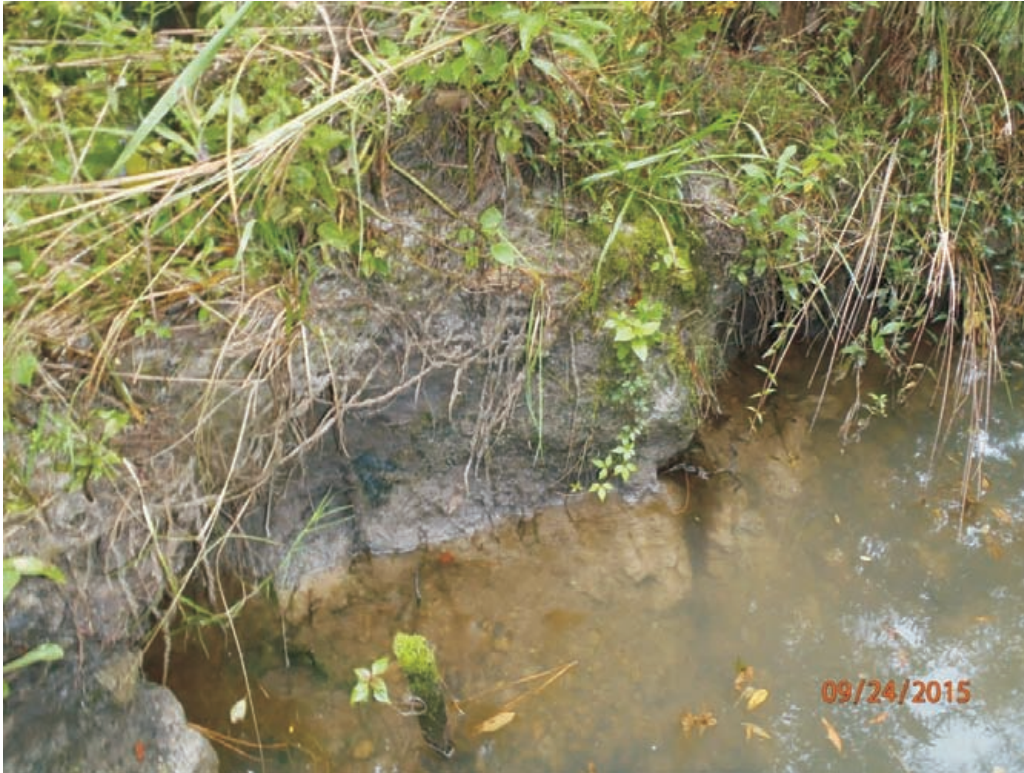
Reach 2A - Stream Problem Area #41; Scour

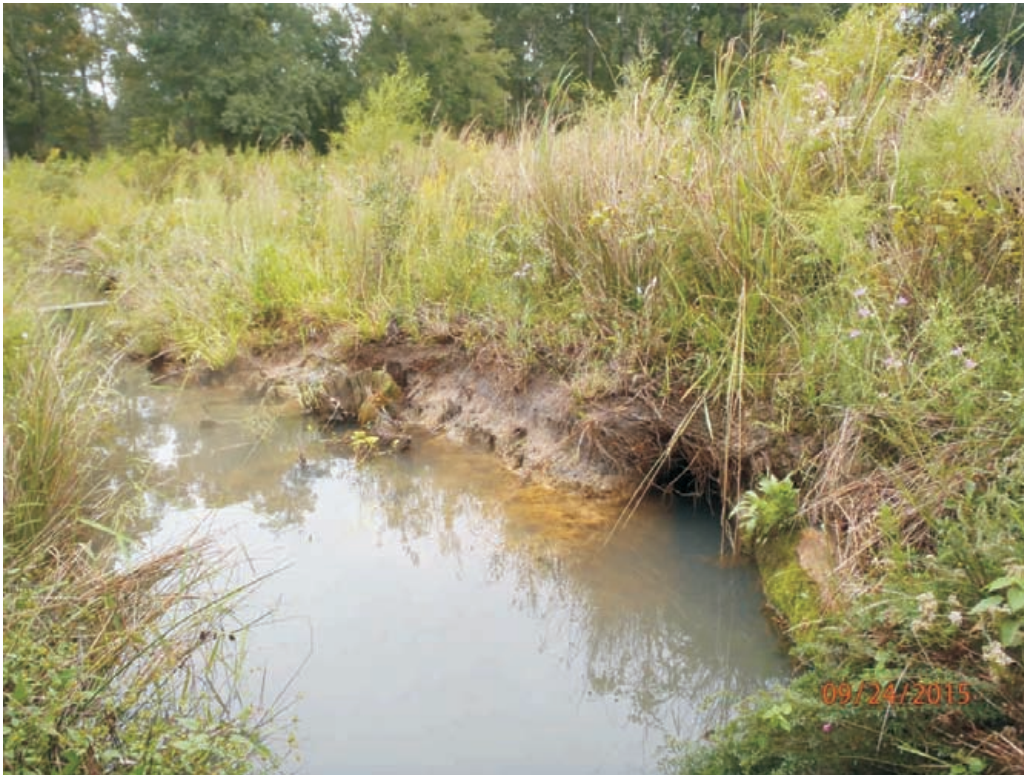
Reach 2A - Stream Problem Area #45; Scour

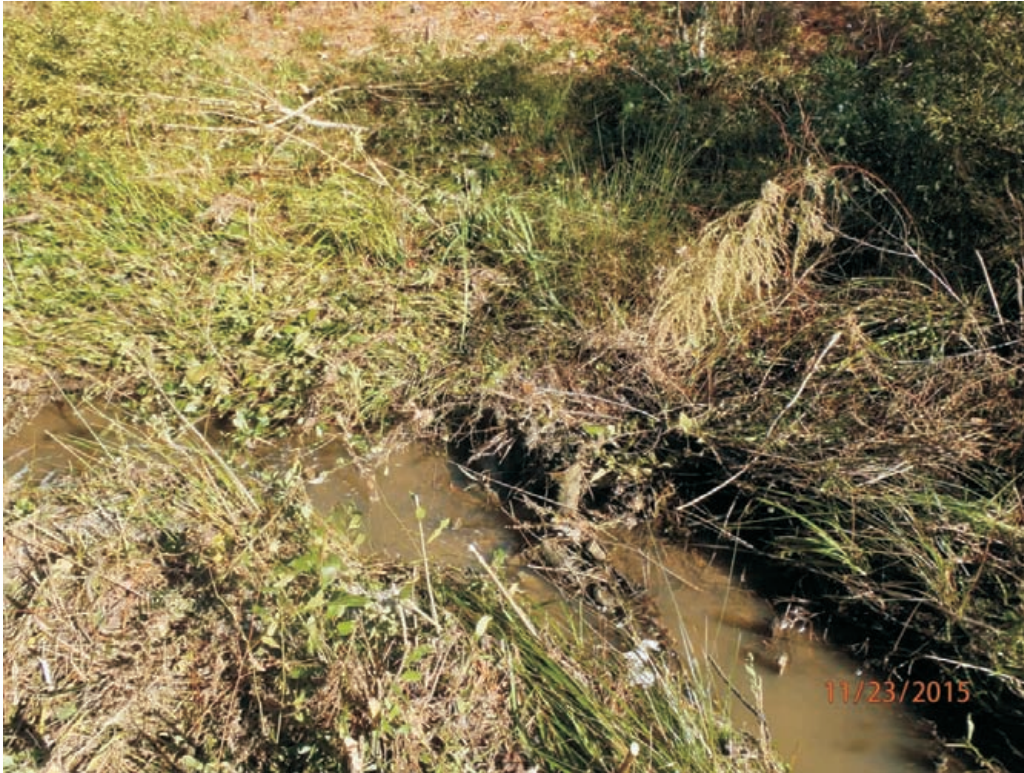
Reach B - Stream Problem Area #53; Undercut

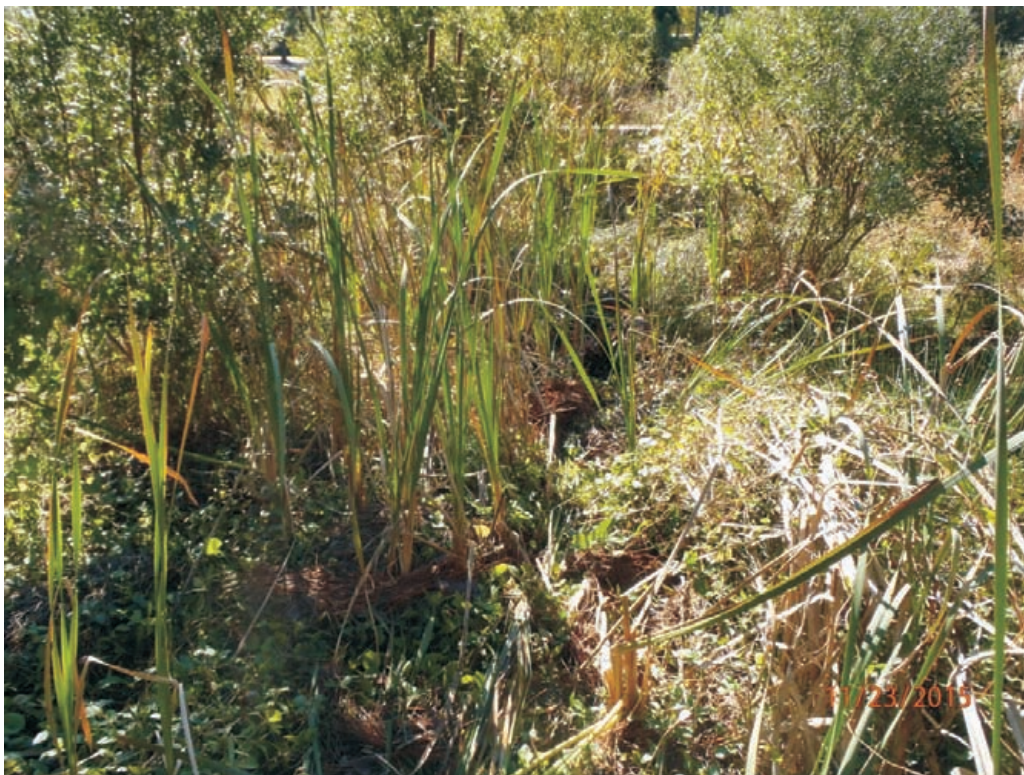
The enhancement reach is a small channel and it contains a great deal of vegetative debris. Two areas of aggradation were also noted within this channel.

Enhancement Reach - Stream Problem Area #57; Aggradation
