Jacksonville Country Club Stream Restoration and Enhancement Project

**SCO No. 070715501
DEQ Contract No. D08049S
DMS Project No. 194
Action ID# 2006-40325-067
Onslow County, North Carolina**

**Year 3 of 5 Monitoring Report
Data Collection: January through December 2016
Submission Date: February 9, 2017**

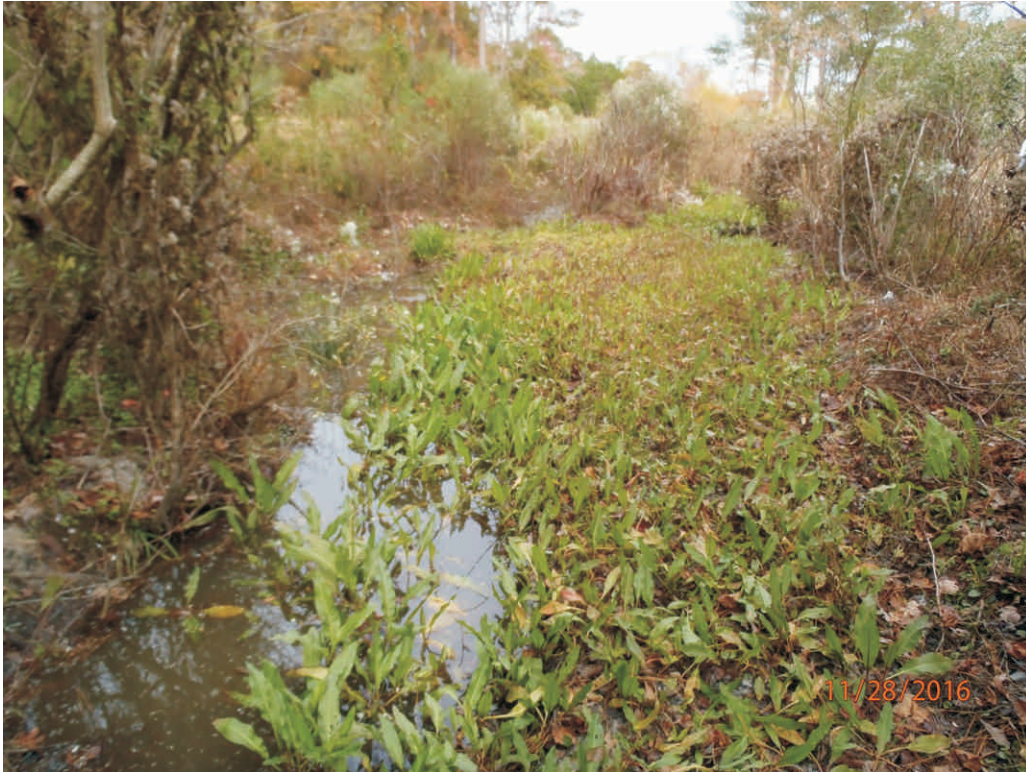
Reach 1A - Stream Problem Area 1; Aggradation; New Channel Continues to Form

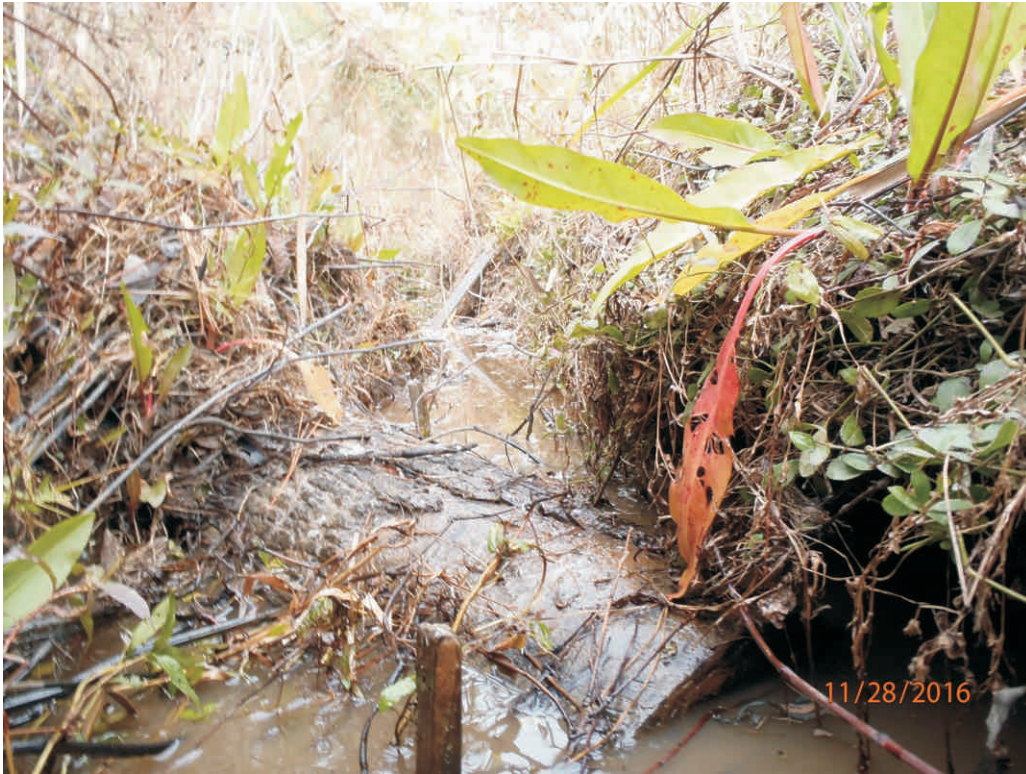
Reach 1A - Stream Problem Area #2a; scour along bank near log vane structure.

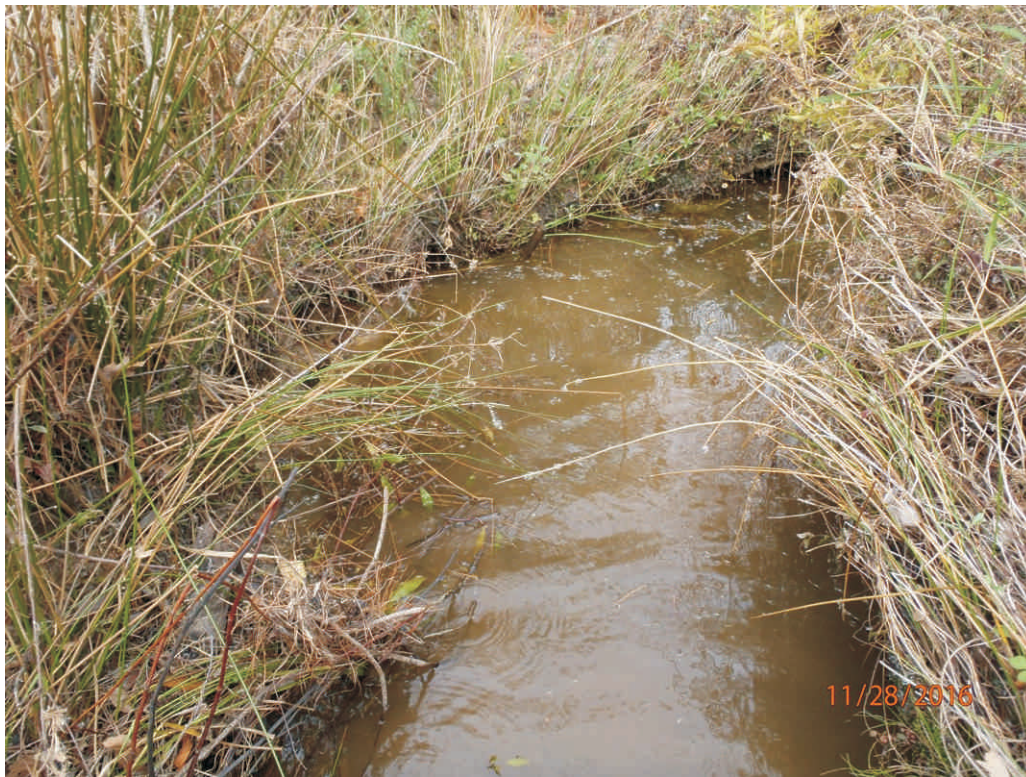
Reach 1A - Stream Problem Area #3; bank undercut

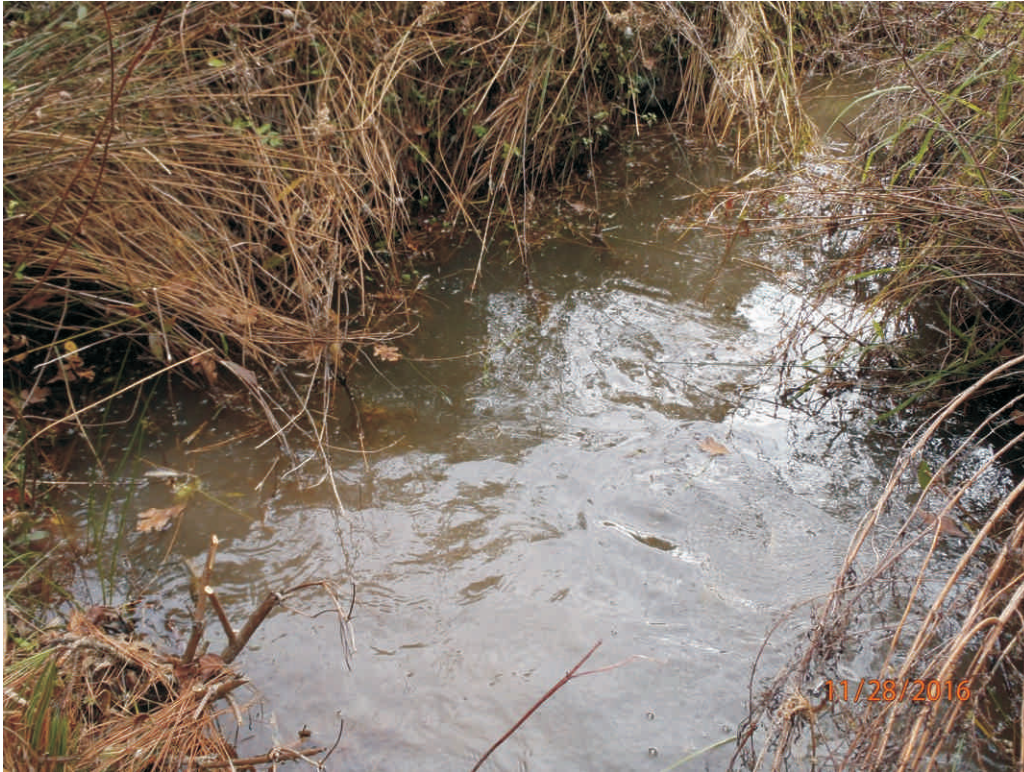
Reach 1A - Stream Problem Area #3a; scour

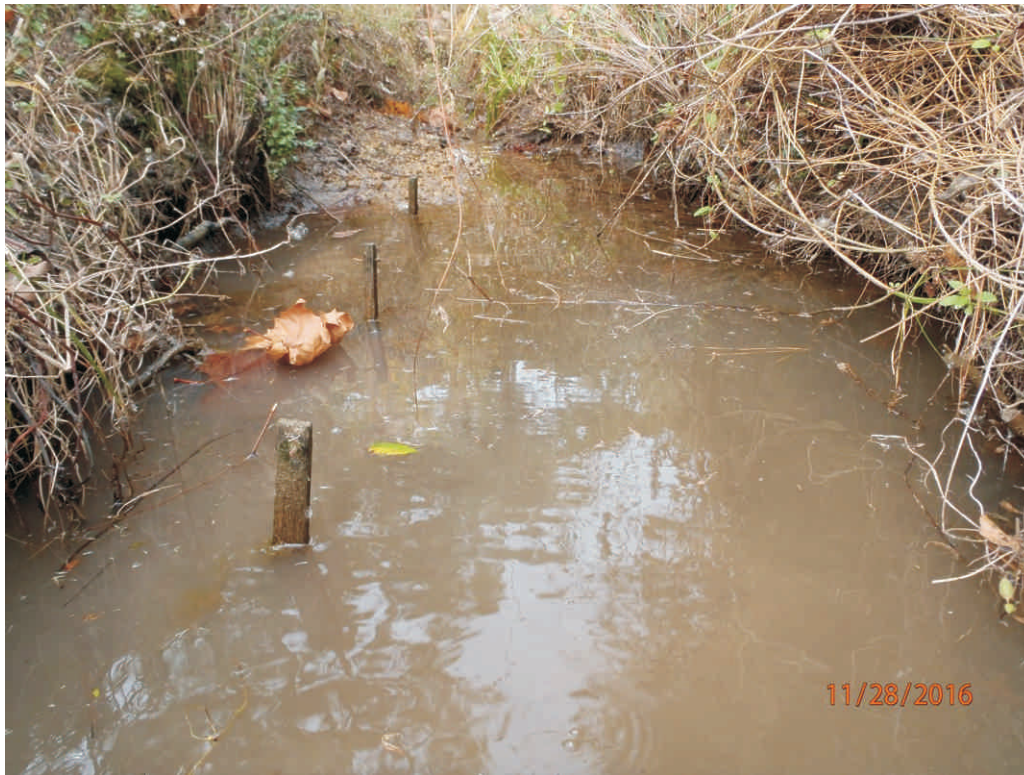
Reach 1A - Stream Problem Area #4; bank undercut

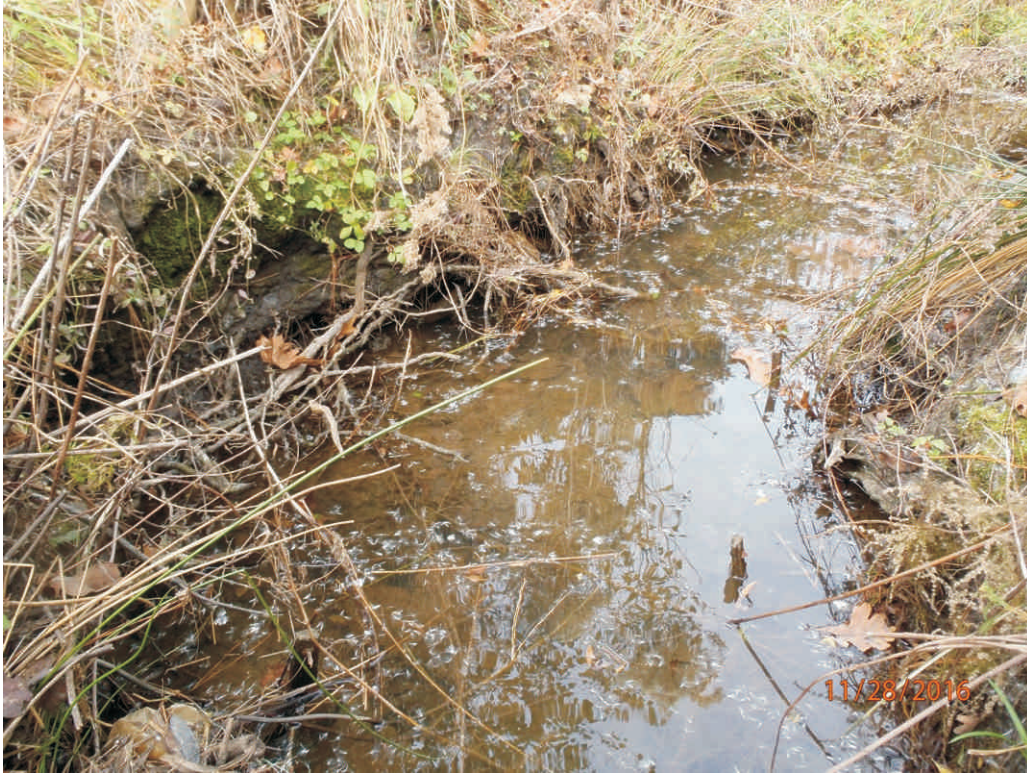
Reach 1A - Stream Problem Area #5; bank undercut becoming scour

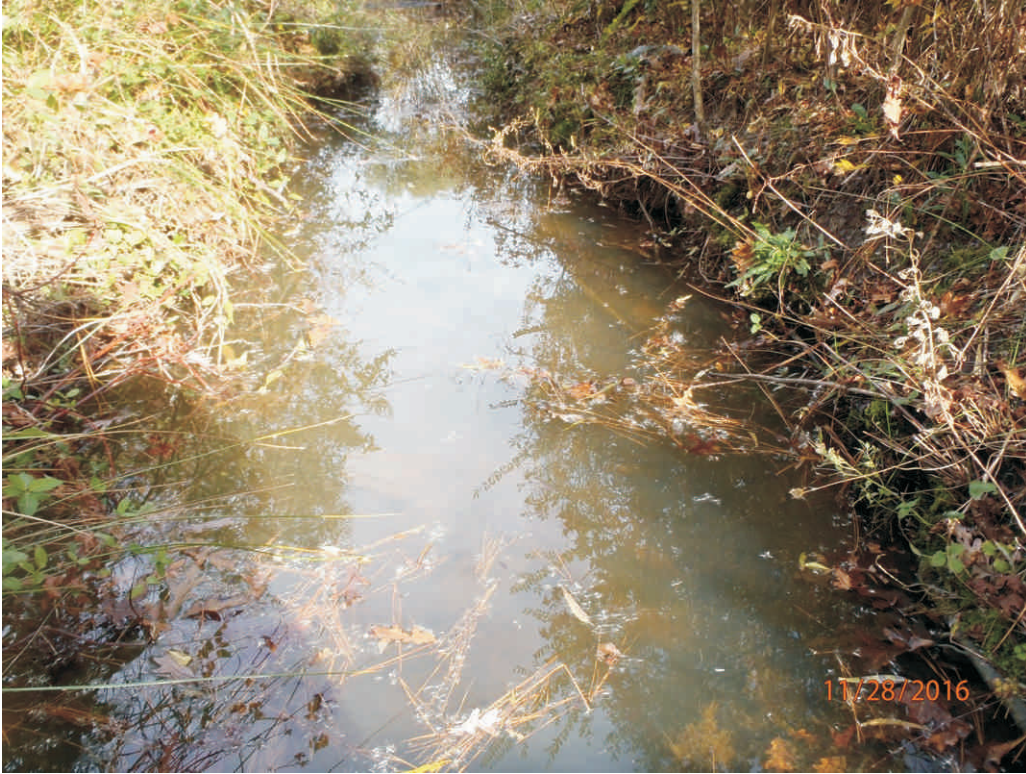
Reach 1A - Stream Problem Area #11; Log Vane Undercut becoming scour

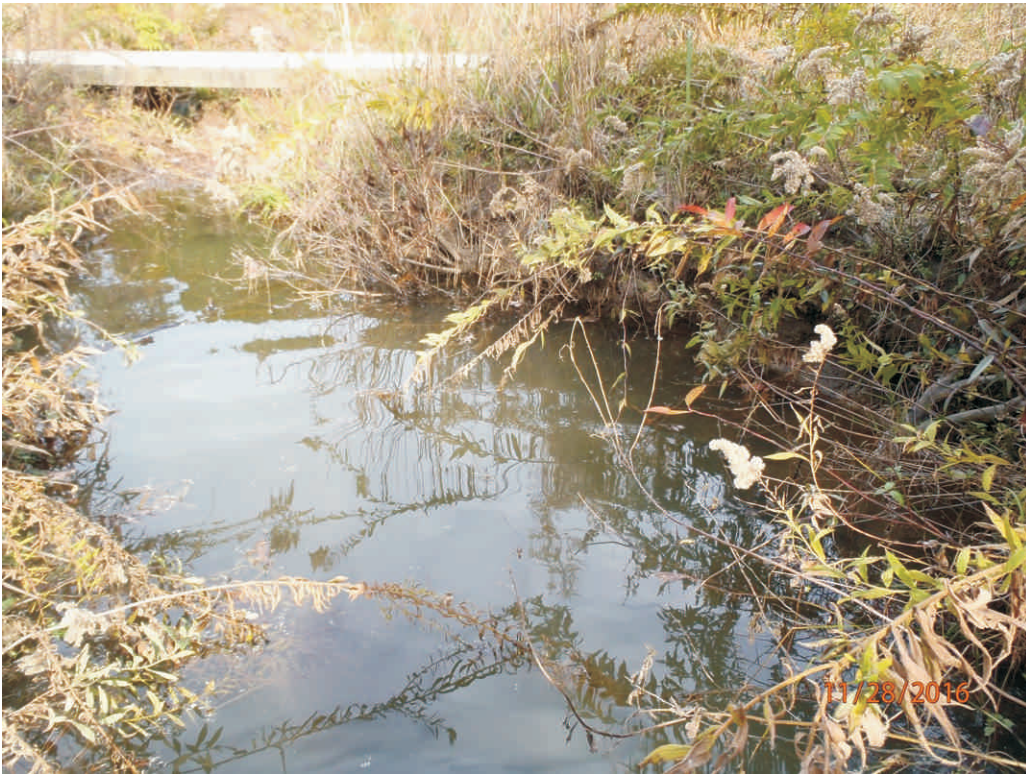
Reach 1A - Stream Problem Area #12; Scour

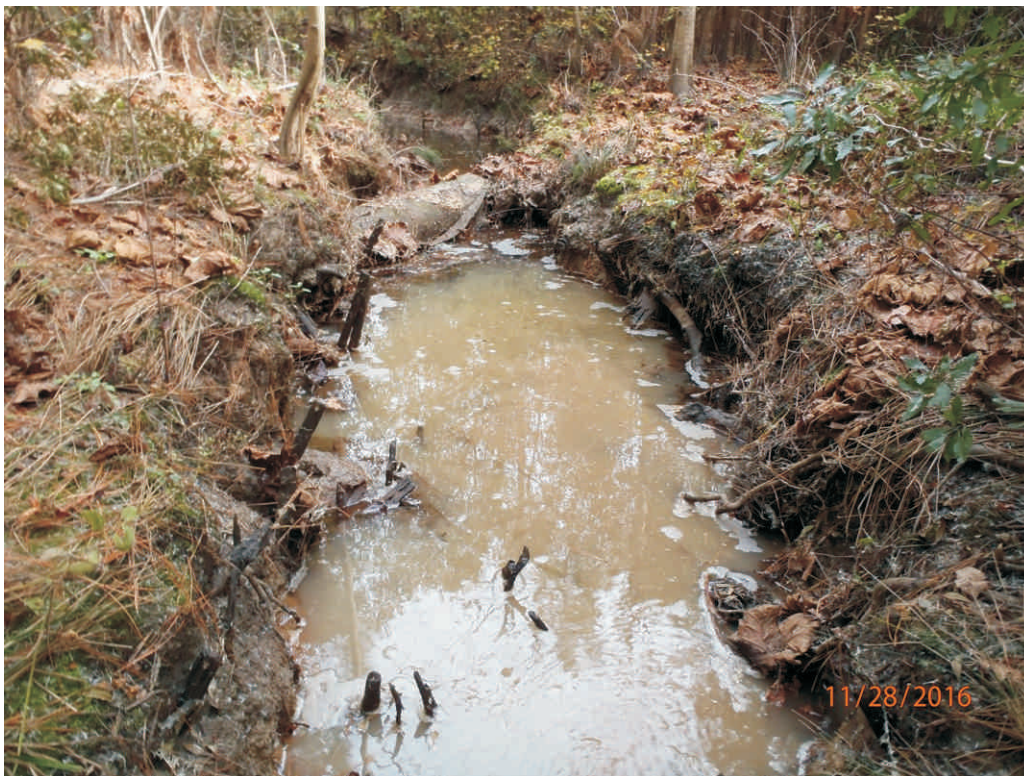
Reach 2A - Stream Problem Area #30; Log Vane Scour

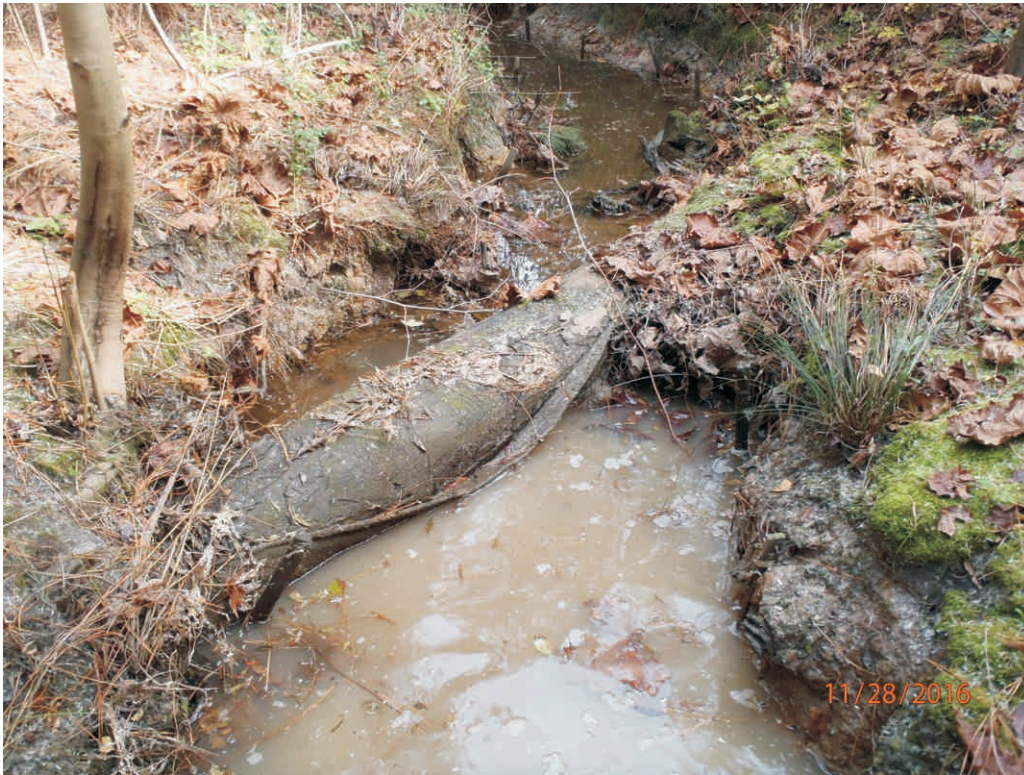
Reach 2A - Stream Problem Area #31; Scour

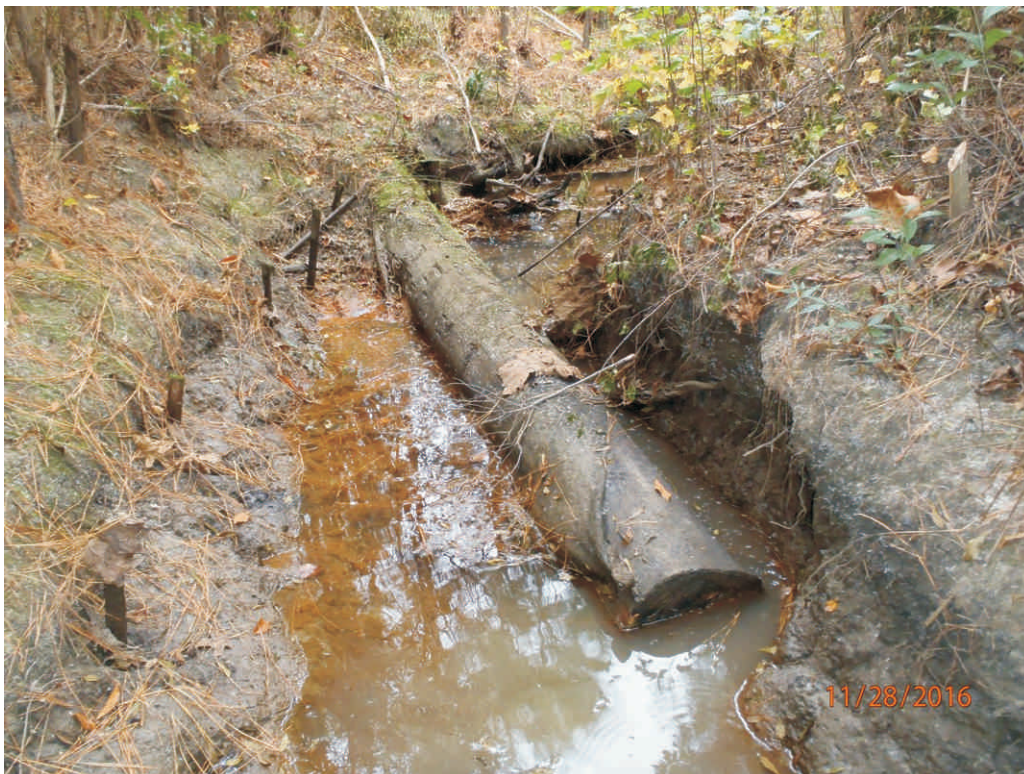
Reach 2A - Stream Problem Area #35a; Log Vane Scour

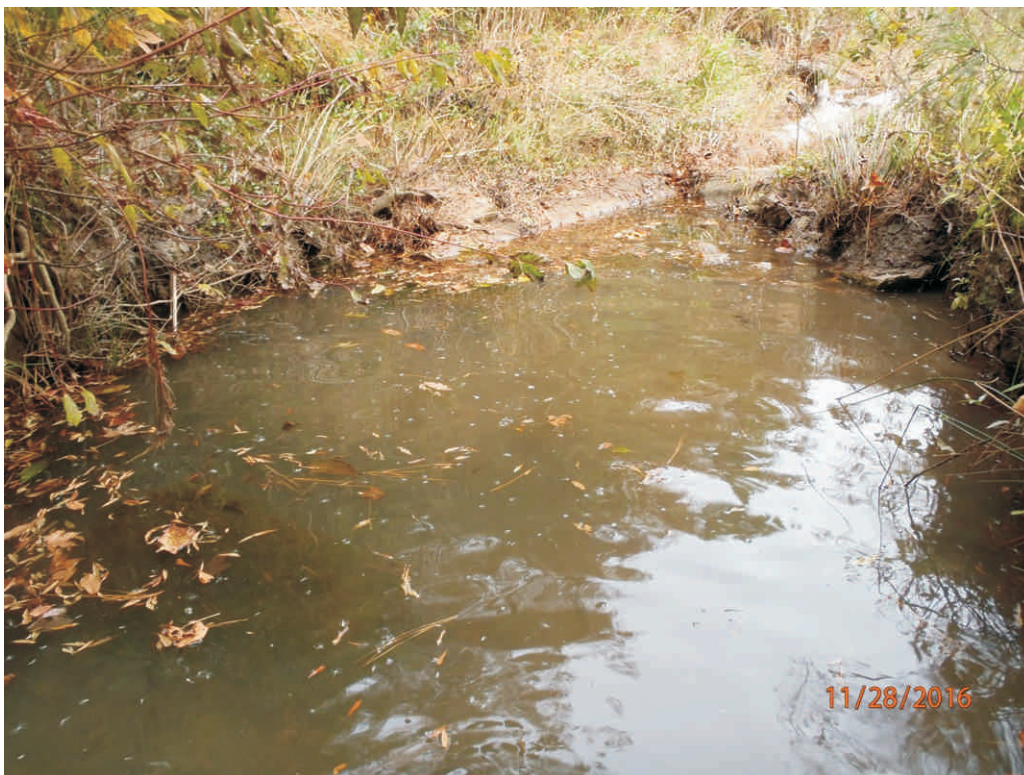
Reach 2A - Stream Problem Area #41; Scour

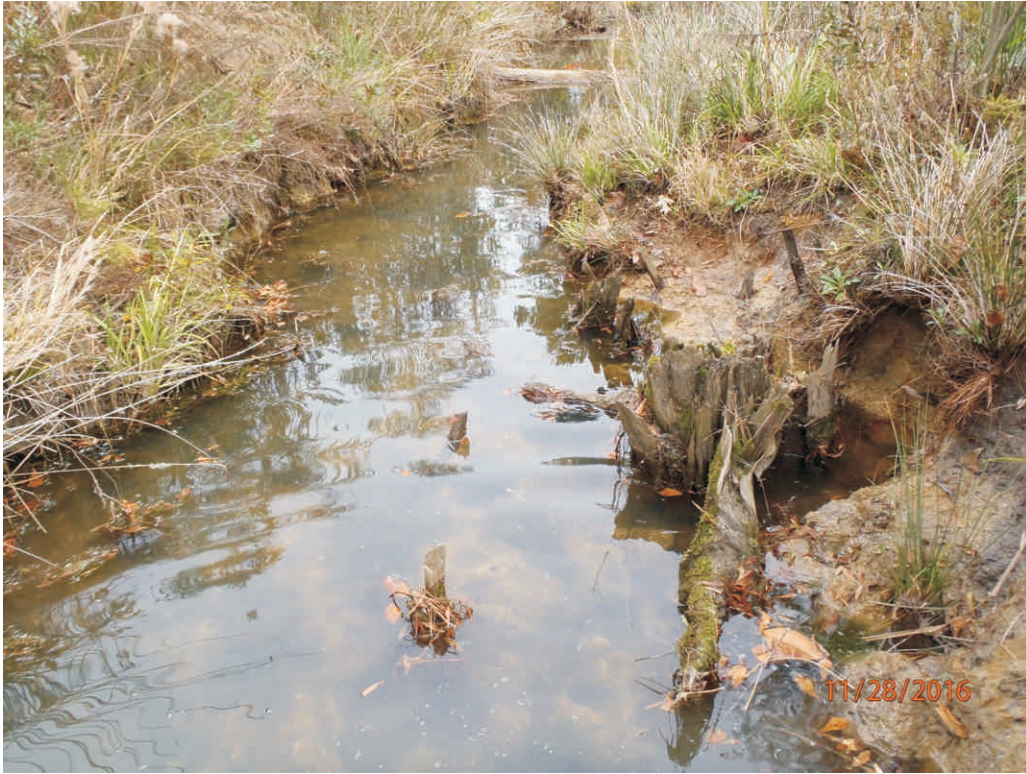
Reach 2A - Stream Problem Area #44; Scour

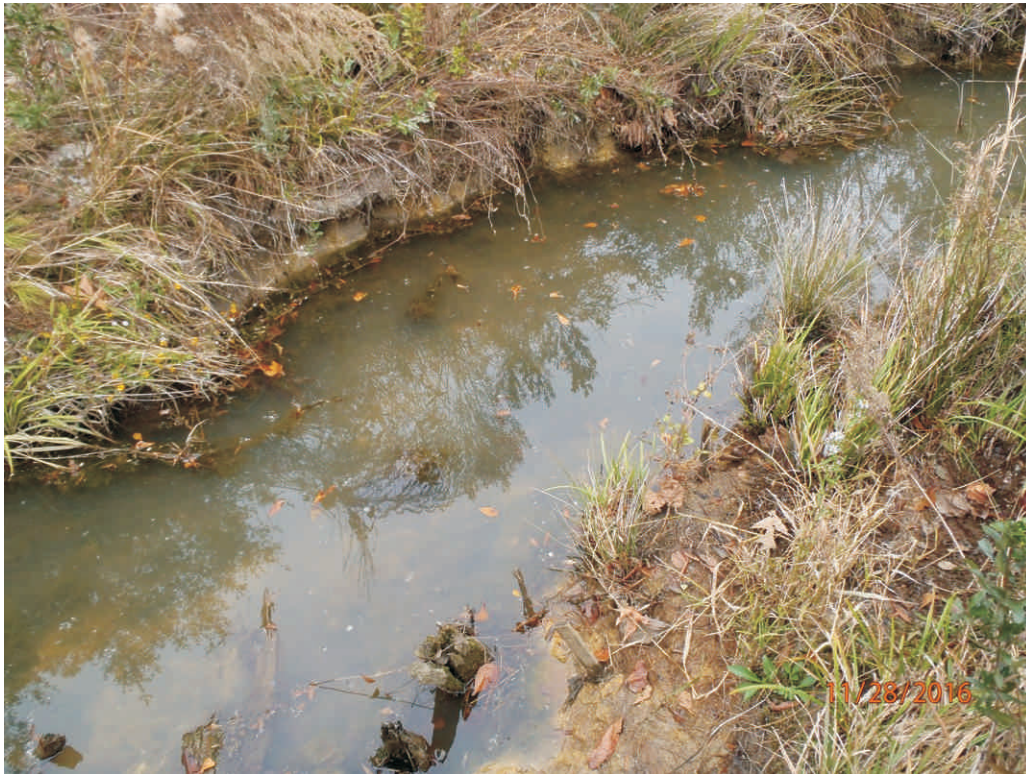
Reach 2A - Stream Problem Area #45; Scour

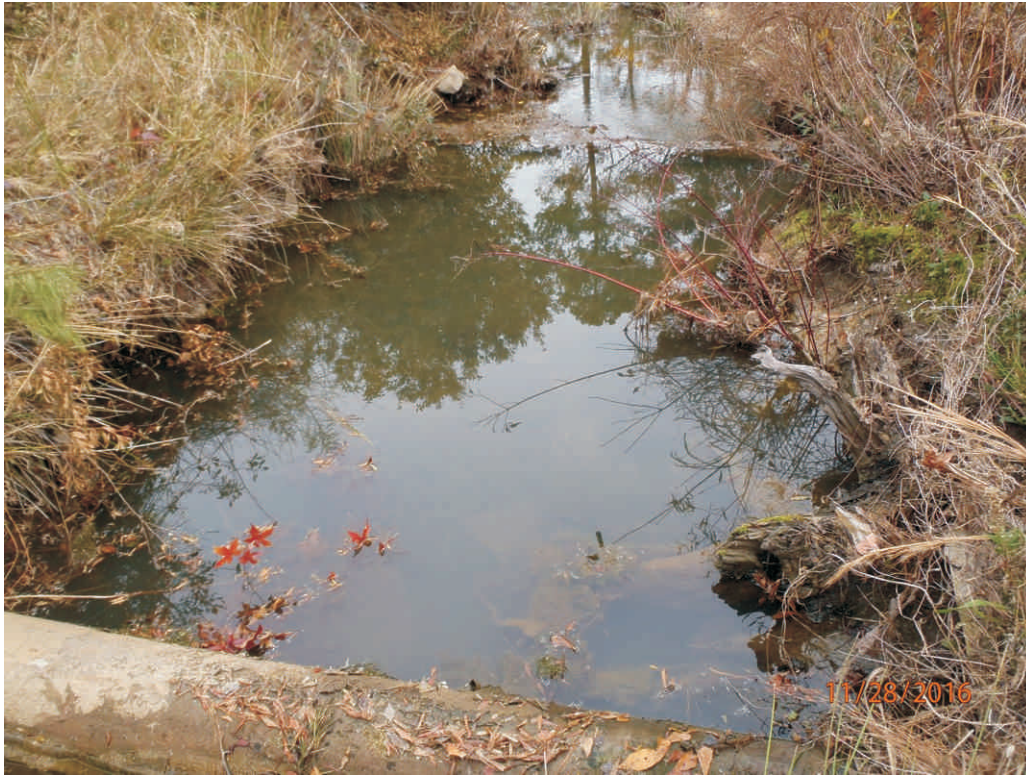
Reach 2A - Stream Problem Area #45a; Log Vane Scour

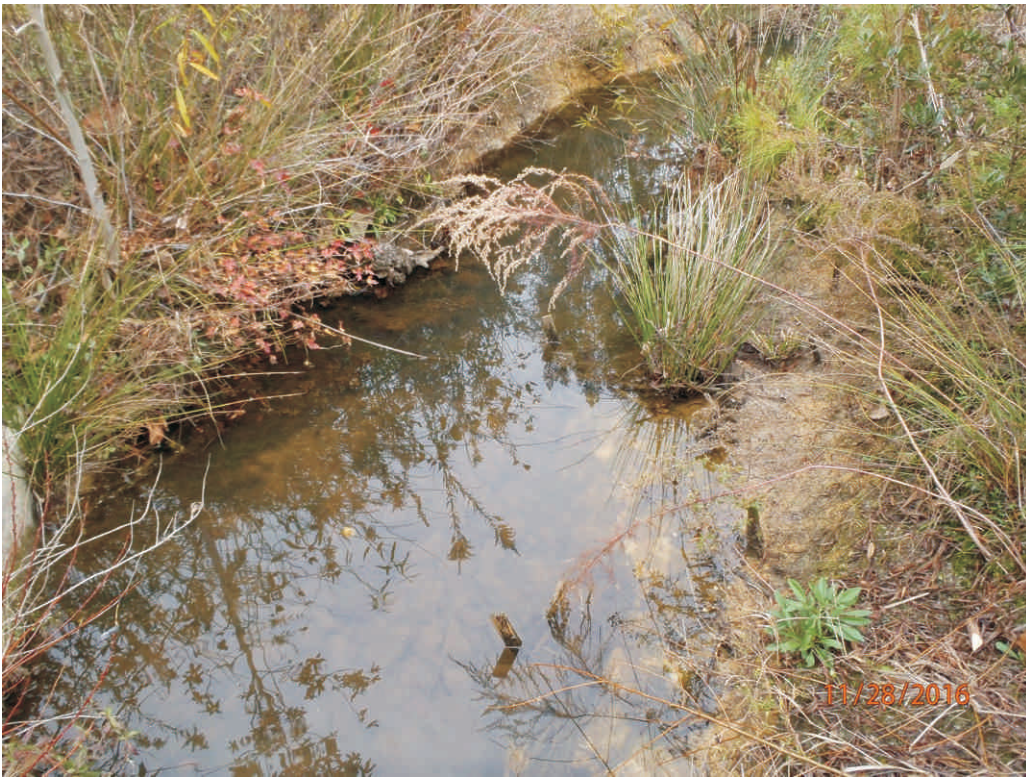
Reach 2A - Stream Problem Areas #47-48; Scour

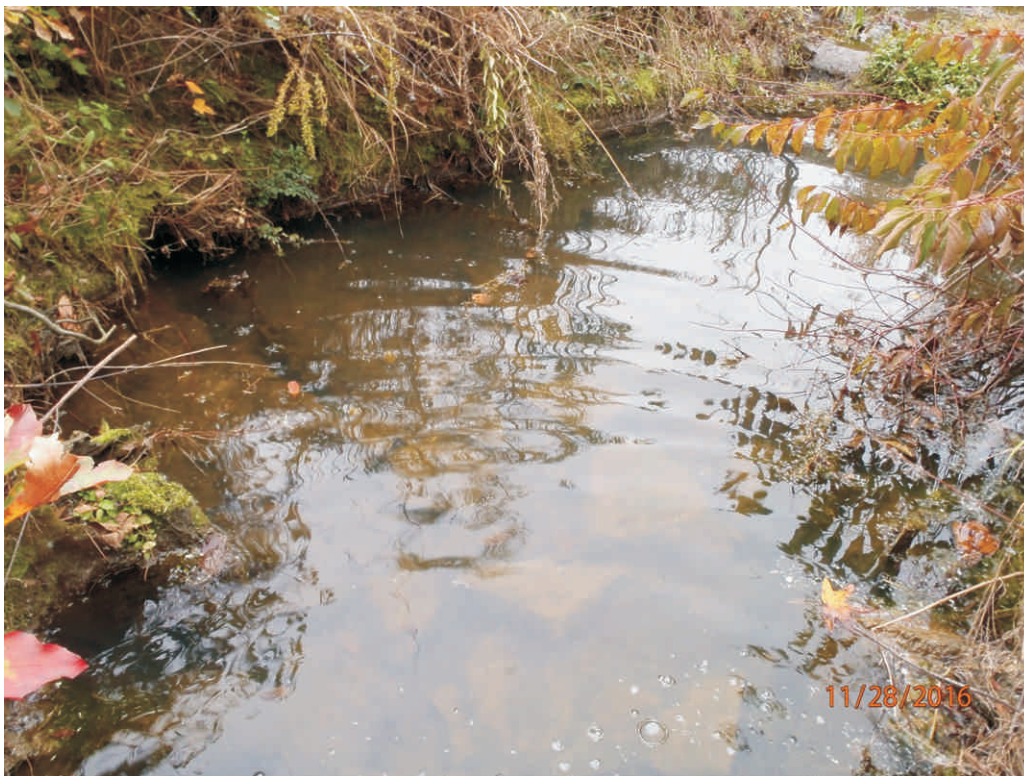
Reach 2A - Stream Problem Area #50; Undercut becoming Scour

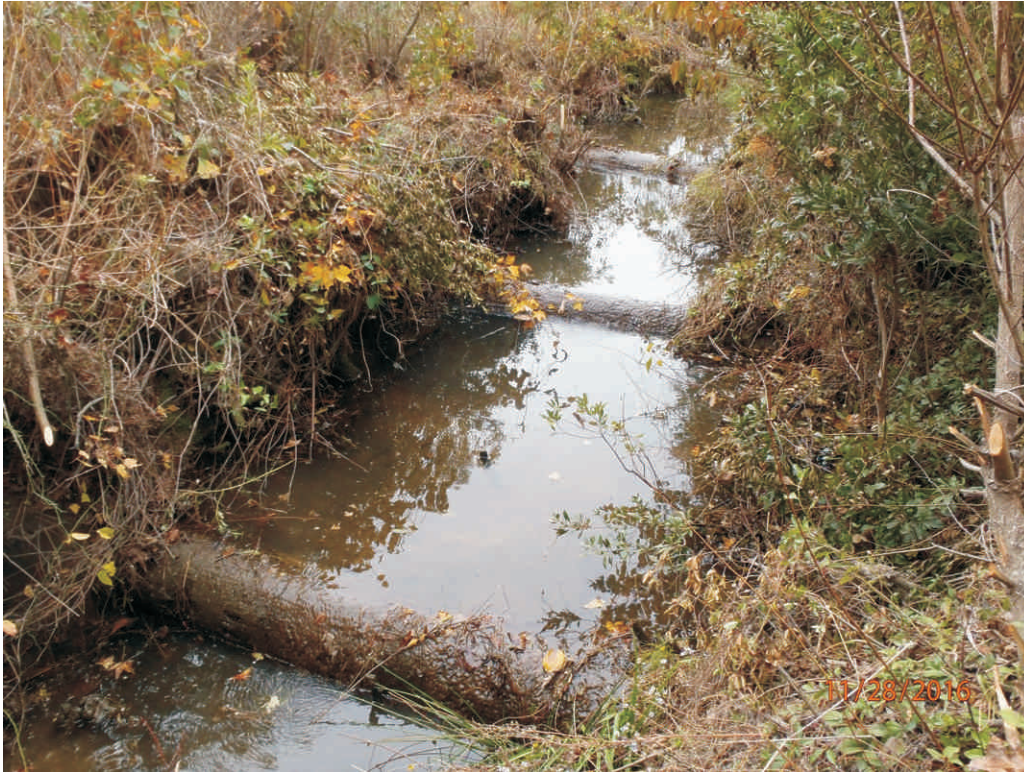
Reach 2A - Stream Problem Area #50a; Scour below Log Vanes

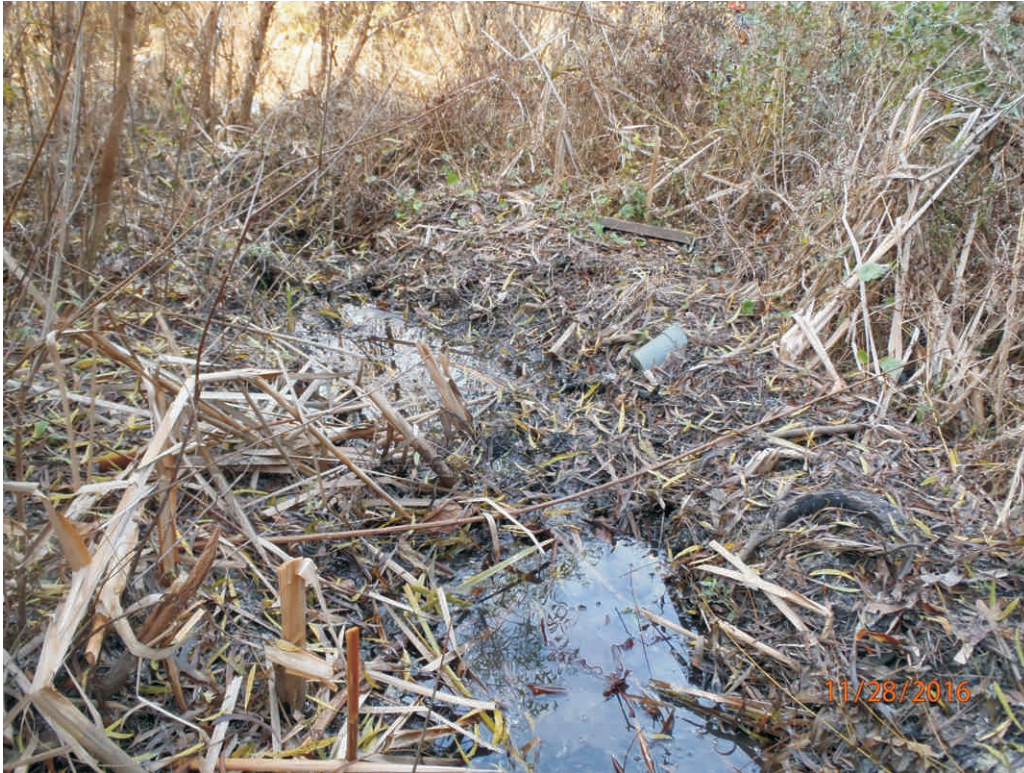
Reach B - Stream Problem Area #51; Aggradation

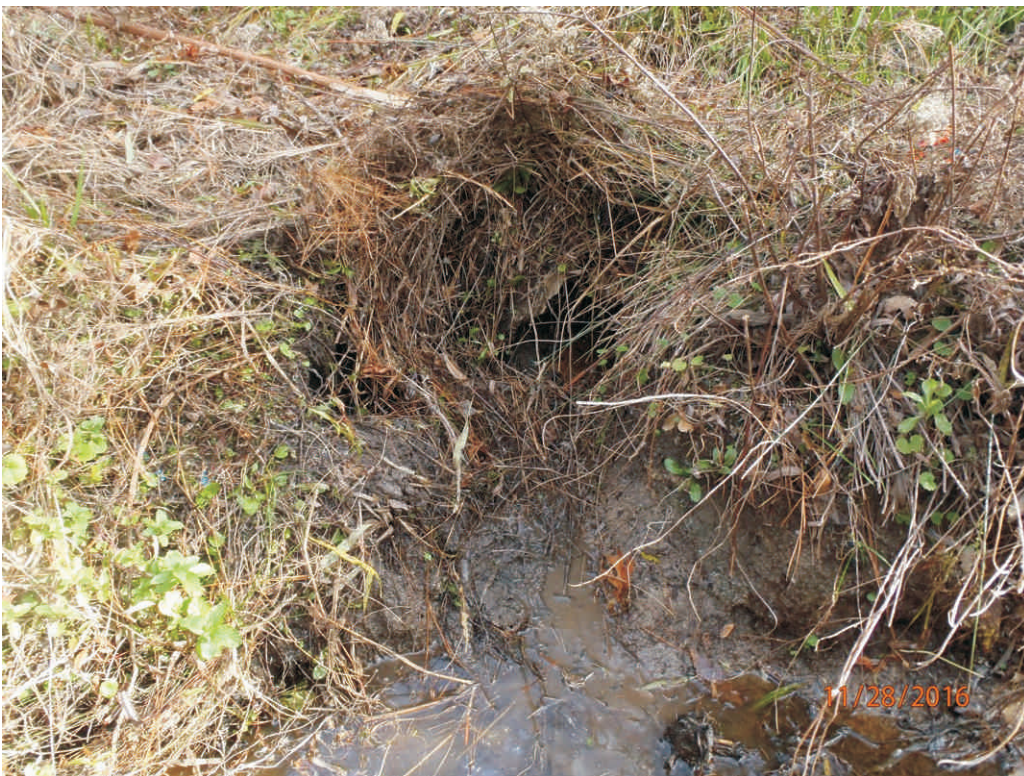
Reach B - Stream Problem Area #52; Mass Wasting

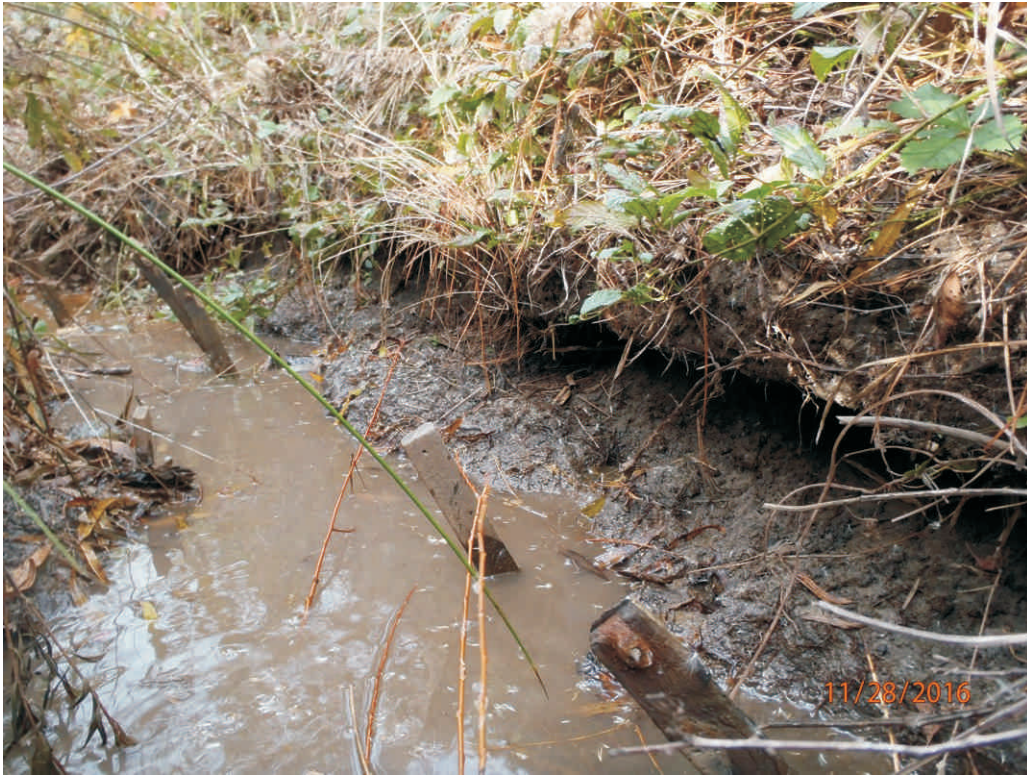
Reach B - Stream Problem Area #53; Undercut

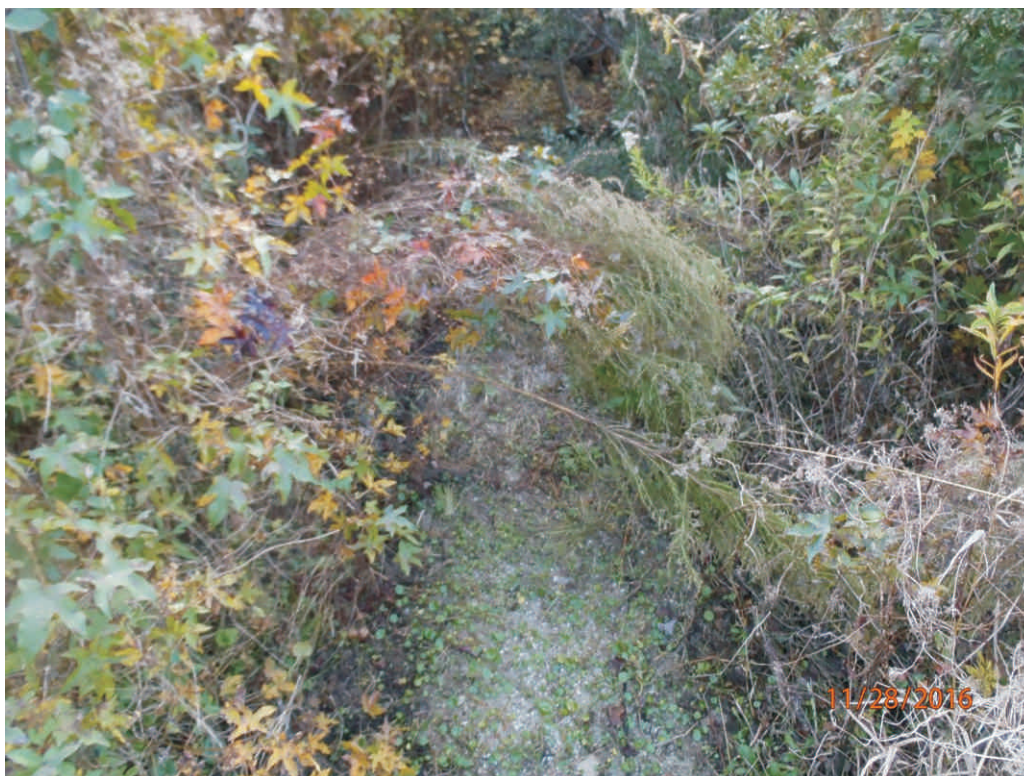
Enhancement Reach - Stream Problem Area #56; Aggradation

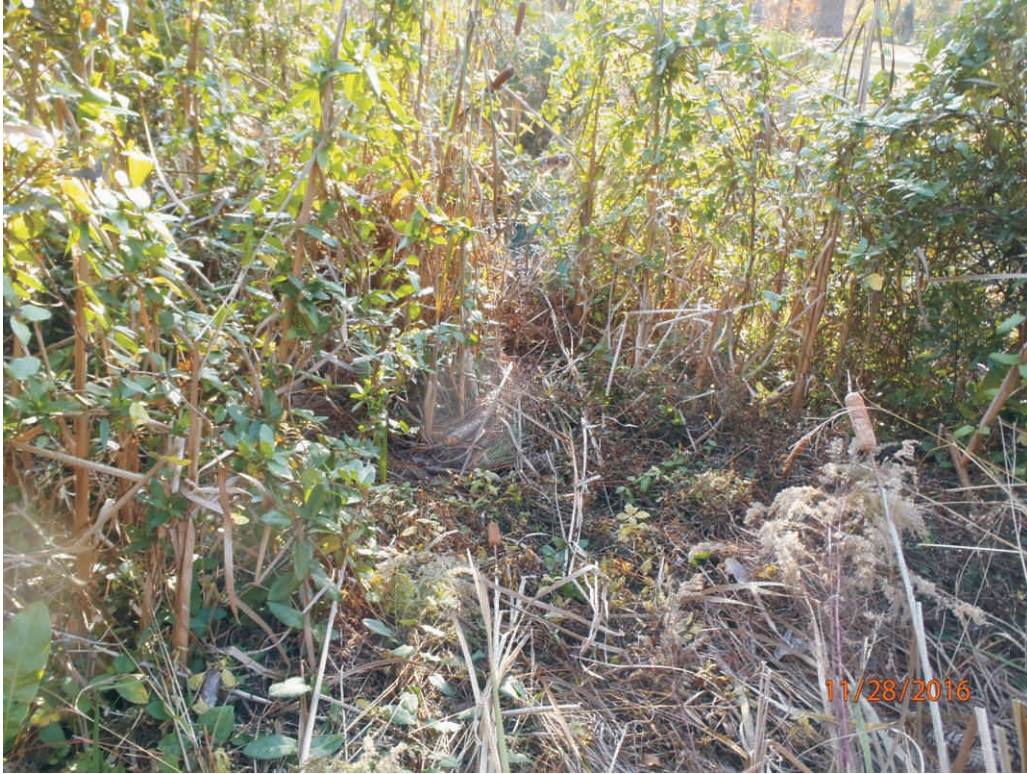
Enhancement Reach - Stream Problem Area #57; Aggradation

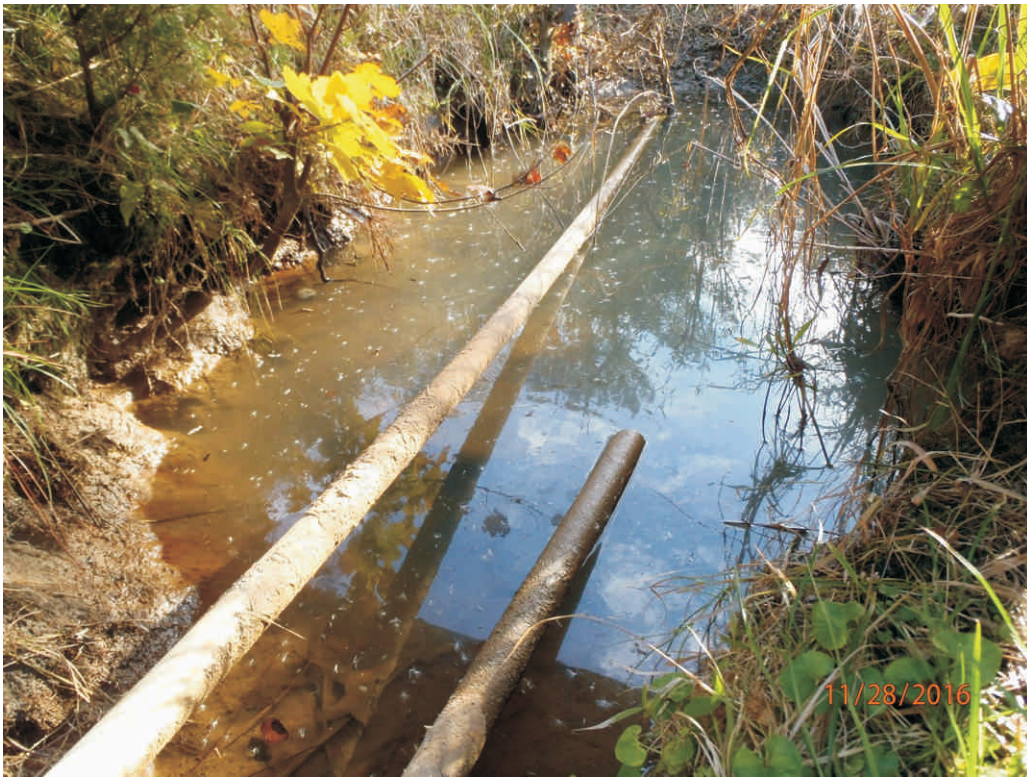
Enhancement Reach - Stream Problem Area #57a; Scour

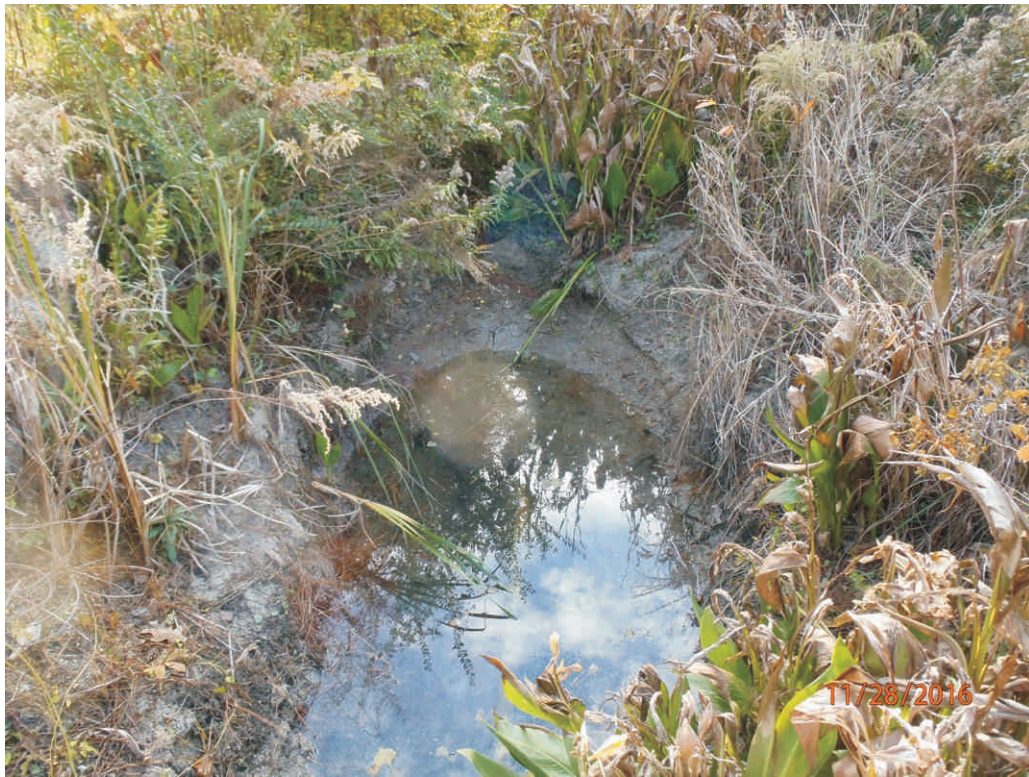
Enhancement Reach - Stream Problem Area #57c; Scour
