Jacksonville Country Club Stream Restoration and Enhancement Project

**SCO No. 070715501
DEQ Contract No. D08049S
DMS Project No. 194
Action ID# 2006-40325-067
Onslow County, North Carolina**

**Year 4 of 5 Monitoring Report
Data Collection: January through December 2017
Submission Date: March 9, 2018**

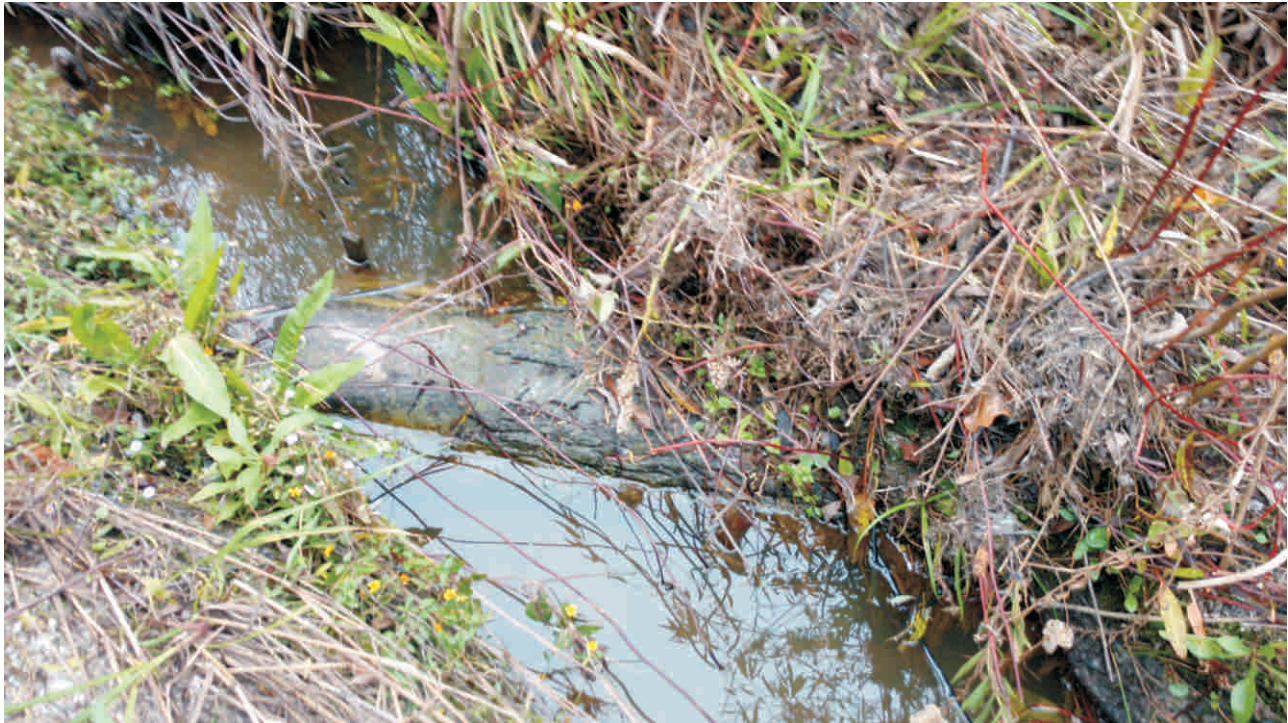
Reach 1A - Stream Problem Area #2a; scour along bank near log vane structure.

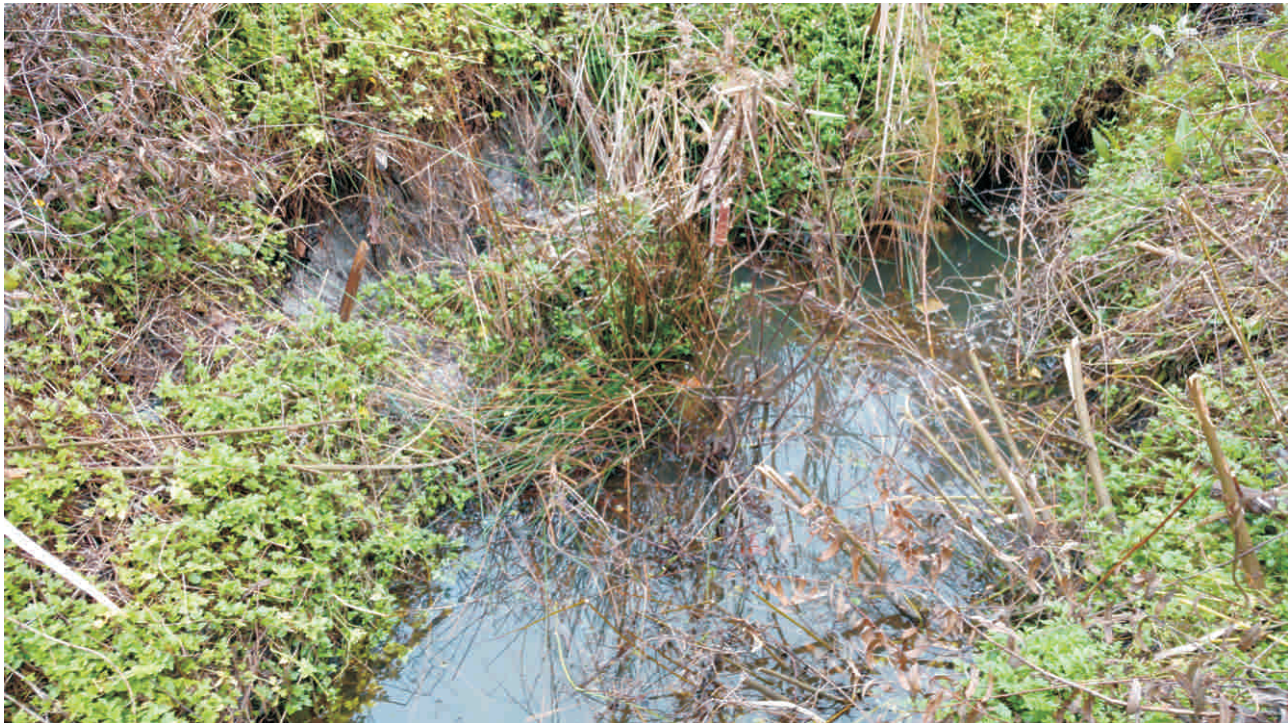
Reach 1A - Stream Problem Area #3; scour

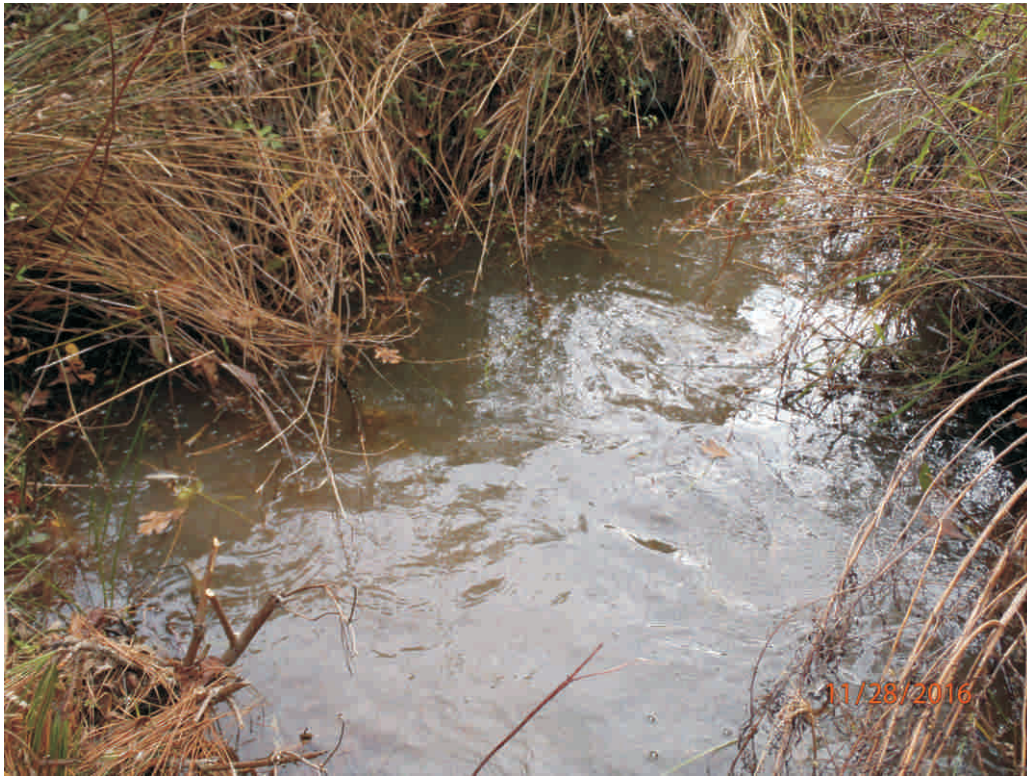
Reach 1A - Stream Problem Area #3a; scour

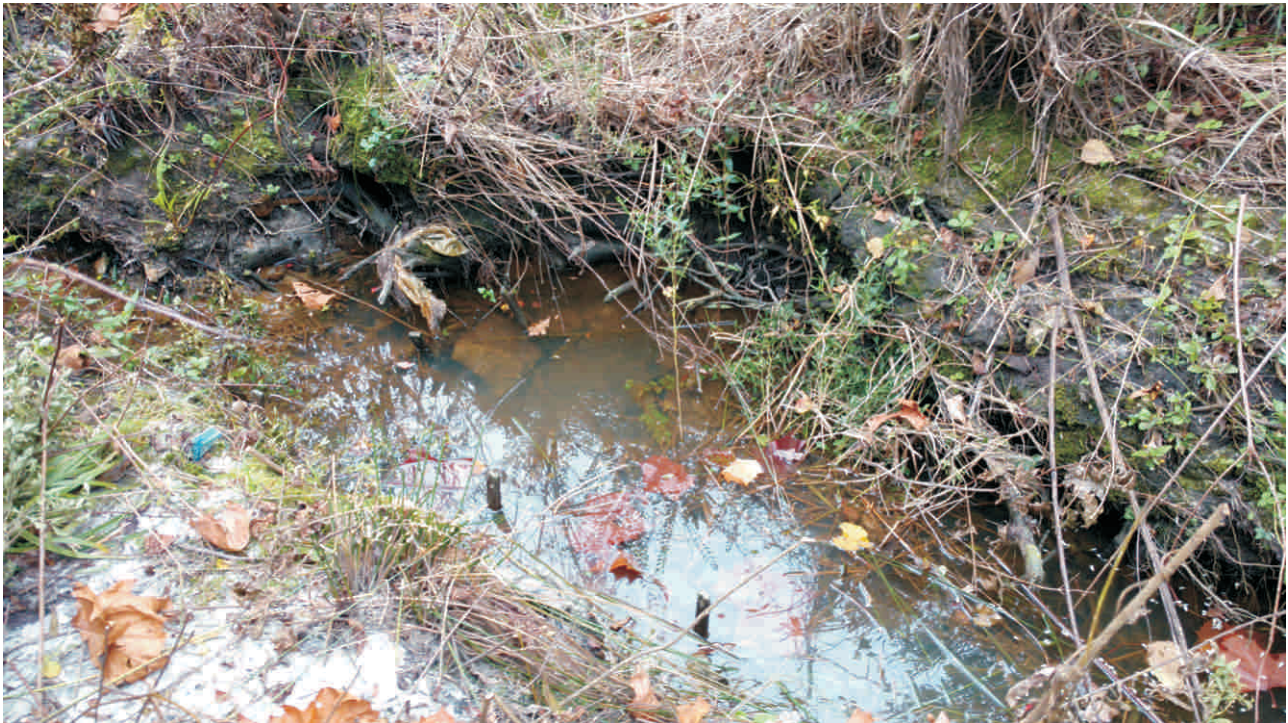
Reach 1A - Stream Problem Area #4; bank undercut

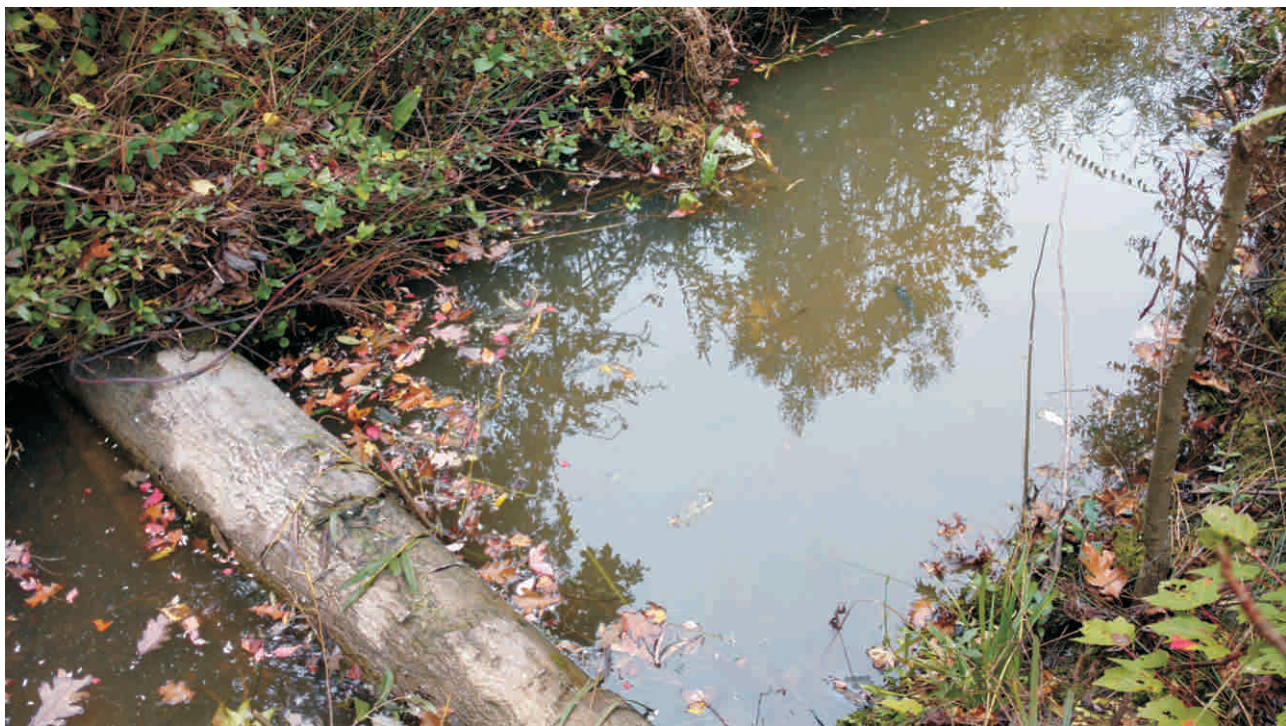
Reach 1A - Stream Problem Area #10; Log Vane Undercut becoming scour

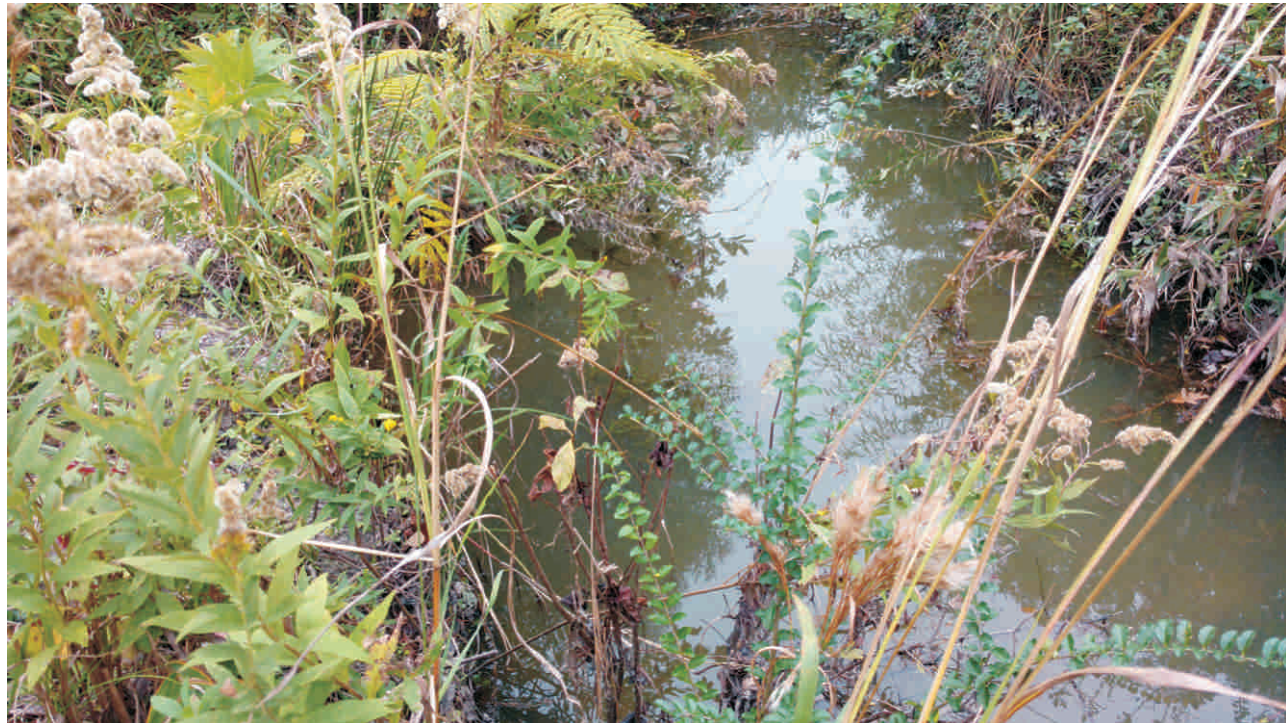
Reach 1A - Stream Problem Area #11; Log Vane Undercut becoming scour

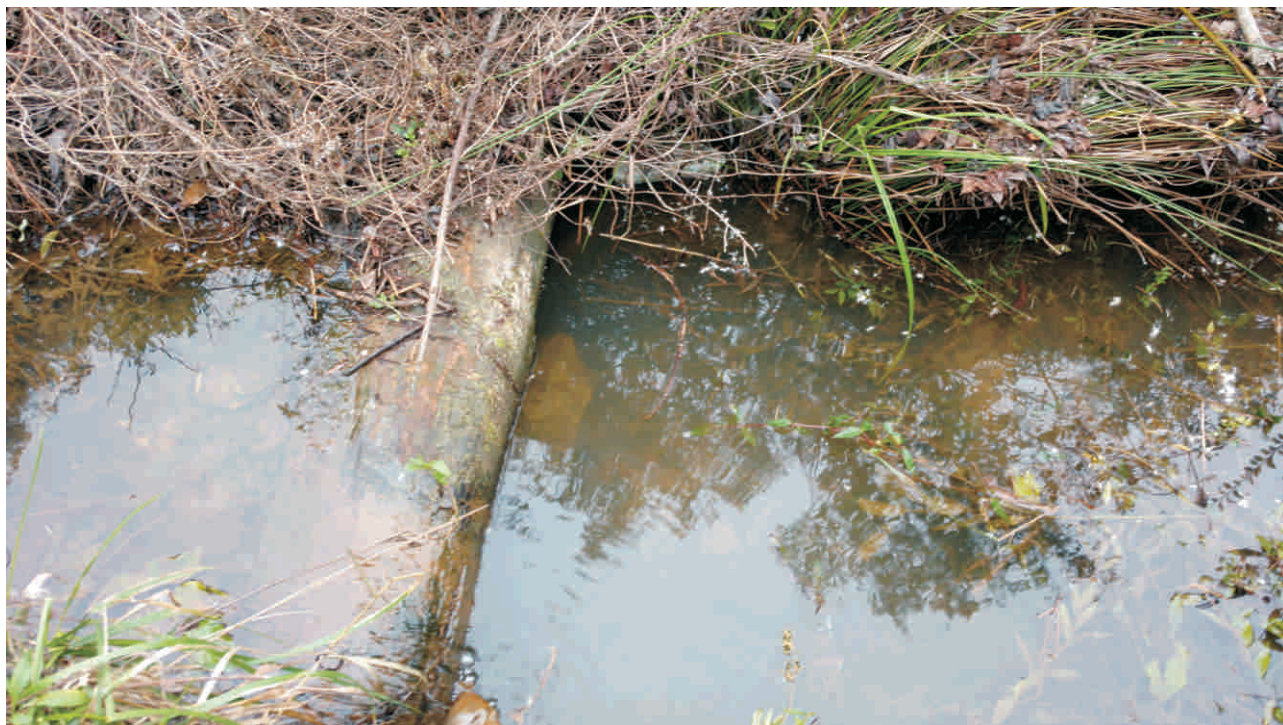
Reach 1A - Stream Problem Area #13a; Scour

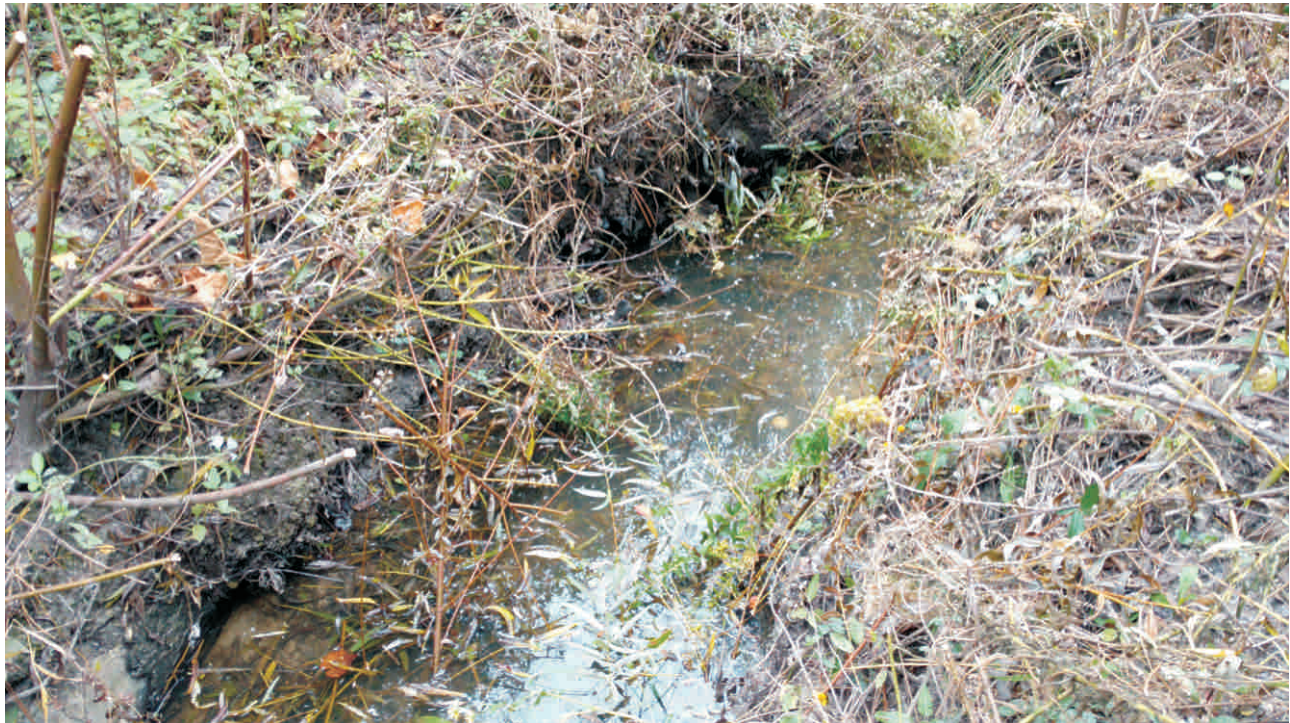
Reach 1A - Stream Problem Area #14; Scour

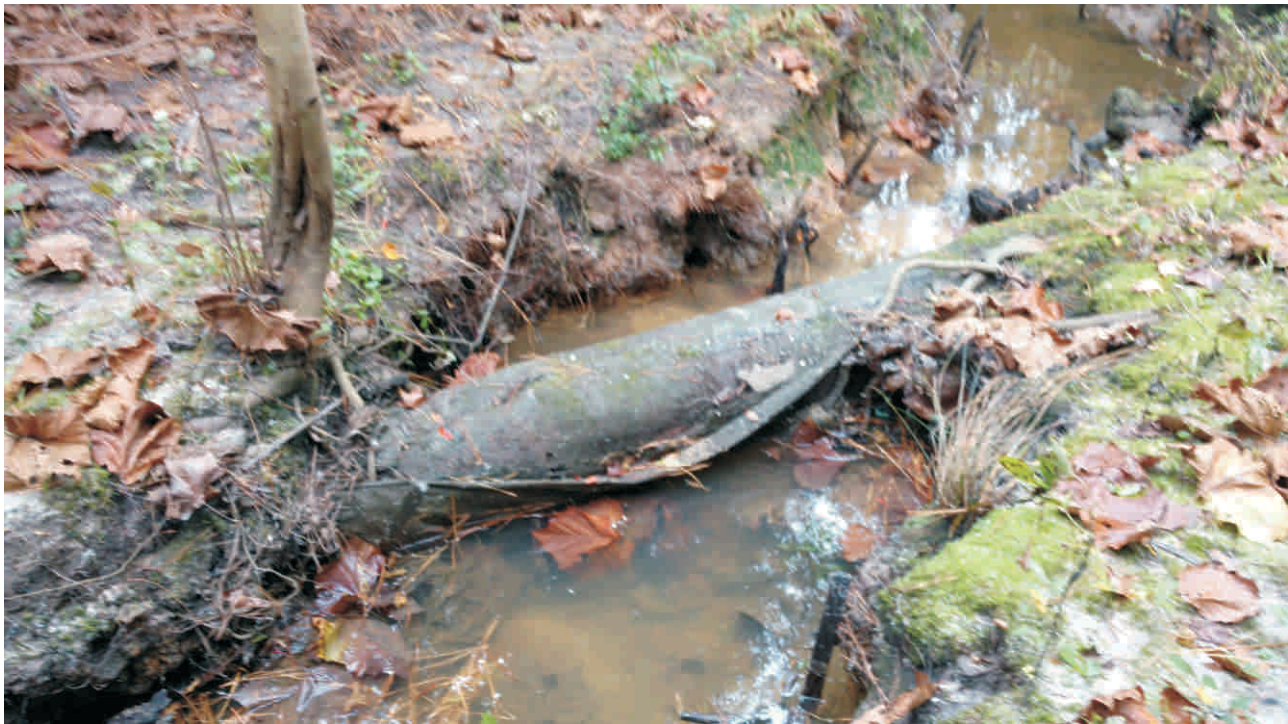
Reach 2A - Stream Problem Area #29; Scour

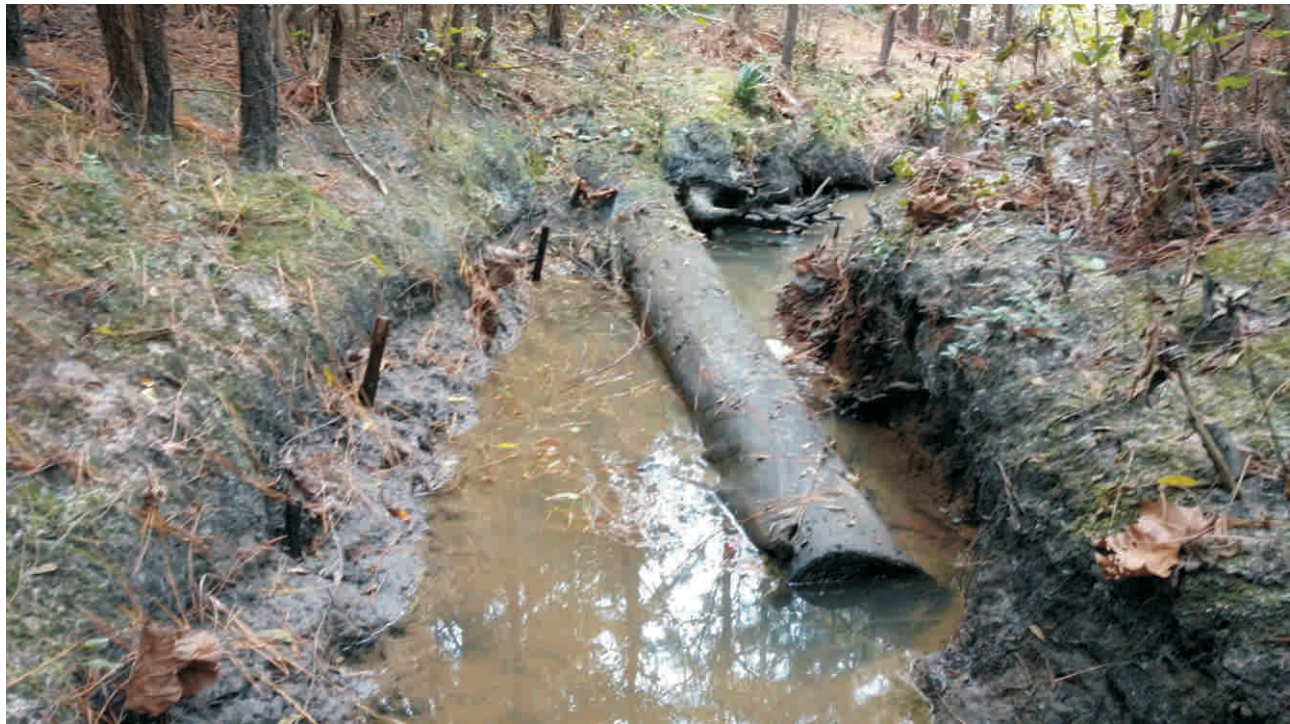
Reach 2A - Stream Problem Area #35; Log Vane Mass Wasting

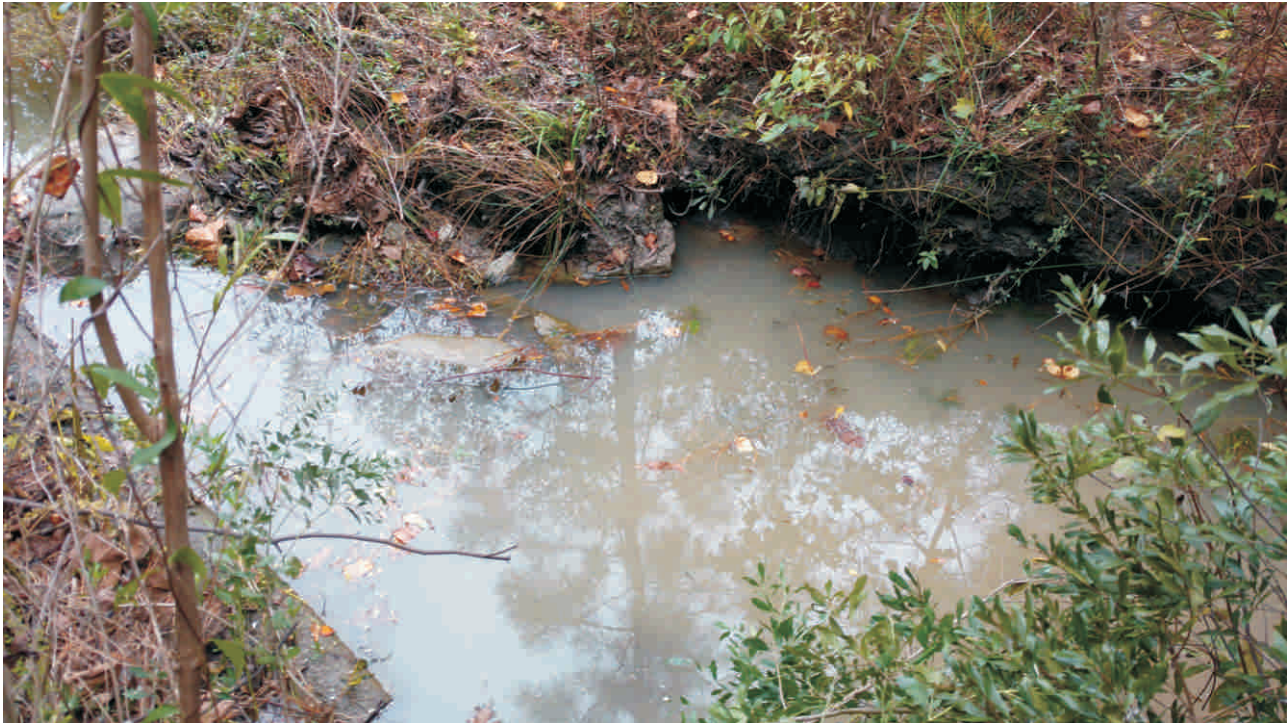
Reach 2A - Stream Problem Area #40; Log Vane Scour

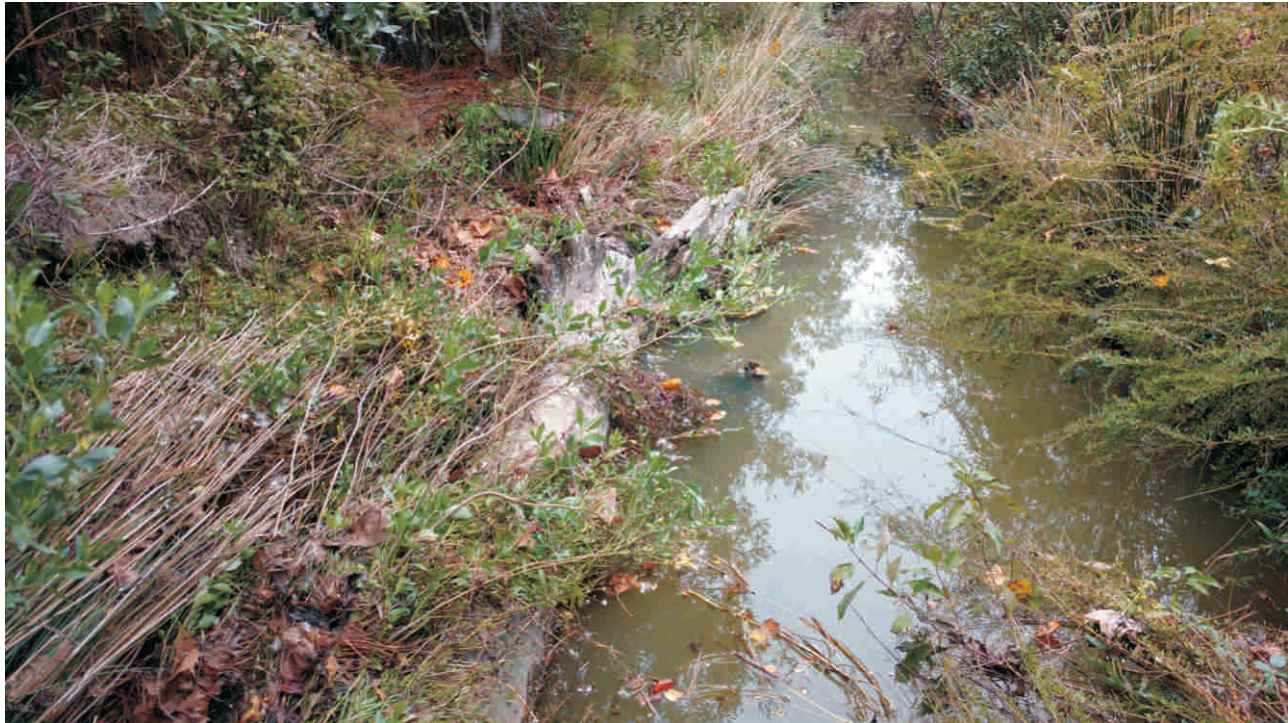
Reach 2A - Stream Problem Area #41; Scour

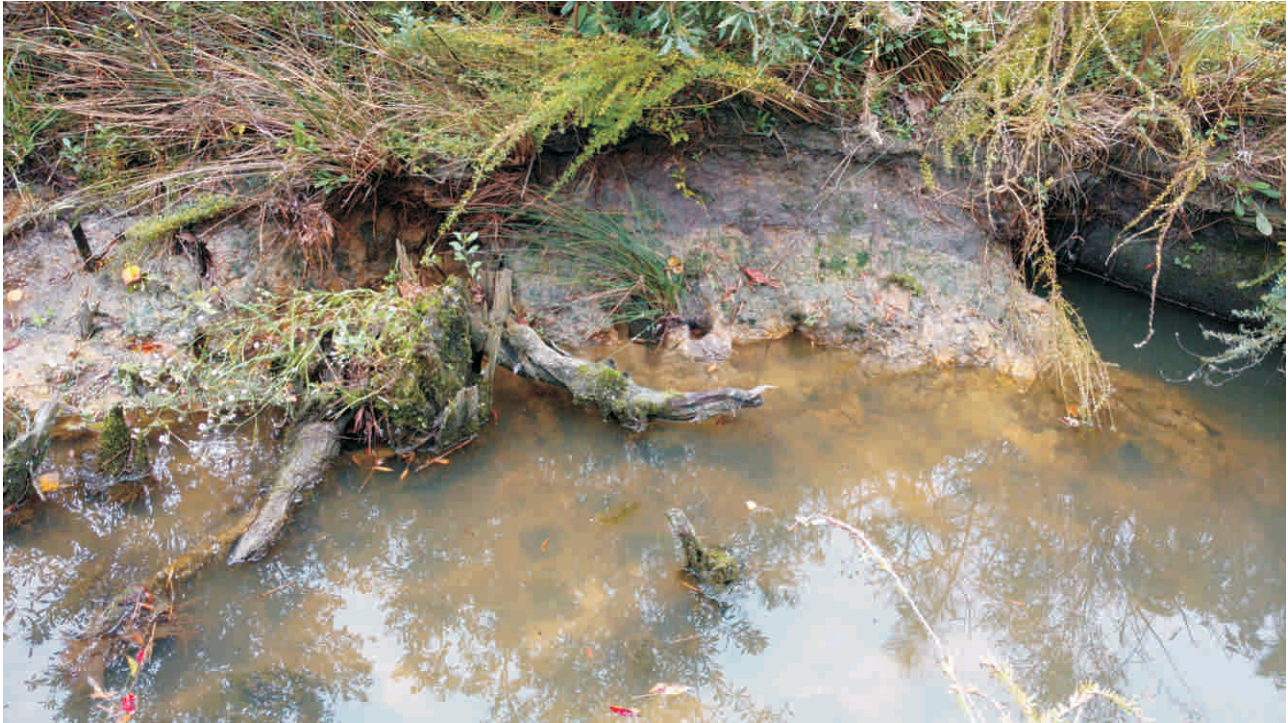
Reach 2A - Stream Problem Area #43a; Scour

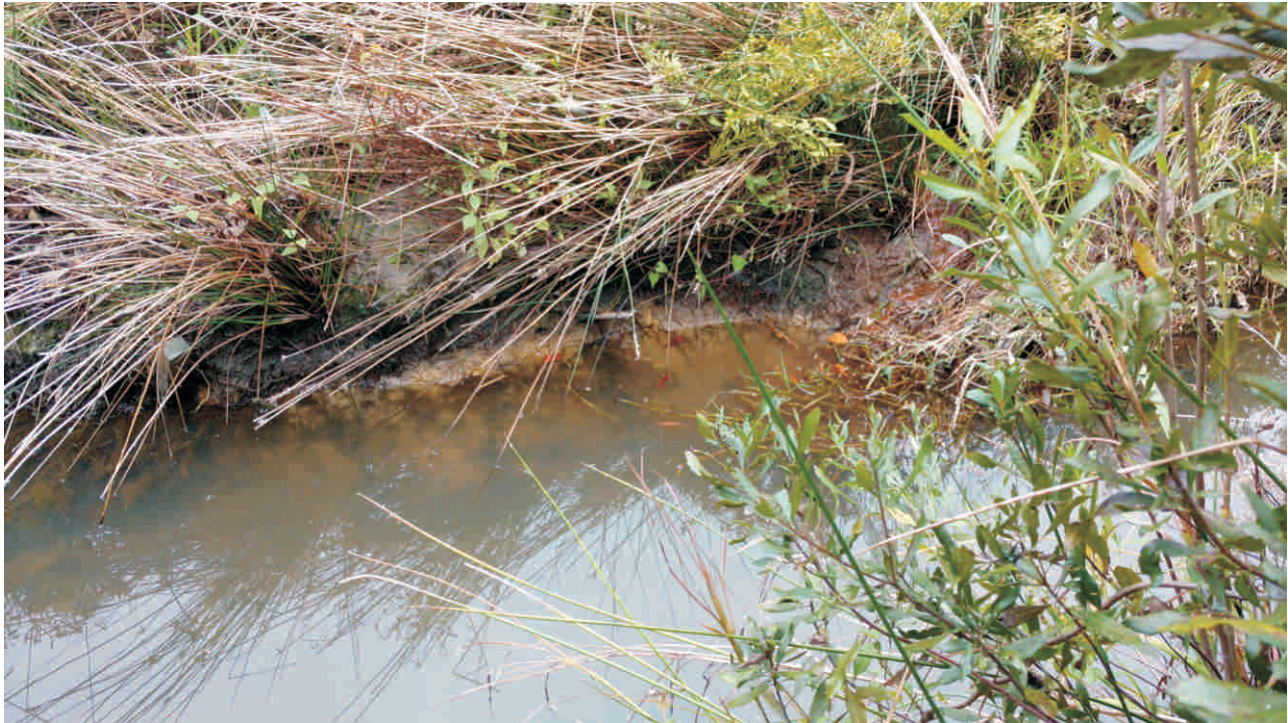
Reach 2A - Stream Problem Area #44; Scour

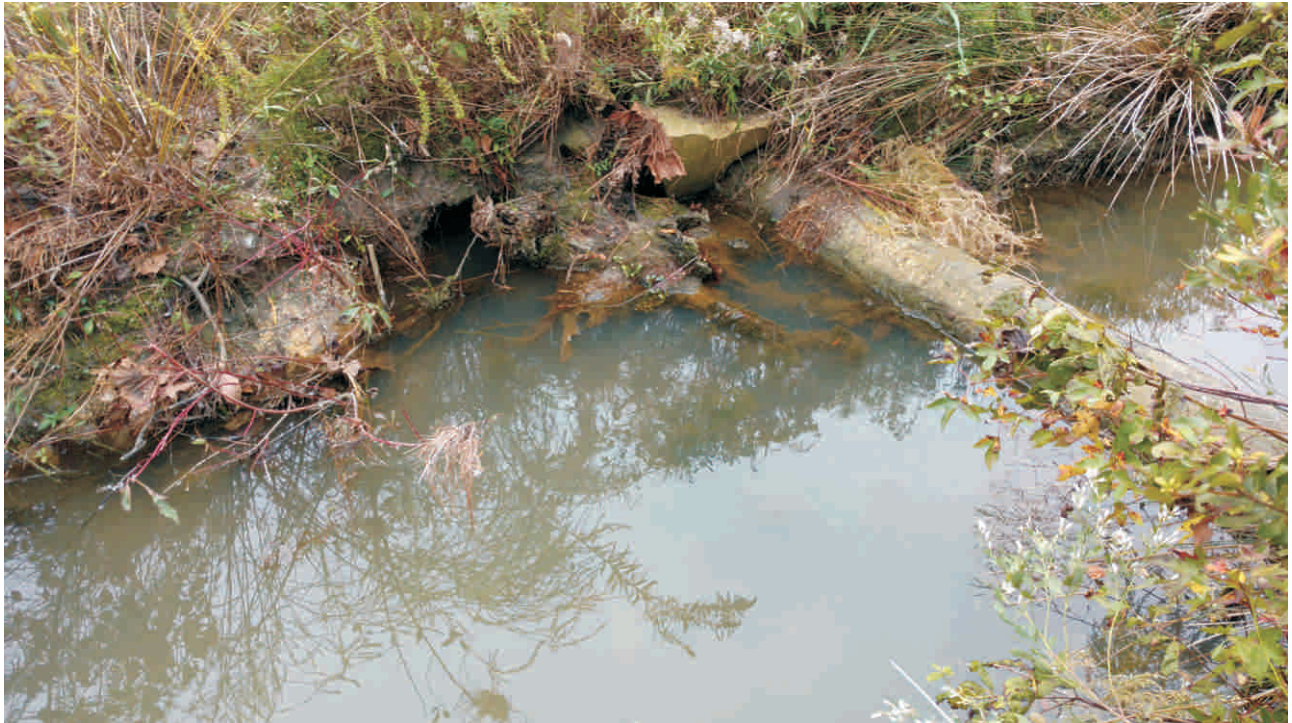
Reach 2A - Stream Problem Area #45; Scour

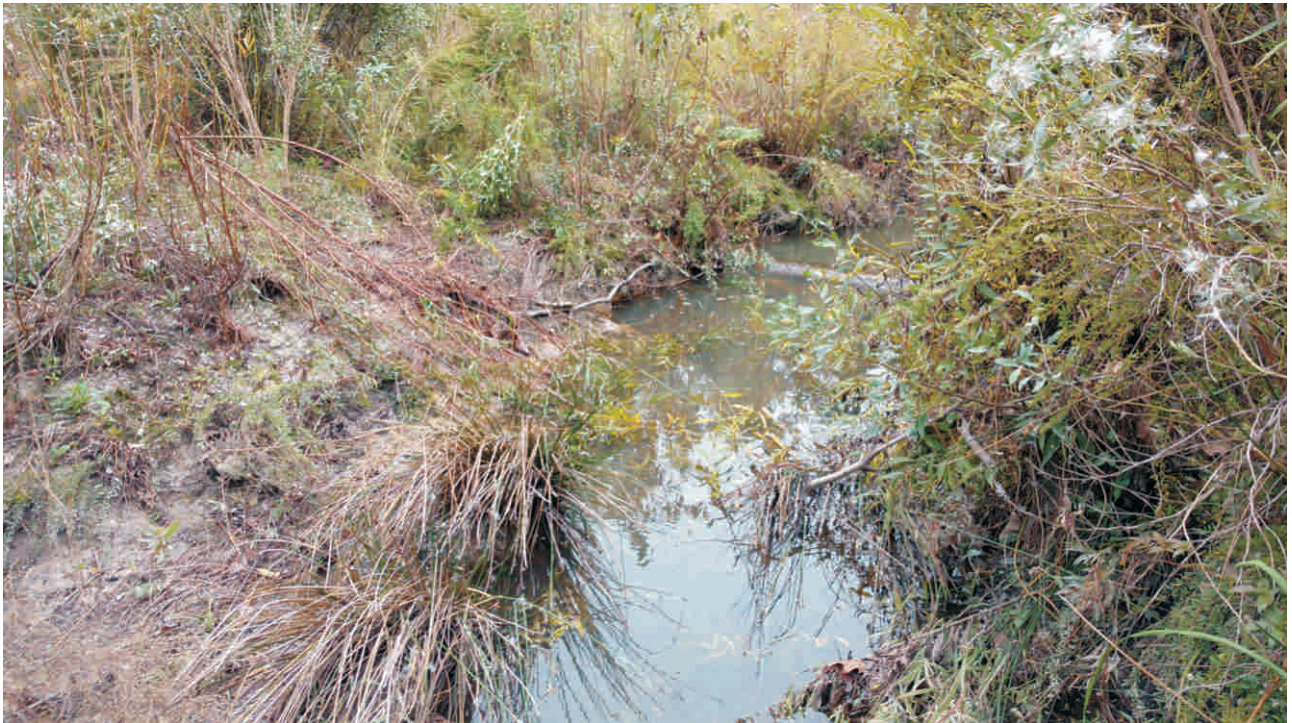
Reach 2A - Stream Problem Area #45a; Log Vane Scour

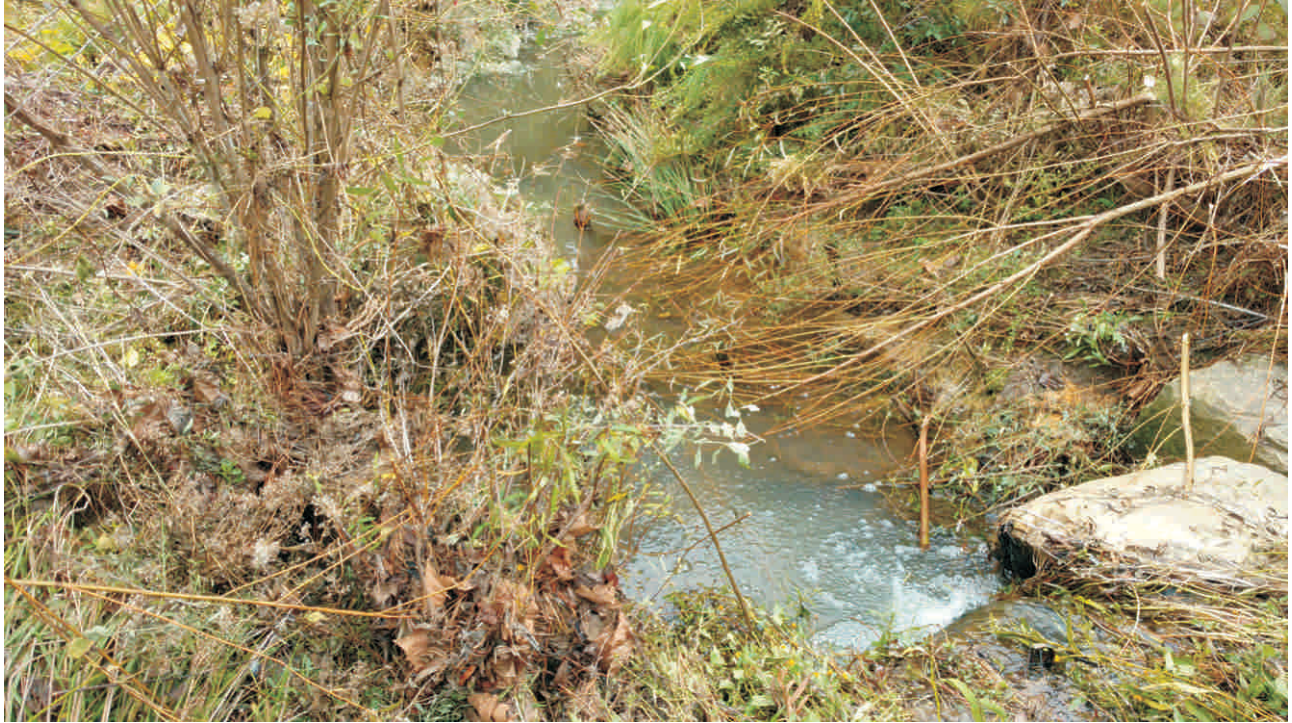
Reach 2A - Stream Problem Area #49; Mass Wasting

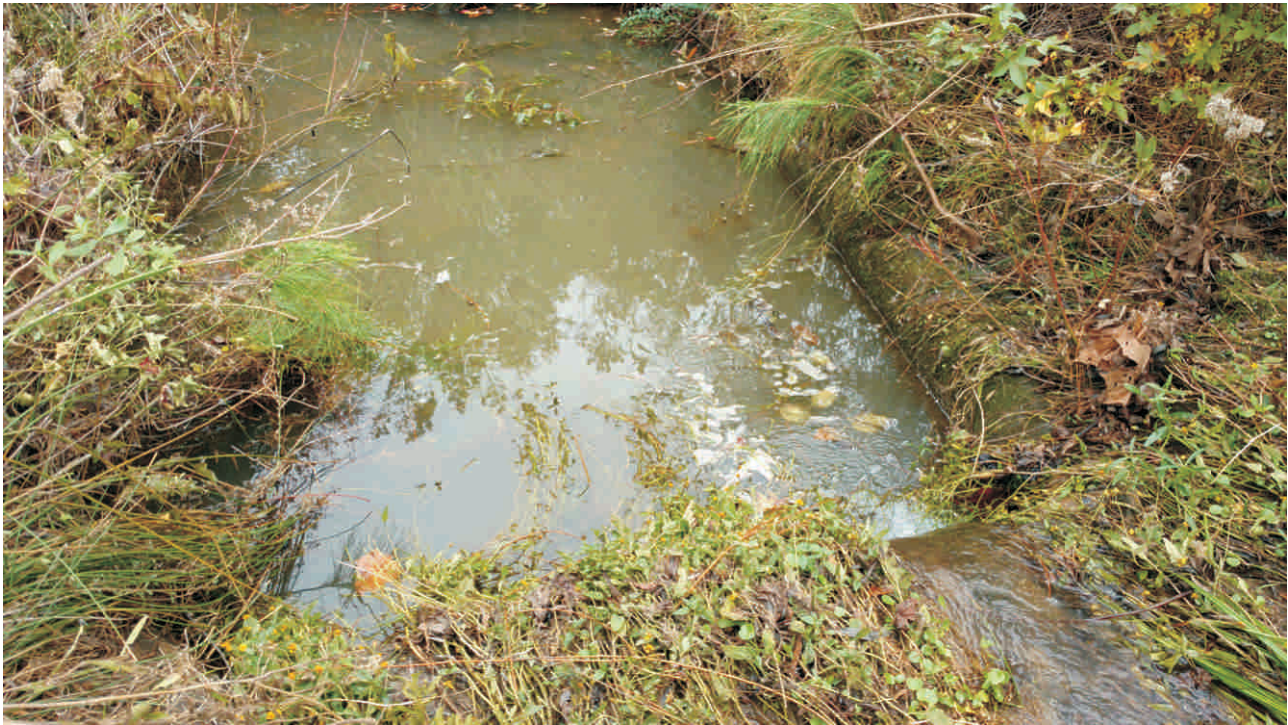
Reach 2A - Stream Problem Area #50; Undercut

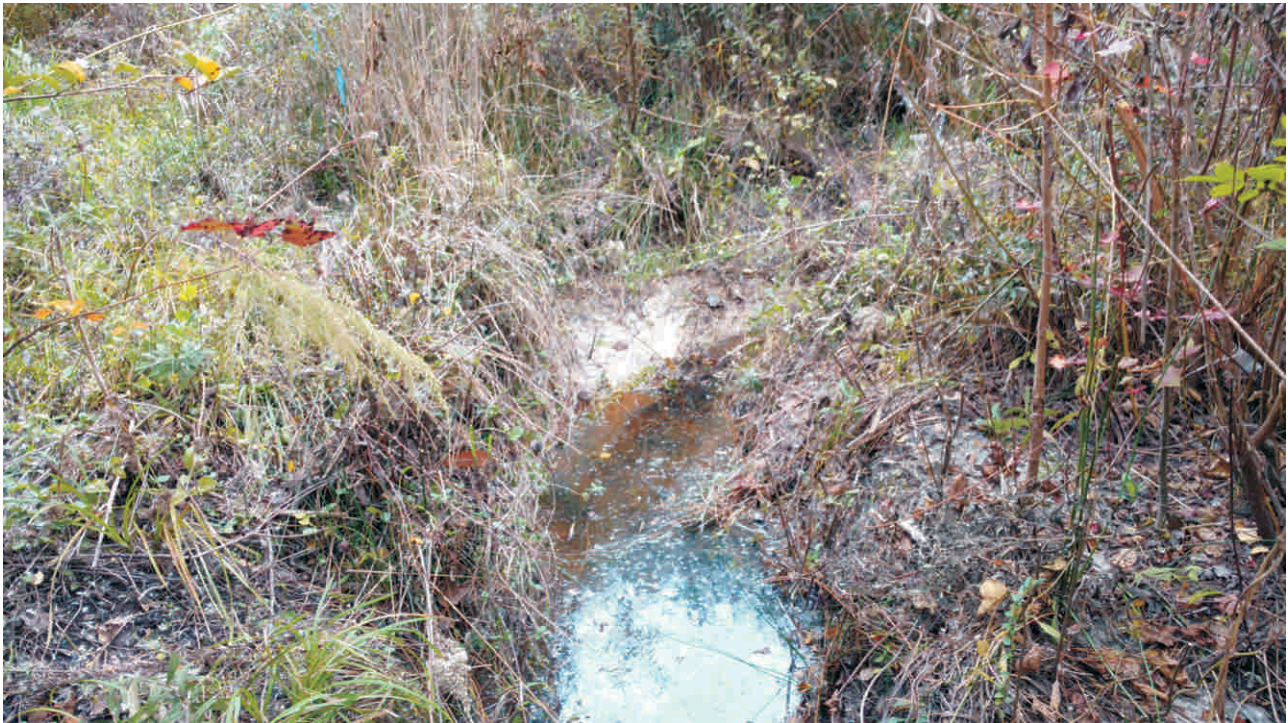
Reach B - Stream Problem Area #51; Aggradation

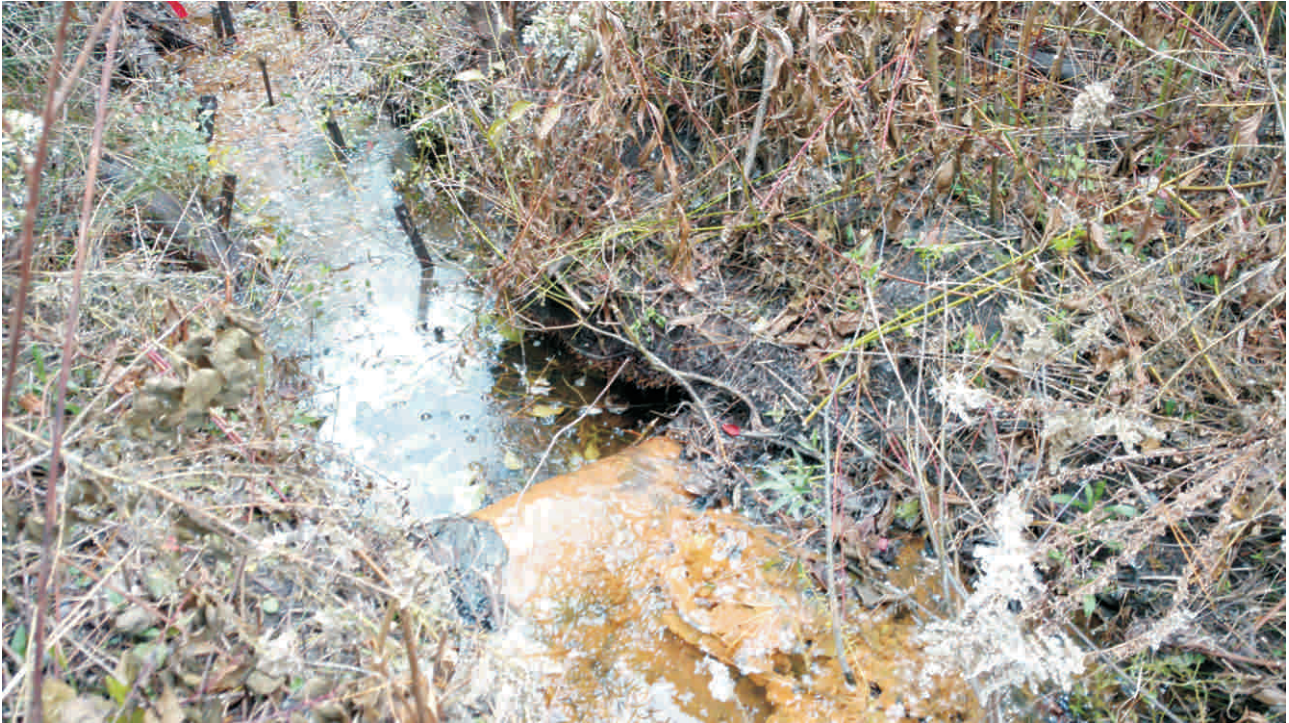
Reach B - Stream Problem Area #52; Mass Wasting

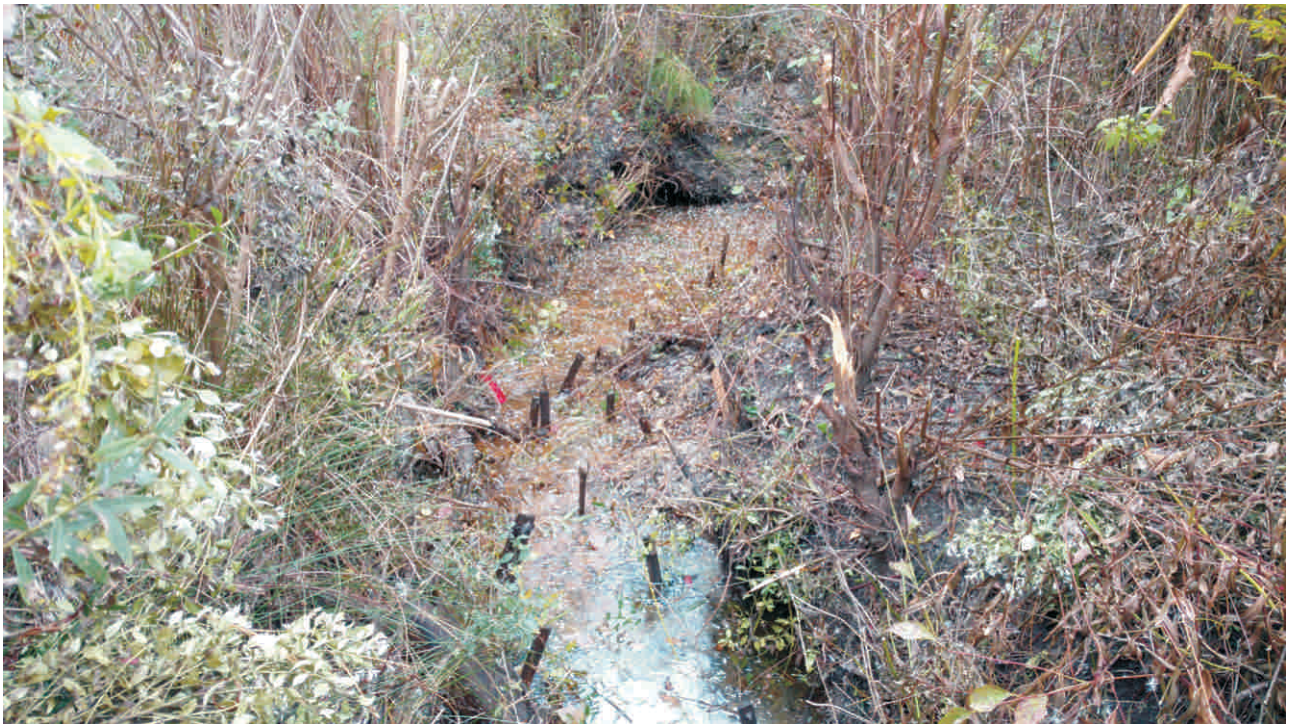
Reach B - Stream Problem Area #52a; Log Vane Undercut

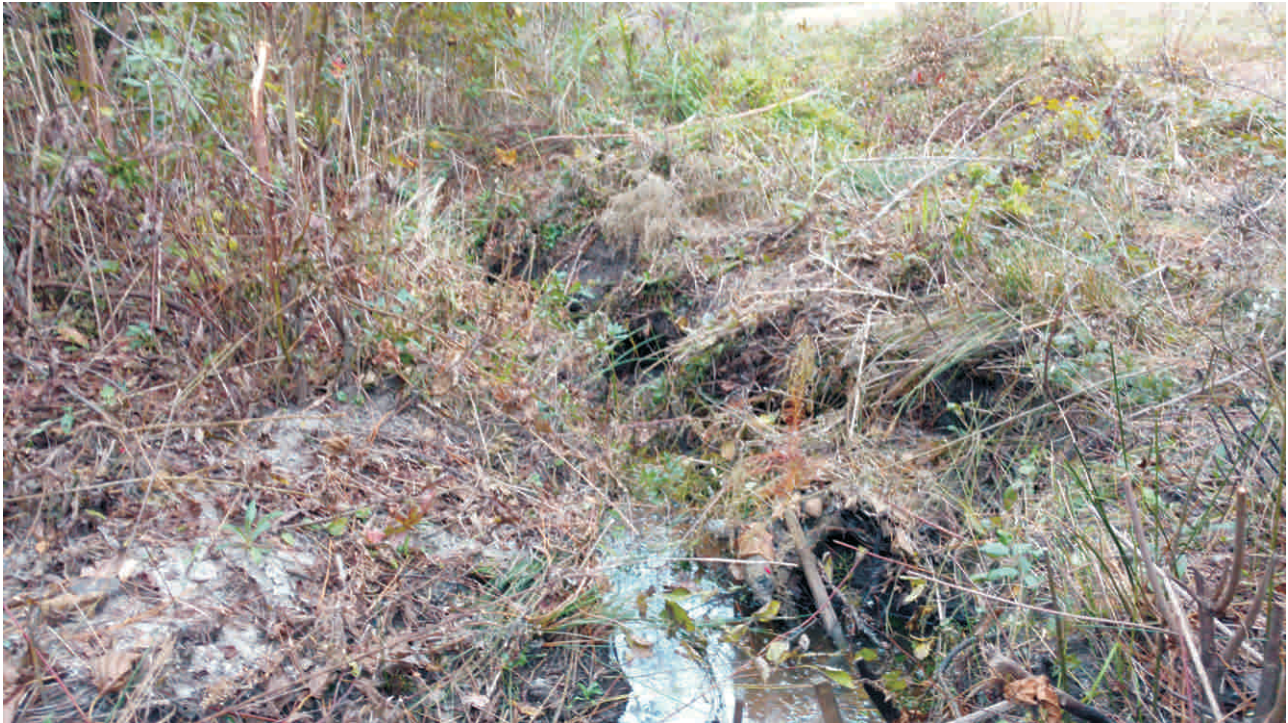
Reach B - Stream Problem Area #52b; Mass Wasting

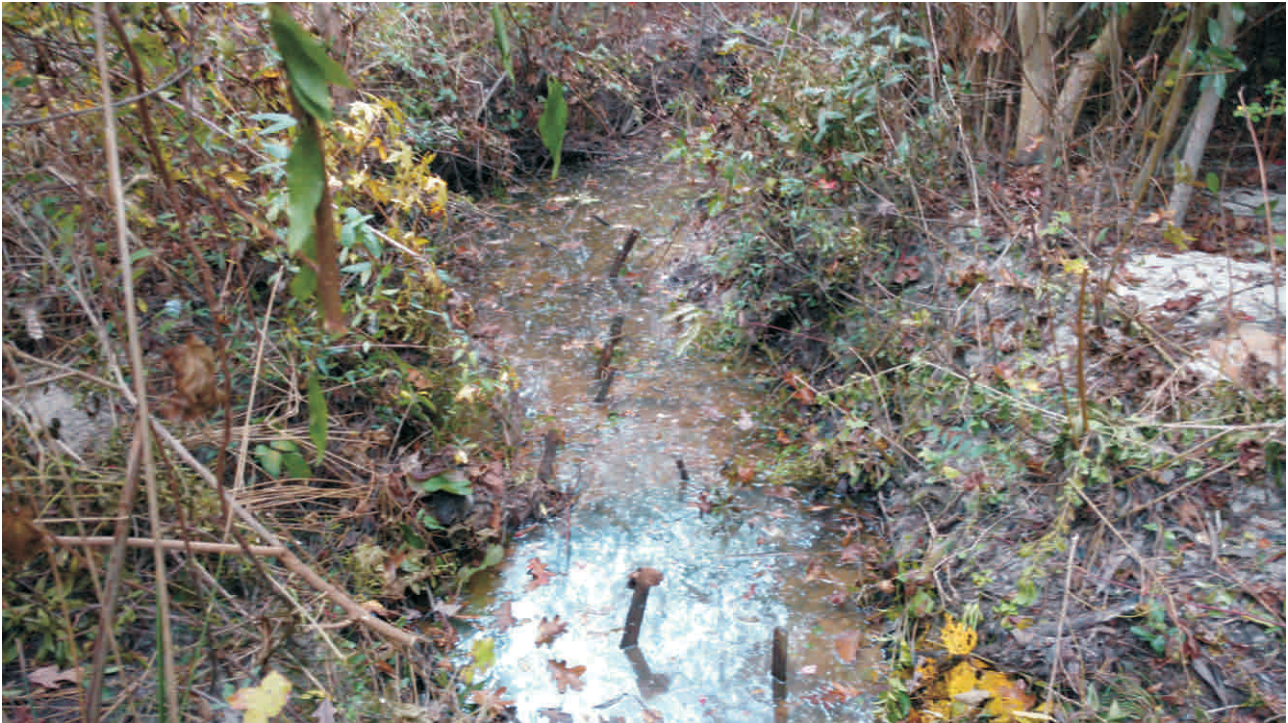
Reach B - Stream Problem Area #53; Undercut

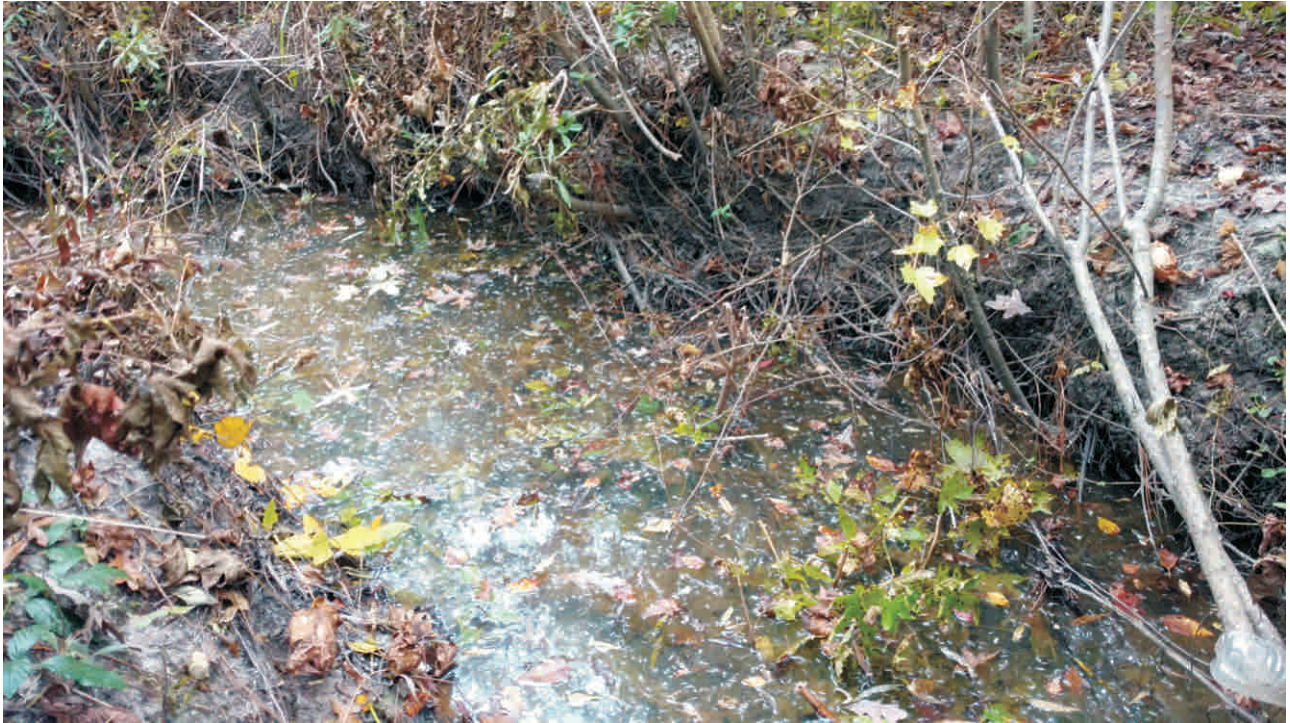
Reach B - Stream Problem Area #54; Undercut
