# **Jacksonville Country Club Stream Restoration and Enhancement Project**

**SCO No. 070715501  
DEQ Contract No. D08049S  
DMS Project No. 194  
Action ID# 2006-40325-067  
Onslow County, North Carolina**

**Year 5 of 5 Monitoring Report  
Data Collection: January through December 2018  
Submission Date: February 13, 2019**

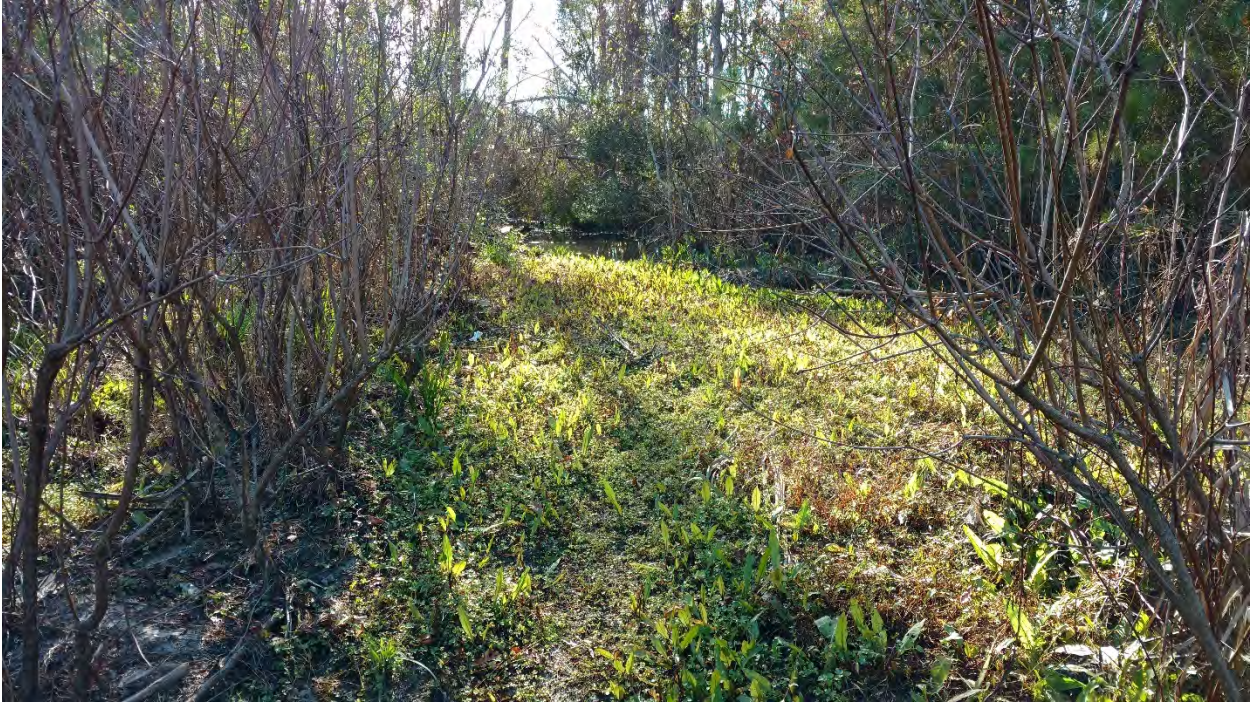
A total of 34 problem areas were noted within Reach 1A (compared to 28 areas in MY4). These included 5 undercuts, 13 areas of degradation, 10 scour holes, 3 areas of mass wasting, and 3 areas of aggradation. As noted in previous years, an area of aggradation has caused a new channel to form at the very top of the reach.

**Reach 1A: Stream Problem Area 1 – Aggradation; New channel has formed**

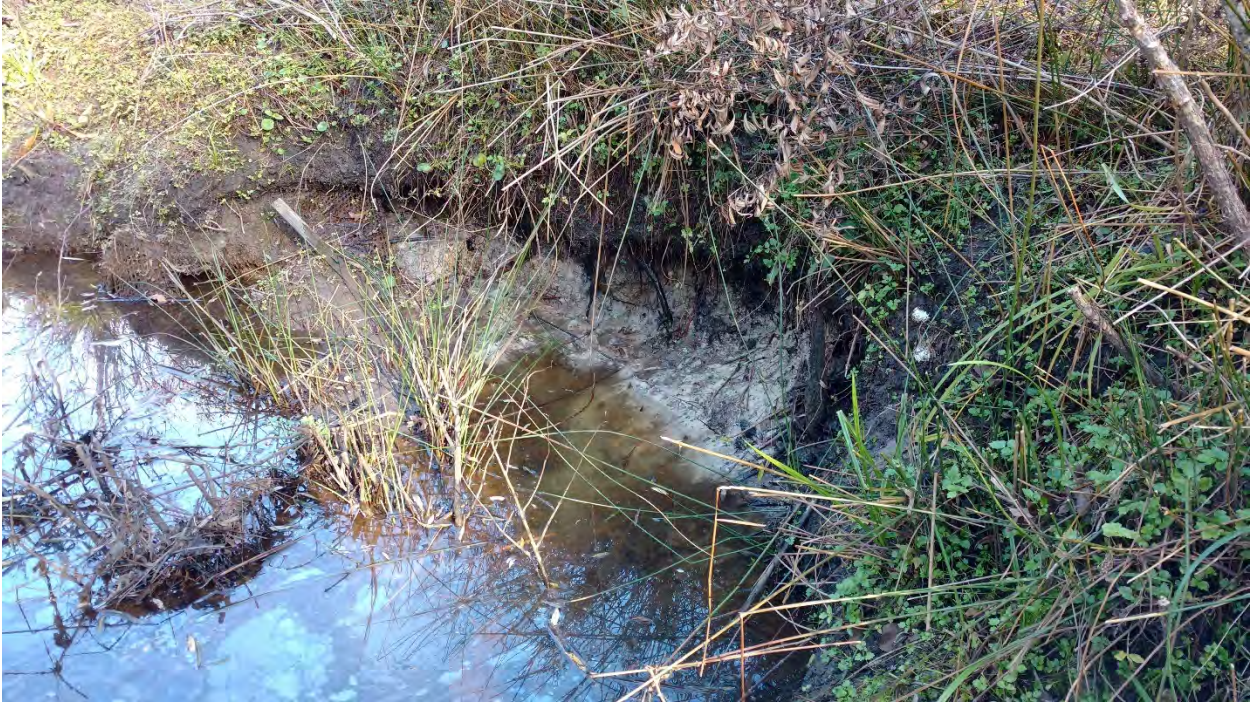
**Reach 1A: Stream Problem Area 2 – Undercut near Log Vane Structure**

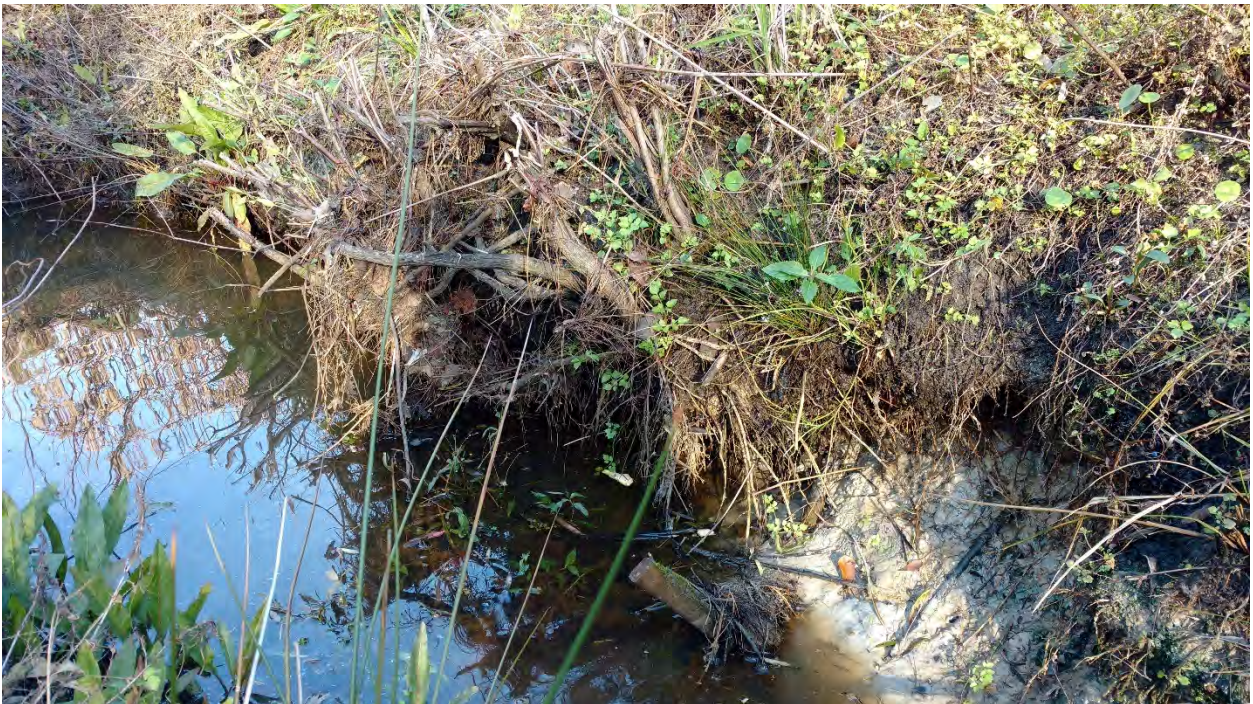
**Reach 1A: Stream Problem Area 2a – Scour near Log Vane Structure**

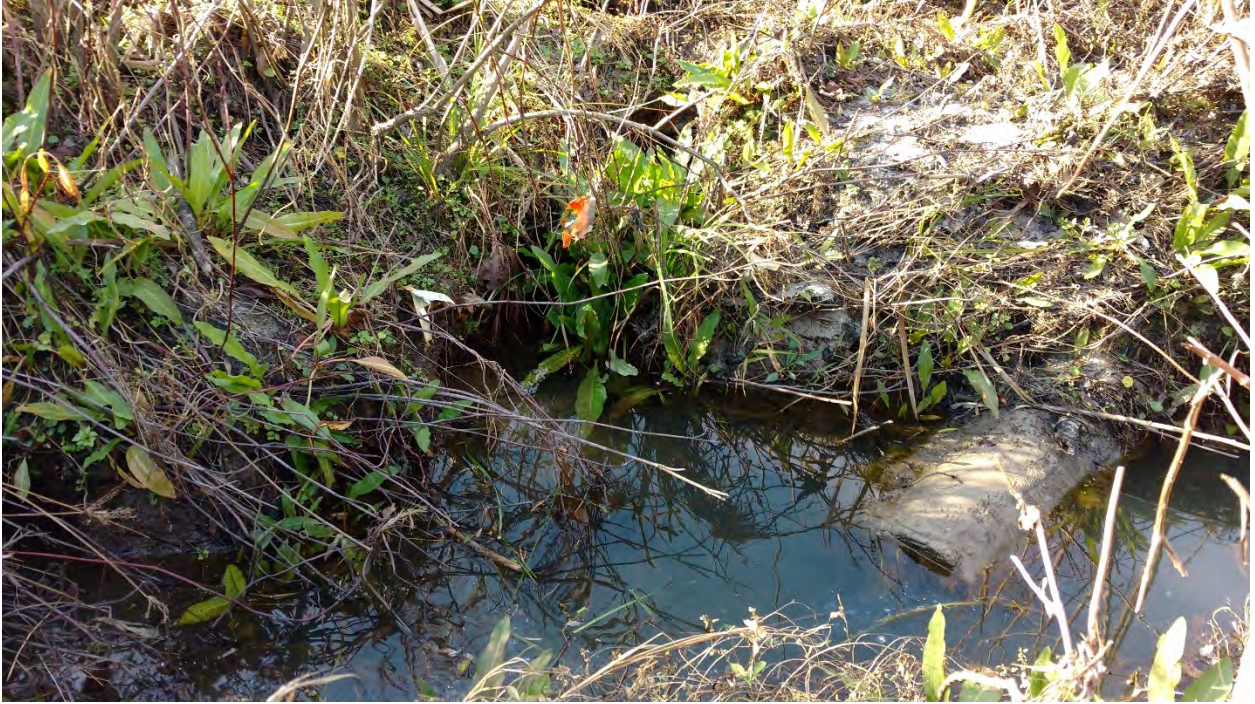
**Reach 1A: Stream Problem Area 2c – Undercut/Scour**

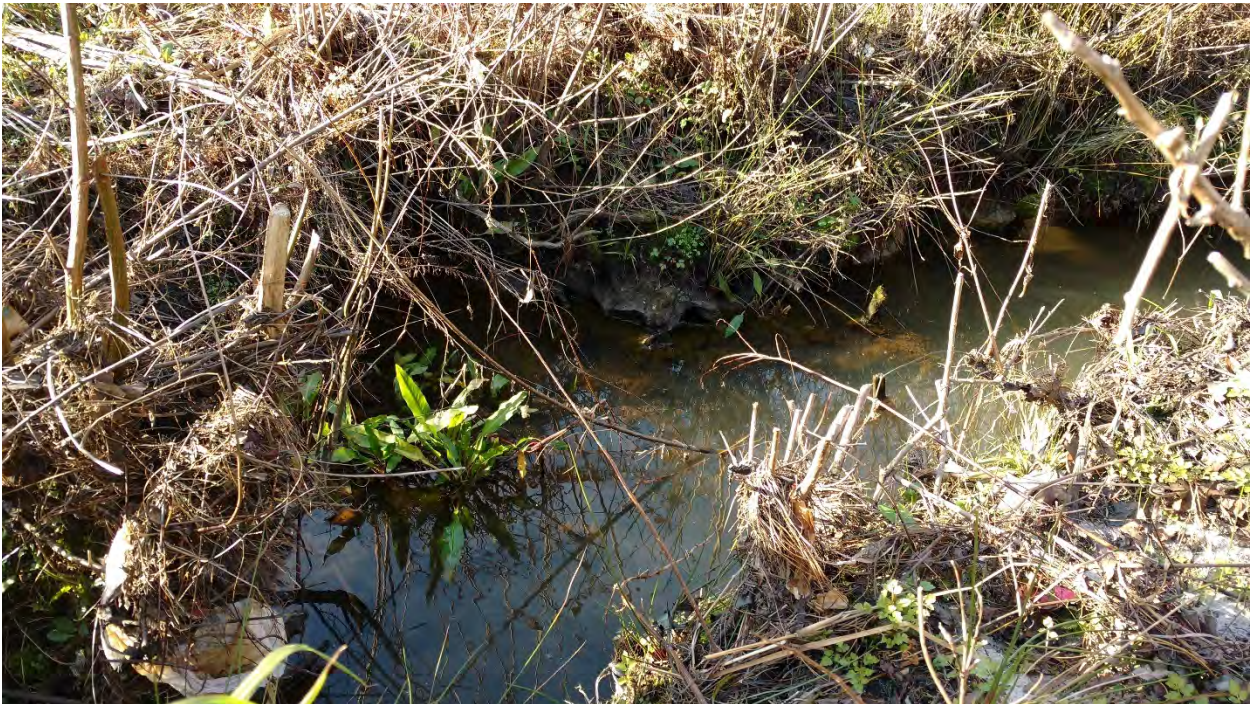
Reach 1A: Stream Problem Area 3 – Mass Wasting where channels come together

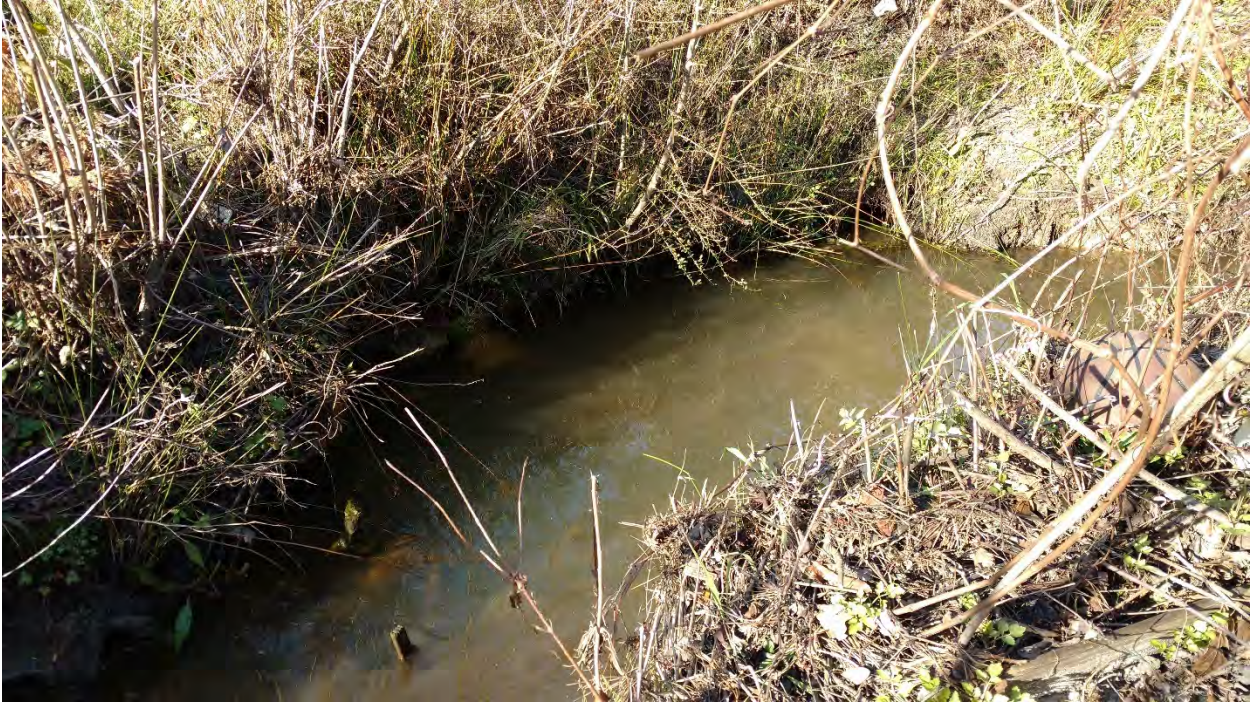
Reach 1A: Stream Problem Area 3a – Mass Wasting

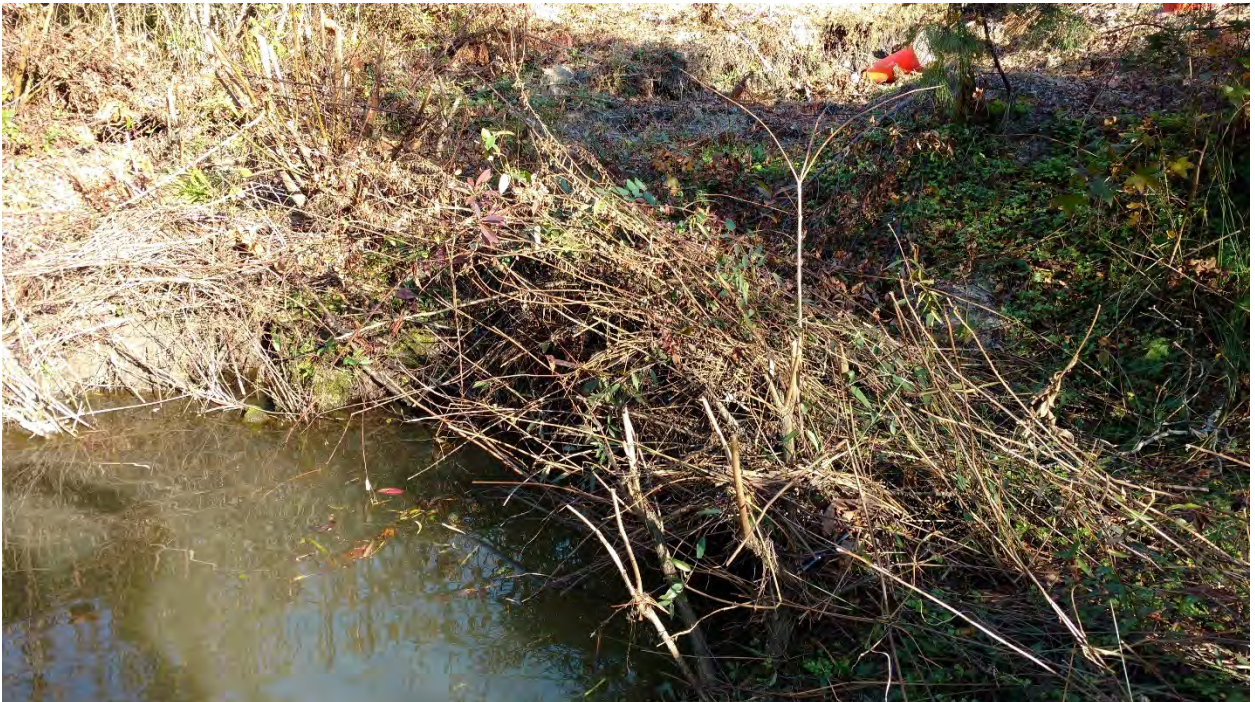
Reach 1A: Stream Problem Area 3b – Undercut on both sides of channel

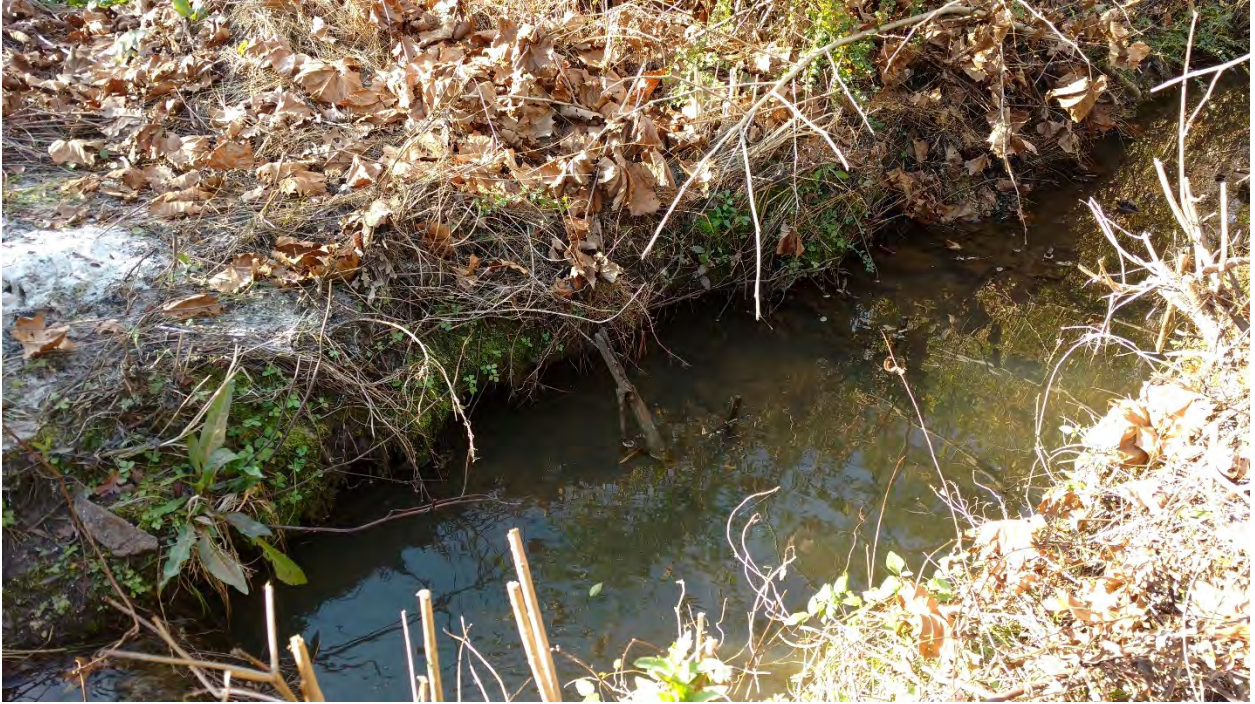
Reach 1A: Stream Problem Area 4 – Mass Wasting

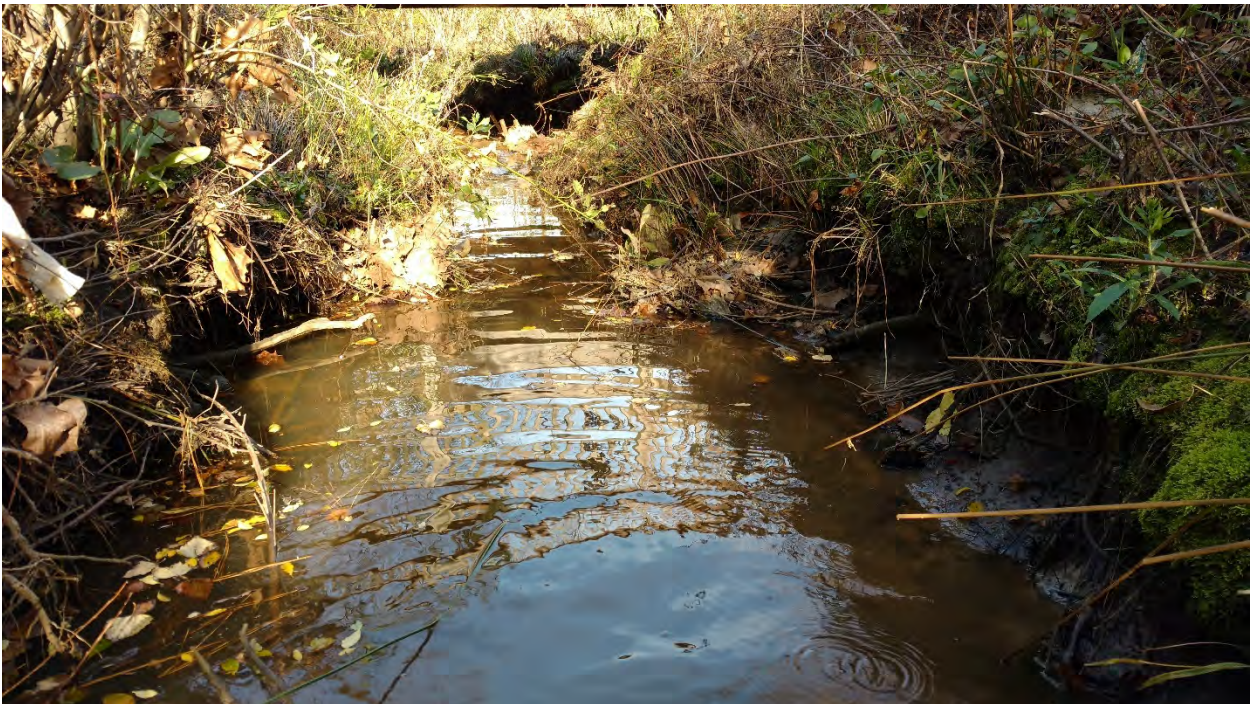
**Reach 1A: Stream Problem Area 6a – Scour**

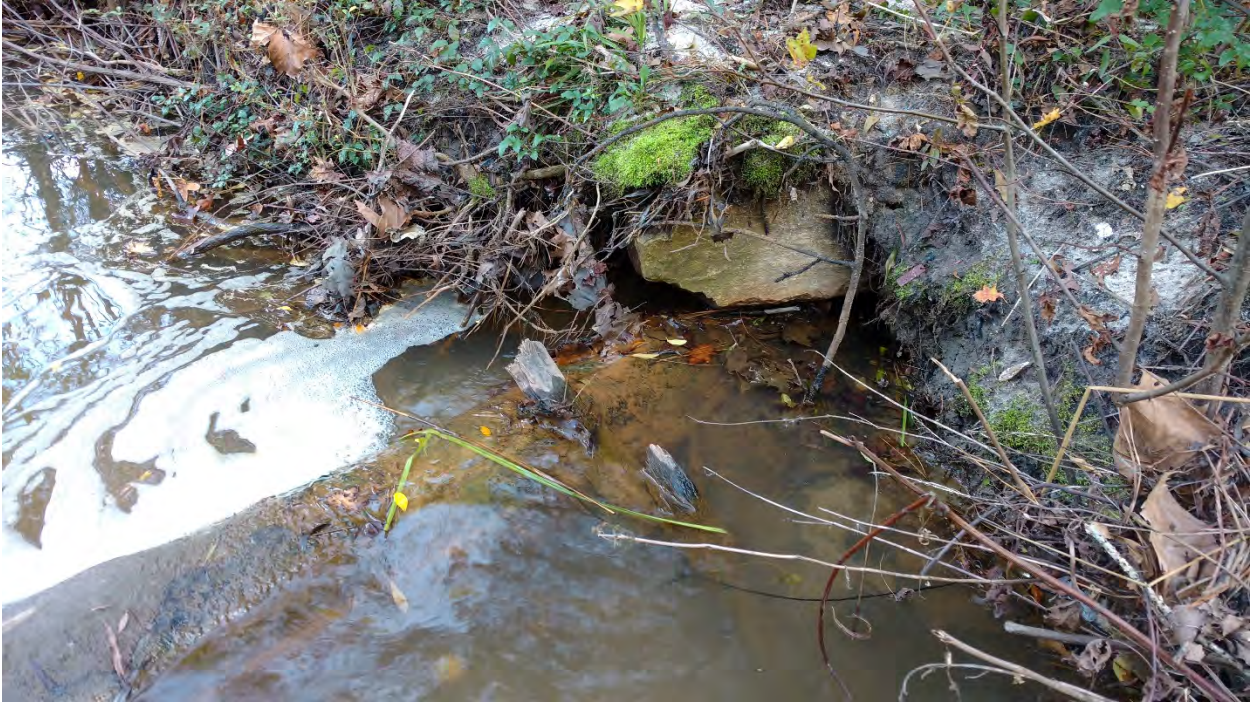
**Reach 1A: Stream Problem Area 10 – Scour**

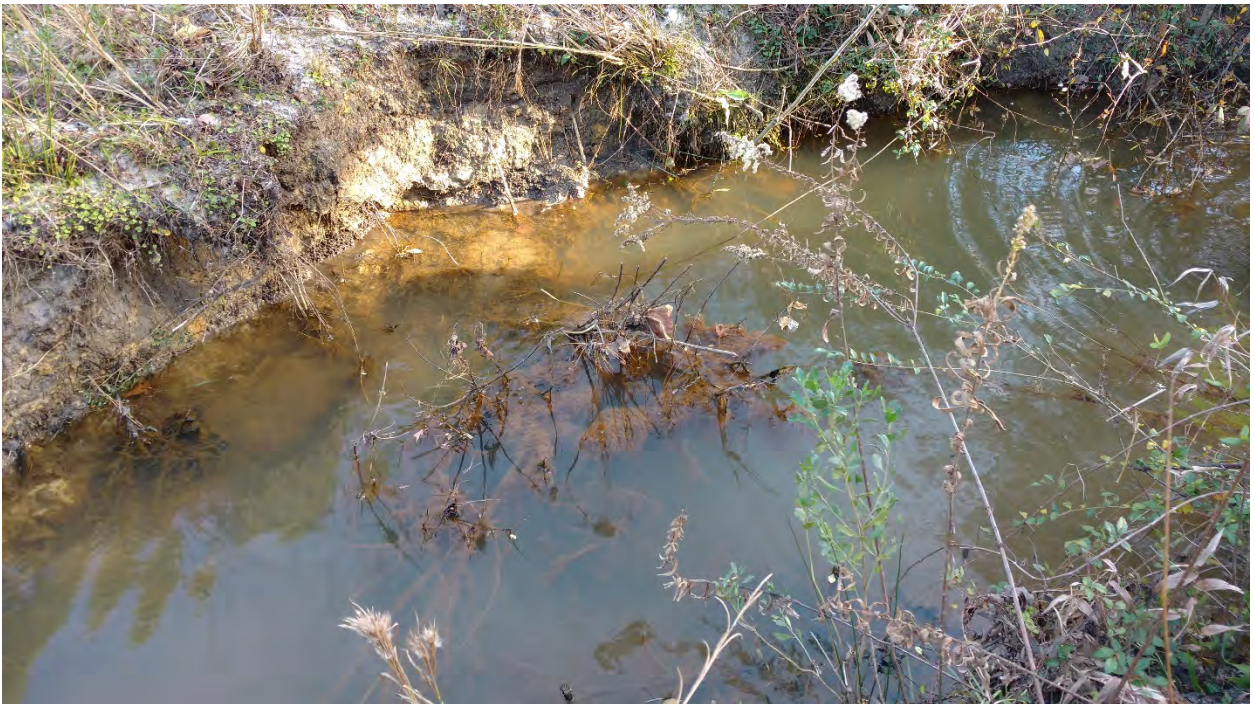
**Reach 1A: Stream Problem Area 11 – Scour and Undercut**

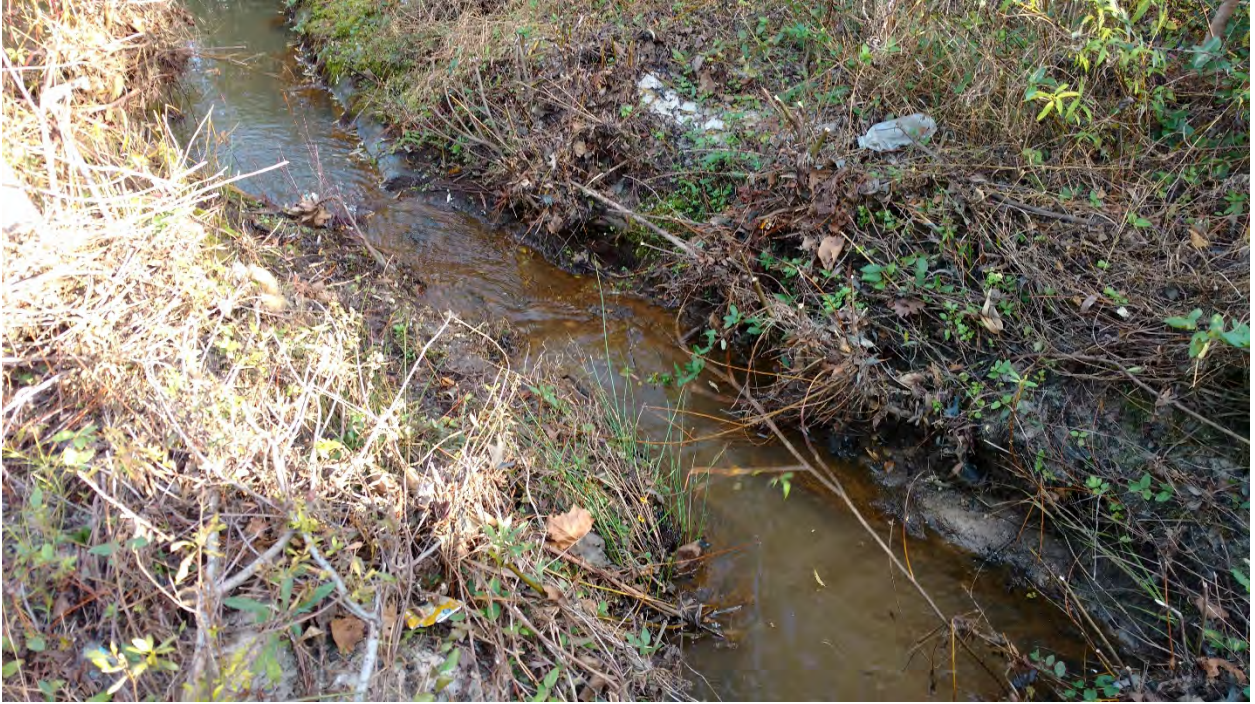
**Reach 1A: Stream Problem Area 13a – Scour**

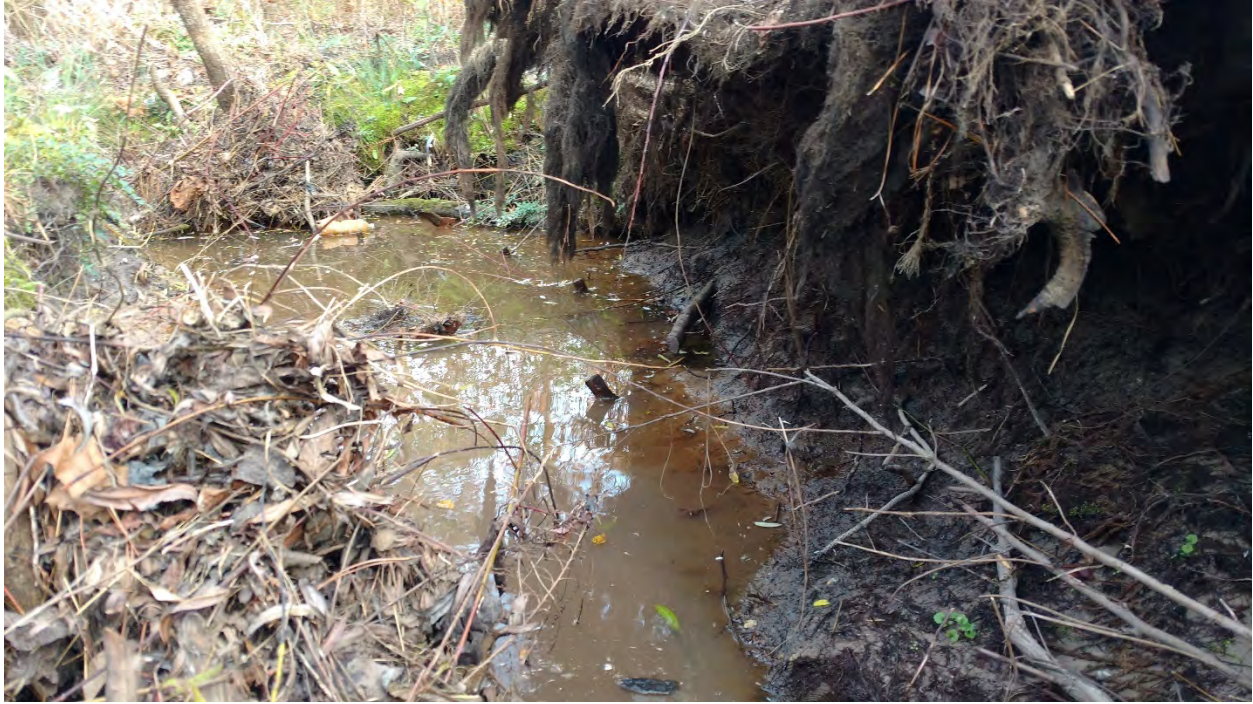
**Reach 1A: Stream Problem Area 20a – Scour**

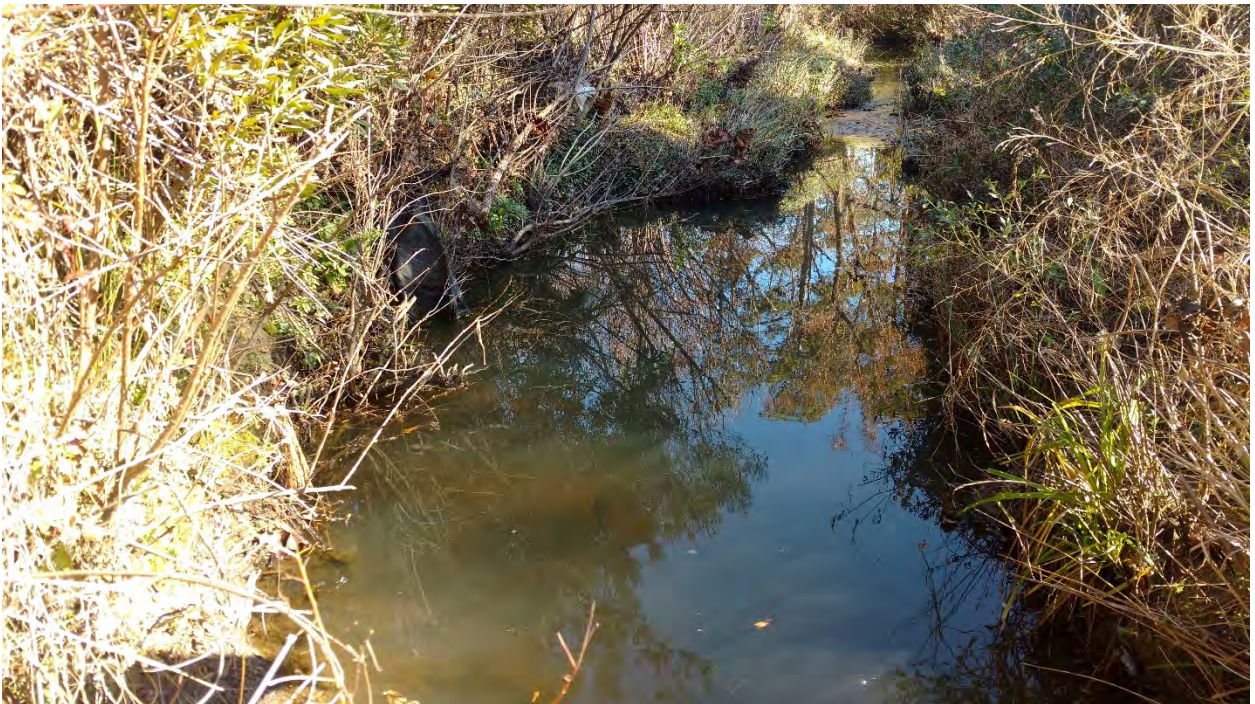
**Reach 2A: Stream Problem Area 25 – Scour off of road**

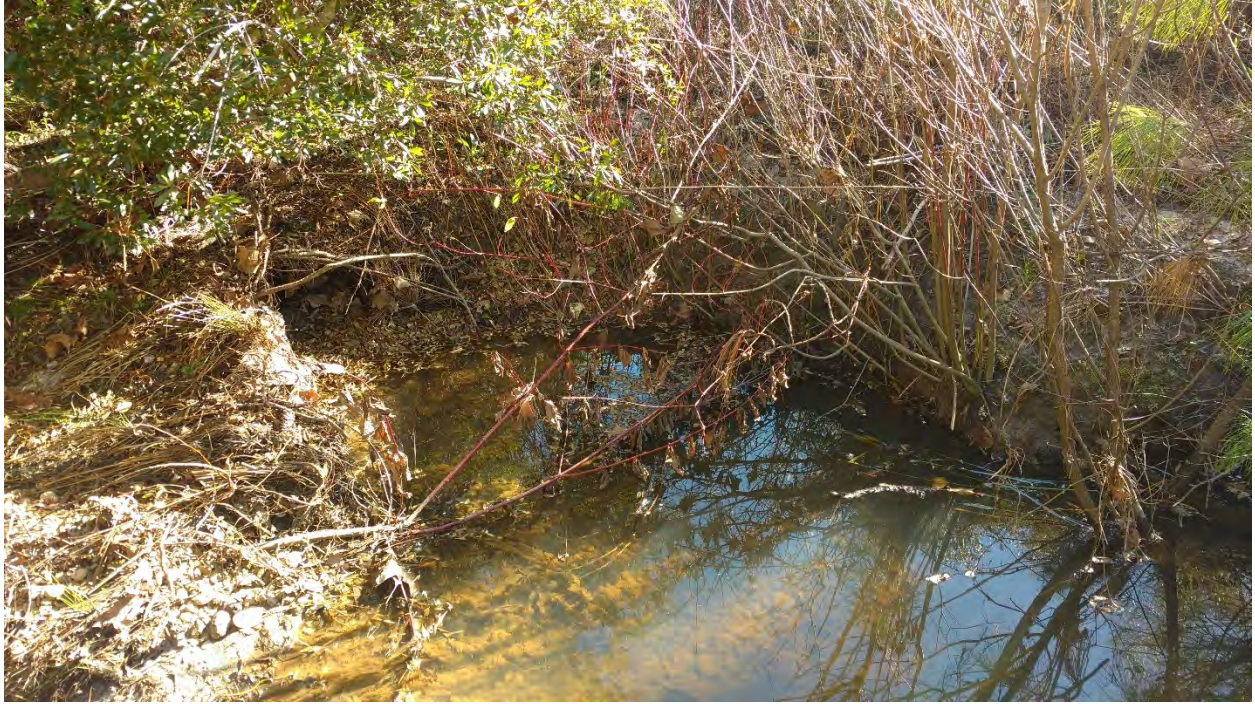
**Reach 2A: Stream Problem Area 25a – Mass Wasting**

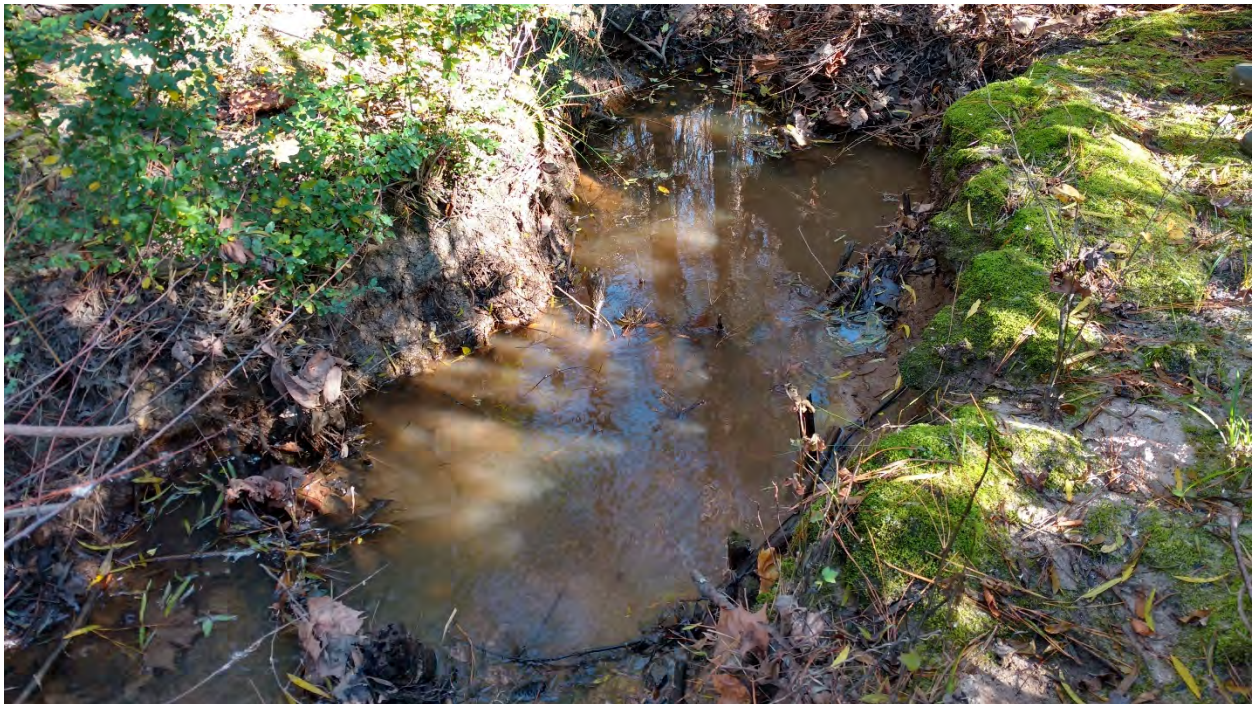
**Reach 2A: Stream Problem Area 26 – Mass Wasting**

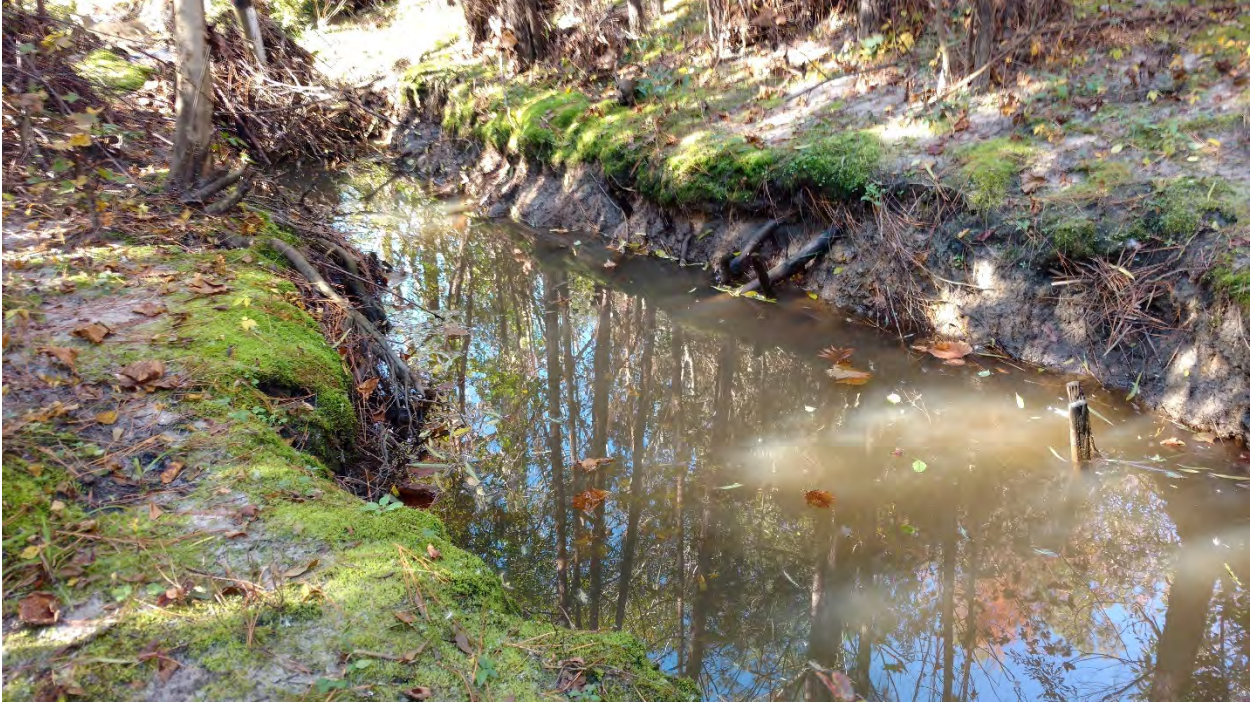
**Reach 2A: Stream Problem Area 29 – Scour**

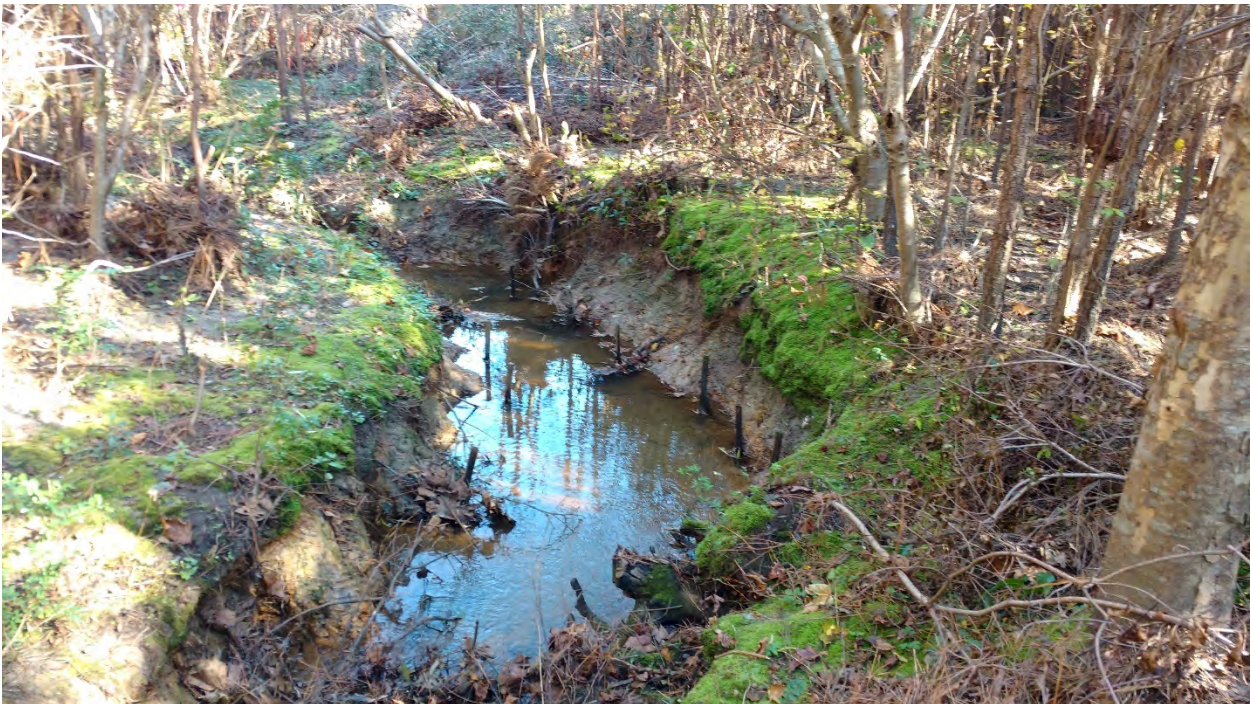
Reach 2A: Stream Problem Area 30 – Scour

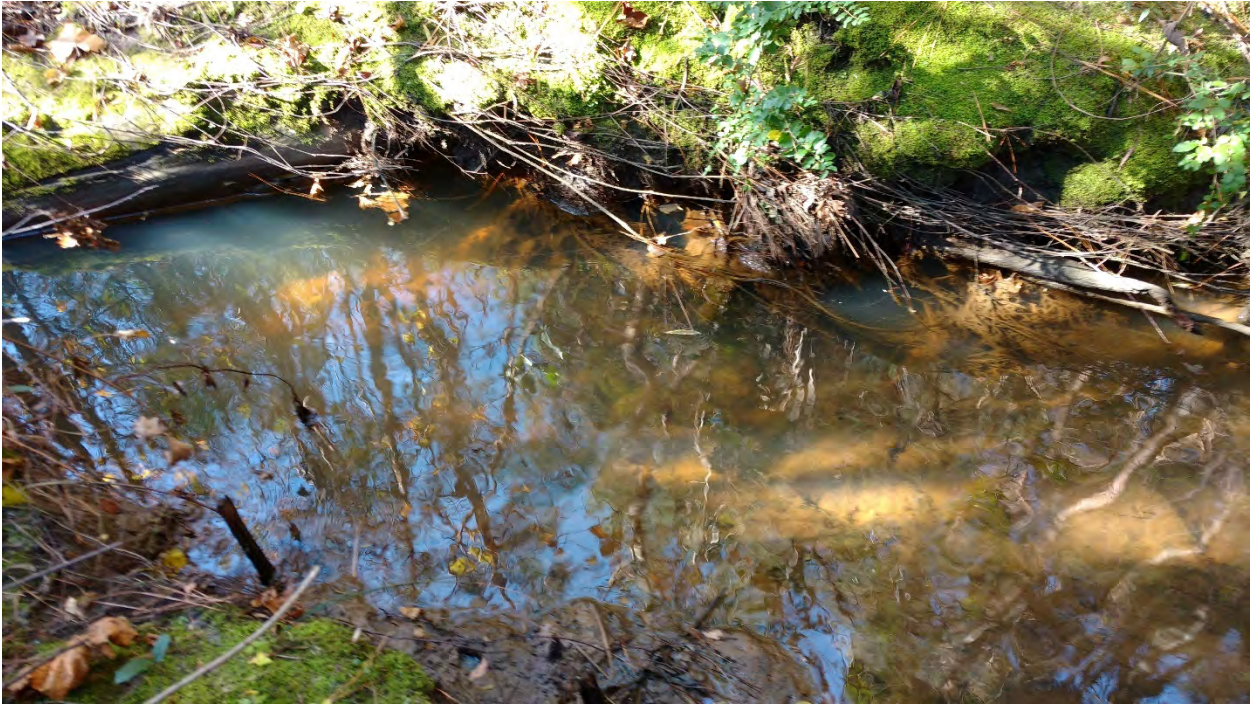
Log Vane at this location not functioning

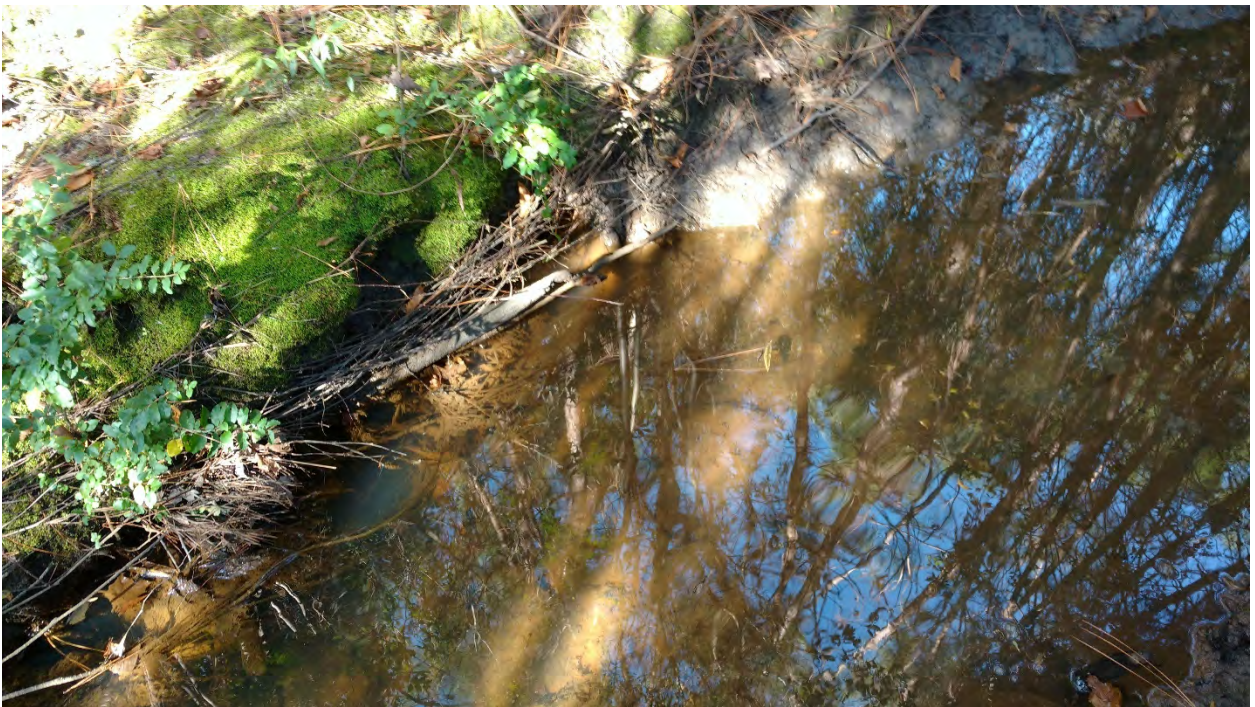
Reach 2A: Stream Problem Area 34 – Scour

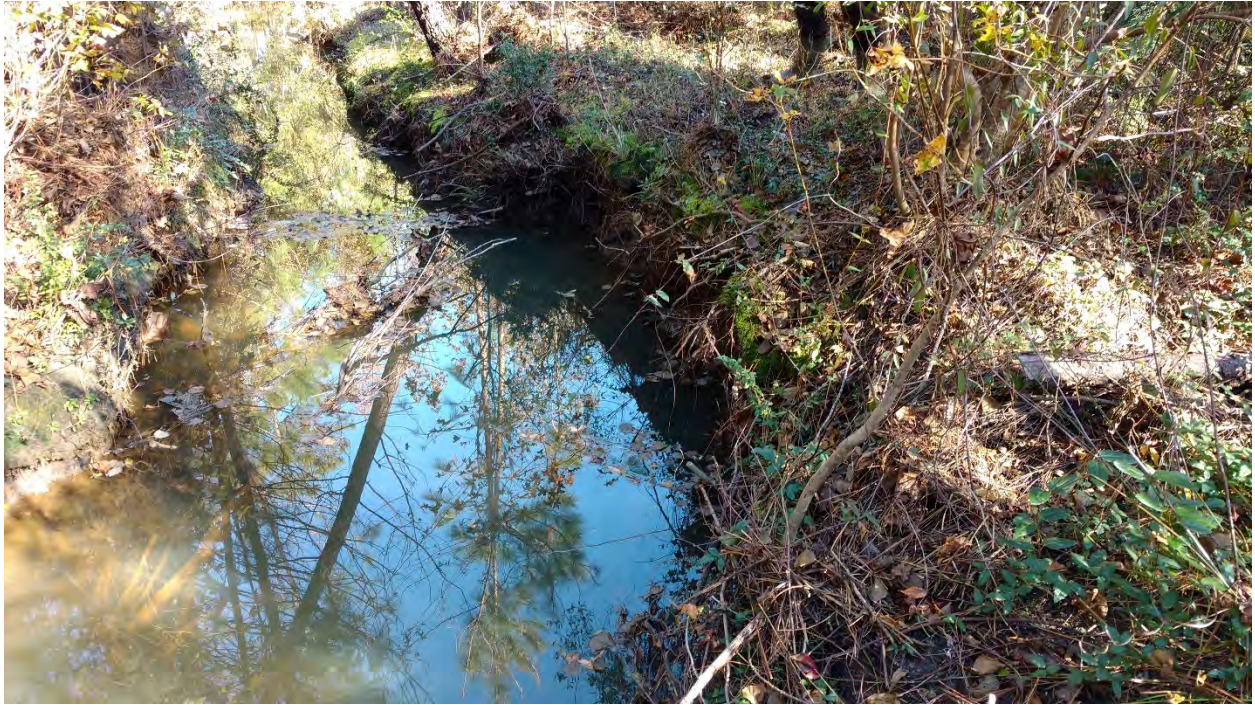
**Reach 2A: Stream Problem Area 37 – Mass Wasting**

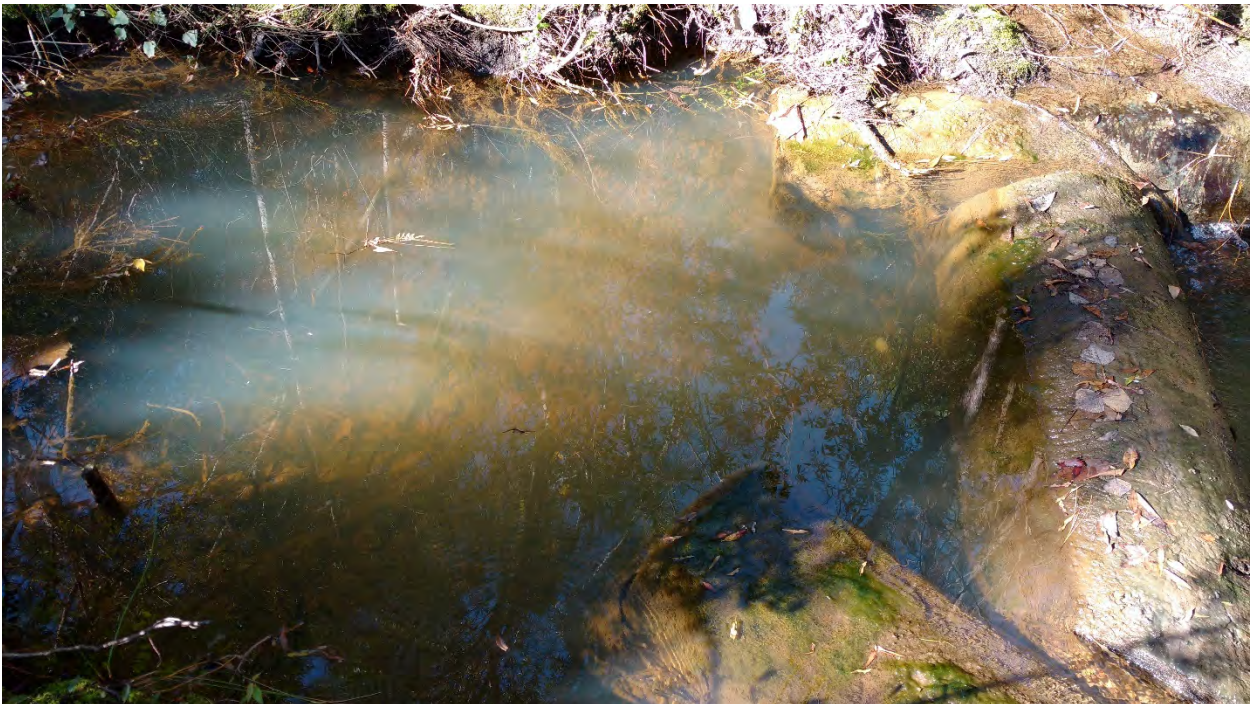
**Reach 2A: Stream Problem Area 39 – Mass Wasting**

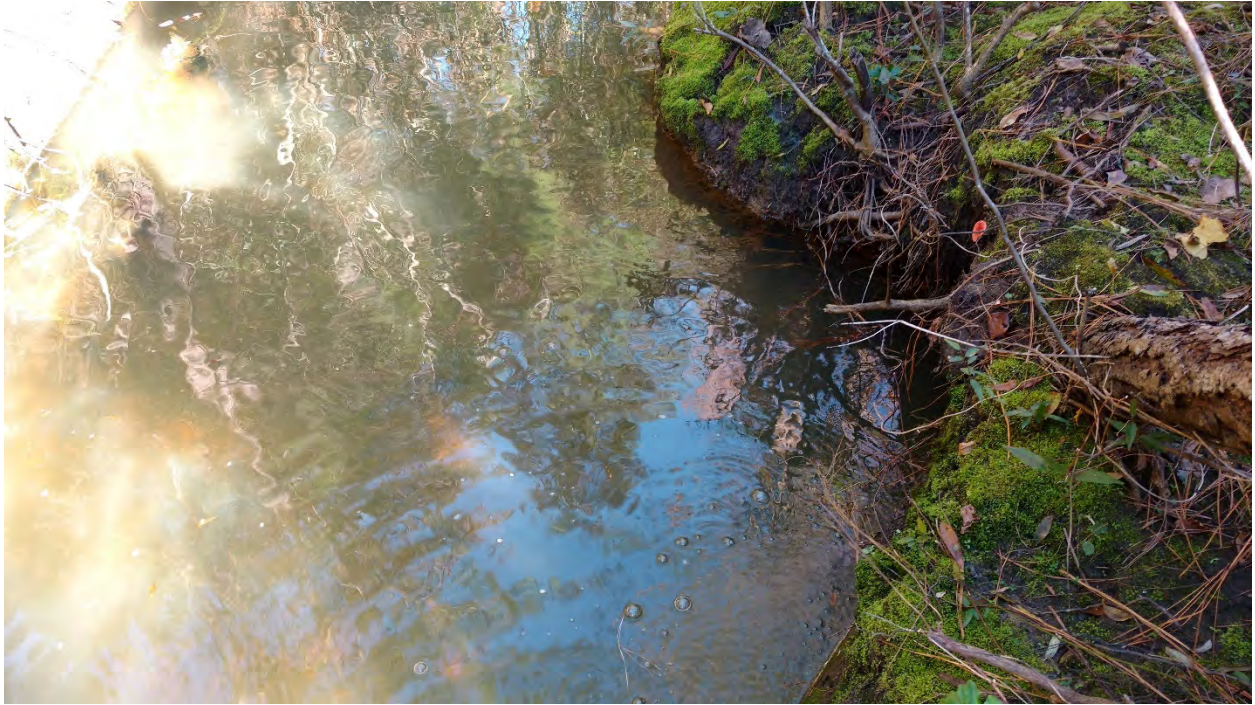
**Reach 2A: Stream Problem Area 40 – Scour**

**Log Vane appears intact and functioning**

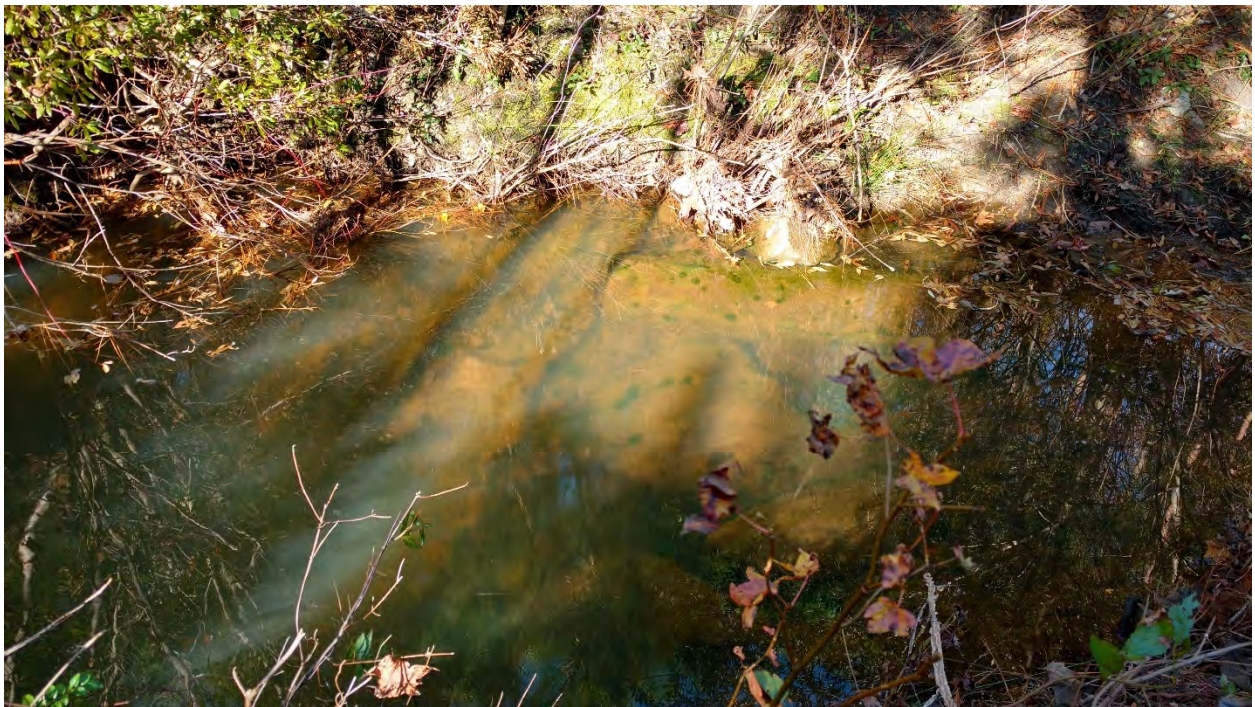
**Reach 2A: Stream Problem Area 41 – Scour**

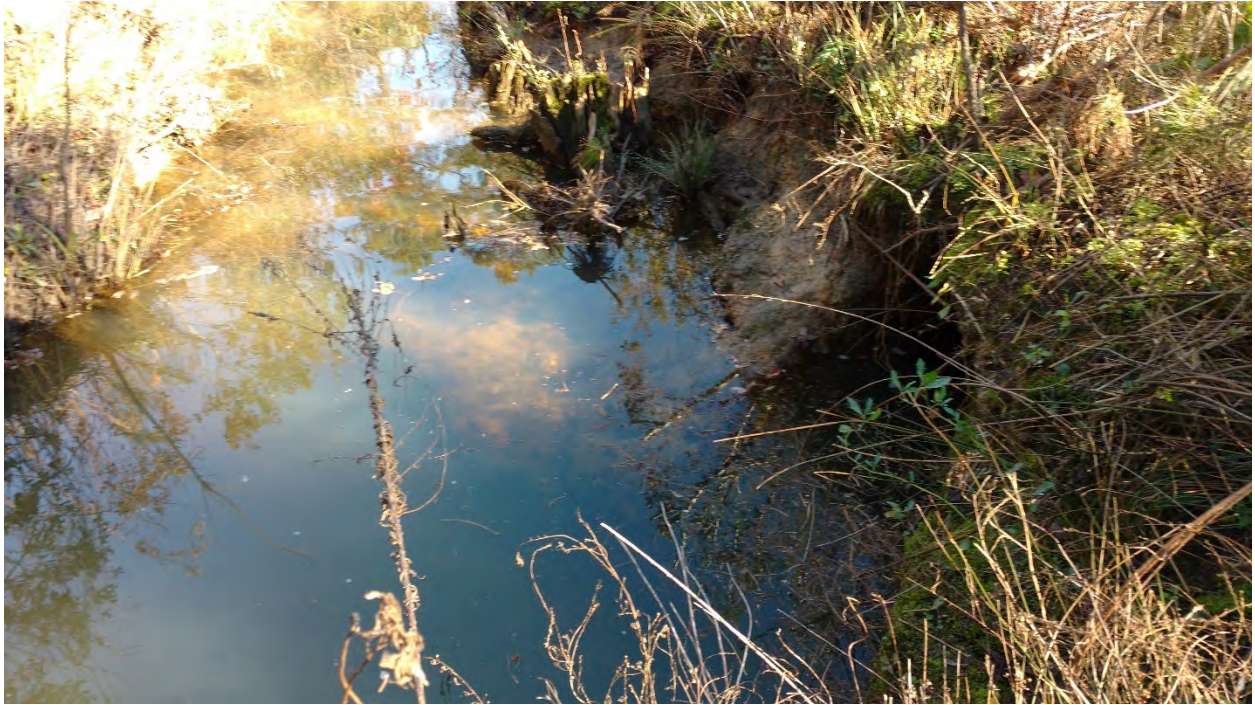
**Reach 2A: Stream Problem Area 43a – Scour**
