# **Jacksonville Country Club Stream Restoration and Enhancement Project**

**SCO No. 070715501  
DEQ Contract No. D08049S  
DMS Project No. 194  
Action ID# 2006-40325-067  
Onslow County, North Carolina**

**Year 5 of 5 Monitoring Report  
Data Collection: January through December 2018  
Submission Date: February 13, 2019**

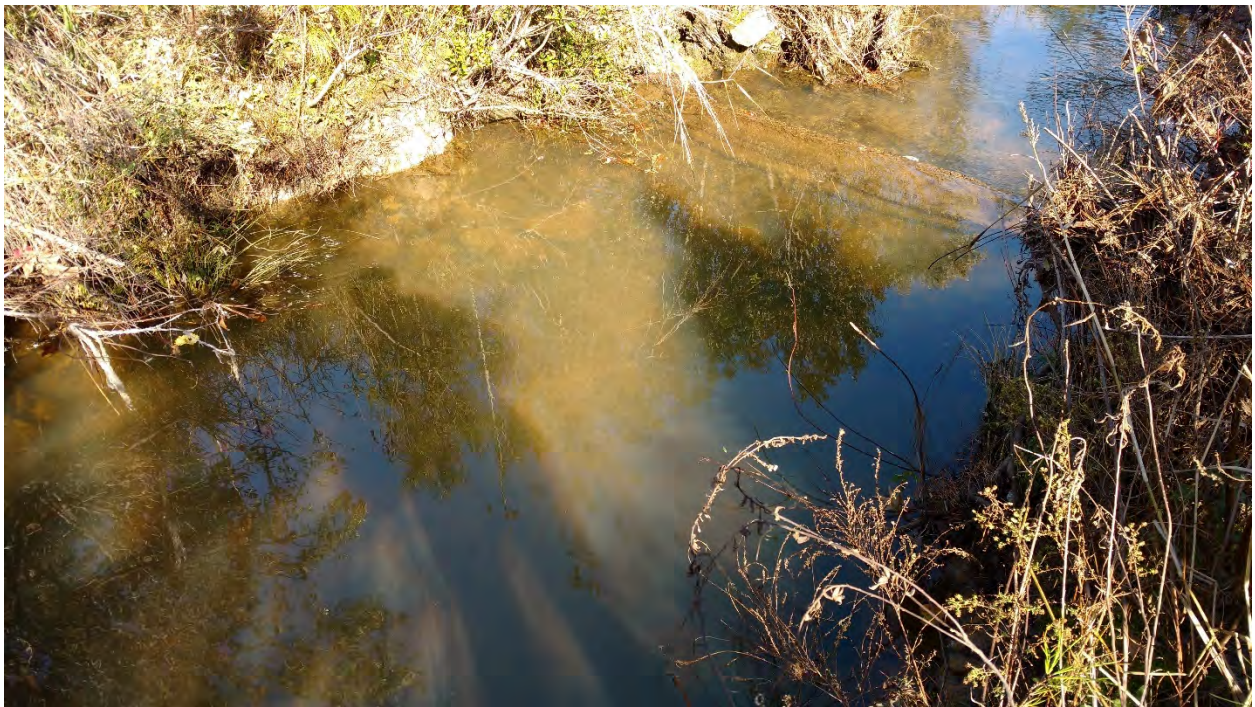
Reach 2A: Stream Problem Area 44 – Scour

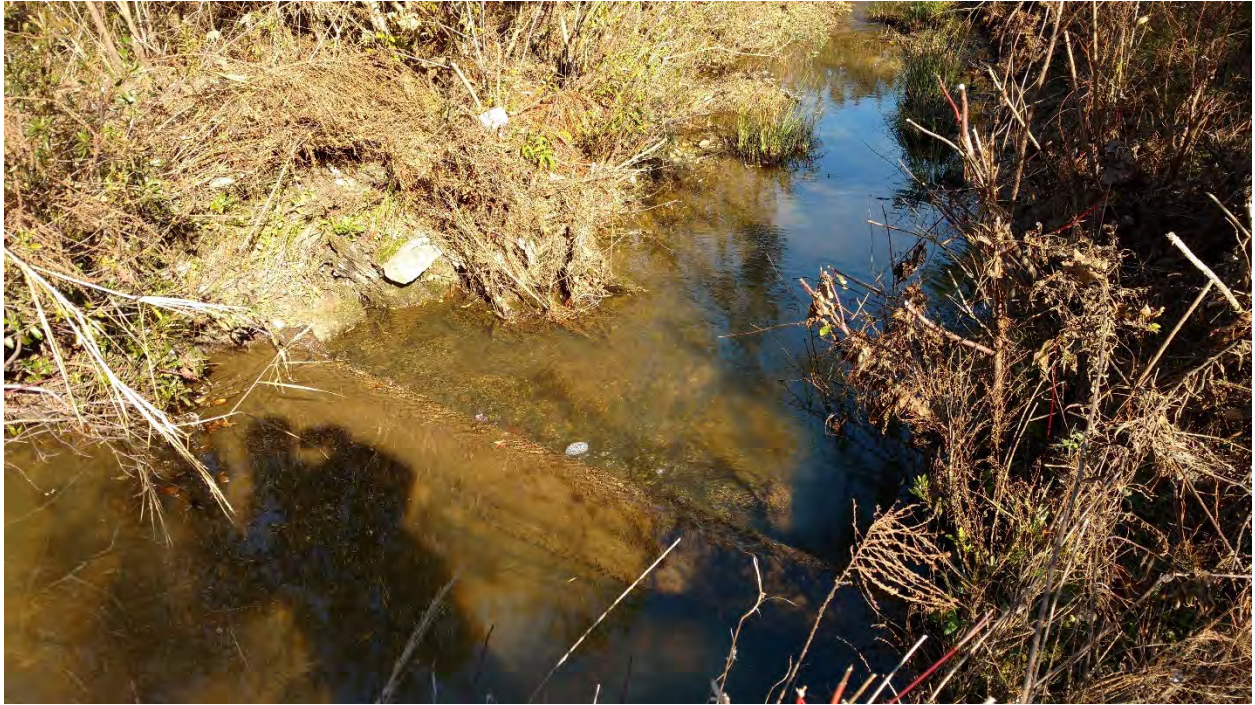
Reach 2A: Stream Problem Area 45 – Scour

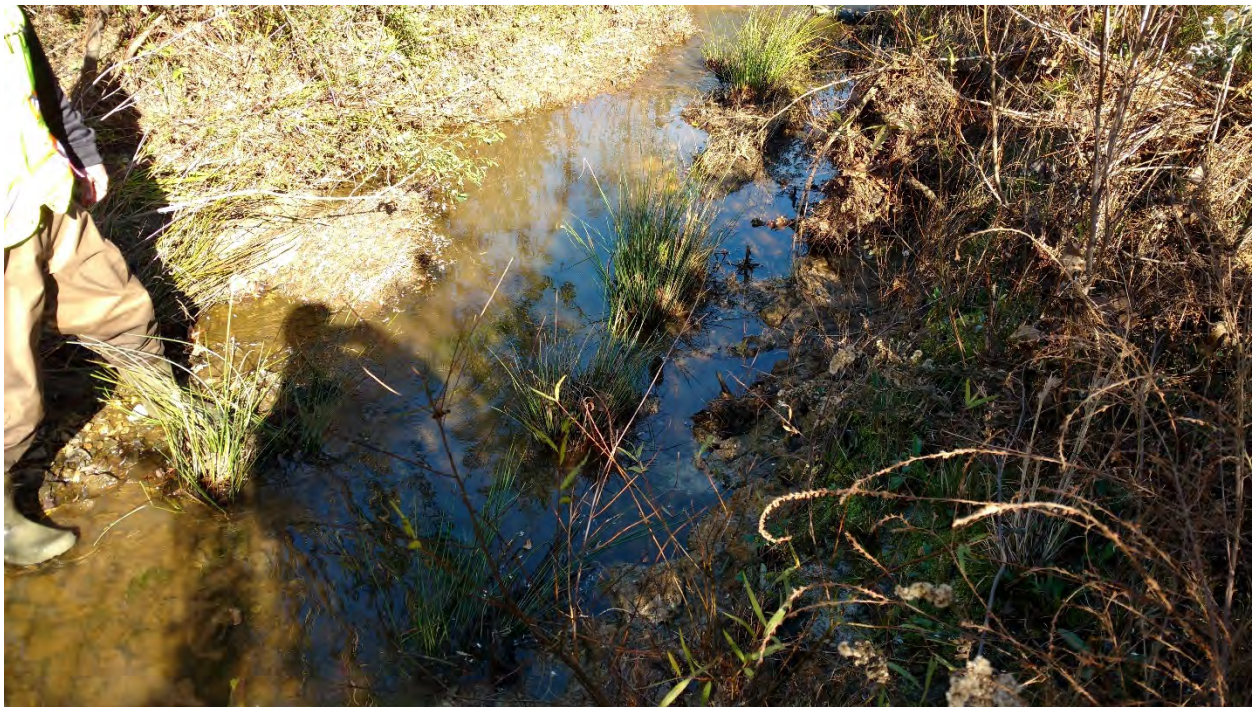
**Reach 2A: Stream Problem Area 45a – Scour**

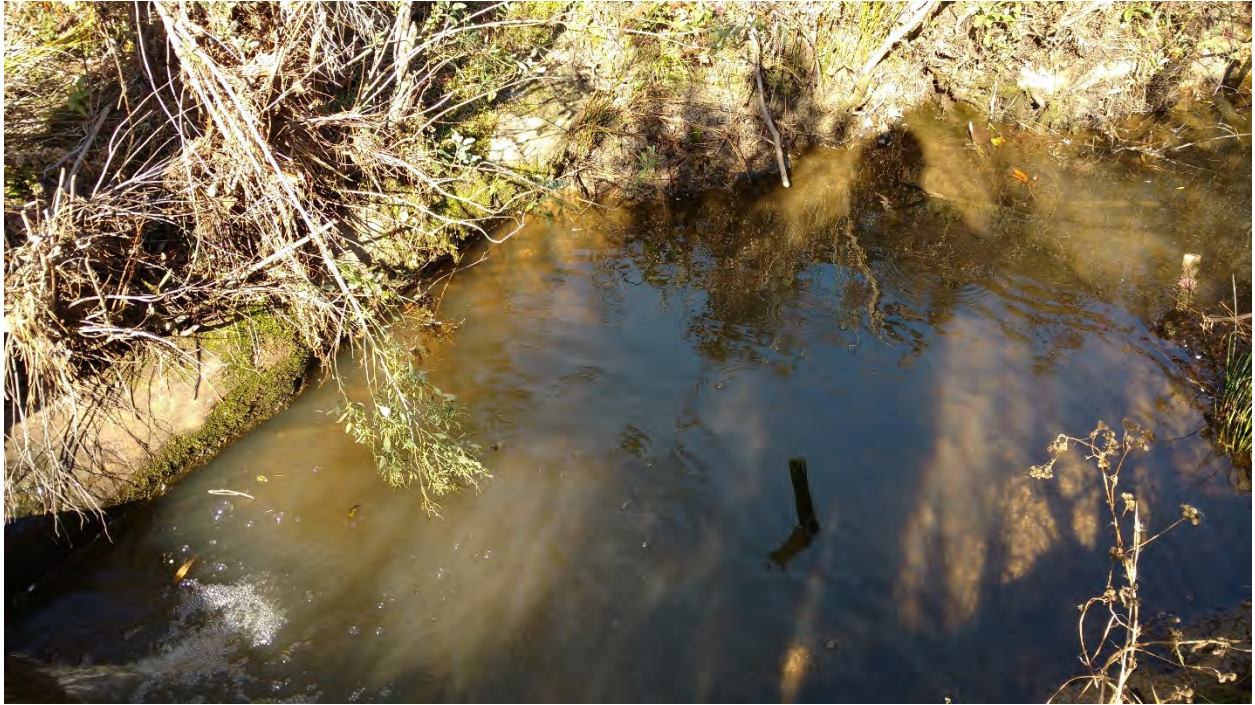
**Reach 2A: Stream Problem Area 47 – Scour**

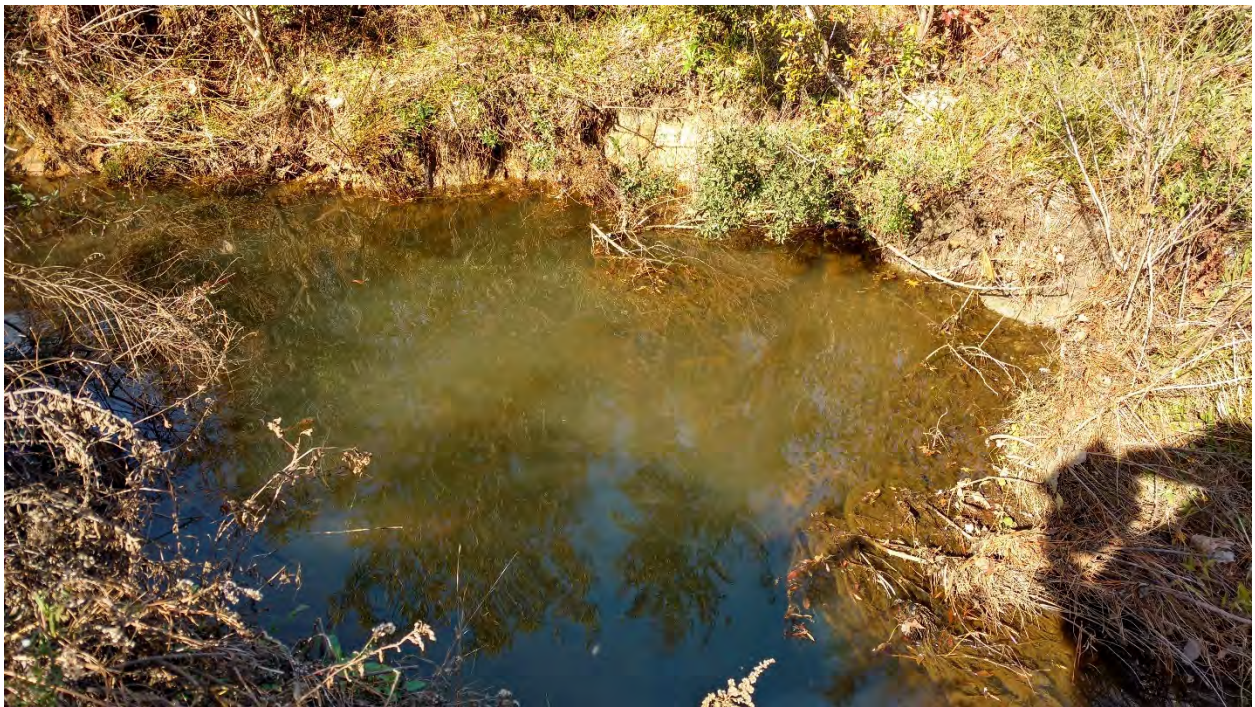
**Reach 2A: Stream Problem Area 48 – Scour**

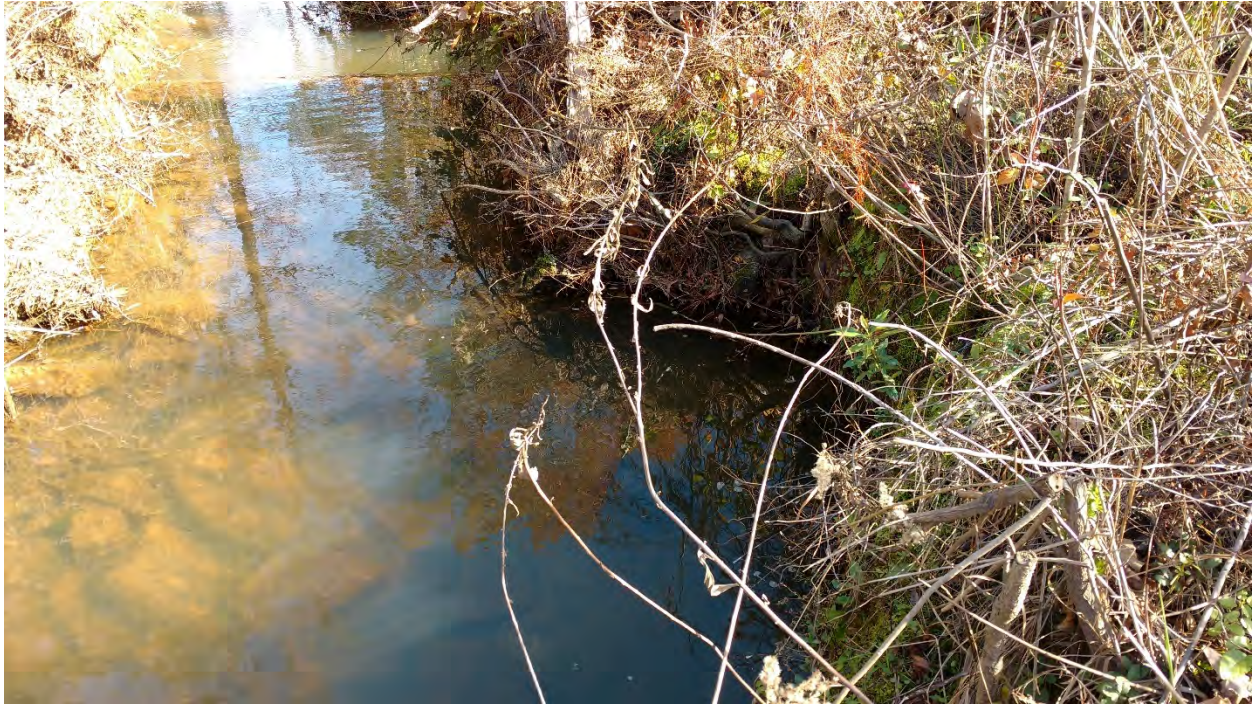
**Reach 2A: Stream Problem Area 49 – Mass Wasting**

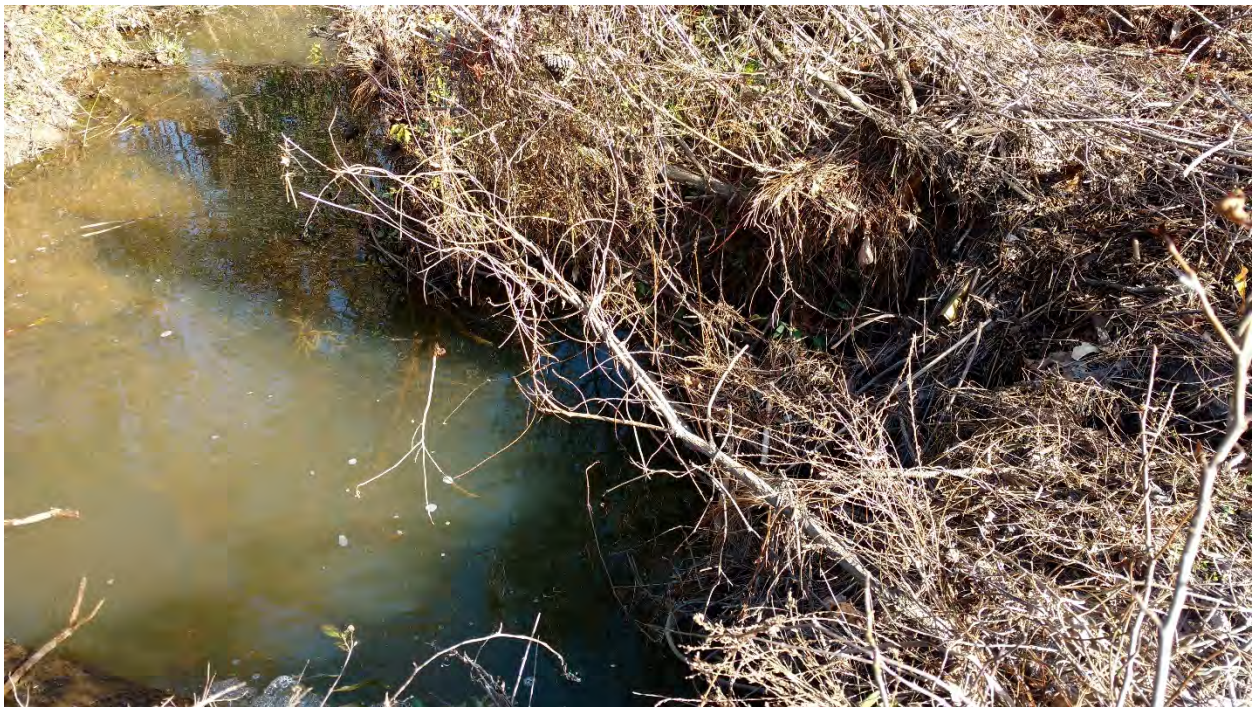
**Reach 2A: Stream Problem Area 50 – Mass Wasting**

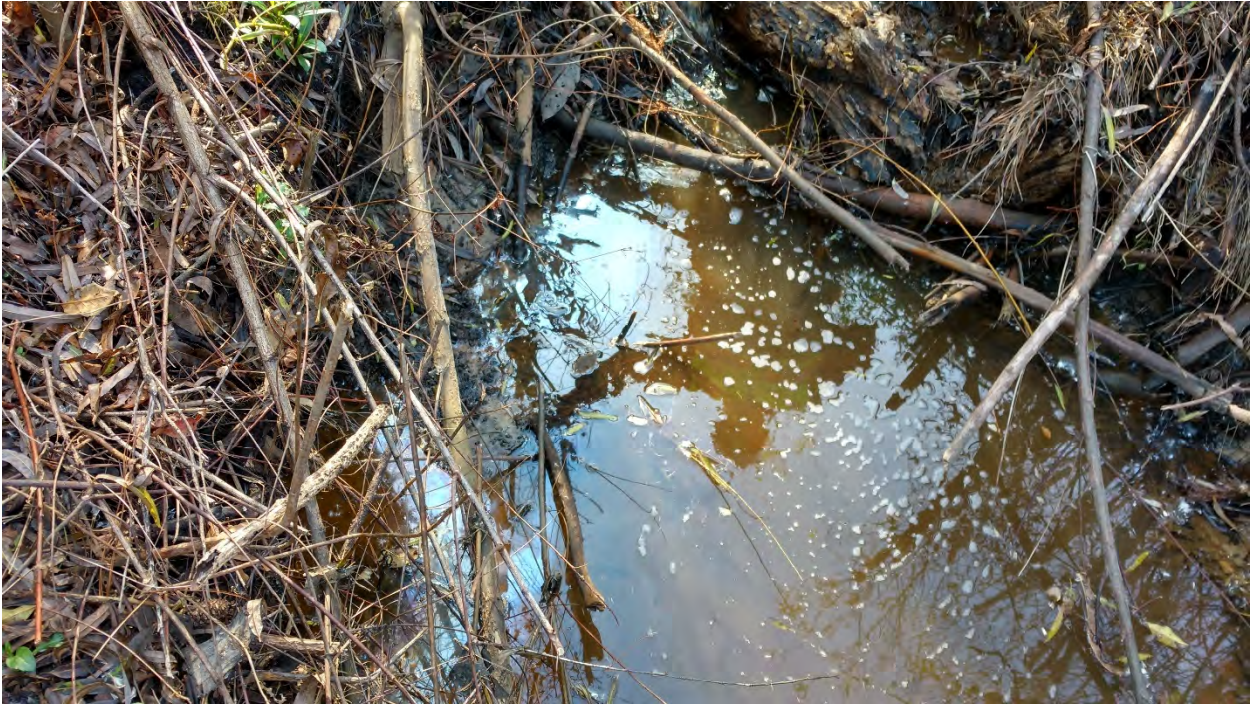
**Reach 2A: Stream Problem Area 50a – Mass Wasting**

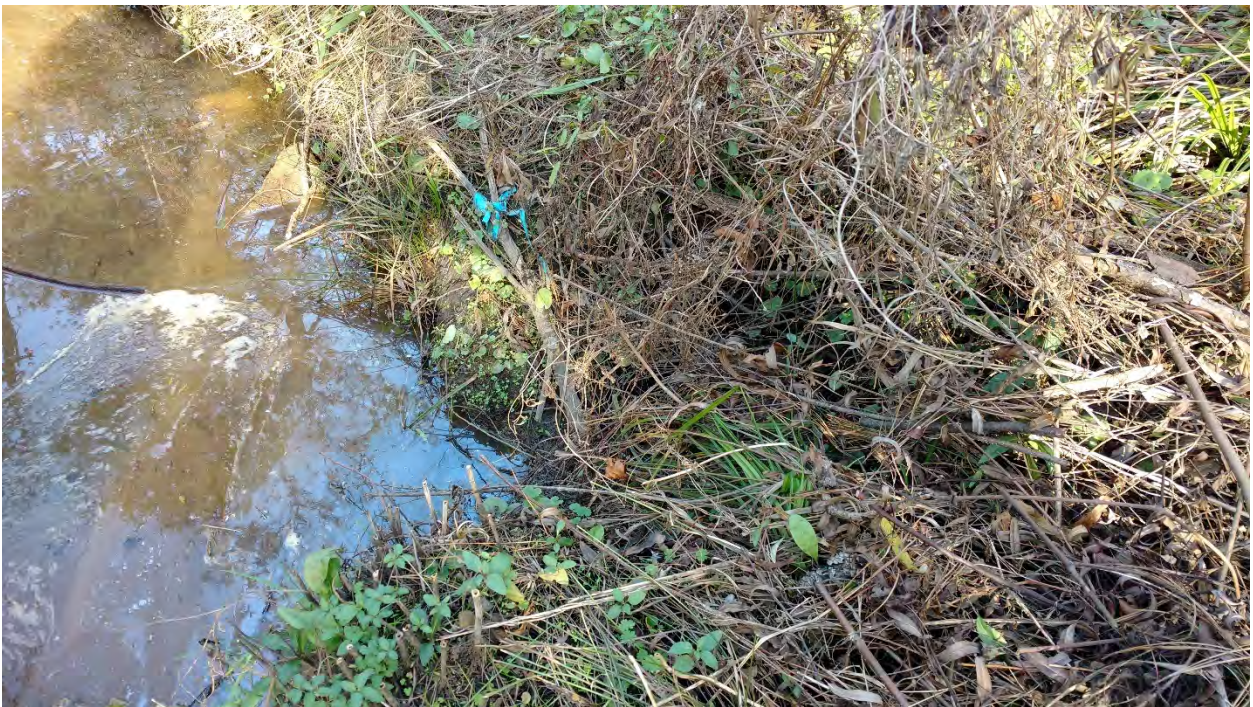
**Reach B: Stream Problem Area 51 – Under Cut**

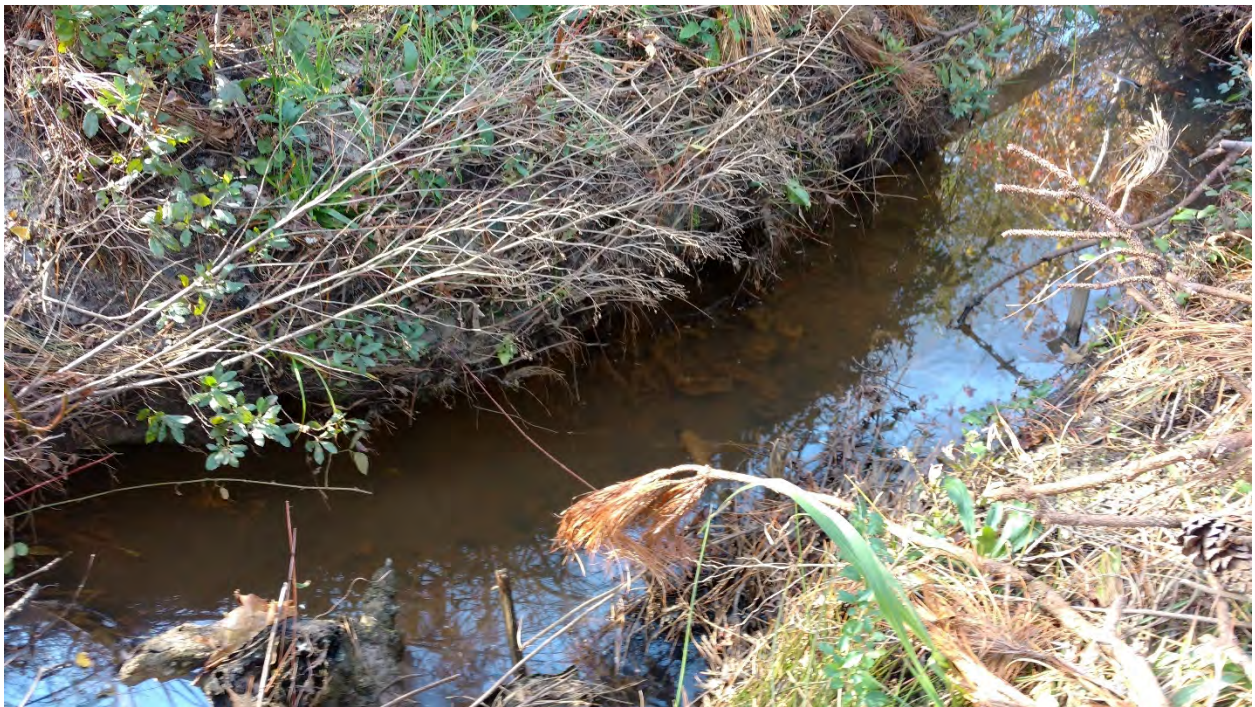
**Reach B: Stream Problem Area 52b – Mass Wasting**

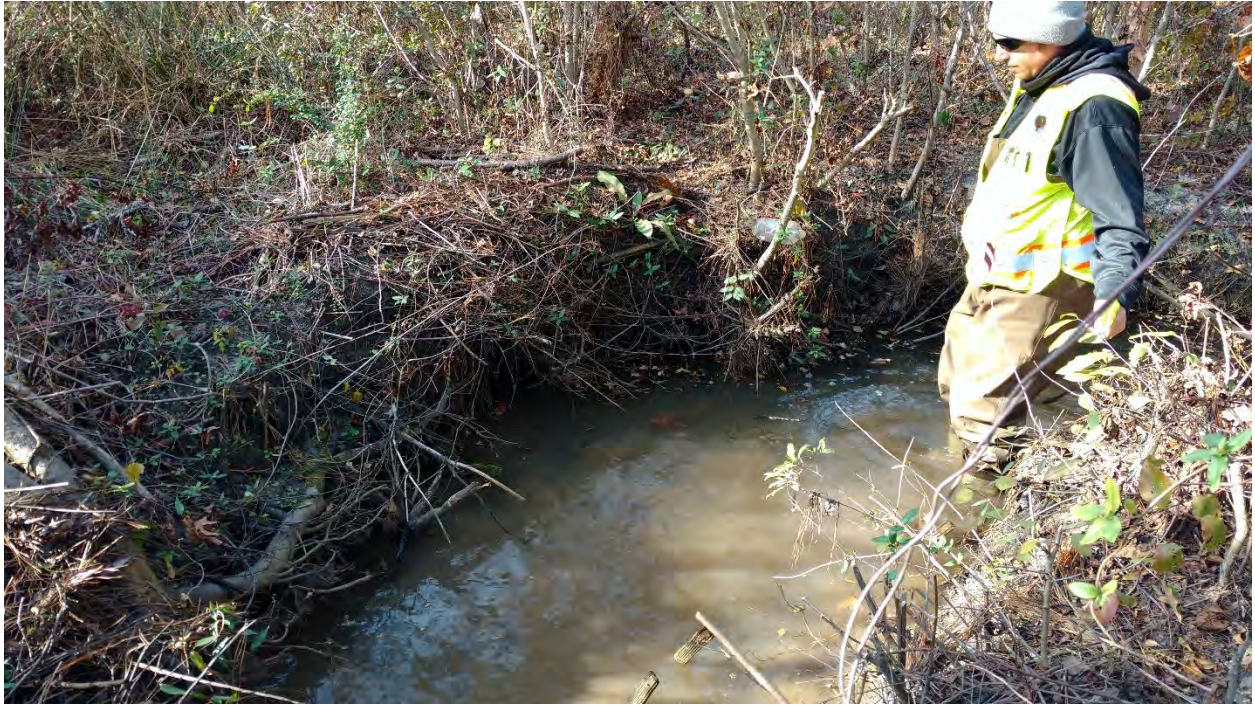
**Reach B: Stream Problem Area 53 – Under Cut**

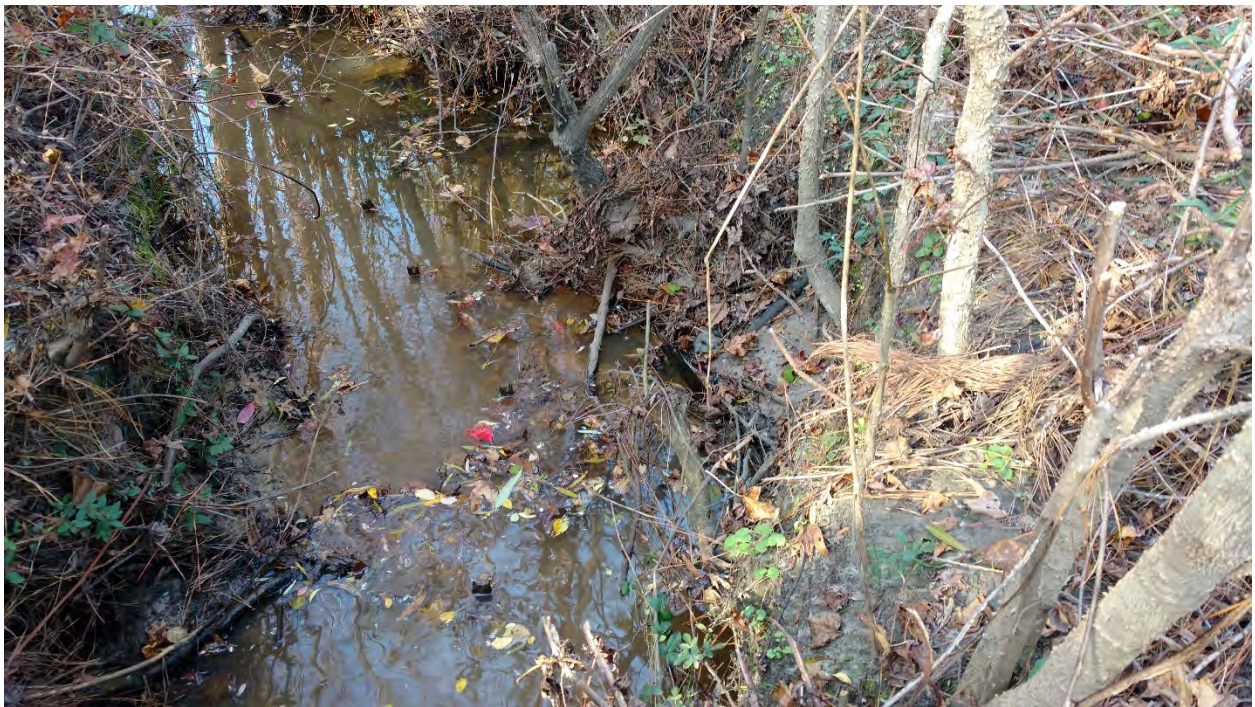
**Reach B: Stream Problem Area 54 – Under Cut**

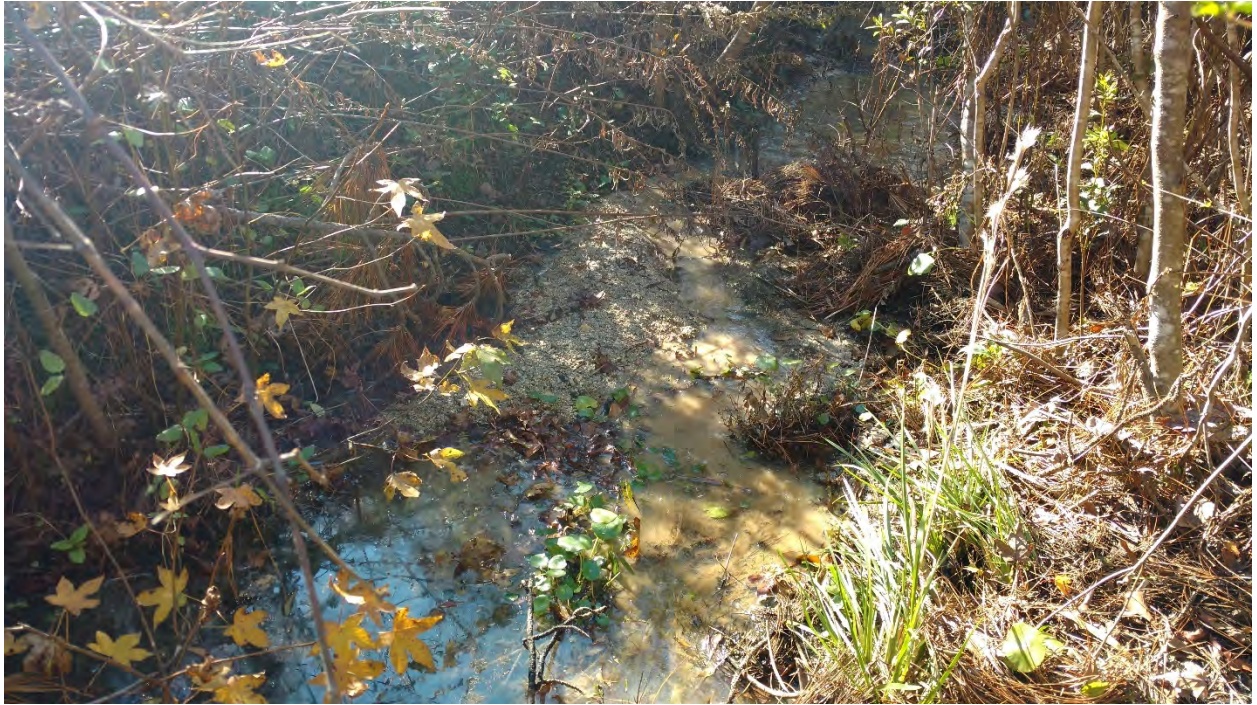
Enhancement Reach: Stream Problem Area 56c – Aggradation

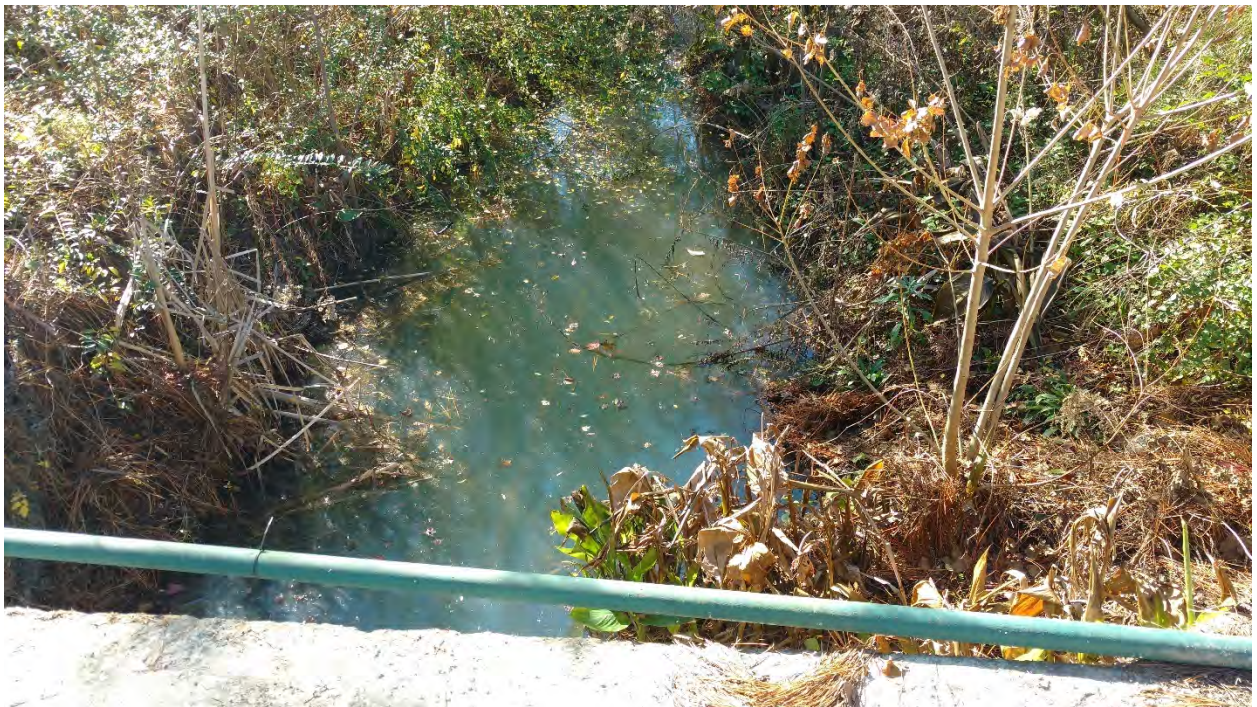
Enhancement Reach: Stream Problem Area 56d – Scour

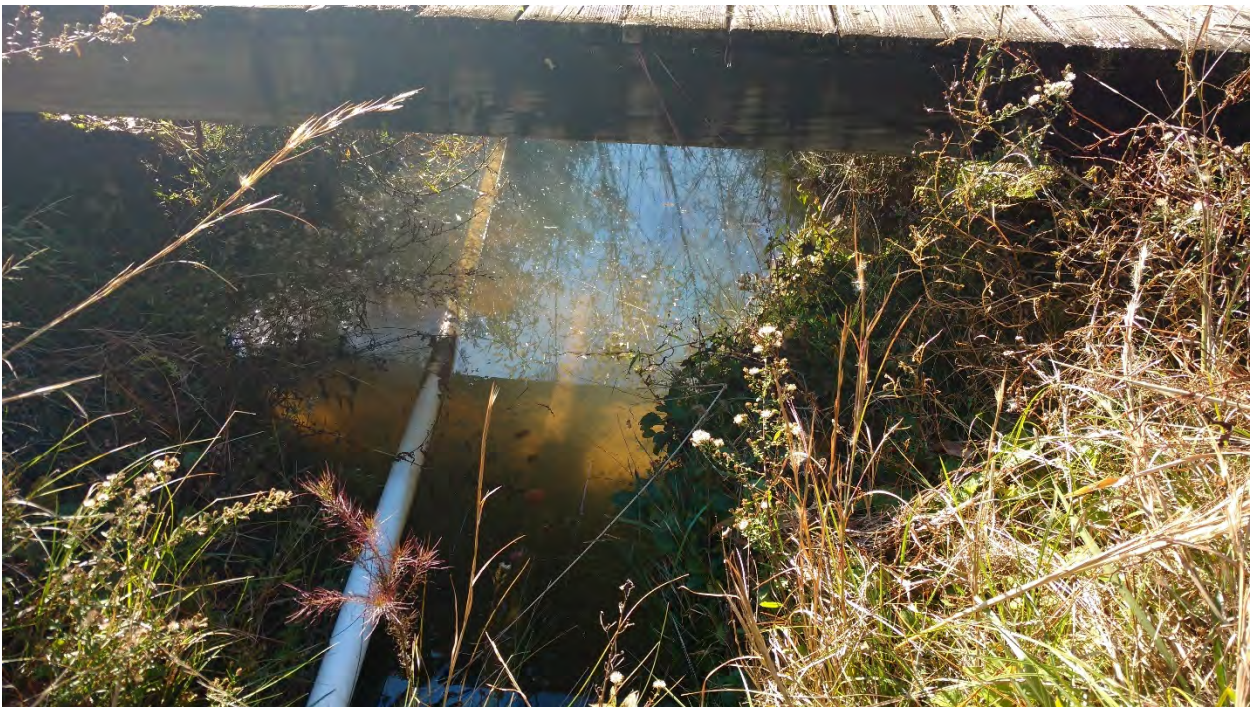
Enhancement Reach: Stream Problem Area 57a – Scour near footbridge

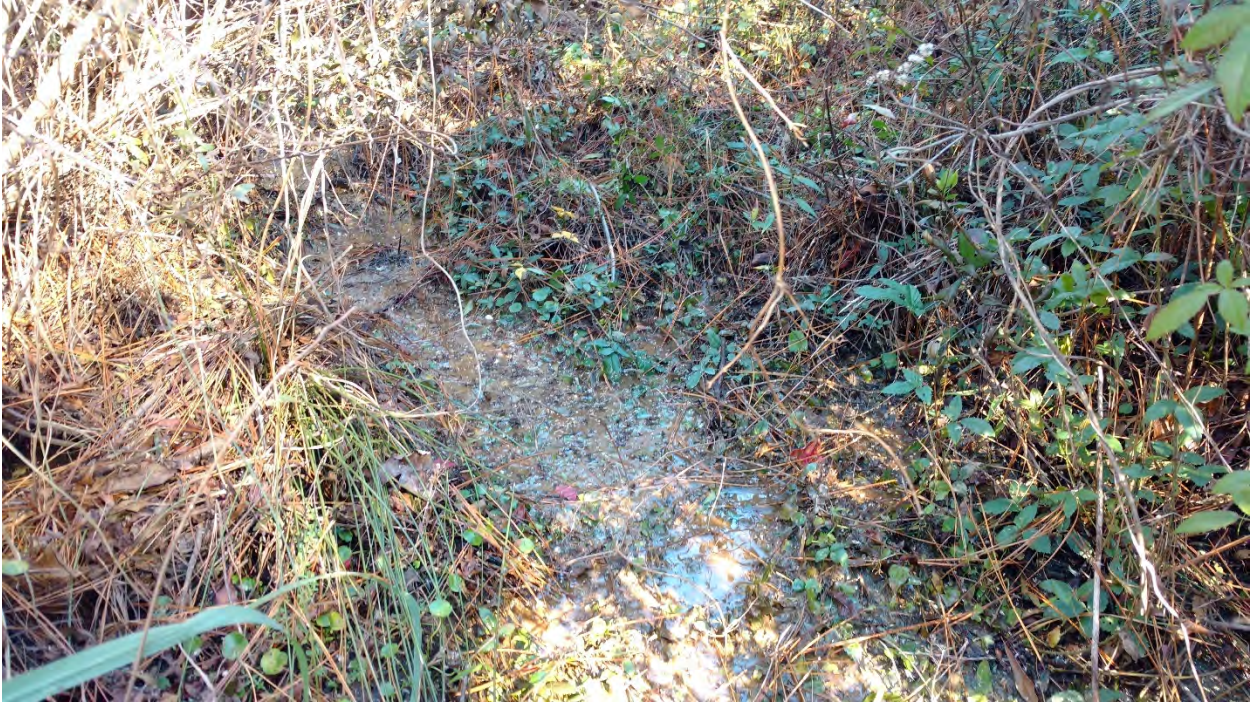
Enhancement Reach: Stream Problem Area 57 – Aggradation

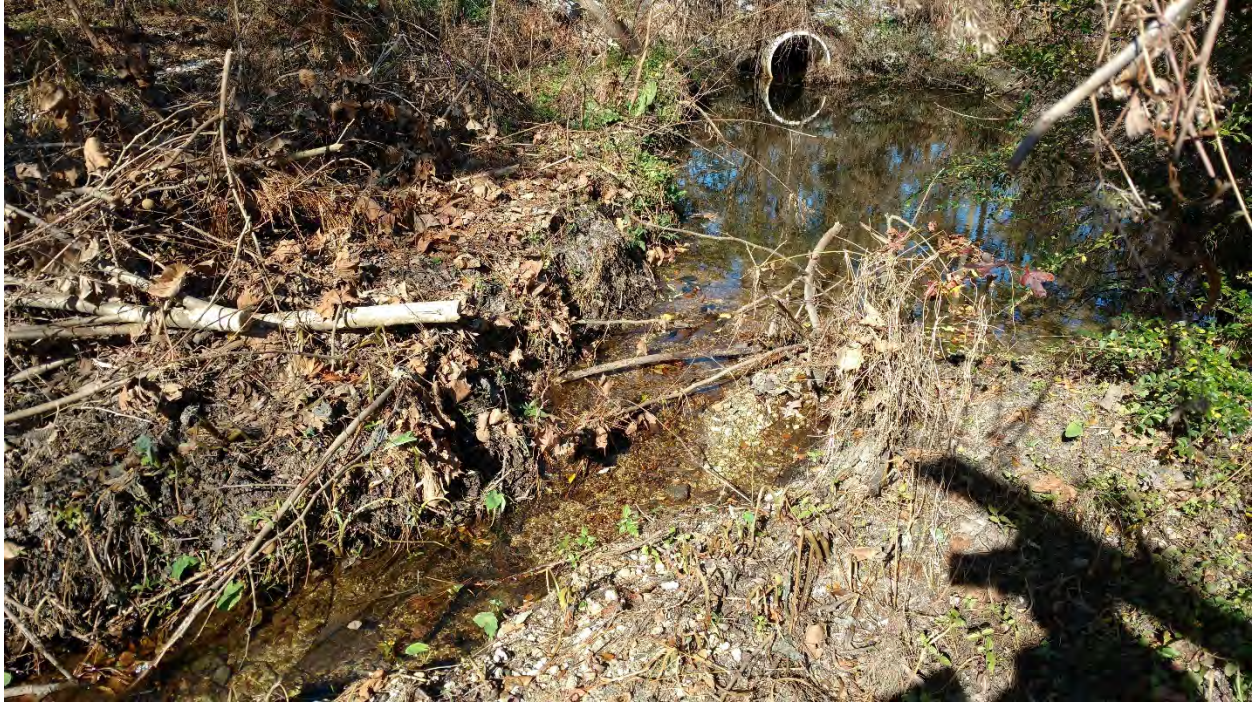
**Reach C: Stream Problem Area 58 – Aggradation**

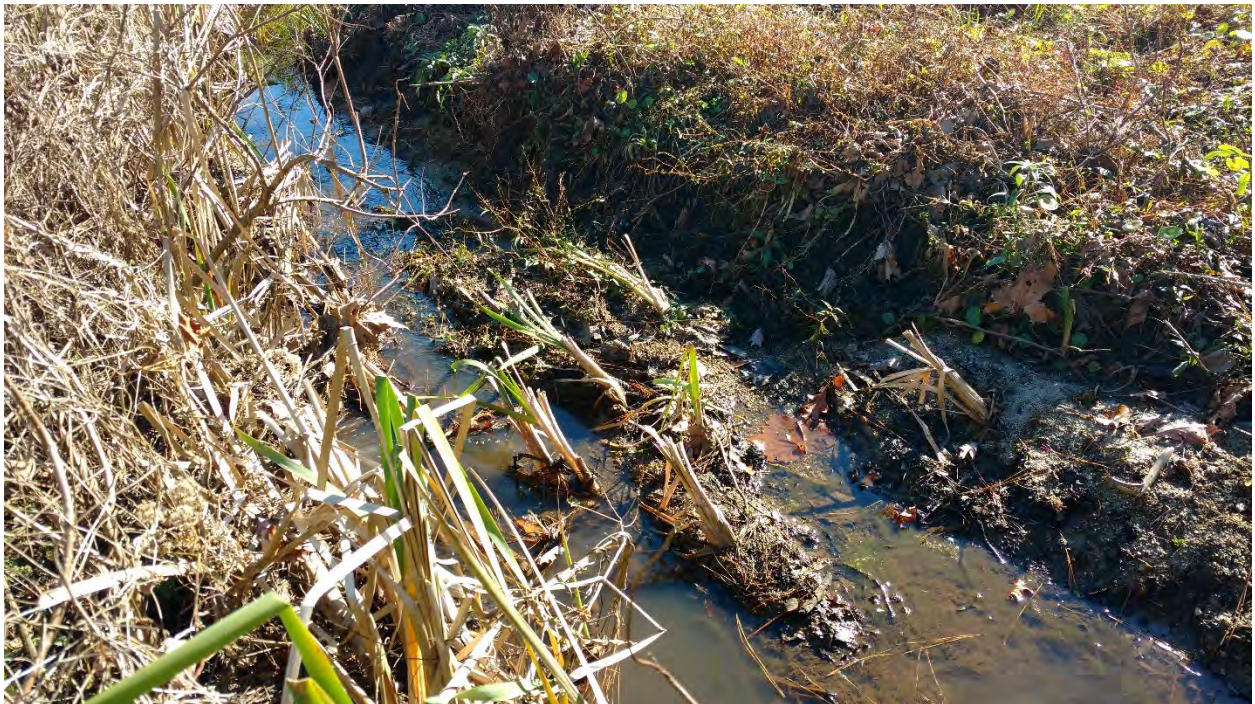
**Reach C: Stream Problem Area 59 – Aggradation**

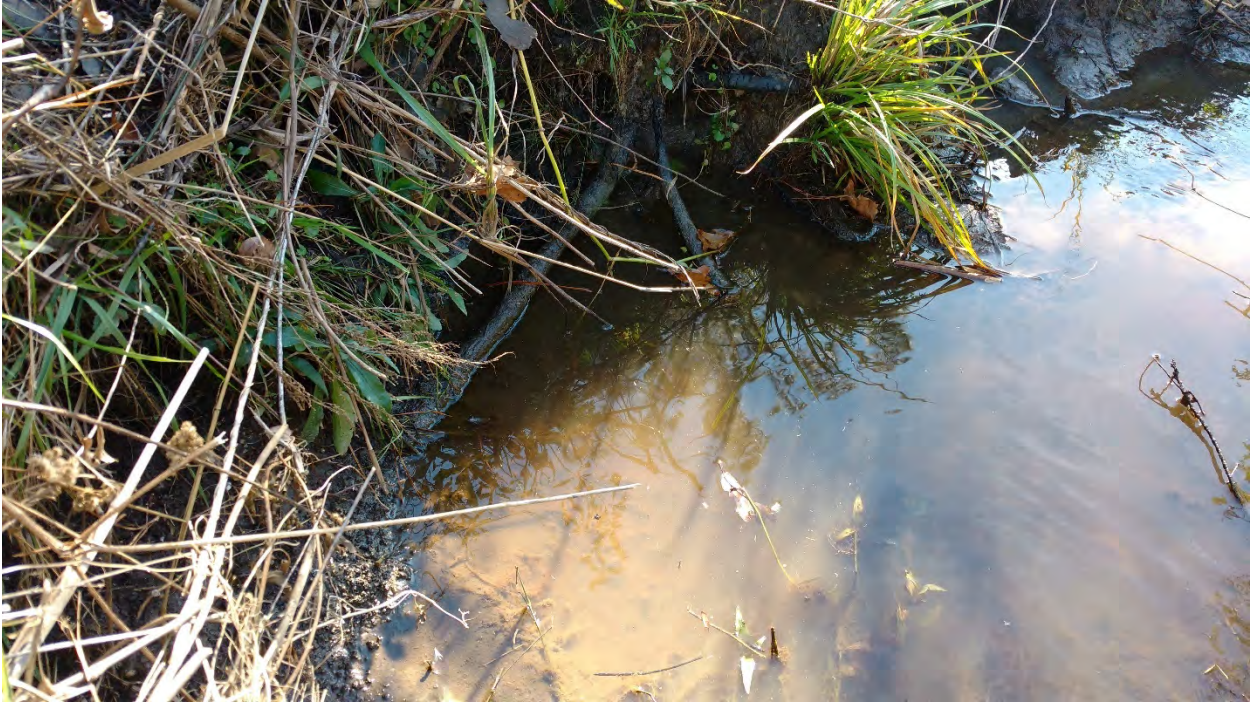
Reach C: Stream Problem Area 60 – Scour

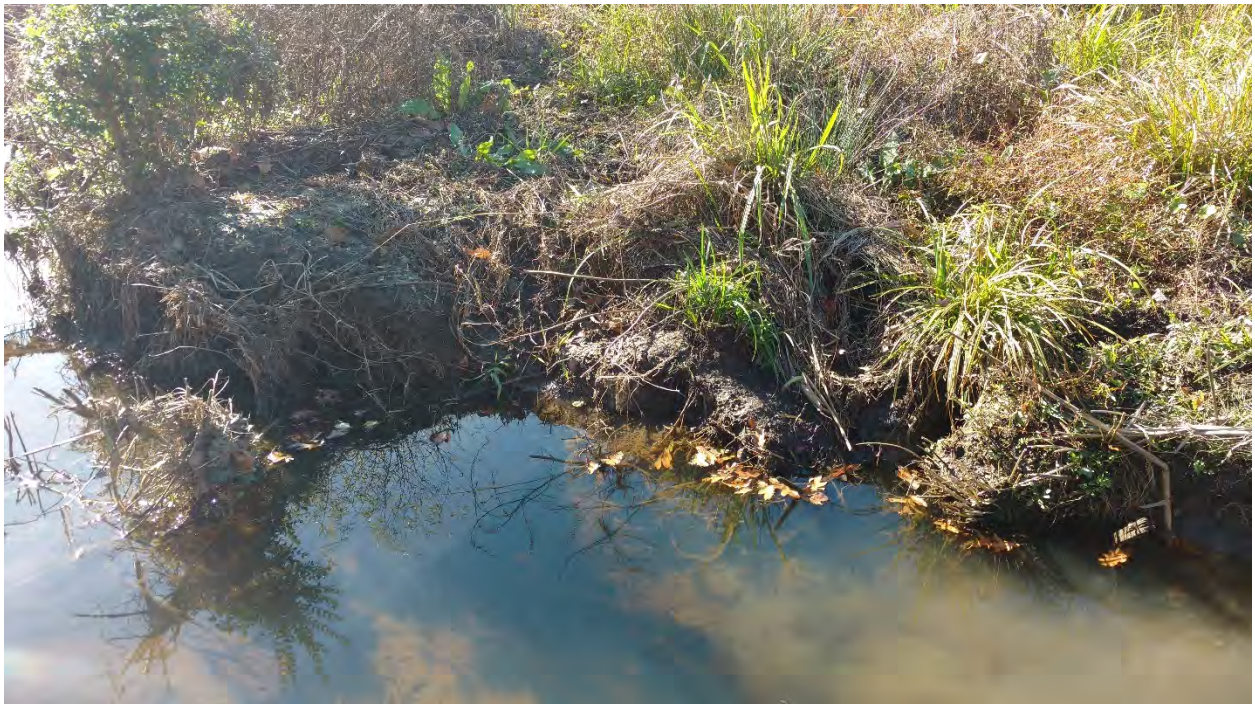
**Reach C: Stream Problem Area 63 – Mass Wasting**
