Jacob's Ladder
Stream Restoration Monitoring Report
DMS Project # 95023
DMS Contract # 003983
Monitoring Year 02

**JACOB'S LADDER
STREAM MITIGATION PROJECT
MONITORING YEAR 2**

CURRENT
CONDITION
PLAN VIEW

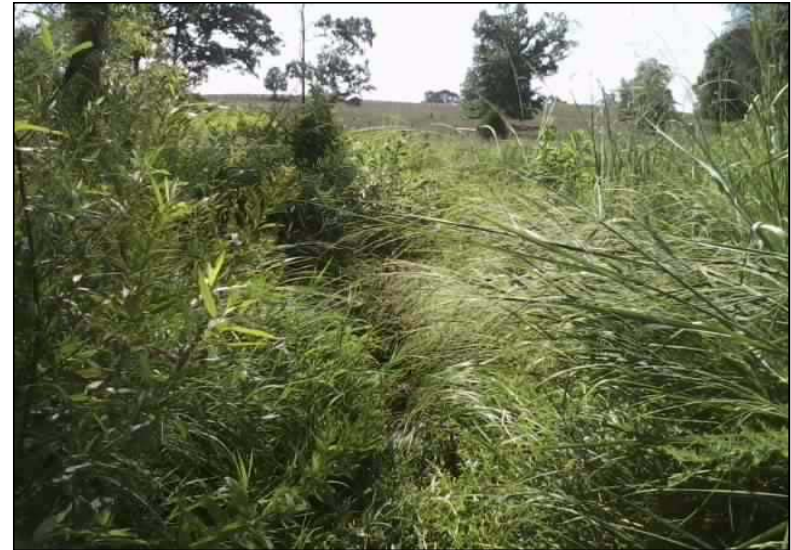
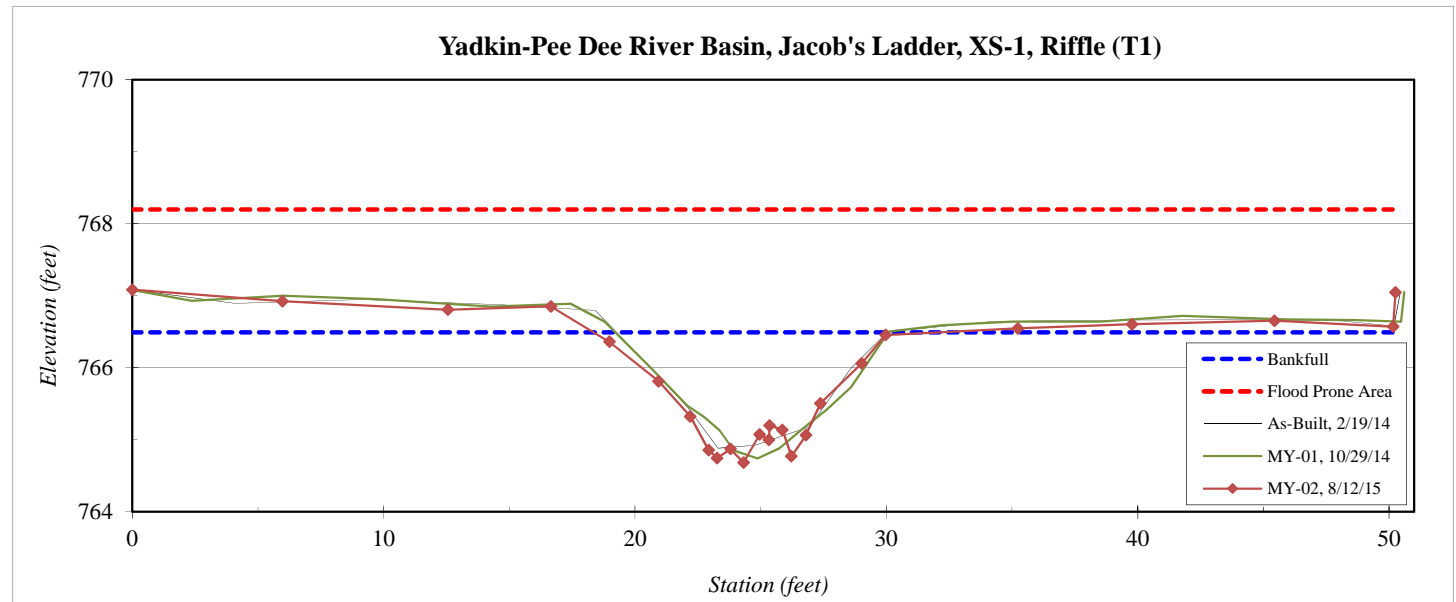
River Basin:	Yadkin-Pee Dee
Watershed:	Jacob's Ladder
XS ID	XS-1, Riffle (T1)
Drainage Area (sq mi):	0.21
Date:	8/12/2015
Field Crew:	T. Seelinger and B. Williams

SUMMARY DATA	
Bankfull Elevation (ft):	766.5
Bankfull Cross-Sectional Area (ft²):	10.1
Bankfull Width (ft):	11.0
Flood Prone Area Elevation (ft):	768.2
Flood Prone Width (ft):	>50
Max Depth at Bankfull (ft):	1.7
Mean Depth at Bankfull (ft):	0.9
W / D Ratio:	12.0
Entrenchment Ratio:	4.5
Bank Height Ratio:	1.0

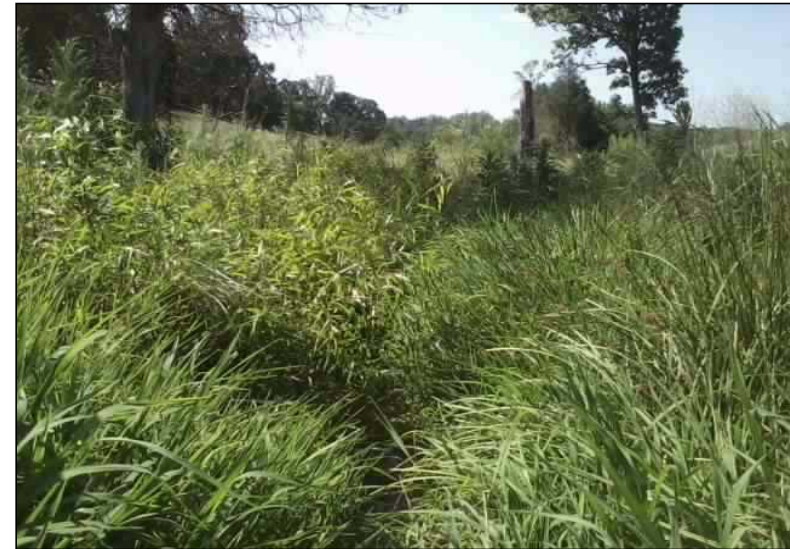
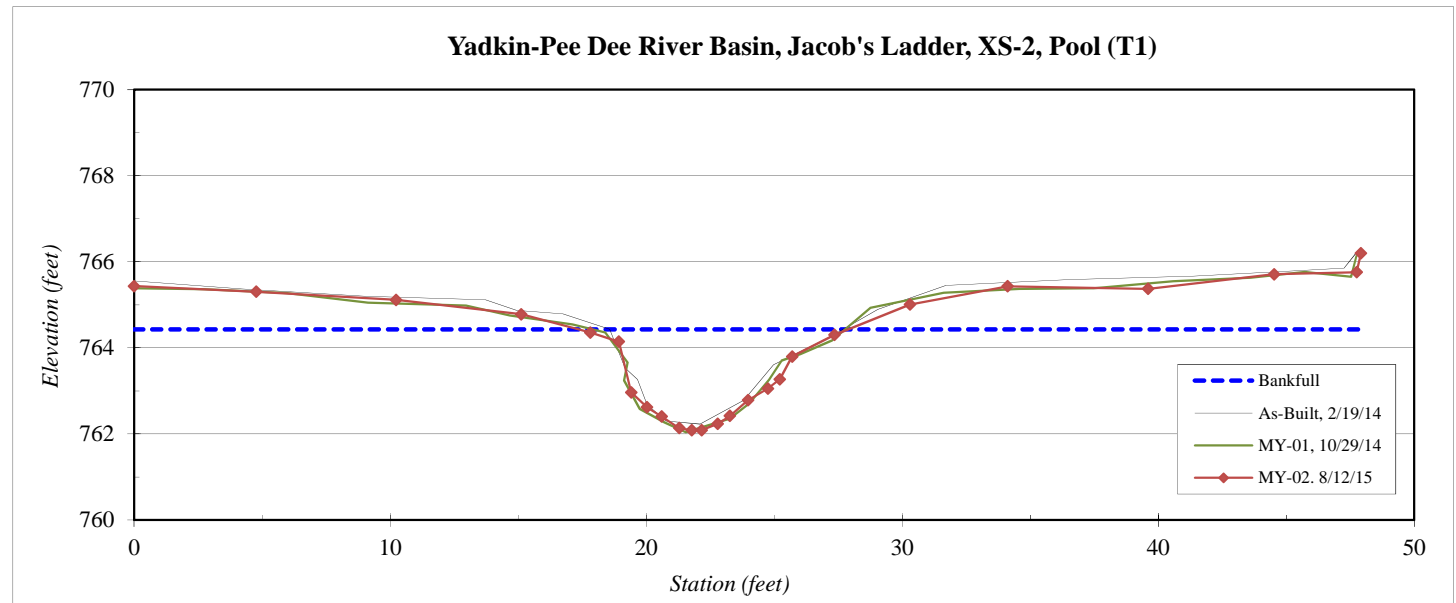
River Basin:	Yadkin-Pee Dee
Watershed:	Jacob's Ladder
XS ID	XS-2, Pool (T1)
Drainage Area (sq mi):	0.21
Date:	8/12/2015
Field Crew:	T. Seelinger and B. Williams

SUMMARY DATA	
Bankfull Elevation (ft):	764.4
Bankfull Cross-Sectional Area (ft²):	12.8
Bankfull Width (ft):	10.5
Flood Prone Area Elevation (ft):	-
Flood Prone Width (ft):	-
Max Depth at Bankfull (ft):	2.3
Mean Depth at Bankfull (ft):	1.2
W / D Ratio:	-
Entrenchment Ratio:	-
Bank Height Ratio:	-

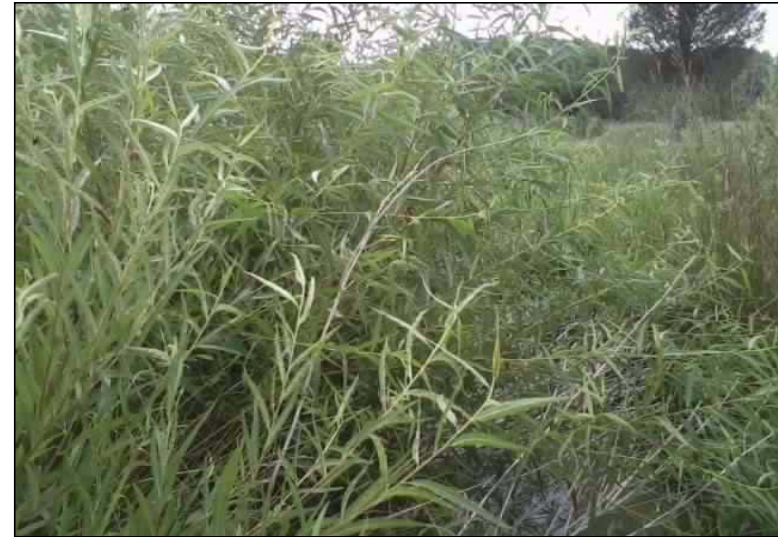
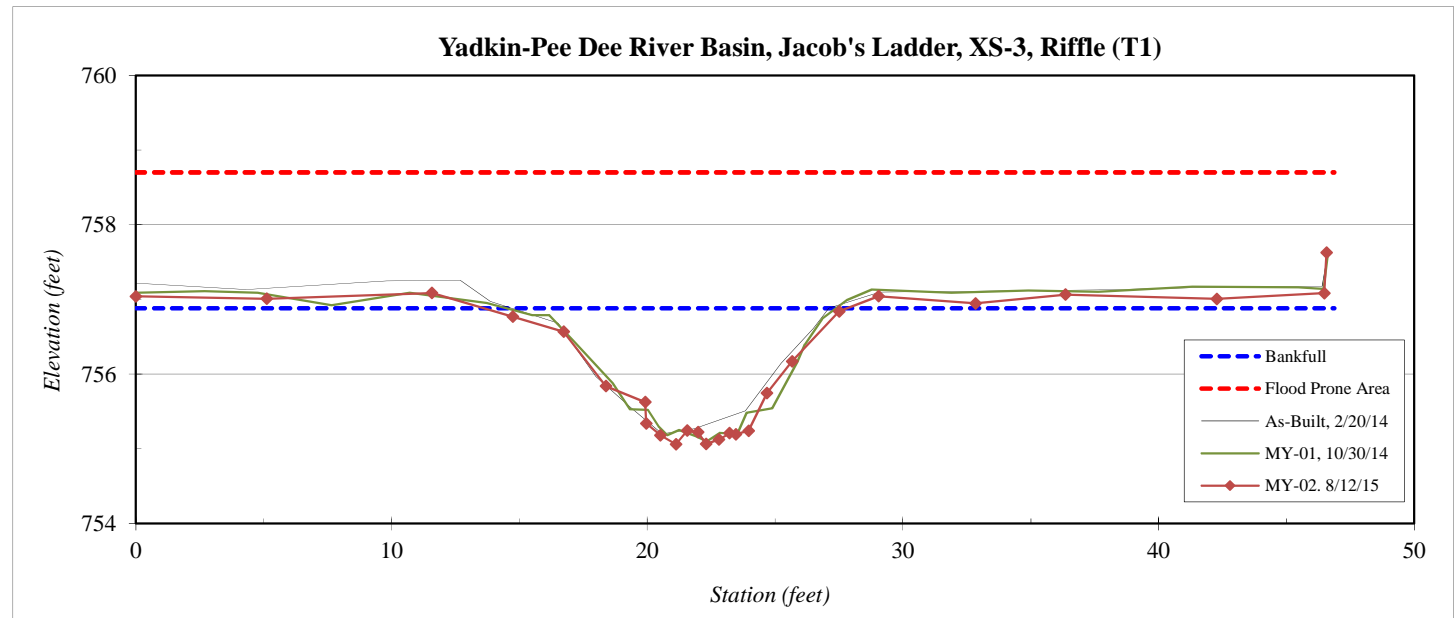
River Basin:	Yadkin-Pee Dee
Watershed:	Jacob's Ladder
XS ID	XS-3, Riffle (T1)
Drainage Area (sq mi):	0.36
Date:	8/12/2015
Field Crew:	T. Seelinger and B. Williams

SUMMARY DATA	
Bankfull Elevation (ft):	756.9
Bankfull Cross-Sectional Area (ft²):	12.9
Bankfull Width (ft):	14.2
Flood Prone Area Elevation (ft):	758.7
Flood Prone Width (ft):	>45
Max Depth at Bankfull (ft):	1.8
Mean Depth at Bankfull (ft):	0.9
W / D Ratio:	15.6
Entrenchment Ratio:	3.2
Bank Height Ratio:	1.0

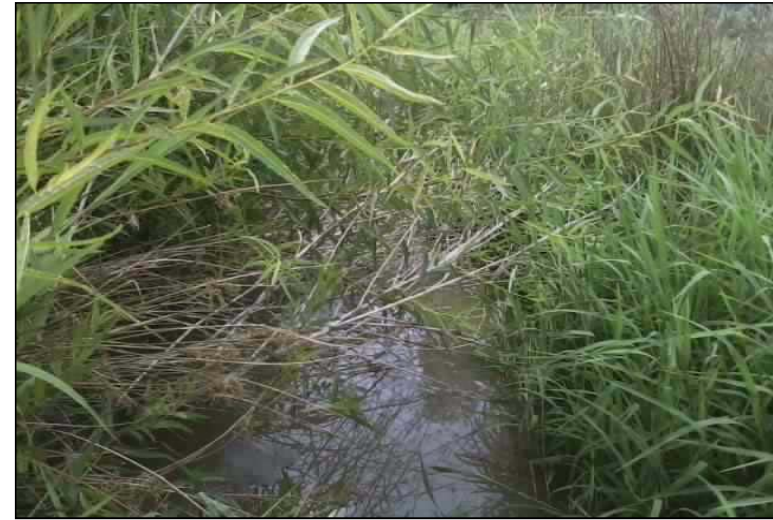
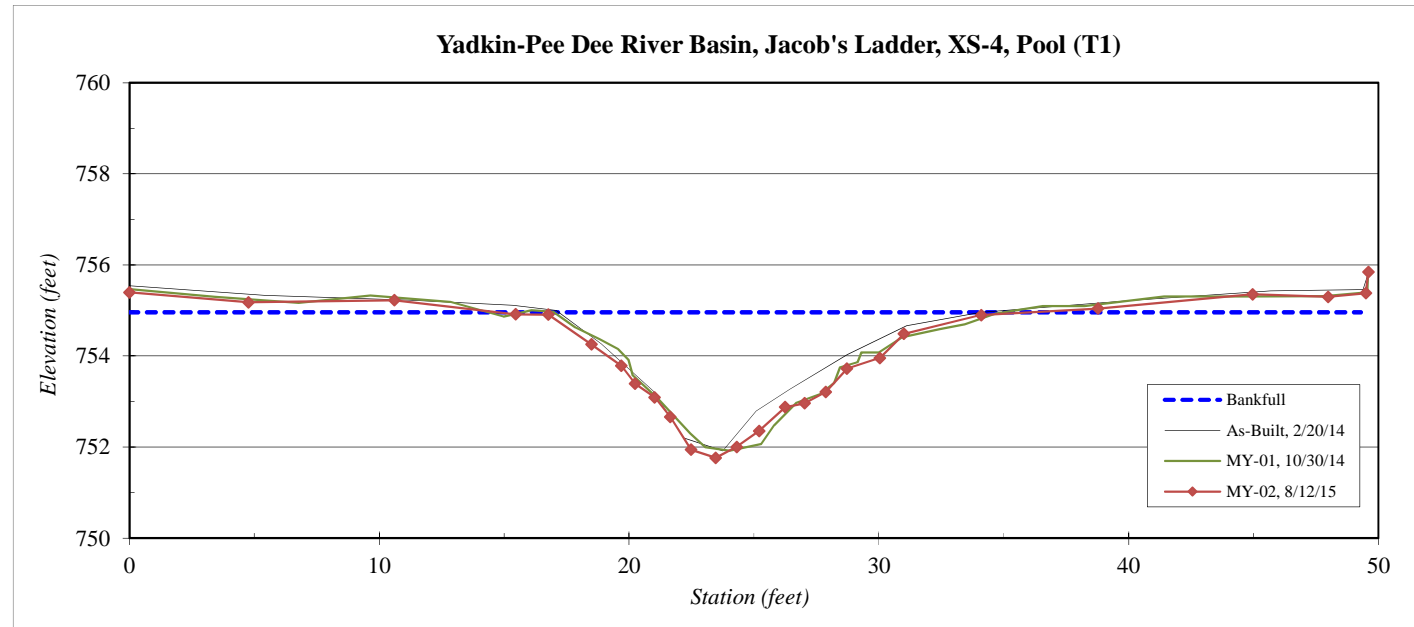
River Basin:	Yadkin-Pee Dee
Watershed:	Jacob's Ladder
XS ID	XS-4, Pool (T1)
Drainage Area (sq mi):	0.36
Date:	8/12/2015
Field Crew:	T. Seelinger and B. Williams

SUMMARY DATA	
Bankfull Elevation (ft):	755.0
Bankfull Cross-Sectional Area (ft²):	25.4
Bankfull Width (ft):	17.3
Flood Prone Area Elevation (ft):	-
Flood Prone Width (ft):	-
Max Depth at Bankfull (ft):	3.2
Mean Depth at Bankfull (ft):	1.5
W / D Ratio:	-
Entrenchment Ratio:	-
Bank Height Ratio:	-

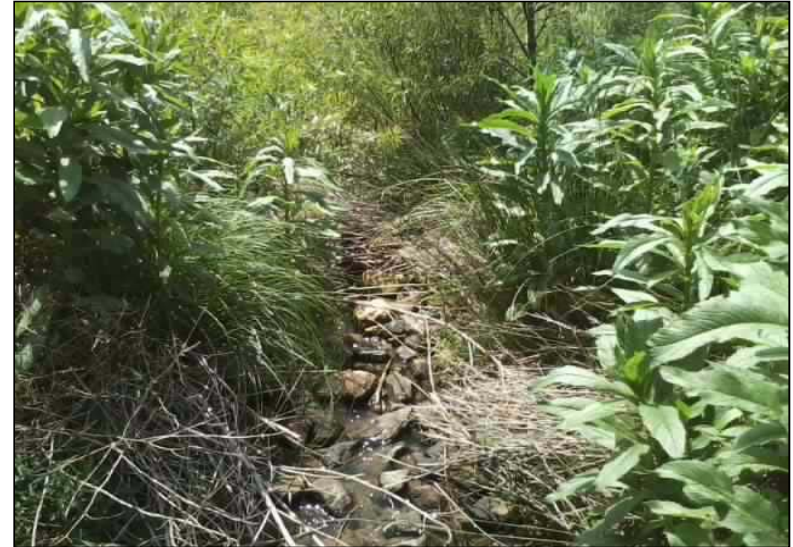
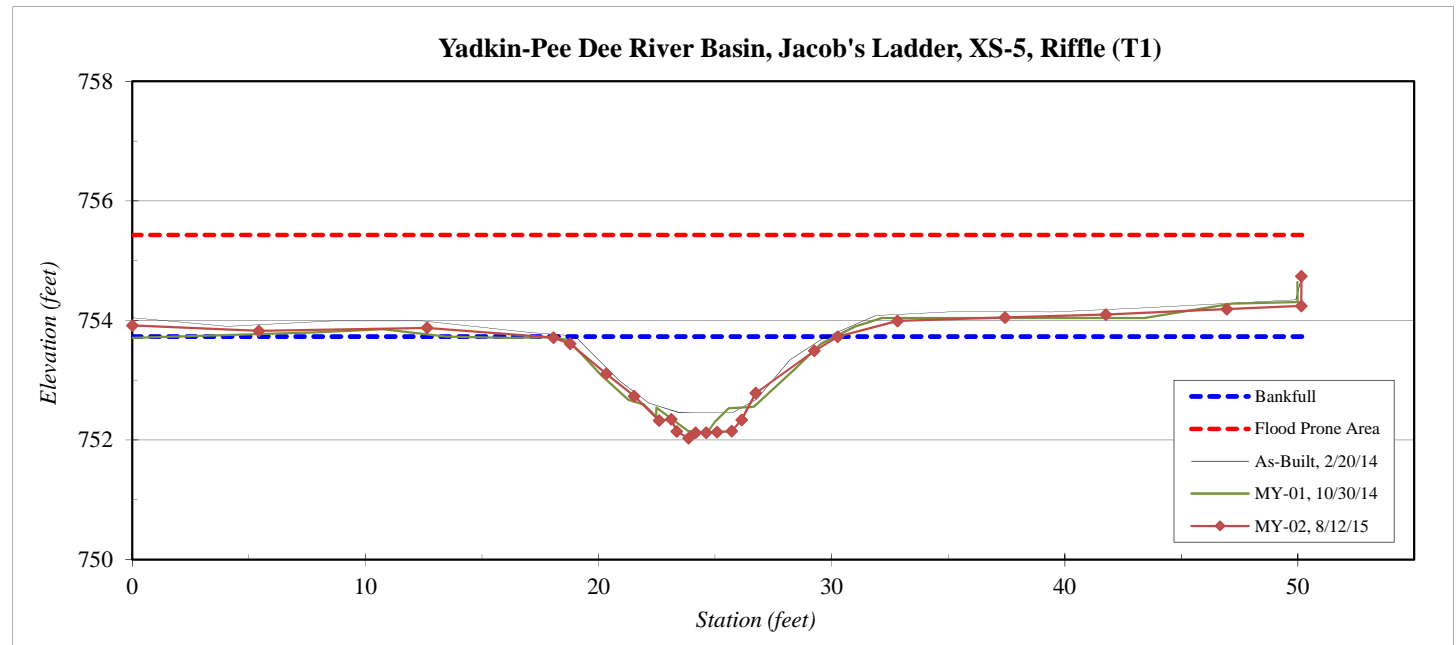
River Basin:	Yadkin-Pee Dee
Watershed:	Jacob's Ladder
XS ID	XS-5, Riffle (T1)
Drainage Area (sq mi):	0.36
Date:	8/12/2015
Field Crew:	T. Seelinger and B. Williams

SUMMARY DATA	
Bankfull Elevation (ft):	753.7
Bankfull Cross-Sectional Area (ft²):	10.7
Bankfull Width (ft):	12.8
Flood Prone Area Elevation (ft):	755.4
Flood Prone Width (ft):	>50
Max Depth at Bankfull (ft):	1.7
Mean Depth at Bankfull (ft):	0.8
W / D Ratio:	15.3
Entrenchment Ratio:	3.9
Bank Height Ratio:	1.0

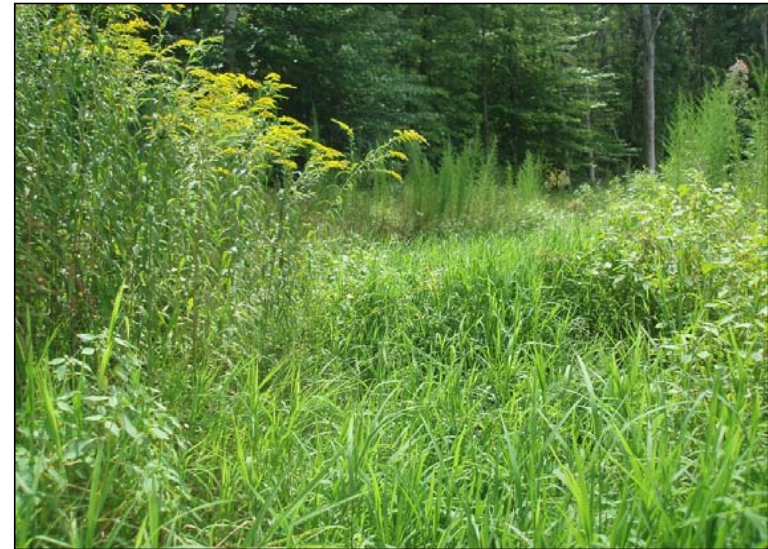
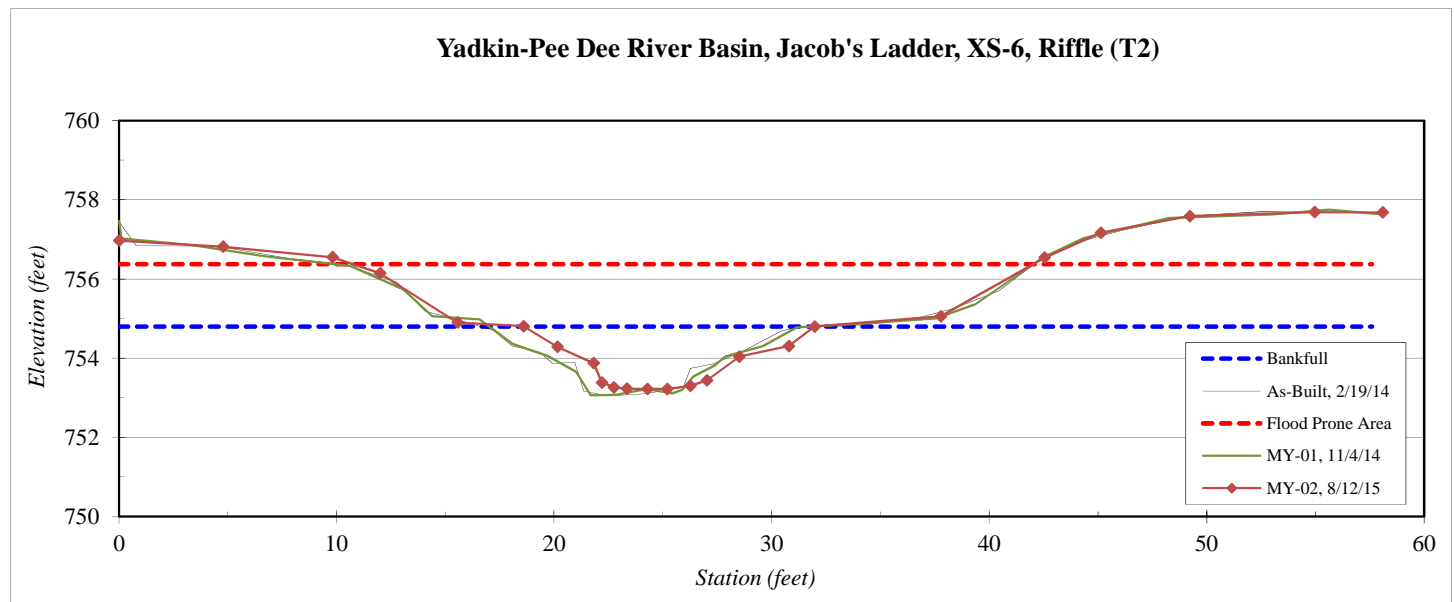
River Basin:	Yadkin-Pee Dee
Watershed:	Jacob's Ladder
XS ID	XS-6, Riffle (T2)
Drainage Area (sq mi):	0.67
Date:	8/12/2015
Field Crew:	T. Seelinger and B. Williams

SUMMARY DATA	
Bankfull Elevation (ft):	754.8
Bankfull Cross-Sectional Area (ft²):	12.7
Bankfull Width (ft):	13.4
Flood Prone Area Elevation (ft):	756.4
Flood Prone Width (ft):	31.3
Max Depth at Bankfull (ft):	1.6
Mean Depth at Bankfull (ft):	0.9
W / D Ratio:	14.1
Entrenchment Ratio:	2.3
Bank Height Ratio:	1.0

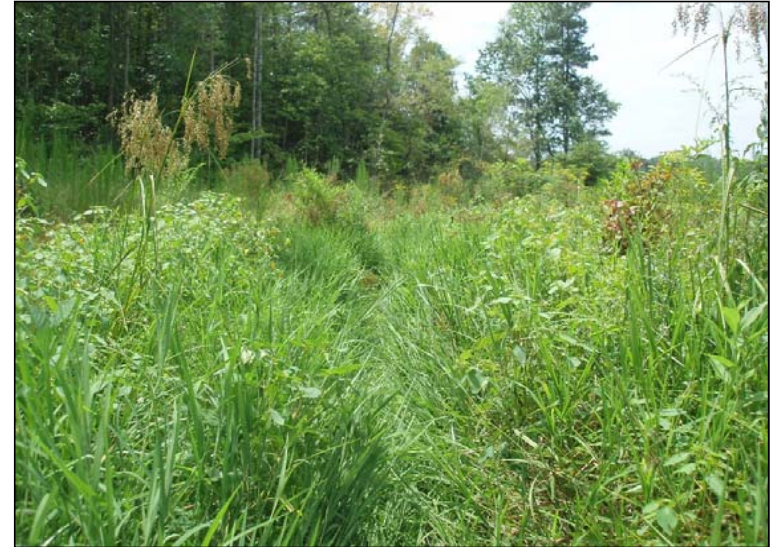
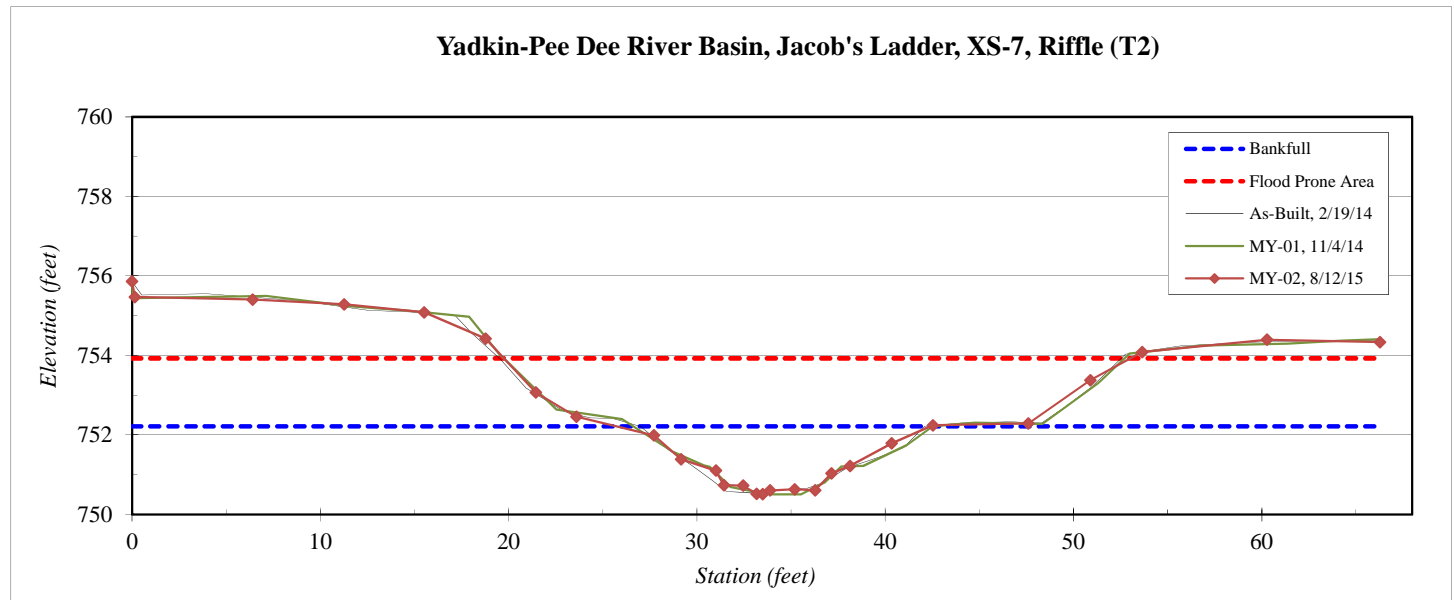
River Basin:	Yadkin-Pee Dee
Watershed:	Jacob's Ladder
XS ID	XS-7, Riffle (T2)
Drainage Area (sq mi):	0.67
Date:	8/12/2015
Field Crew:	T. Seelinger and B. Williams

SUMMARY DATA	
Bankfull Elevation (ft):	752.2
Bankfull Cross-Sectional Area (ft²):	15.4
Bankfull Width (ft):	16.7
Flood Prone Area Elevation (ft):	753.9
Flood Prone Width (ft):	33
Max Depth at Bankfull (ft):	1.7
Mean Depth at Bankfull (ft):	0.9
W / D Ratio:	18.1
Entrenchment Ratio:	2.0
Bank Height Ratio:	1.0

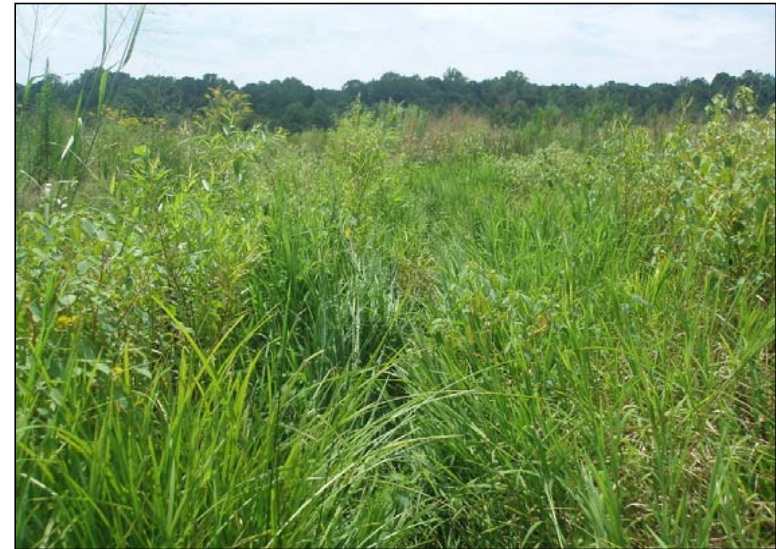
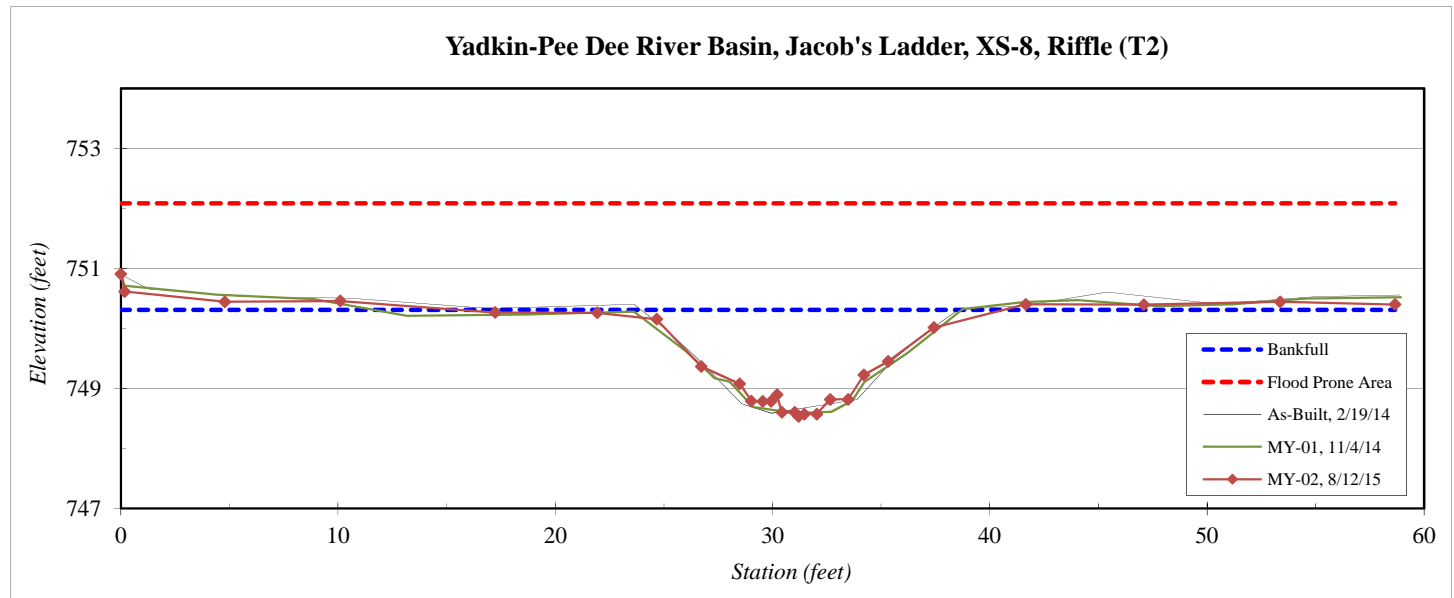
River Basin:	Yadkin-Pee Dee
Watershed:	Jacob's Ladder
XS ID	XS-8, Riffle (T2)
Drainage Area (sq mi):	0.70
Date:	8/12/2015
Field Crew:	T. Seelinger and B. Williams

SUMMARY DATA	
Bankfull Elevation (ft):	750.3
Bankfull Cross-Sectional Area (ft²):	14.6
Bankfull Width (ft):	16.0
Flood Prone Area Elevation (ft):	752.1
Flood Prone Width (ft):	>59
Max Depth at Bankfull (ft):	1.8
Mean Depth at Bankfull (ft):	0.9
W / D Ratio:	17.5
Entrenchment Ratio:	3.8
Bank Height Ratio:	1.0

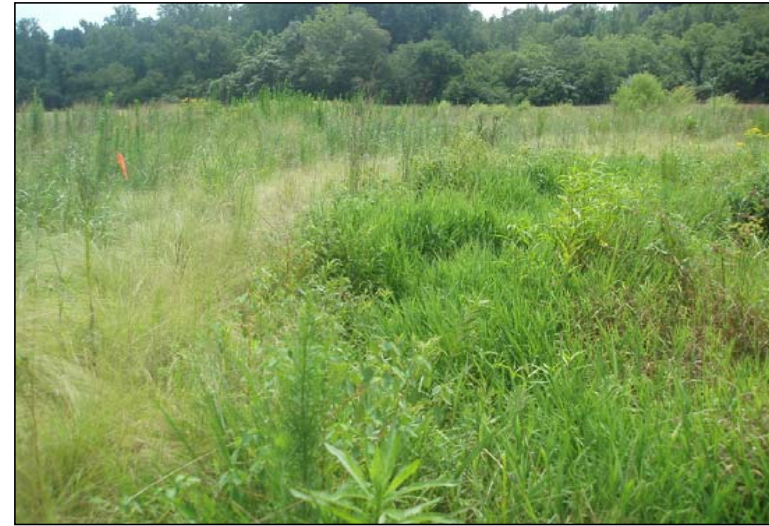
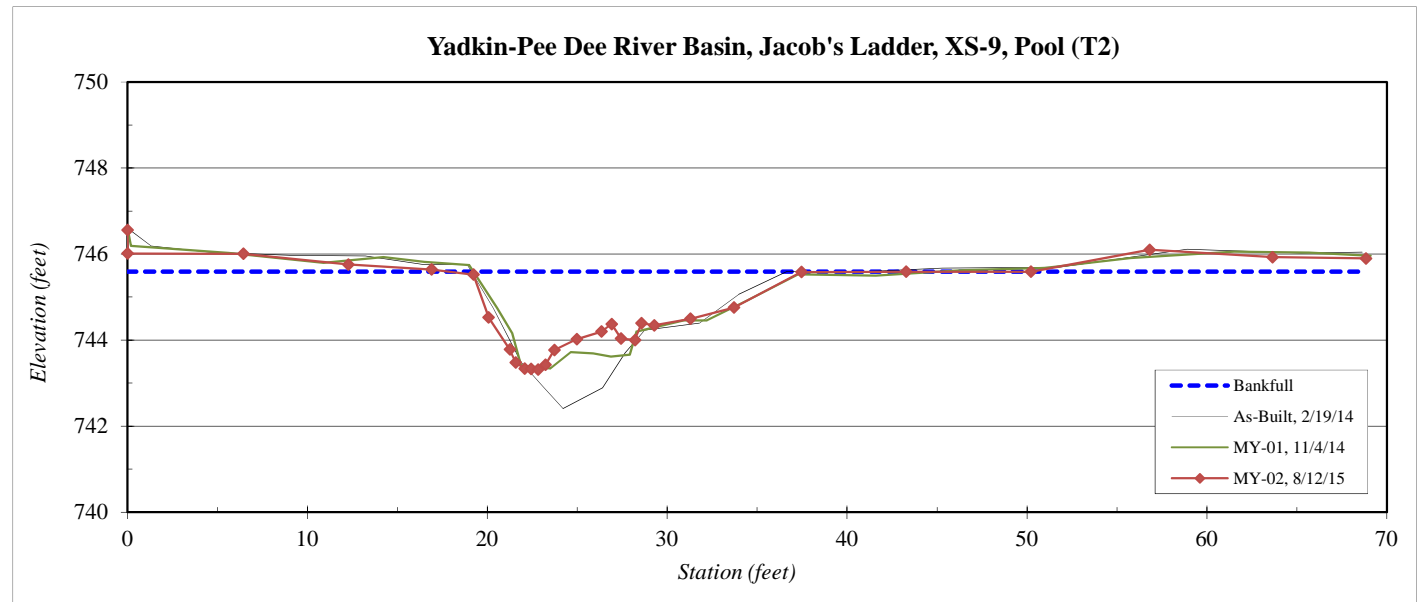
River Basin:	Yadkin-Pee Dee
Watershed:	Jacob's Ladder
XS ID	XS-9, Pool (T2)
Drainage Area (sq mi):	0.70
Date:	8/12/2015
Field Crew:	T. Seelinger and B. Williams

SUMMARY DATA	
Bankfull Elevation (ft):	745.6
Bankfull Cross-Sectional Area (ft²):	21.9
Bankfull Width (ft):	18.2
Flood Prone Area Elevation (ft):	-
Flood Prone Width (ft):	-
Max Depth at Bankfull (ft):	2.3
Mean Depth at Bankfull (ft):	1.2
W / D Ratio:	-
Entrenchment Ratio:	-
Bank Height Ratio:	-

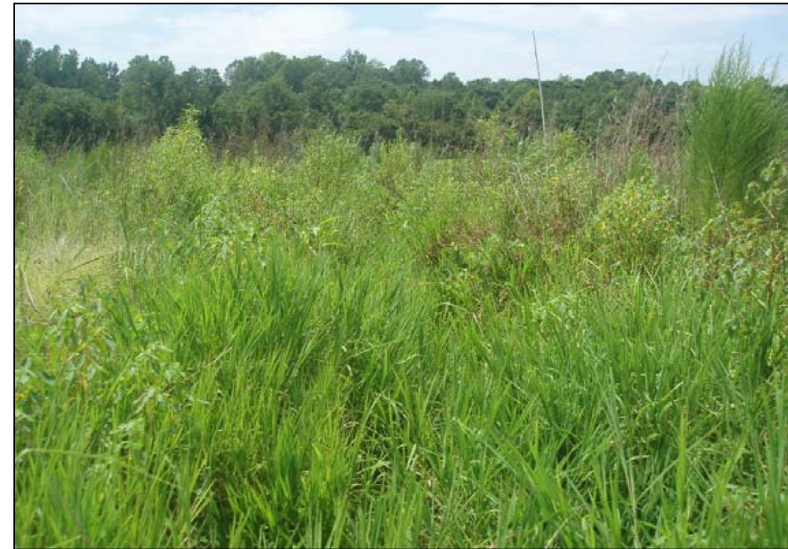
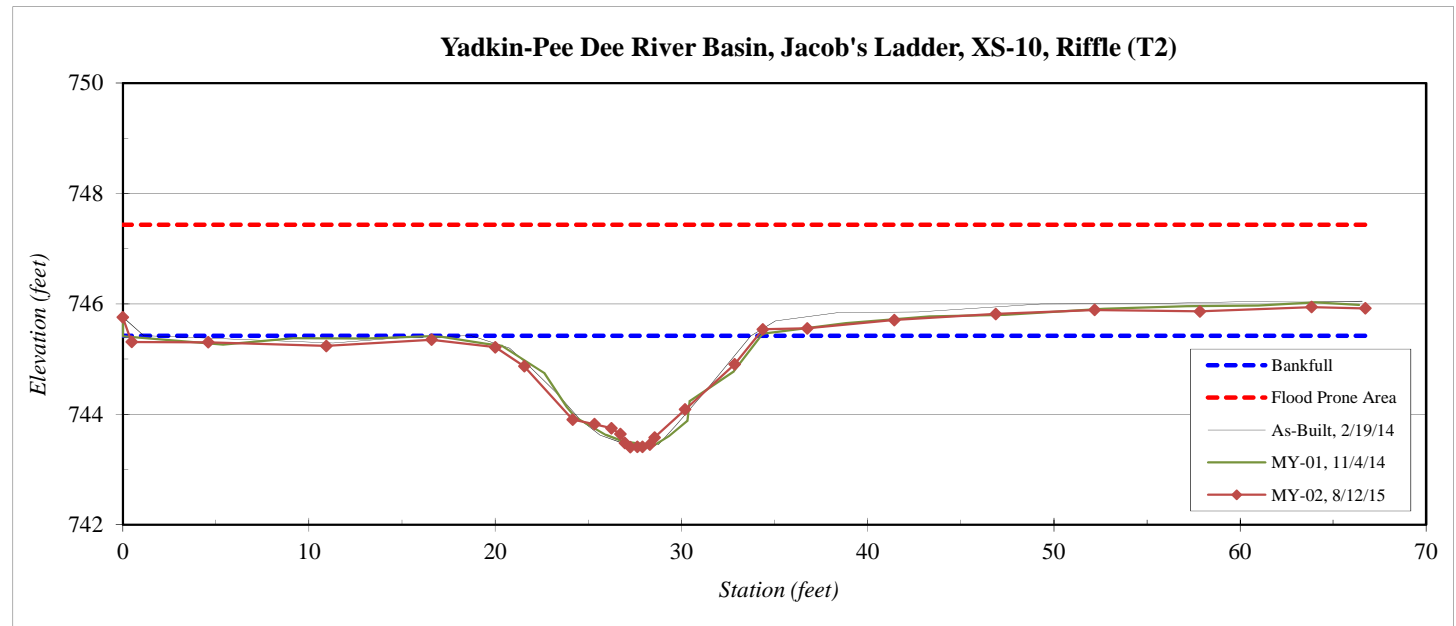
River Basin:	Yadkin-Pee Dee
Watershed:	Jacob's Ladder
XS ID	XS-10, Riffle (T2)
Drainage Area (sq mi):	0.70
Date:	8/12/2015
Field Crew:	T. Seelinger and B. Williams

SUMMARY DATA	
Bankfull Elevation (ft):	745.4
Bankfull Cross-Sectional Area (ft²):	16.9
Bankfull Width (ft):	17.5
Flood Prone Area Elevation (ft):	747.4
Flood Prone Width (ft):	>65
Max Depth at Bankfull (ft):	2.0
Mean Depth at Bankfull (ft):	1.0
W / D Ratio:	18.1
Entrenchment Ratio:	3.8
Bank Height Ratio:	1.0
