Mitigation Project Name Jacobs Ladder
 DMS ID 95023
 River Basin Yadkin
 Cataloging Unit 03040105

Jacob's Ladder
Stream Restoration Monitoring Report
DMS Project # 95023
DMS Contract # 003983
Monitoring Year 05

Subject: Jacob's Ladder Stream Restoration Site
MY-05 Monitoring Report Comments
Yadkin River Basin CU 03040105
Rowan County, North Carolina
NCDMS Project # 95023
Contract # 003983

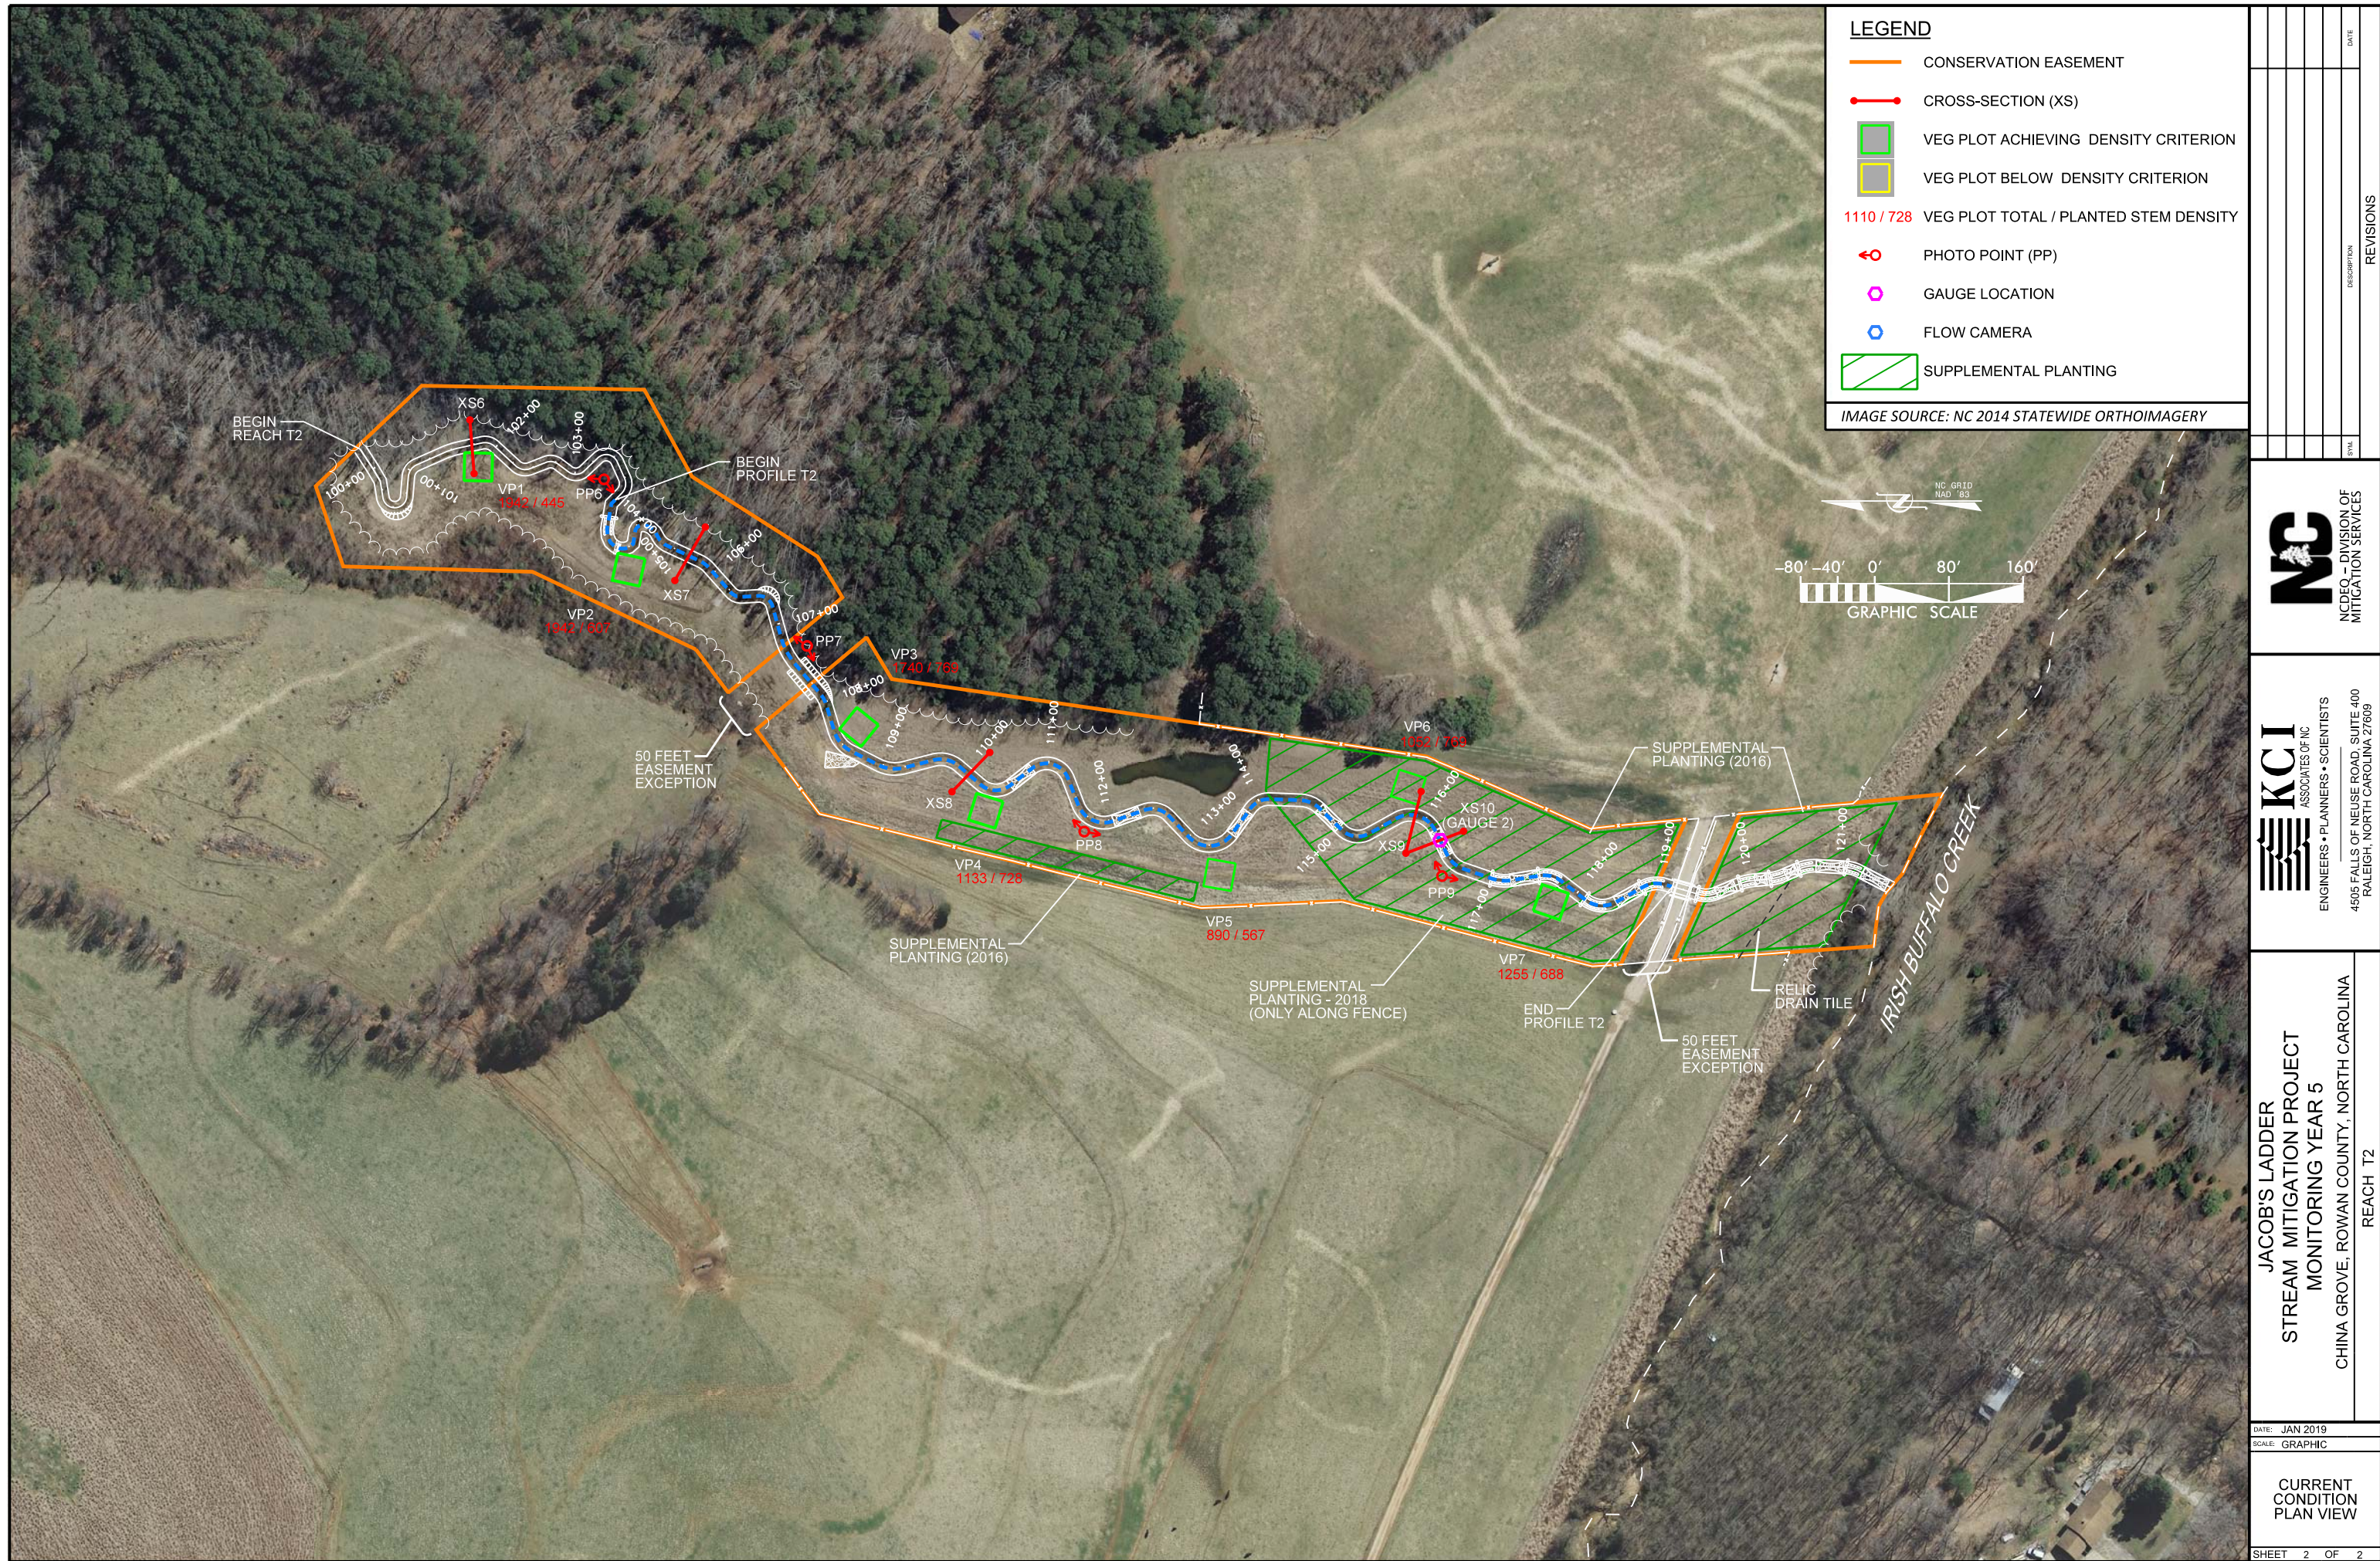
DATE: JAN 2019
SCALE: GRAPHIC
CURRENT
CONDITION
PLAN VIEW
SHEET 1 OF 2

Fifth-year monitoring found the Jacob's Ladder streams to be stable, with only minor changes from the as-built conditions. No areas show signs of serious bank erosion. The monitoring components were installed in February/March 2014. An automatic recording gauge has been installed on both T1 and T2. Both gauges recorded bankfull events in 2018. The monitoring plan for each tributary is as follows: T1 has a 1,500 foot longitudinal profile, 3 riffle cross-sections and 2 pool cross-sections; T2 has a 1,500 foot longitudinal profile, 4 riffle cross-sections and 1 pool cross-section; T1A is being monitored visually since it is small, partially intermittent, and a mix of mitigation types. Pebble counts were conducted at all ten cross-sections. Nine permanent photo points have been established with a total of nineteen photos to be taken annually. Monitoring Year Five found both T1 and T2 functioning as designed with little change from the baseline conditions.

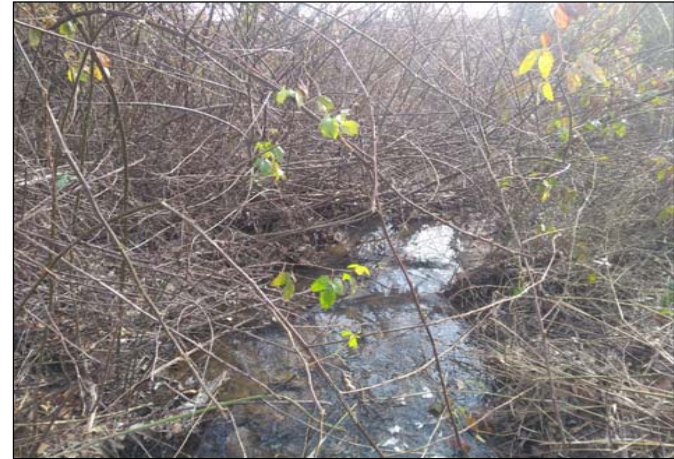
River Basin:	Yadkin-Pee Dee
Site:	Jacob's Ladder
XS ID	XS-1
Drainage Area (sq mi):	0.21
Date:	12/19/2018
Field Crew:	T. Seelinger and B. Rose

SUMMARY DATA	
Current Bankfull Elevation:	766.5
Bankfull Cross-Sectional Area:	10.1
Total Cross-Sectional Area:	10.4
Bankfull Width:	11.0
Flood Prone Area Elevation:	768.2
Flood Prone Width:	50.9
Max Depth at Bankfull:	1.7
Mean Depth at Bankfull:	0.9
W / D Ratio:	12.0
Entrenchment Ratio:	4.6
Bank Height Ratio:	1.0

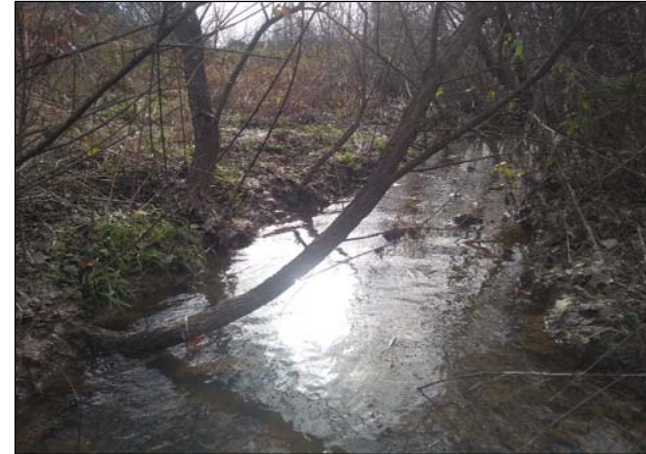
River Basin:	Yadkin-Pee Dee
Site:	Jacob's Ladder
XS ID	XS-2
Drainage Area (sq mi):	0.21
Date:	12/19/2018
Field Crew:	T. Seelinger and B. Rose

SUMMARY DATA	
Current Bankfull Elevation:	764.3
Bankfull Cross-Sectional Area:	11.5
Total Cross-Sectional Area:	12.7
Bankfull Width:	8.7
Flood Prone Area Elevation:	---
Flood Prone Width:	---
Max Depth at Bankfull:	2.2
Mean Depth at Bankfull:	1.3
W / D Ratio:	---
Entrenchment Ratio:	---
Bank Height Ratio:	---

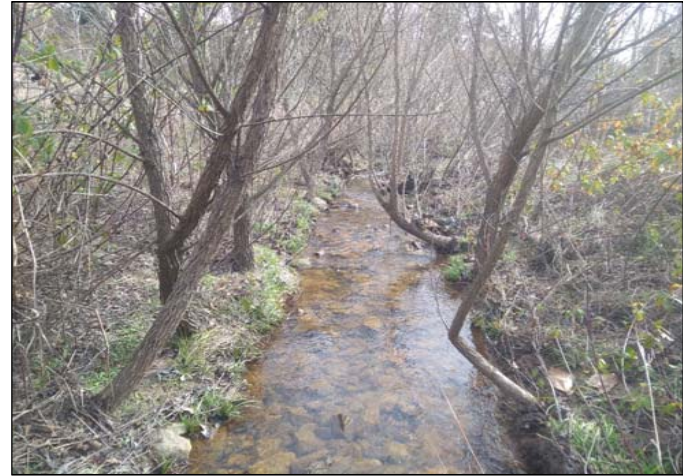
River Basin:	Yadkin-Pee Dee
Site:	Jacob's Ladder
XS ID	XS-3
Drainage Area (sq mi):	0.36
Date:	12/19/2018
Field Crew:	T. Seelinger and B. Rose

SUMMARY DATA	
Current Bankfull Elevation:	756.79
Bankfull Cross-Sectional Area:	11.6
Total Cross-Sectional Area:	12.7
Bankfull Width:	11.9
Flood Prone Area Elevation:	758.5
Flood Prone Width:	46.8
Max Depth at Bankfull:	1.7
Mean Depth at Bankfull:	1.0
W / D Ratio:	12.3
Entrenchment Ratio:	3.9
Bank Height Ratio:	0.9

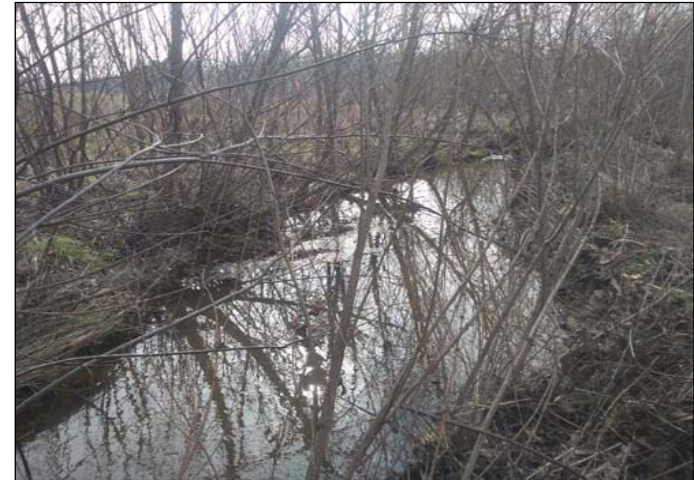
River Basin:	Yadkin-Pee Dee
Site:	Jacob's Ladder
XS ID	XS-4
Drainage Area (sq mi):	0.36
Date:	12/19/2018
Field Crew:	T. Seelinger and B. Rose

SUMMARY DATA	
Current Bankfull Elevation:	755.1
Bankfull Cross-Sectional Area:	21.4
Total Cross-Sectional Area:	19.8
Bankfull Width:	18.5
Flood Prone Area Elevation:	---
Flood Prone Width:	---
Max Depth at Bankfull:	2.8
Mean Depth at Bankfull:	1.2
W / D Ratio:	---
Entrenchment Ratio:	---
Bank Height Ratio:	---

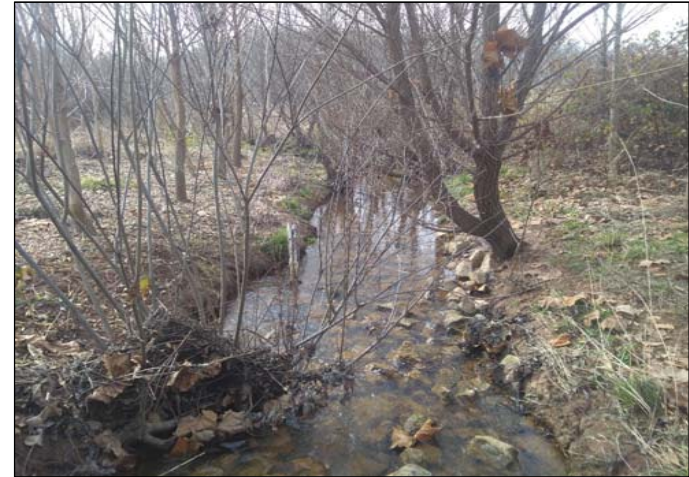
River Basin:	Yadkin-Pee Dee
Site:	Jacob's Ladder
XS ID	XS-5
Drainage Area (sq mi):	0.36
Date:	12/19/2018
Field Crew:	T. Seelinger and B. Rose

SUMMARY DATA	
Current Bankfull Elevation:	753.1
Bankfull Cross-Sectional Area:	8.8
Total Cross-Sectional Area:	14.7
Bankfull Width:	8.5
Flood Prone Area Elevation:	754.7
Flood Prone Width:	50.4
Max Depth at Bankfull:	1.5
Mean Depth at Bankfull:	1.0
W / D Ratio:	8.3
Entrenchment Ratio:	5.9
Bank Height Ratio:	1.4

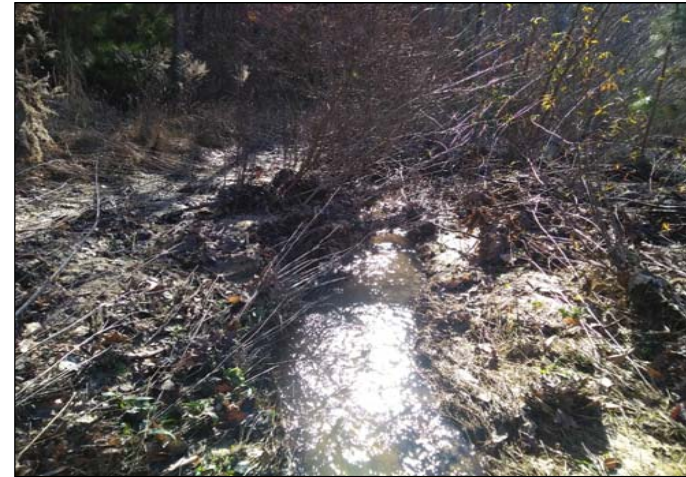
River Basin:	Yadkin-Pee Dee
Site:	Jacob's Ladder
XS ID	XS-6
Drainage Area (sq mi):	0.67
Date:	12/19/2018
Field Crew:	T. Seelinger and B. Rose

SUMMARY DATA	
Current Bankfull Elevation:	755.8
Bankfull Cross-Sectional Area:	13.9
Total Cross-Sectional Area:	4.0
Bankfull Width:	13.1
Flood Prone Area Elevation:	758.0
Flood Prone Width:	58.1
Max Depth at Bankfull:	2.2
Mean Depth at Bankfull:	1.1
W / D Ratio:	12.3
Entrenchment Ratio:	4.4
Bank Height Ratio:	0.8

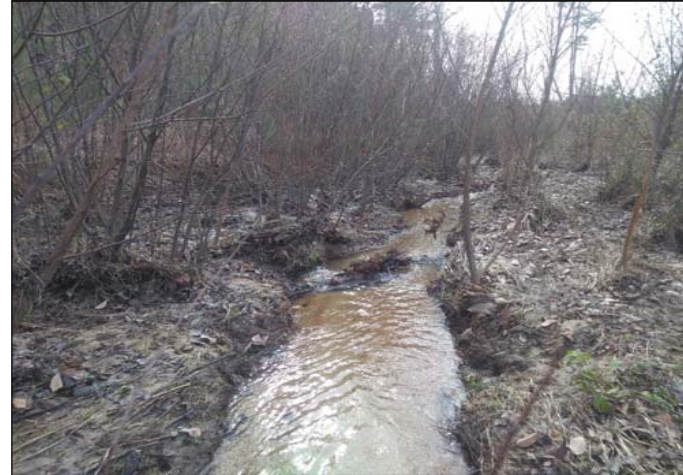
River Basin:	Yadkin-Pee Dee
Site:	Jacob's Ladder
XS ID	XS-7
Drainage Area (sq mi):	0.67
Date:	12/19/2018
Field Crew:	T. Seelinger and B. Rose

SUMMARY DATA	
Current Bankfull Elevation:	752.8
Bankfull Cross-Sectional Area:	16.3
Total Cross-Sectional Area:	4.9
Bankfull Width:	26.4
Flood Prone Area Elevation:	754.5
Flood Prone Width:	48.1
Max Depth at Bankfull:	1.8
Mean Depth at Bankfull:	0.6
W / D Ratio:	42.7
Entrenchment Ratio:	1.8
Bank Height Ratio:	0.7

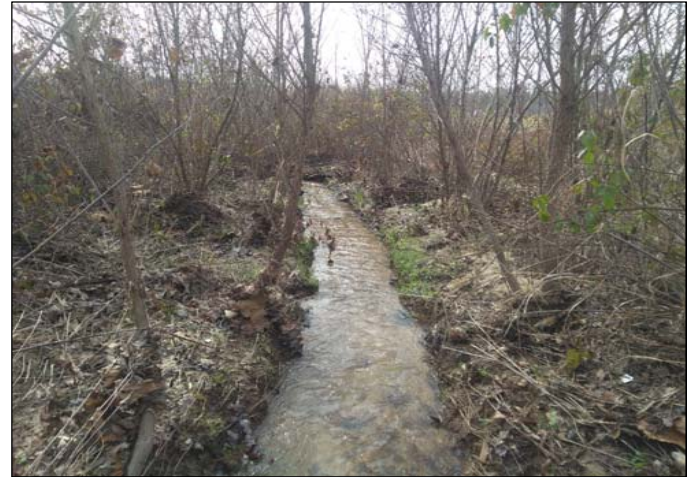
River Basin:	Yadkin-Pee Dee
Site:	Jacob's Ladder
XS ID	XS-8
Drainage Area (sq mi):	0.70
Date:	12/19/2018
Field Crew:	T. Seelinger and B. Rose

SUMMARY DATA	
Current Bankfull Elevation:	750.6
Bankfull Cross-Sectional Area:	15.2
Total Cross-Sectional Area:	10.8
Bankfull Width:	16.6
Flood Prone Area Elevation:	752.7
Flood Prone Width:	58.8
Max Depth at Bankfull:	2.1
Mean Depth at Bankfull:	0.9
W / D Ratio:	18.2
Entrenchment Ratio:	3.5
Bank Height Ratio:	0.8

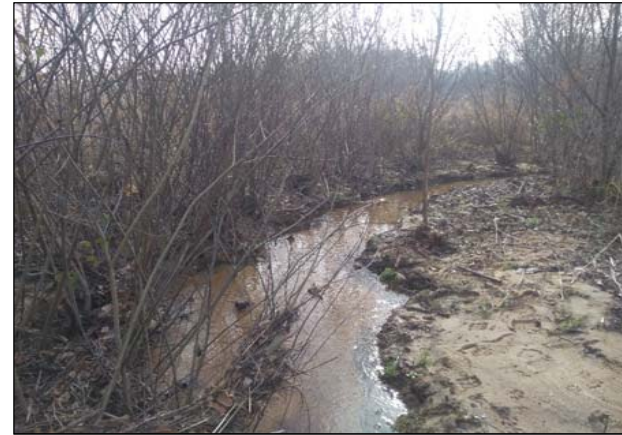
River Basin:	Yadkin-Pee Dee
Site:	Jacob's Ladder
XS ID	XS-9
Drainage Area (sq mi):	0.70
Date:	12/19/2018
Field Crew:	T. Seelinger and B. Rose

SUMMARY DATA	
Current Bankfull Elevation:	745.8
Bankfull Cross-Sectional Area:	26.5
Total Cross-Sectional Area:	21.0
Bankfull Width:	24.0
Flood Prone Area Elevation:	---
Flood Prone Width:	---
Max Depth at Bankfull:	2.3
Mean Depth at Bankfull:	1.1
W / D Ratio:	---
Entrenchment Ratio:	---
Bank Height Ratio:	---

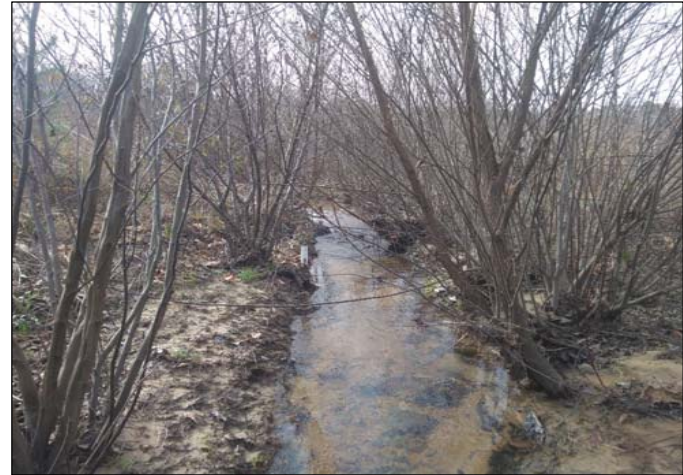
River Basin:	Yadkin-Pee Dee
Site:	Jacob's Ladder
XS ID	XS-10
Drainage Area (sq mi):	0.70
Date:	12/19/2018
Field Crew:	T. Seelinger and B. Rose

SUMMARY DATA	
Current Bankfull Elevation:	745.5
Bankfull Cross-Sectional Area:	16.2
Total Cross-Sectional Area:	15.4
Bankfull Width:	15.1
Flood Prone Area Elevation:	747.6
Flood Prone Width:	66.5
Max Depth at Bankfull:	2.1
Mean Depth at Bankfull:	1.1
W / D Ratio:	14.0
Entrenchment Ratio:	4.4
Bank Height Ratio:	0.9

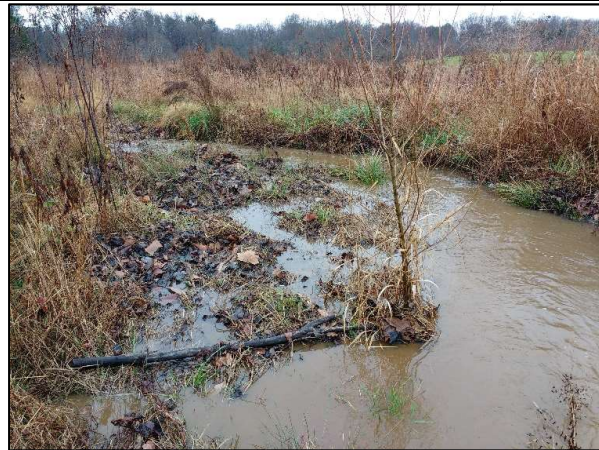
Photo 2. T2 at bankfull, 12/17/15

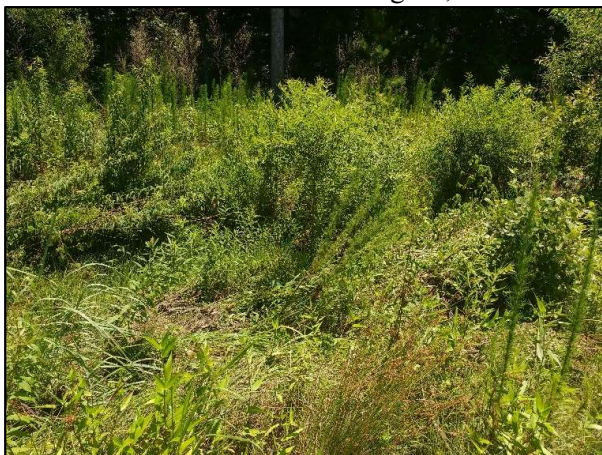
Photo 3. Bankfull indicators along T1, 7/20/18
