YEAR 3 (2010)
ANNUAL MONITORING REPORT
JARMANS OAK RESTORATION SITE
ONslow COUNTY, NORTH CAROLINA

(CONTRACT D06069-A)
FULL DELIVERY PROJECT
WHITE OAK RIVER BASIN
CATALOGING UNIT 03030001

August 2010

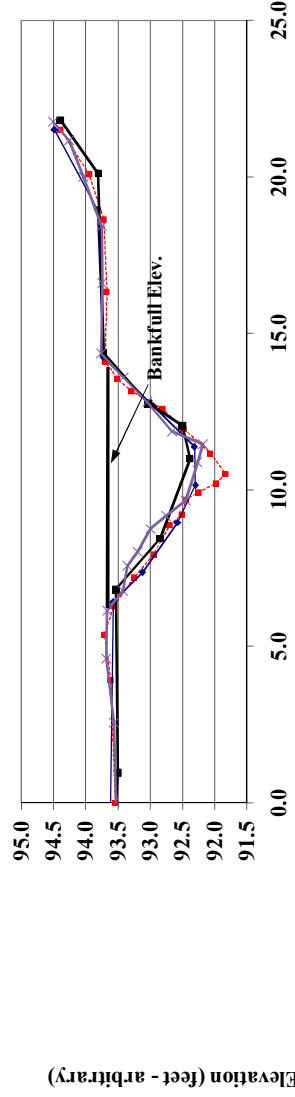
Jarman's Oak Reach 5 - XS1 Pool

As-built	2008	2009	2010
Area	5.3	3.1	3.1	3.3
Width	8.4	5.6	6.4	5.5
Mean Depth	0.6	0.6	0.5	0.6
Max Depth	1.0	0.9	1.0	1.2
W/D Ratio	13.3	10.0	12.1	9.1

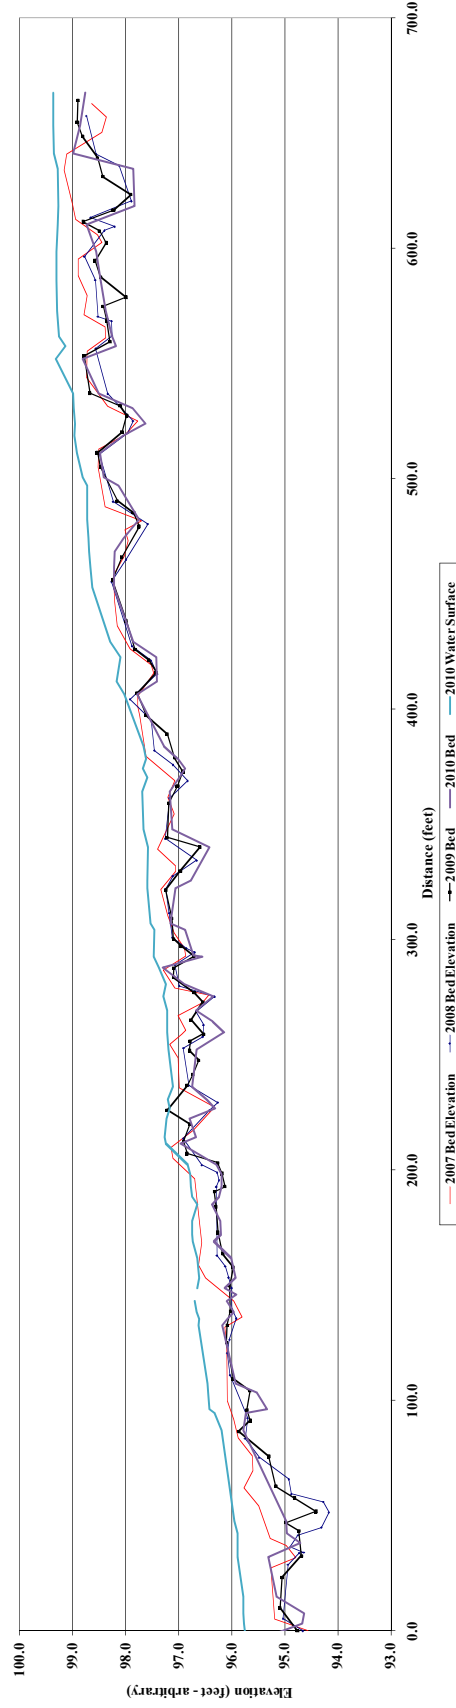
Jarman's Oak Profile - Reach 4

As-built	2008	2009	2010
Avg. Water Surface Slope	0.0038	0.0060	0.0066
Avg. Riffle Slope	***	0.0004	0.0066
Avg. Pool Slope	***	0.0038	0.0004
Avg. Run Slope	***	0.0050	0.0064
Avg. Glide Slope	***	0.0021	0.0000
*** Insufficient water in stream to determine

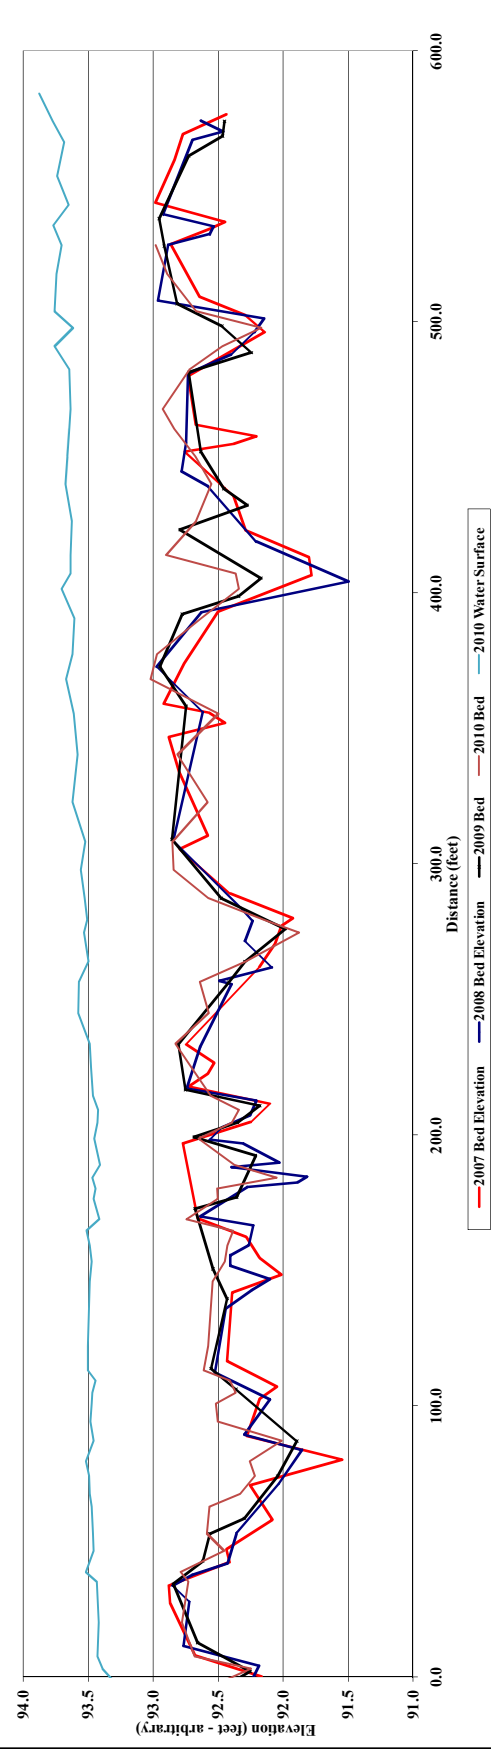
Jarman's Oak Profile - Reach 5

As-built	2008	2009	2010
Avg. Water Surface Slope	0.0004	0.0008	0.0007
Avg. Riffle Slope	0.0013	0.0011	0.0005
Avg. Pool Slope	0.0014	0.0013	0.0006
Avg. Run Slope	0.0013	0.0030	0.0010
Avg. Cule Slope	0.0004	0.0039	0.0019

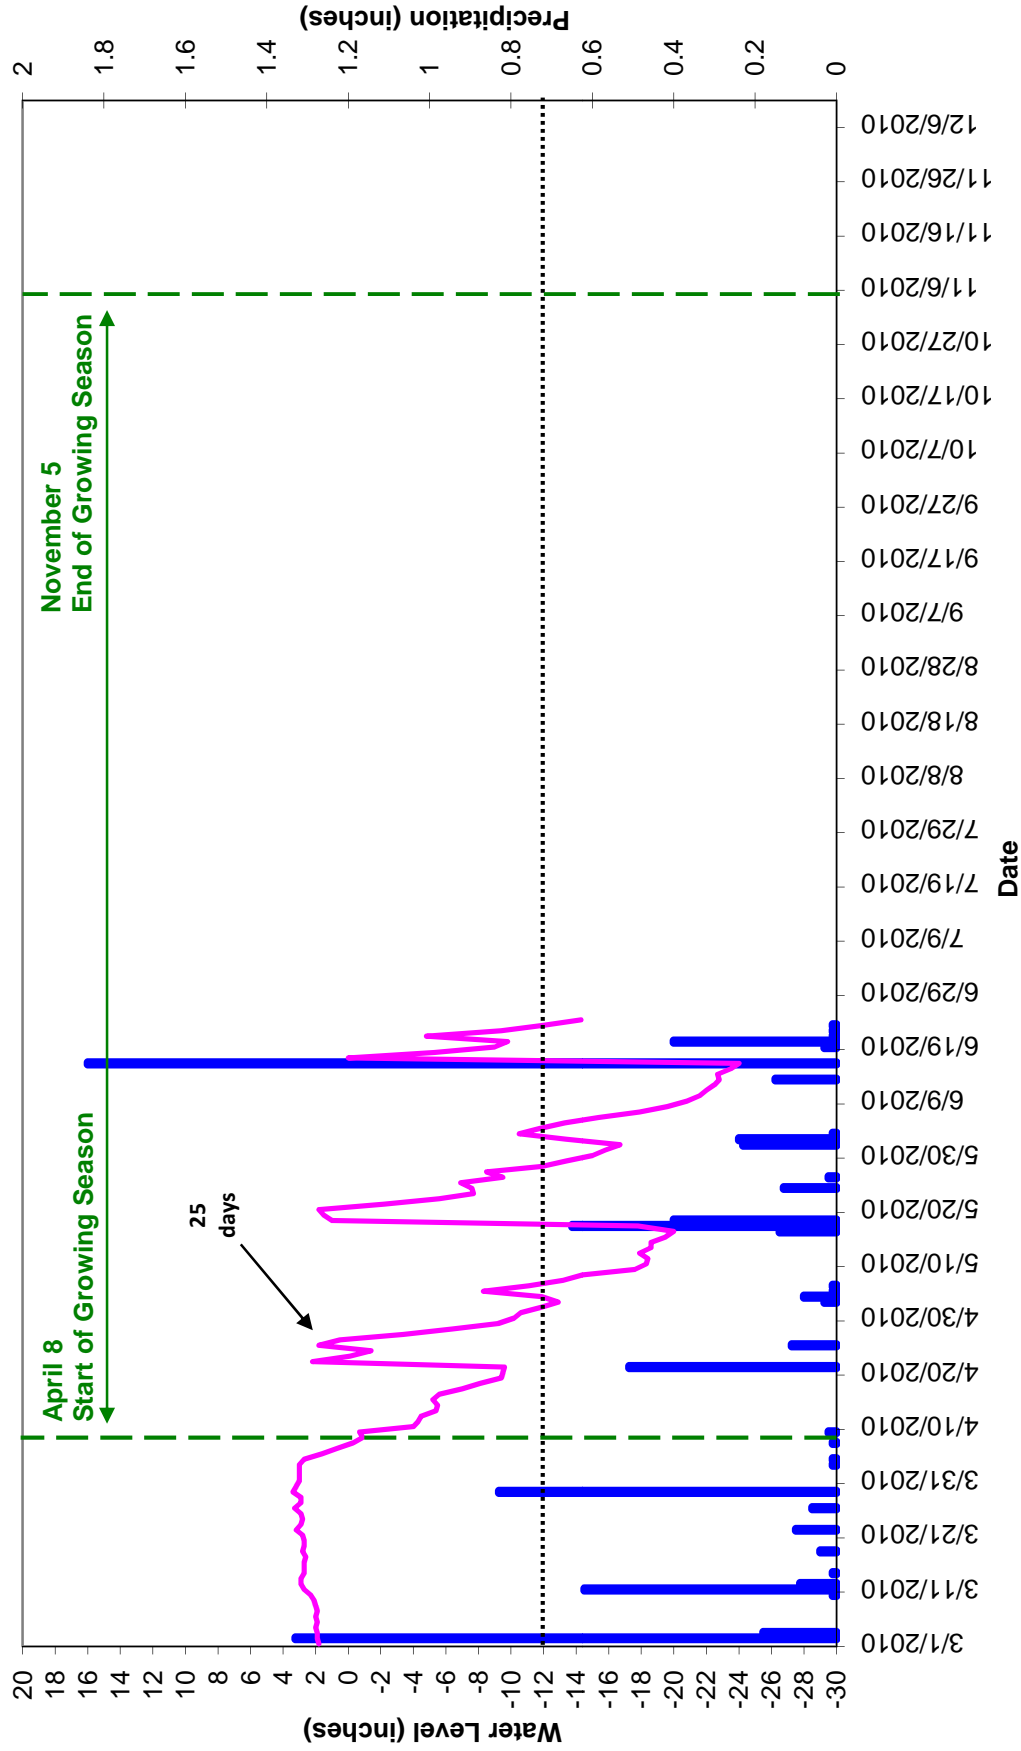
Jarman's Oak - Groundwater Gauge 1 Year 3 (20010 Data)

All monitored gauges within restoration areas were inundated/saturated within 12 inches of the surface for greater than 8 percent of the growing season (Table 10). Hydrographs containing groundwater and precipitation data for each gauge can be found in Appendix C.
