**YEAR 4 (2011)**  
**ANNUAL MONITORING REPORT**  
**JARMANS OAK RESTORATION SITE**  
**ONslow COUNTY, NORTH CAROLINA**

**(CONTRACT D06069-A)**  
**FULL DELIVERY PROJECT**  
**WHITE OAK RIVER BASIN**  
**CATALOGING UNIT 03030001**

**October 2011**

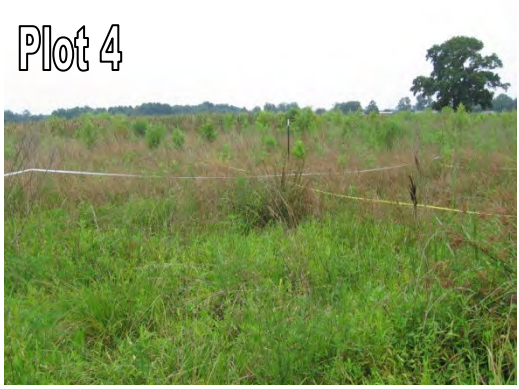
Plot 4

Vegetation sampling across the Site was above the required average density with an overall average of 460 planted stems per acre. Two of the fourteen plots had low densities of planted stems (plots 1 and 5 with 121 and 243 planted stems per acre, respectively) as the result of ponded water from a previous beaver impoundment. Beaver management is now occurring on the Site and will continue as necessary. No additional vegetation problem areas were noted during the Year 4 (2011) monitoring season. The Site will be replanted in the areas that were affected by the inundation before the start of the 2012 growing season.
