**UT to Little Hunting Creek (Johnson Site)
Stream Restoration
Project No. 197
2009 Monitoring Report: Year 2 of 5**

November 2009 (Revised May 2010)

Prepared for: NCDENR-EEP
1652 Mail Service Center
Raleigh, NC 27699-1652

Prepared by: Jordan, Jones & Goulding
9101 Southern Pine Blvd., Suite 160
Charlotte, NC 28273

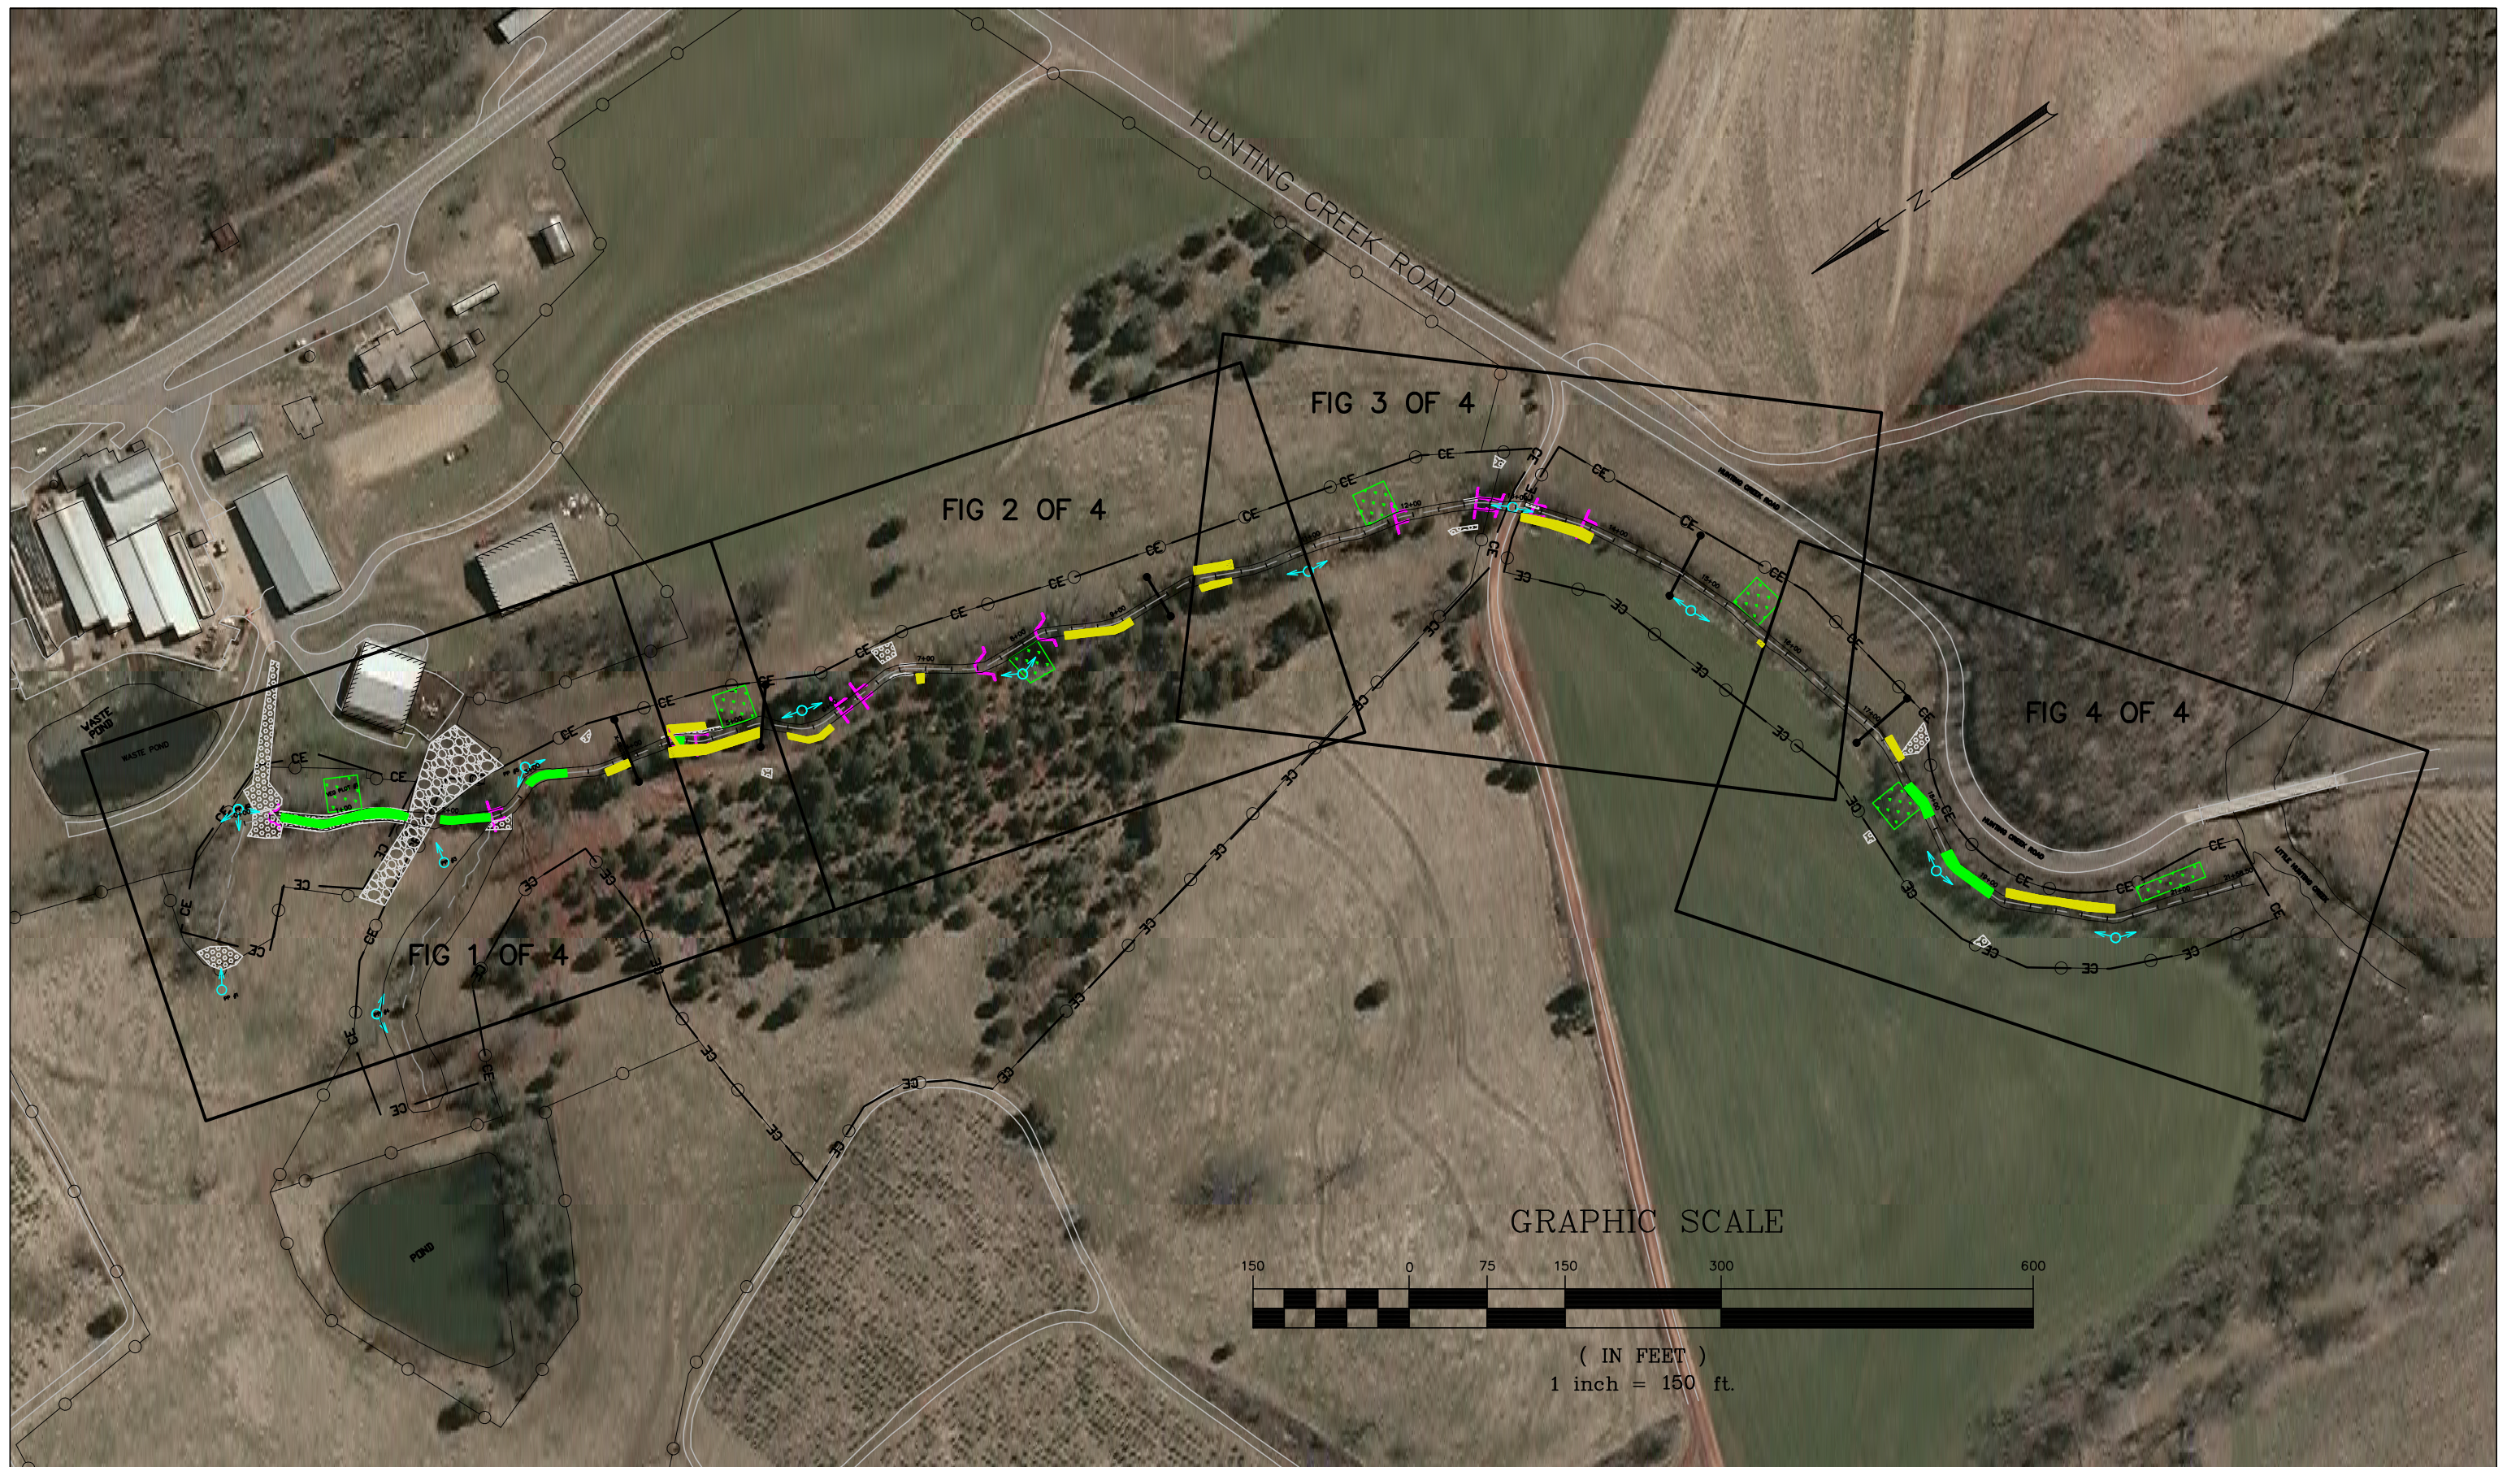
APPENDIX 1.2
 CURRENT CONDITION PLAN VIEW

- The pattern, profile, and dimension of the restored channel appear stable.
- There are several areas with bare banks due to lack of vegetation growth. One area has resulted in moderate bank erosion (approximate station 10+15 and 15+71).
- All structures appear to be in good condition.
