**UT to Little Hunting Creek (Johnson Site)
Stream Restoration
EEP Project No. 197
2010 Monitoring Report: Year 3 of 5**

**Construction Completed: November 2007
Submission Date: September 2011**

Jordan, Jones and Goulding
309 East Morehead Street, Suite 110
Charlotte, NC 28202

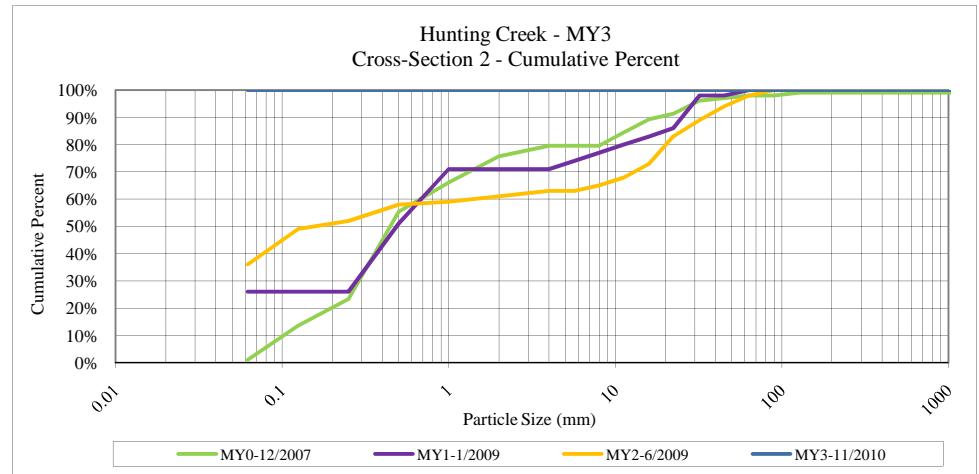
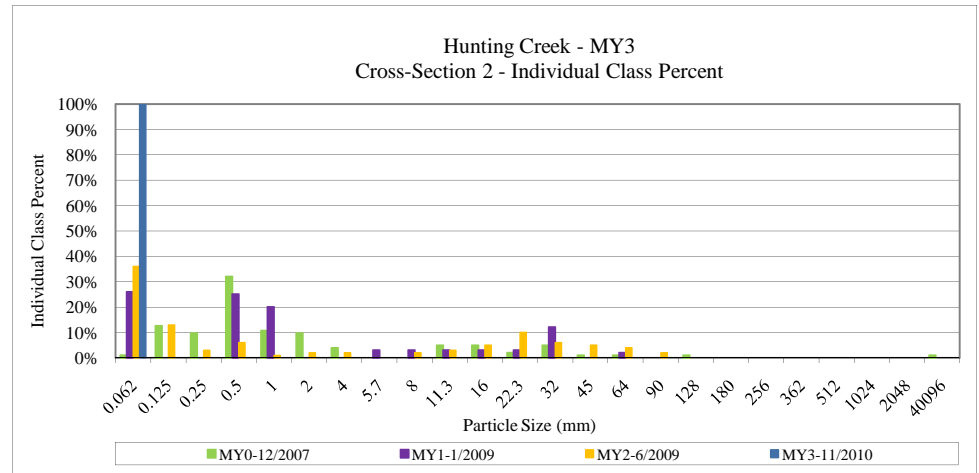
Project Name	Hunting Creek
EEP Project Number	197
Cross-Section ID	XS-2, Pool, 5+25
Survey Date	11/2010

Description	Material	Size (mm)	Total #	Item %	Cum %
Silt/Clay	silt/clay	0.062	100	100%	100%
Sand	very fine sand	0.125	0	0%	0%
	fine sand	0.250	0	0%	0%
	medium sand	0.50	0	0%	0%
	coarse sand	1.00	0	0%	0%
	very coarse sand	2.0	0	0%	0%
Gravel	very fine gravel	4.0	0	0%	0%
	fine gravel	5.7	0	0%	0%
	fine gravel	8.0	0	0%	0%
	medium gravel	11.3	0	0%	0%
	medium gravel	16.0	0	0%	0%
	course gravel	22.3	0	0%	0%
	course gravel	32.0	0	0%	0%
	very coarse gravel	45	0	0%	0%
	very coarse gravel	64	0	0%	0%
Cobble	small cobble	90	0	0%	0%
	medium cobble	128	0	0%	0%
	large cobble	180	0	0%	0%
	very large cobble	256	0	0%	0%
Boulder	small boulder	362	0	0%	0%
	small boulder	512	0	0%	0%
	medium boulder	1024	0	0%	0%
	large boulder	2048	0	0%	0%
Bedrock	bedrock	40096	0	0%	0%
TOTAL % of whole count			100	100%	100%

Summary Data	
D50	0.05
D84	0.06
D95	0.06

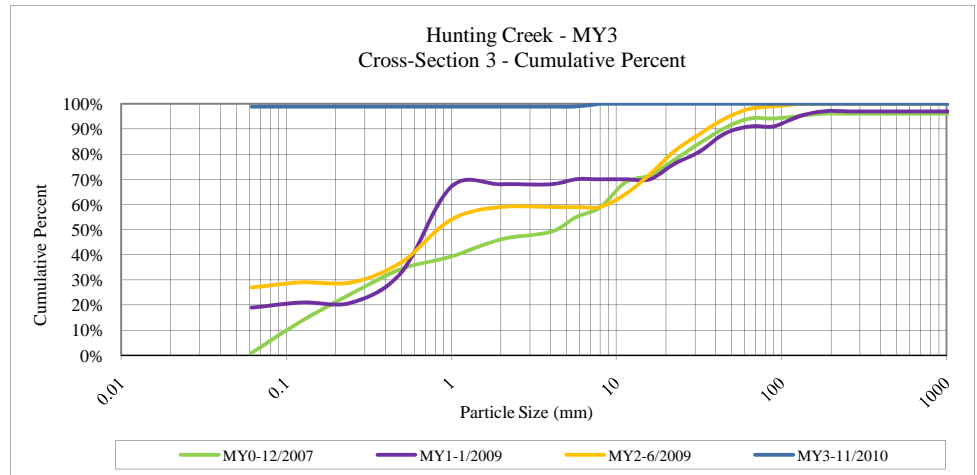
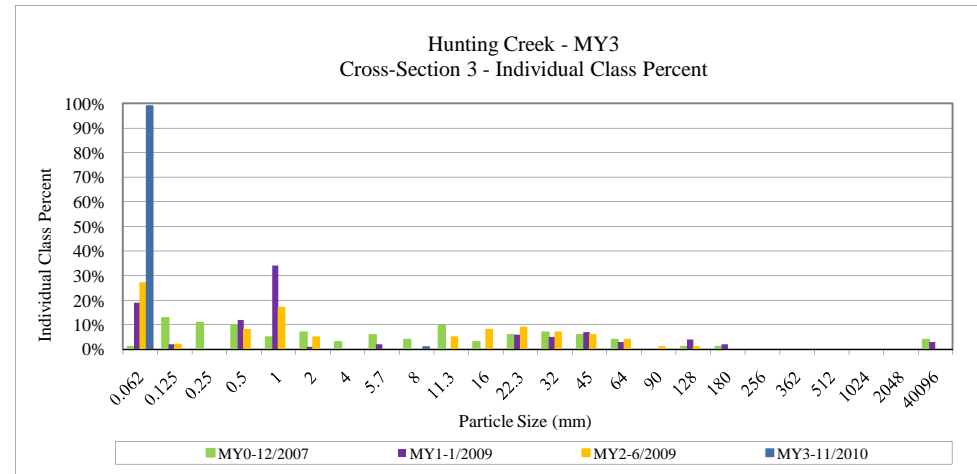
Project Name	Hunting Creek
EEP Project Number	197
Cross-Section ID	XS-3, Pool, 9+41
Survey Date	11/2010

Description	Material	Size (mm)	Total #	Item %	Cum %
Silt/Clay	silt/clay	0.062	99	99%	99%
Sand	very fine sand	0.125	0	0%	0%
	fine sand	0.250	0	0%	0%
	medium sand	0.50	0	0%	0%
	coarse sand	1.00	0	0%	0%
	very coarse sand	2.0	0	0%	0%
Gravel	very fine gravel	4.0	0	0%	0%
	fine gravel	5.7	0	0%	0%
	fine gravel	8.0	1	1%	1%
	medium gravel	11.3	0	0%	0%
	medium gravel	16.0	0	0%	0%
	course gravel	22.3	0	0%	0%
	course gravel	32.0	0	0%	0%
	very coarse gravel	45	0	0%	0%
	very coarse gravel	64	0	0%	0%
Cobble	small cobble	90	0	0%	0%
	medium cobble	128	0	0%	0%
	large cobble	180	0	0%	0%
	very large cobble	256	0	0%	0%
Boulder	small boulder	362	0	0%	0%
	small boulder	512	0	0%	0%
	medium boulder	1024	0	0%	0%
	large boulder	2048	0	0%	0%
Bedrock	bedrock	40096	0	0%	0%
TOTAL % of whole count			100	100%	100%

Summary Data	
D50	0.03
D84	0.05
D95	0.06

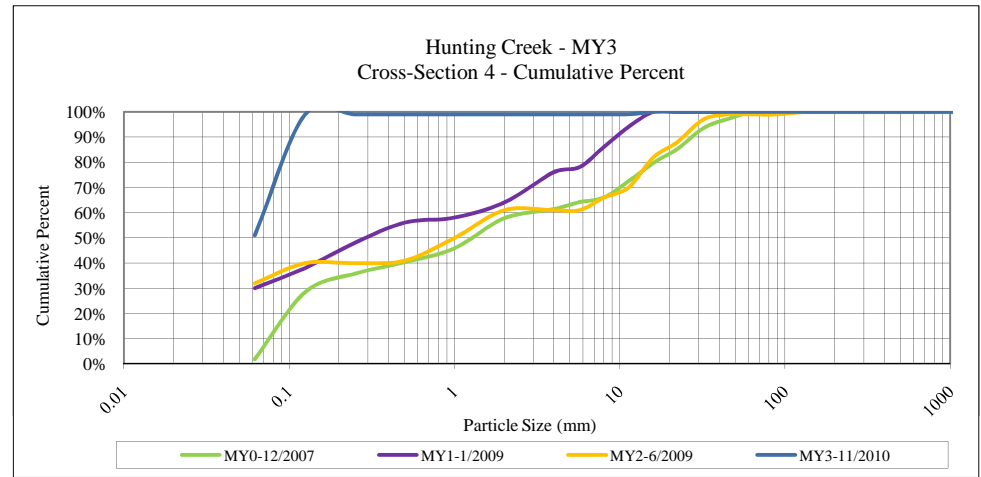
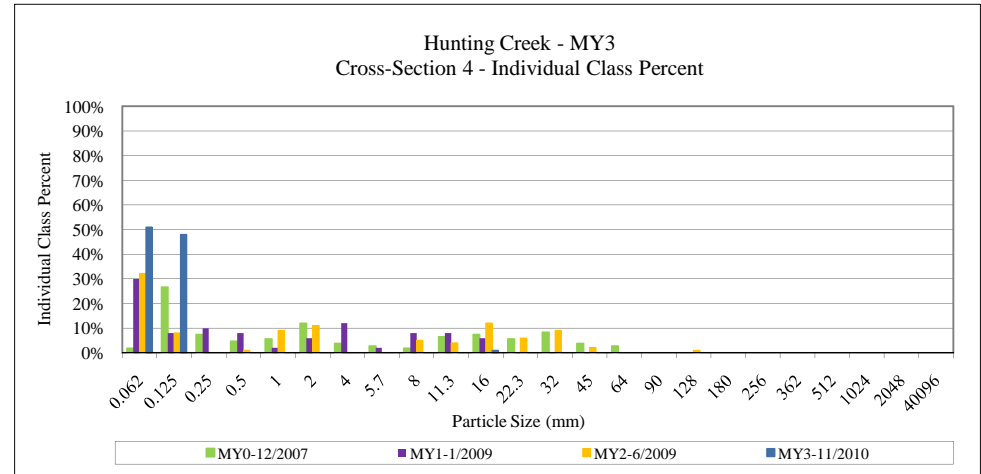
Project Name	Hunting Creek
EEP Project Number	197
Cross-Section ID	XS-4, Riffle, 14+72
Survey Date	11/2010

Description	Material	Size (mm)	Total #	Item %	Cum %
Silt/Clay	silt/clay	0.062	51	51%	51%
Sand	very fine sand	0.125	48	48%	48%
	fine sand	0.250	0	0%	0%
	medium sand	0.50	0	0%	0%
	coarse sand	1.00	0	0%	0%
	very coarse sand	2.0	0	0%	0%
Gravel	very fine gravel	4.0	0	0%	0%
	fine gravel	5.7	0	0%	0%
	fine gravel	8.0	0	0%	0%
	medium gravel	11.3	0	0%	0%
	medium gravel	16.0	1	1%	1%
	course gravel	22.3	0	0%	0%
	course gravel	32.0	0	0%	0%
	very coarse gravel	45	0	0%	0%
	very coarse gravel	64	0	0%	0%
Cobble	small cobble	90	0	0%	0%
	medium cobble	128	0	0%	0%
	large cobble	180	0	0%	0%
	very large cobble	256	0	0%	0%
Boulder	small boulder	362	0	0%	0%
	small boulder	512	0	0%	0%
	medium boulder	1024	0	0%	0%
	large boulder	2048	0	0%	0%
Bedrock	bedrock	40096	0	0%	0%
TOTAL % of whole count			100	100%	100%

Summary Data	
D50	0.06
D84	0.11
D95	0.12

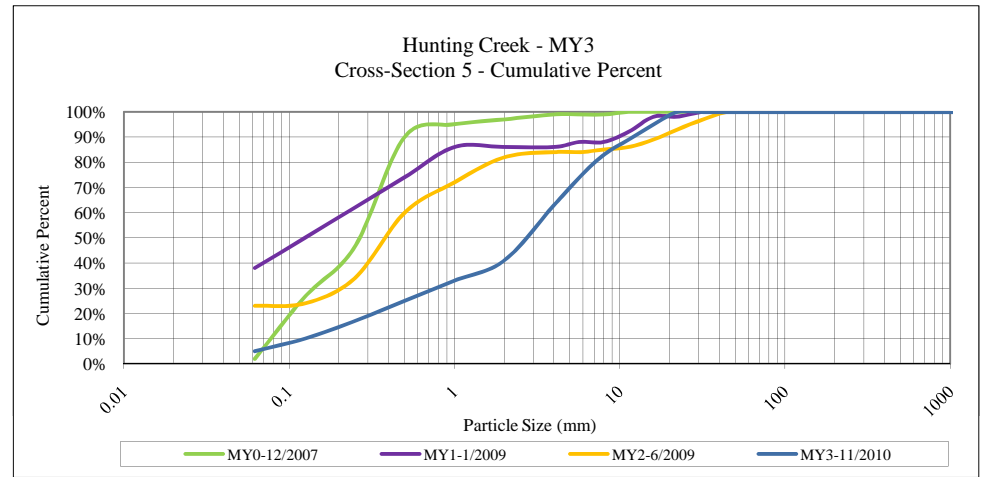
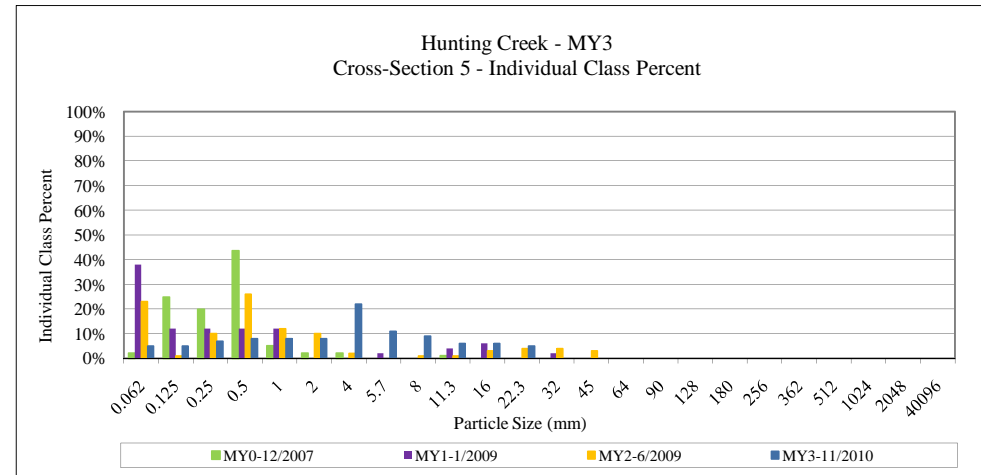
Project Name	Hunting Creek
EEP Project Number	197
Cross-Section ID	XS-5, Riffle, 17+10
Survey Date	11/2010

Description	Material	Size (mm)	Total #	Item %	Cum %
Silt/Clay	silt/clay	0.062	5	5%	5%
Sand	very fine sand	0.125	5	5%	5%
	fine sand	0.250	7	7%	7%
	medium sand	0.50	8	8%	8%
	coarse sand	1.00	8	8%	8%
	very coarse sand	2.0	8	8%	8%
Gravel	very fine gravel	4.0	22	22%	22%
	fine gravel	5.7	11	11%	11%
	fine gravel	8.0	9	9%	9%
	medium gravel	11.3	6	6%	6%
	medium gravel	16.0	6	6%	6%
	course gravel	22.3	5	5%	5%
	course gravel	32.0	0	0%	0%
	very coarse gravel	45	0	0%	0%
	very coarse gravel	64	0	0%	0%
	Cobble	small cobble	90	0	0%
medium cobble		128	0	0%	0%
large cobble		180	0	0%	0%
very large cobble		256	0	0%	0%
Boulder	small boulder	362	0	0%	0%
	small boulder	512	0	0%	0%
	medium boulder	1024	0	0%	0%
	large boulder	2048	0	0%	0%
Bedrock	bedrock	40096	0	0%	0%
TOTAL % of whole count			100	100%	100%

Summary Data	
D50	2.82
D84	8.55
D95	16
