# OVERHILLS STREAM AND WETLAND RESTORATION MONITORING REPORT (YEAR 1 OF 5)

Harnett County, North Carolina  
NCEEP Project Number 199

Status of Plan: Final  
Submission Date: March 2008

Stantec Consulting Services Inc  
801 Jones Franklin Road, Suite 300  
Raleigh, NC 27606

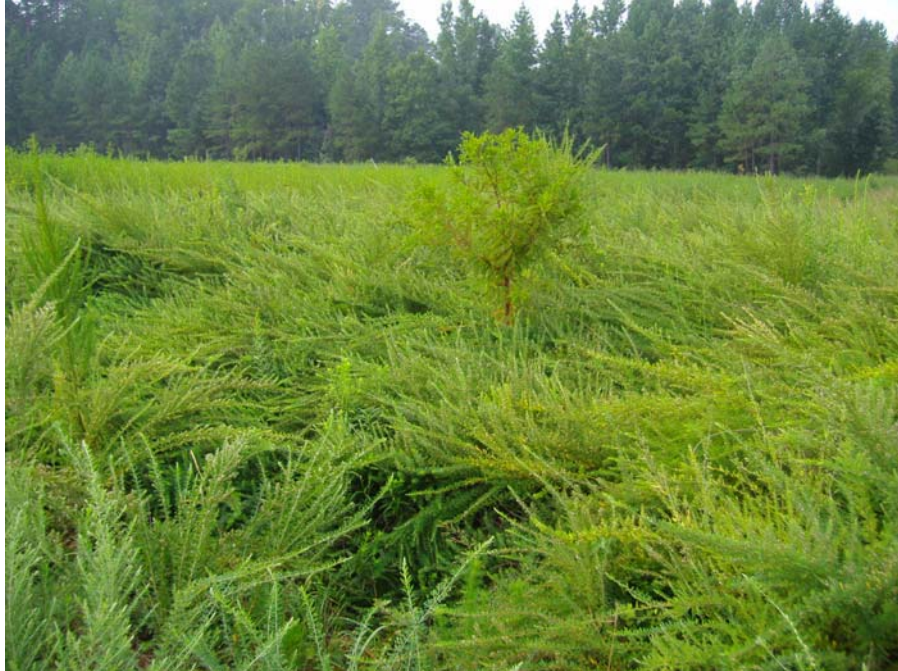
Feature/Issue	Station # / Range	Probable Cause	Photo #
death of trees and plants	VPA1 & VPA2	previous flooding	1 & 2
invasive/exotic species	VPA3	Invasion of <i>Lespedeza</i>	3 & 4

Photo 3. Invasive species, *Lespedeza*, in VPA3 (8/23/07)

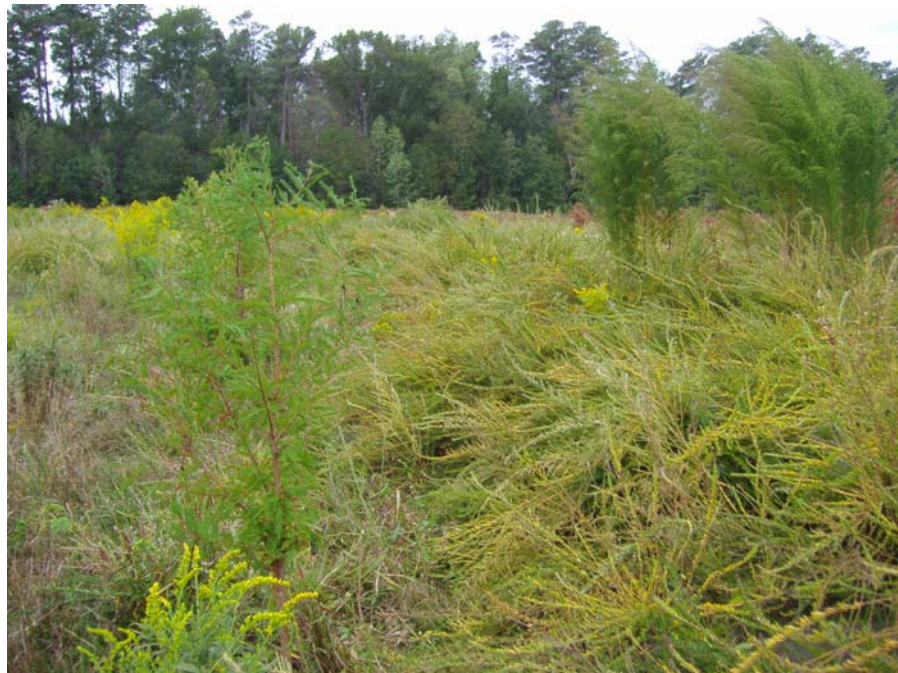
In addition to the four failing vegetation plot sites, several vegetation problem areas exist on site. These sites are referred to as VPA 1, 2, & 3 on the Integrated Problem Area Plan View located in Appendix D. In VPA 1 and 2, standing water had been present for a substantial length of time, causing the majority of the planted vegetation to die (Photos 1 & 2 in Appendix A2). VPA 3 is currently overrun with invasive species, primarily *Lespedeza* (Photo 3). *Lespedeza* is a major problem on this project site, as it is also invading berms and most high areas (Photo 4).

Photo 4. Invasive species, *Lespedeza*, on berms and high areas throughout the project area (10/2/07)

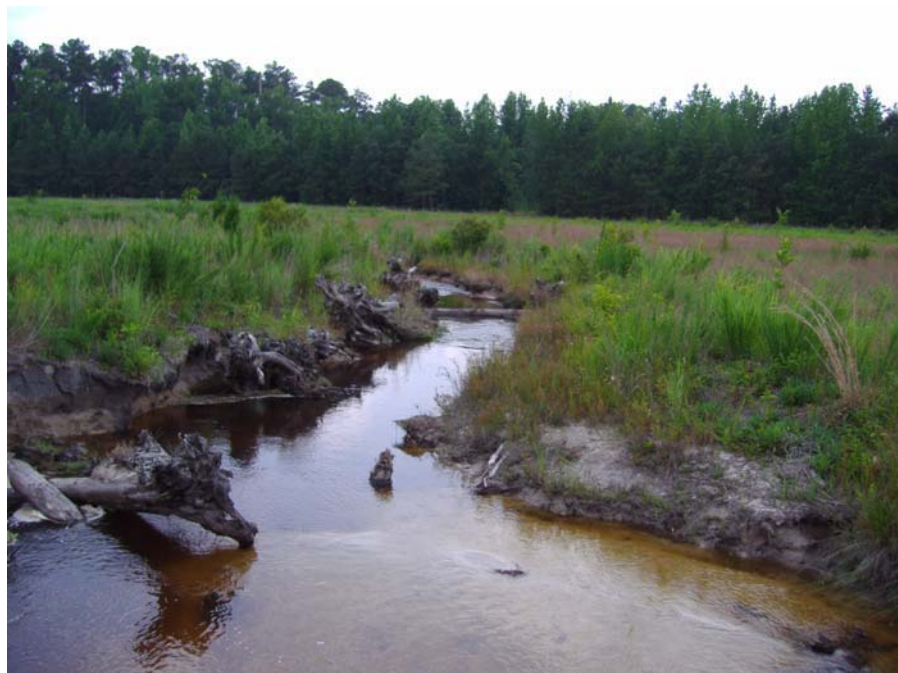
A major stream problem area is located from station 33+00 to 44+00 (1100 linear feet) where the stream has experienced serious failure. At Station 33+00 a head cut has developed and produced massive erosion around the bend at this location (see SPA Photos 1 & 2 in Appendix B3 and Appendix D Integrated Problem Areas Plan View). Downstream from this head cut, most of the in-stream structures have failed (SPA Photos 3 & 4). Erosion around the structures has forced the banks to migrate as much as seven feet, making this section of stream extremely unstable. Mid-channel bar formation is also occurring along the reach (SPA Photo 5). The headcut and downstream problems are apparent in the longitudinal profile of the channel. The survey data suggest that this section of the stream may not have been transitioned to the existing stream properly. The designed pattern and structures were not appropriate for a channel with this gradient. The log cross-vane structures on this reach do not match the goals of the design. Instead of notching the log arms that connect to the vane, the log arms were simply “buted” up against one another (SPA Photo 3). There was also a lack of geotextile fabric in the installation and the angle of the structure was not optimal to reduce near bank shear stress and bank scour. Other major issues include the presence of a beaver dam near Station 6+30 (Photo 6). The dam is causing a hydraulic jump, producing scour downstream.

Photo 2. Looking upstream at the location of the head cut at Station 33+00 (7/4/07)

With the extent of the existing deterioration of this 1100 linear foot portion of the restoration reach, it will not be possible to repair the stream around the failed structures, or to rebuild or replace structures without addressing the characteristics of the stream. The stream has migrated vertically and is actively migrating horizontally. There are too many failed structures and the potential for future bank erosion and additional horizontal migration is too great for a simple repair. The stream channel in this location has eroded below a clay layer into a highly erosive sandy soil layer which will continue to create stability problems. The channel should be realigned with the appropriate pattern, dimension, and structures that will adequately transition from the higher elevation of the restoration to the receiving stream which is at a lower elevation. There is room on the right side of the existing alignment to be able to develop a new pattern that will provide the correct channel dimensions, grade control structures, and step pools needed to dissipate energy though this section of the reach. This action will stop the head cut from continuing upstream causing further damage to the restored channel. The majority of the materials needed for construction could be salvaged from the impaired reach.

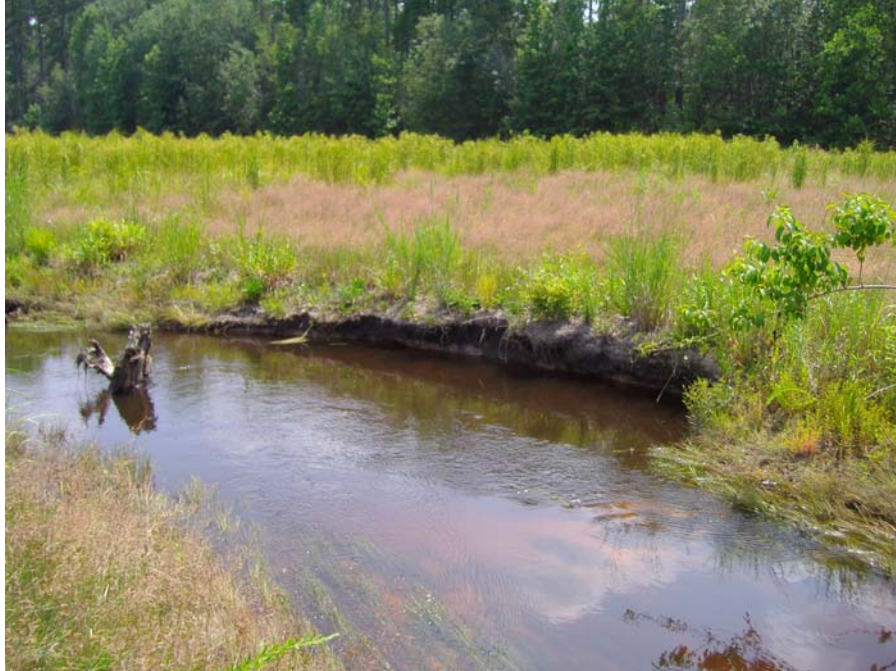
Minor erosion problem areas were found from station 0+00 to station 32+00 of the restoration reach (Photo 7). Erosion causes were attributed to failure at the root wad in some cases and shear stress in others. Shear stress is caused by high velocity flows towards the outside of the meander. The placement and/or installation of some root wads has caused scouring, along with bank erosion and migration from

Photo 7. Bank erosion developing around the meander bends at various locations of the project (7/4/07)

eddies that form around and behind the root wad structures (SPA Photo 8). The problem areas here can be fixed with simple hand grading of the banks and live stake planting around the toe of the structures. This will help stabilize the banks and limit the amount of erosion and degradation currently occurring. The hand grading should bring the banks back to a reasonable slope to the top of the banks or the berms on either side. These areas should be addressed to prevent additional erosion and migration from occurring. See Exhibit Table B1 and representative photos in Appendix B as well as the map in Appendix D for more information.

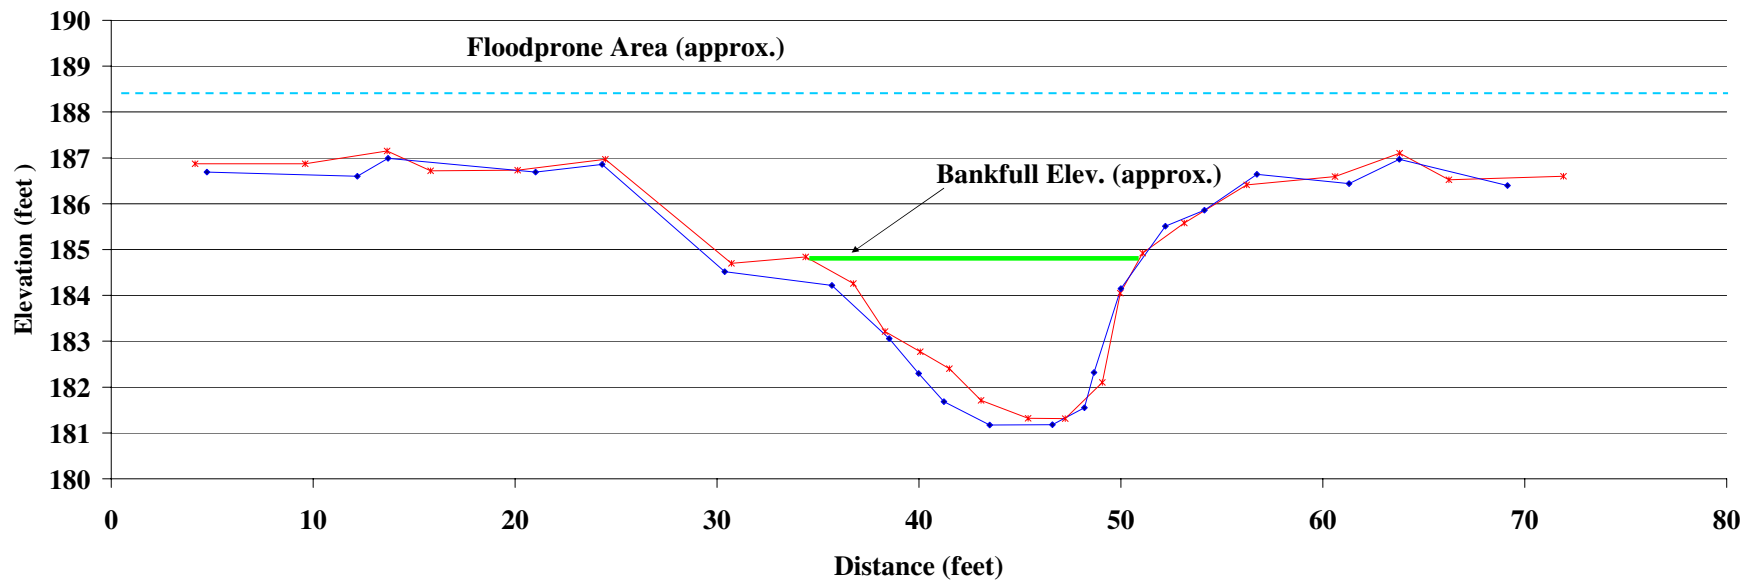
Photo of Cross-Section 7 - Looking Downstream @ STA 37+24

Year 5 - 2011	Year 4 - 2010	Year 3 - 2009	Year 2 - 2008	Year 1 - 2007	Baseline	Bench
Area					39.41	35.21	
Width					16.68	16.54	
Mean Depth					2.36	2.13	
Max Depth					3.67	3.53	
W/D					7.06	7.77

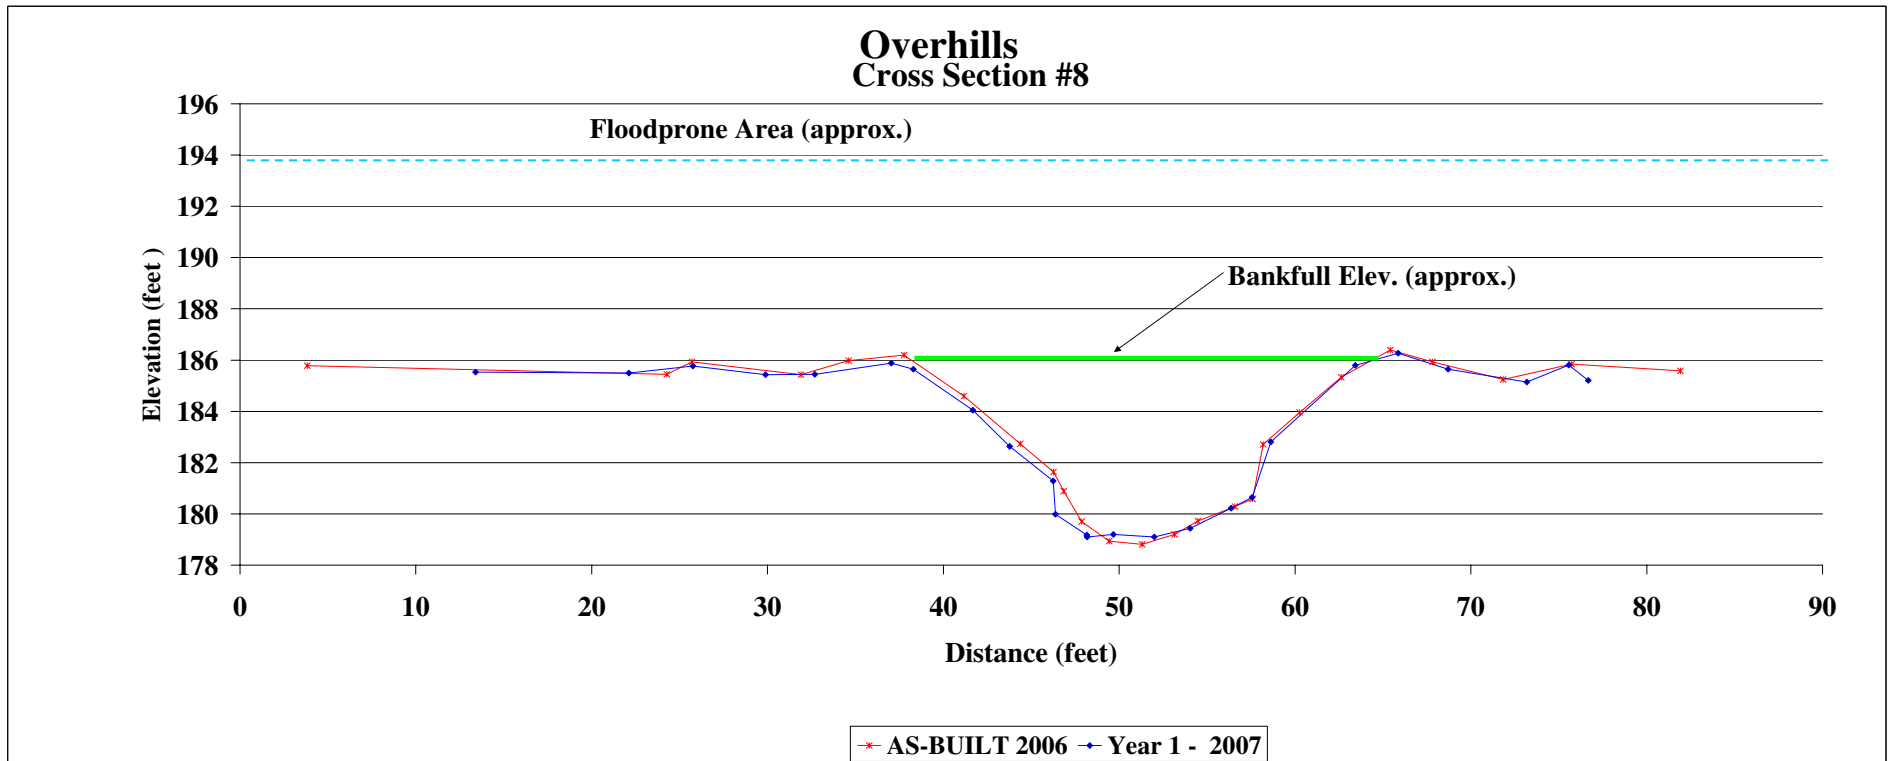
Photo of Cross-Section 8 - Looking Downstream @ STA 43+02							
	Year 5 - 2011	Year 4 - 2010	Year 3 - 2009	Year 2 - 2008	Year 1 - 2007	AS-BUILT 2006	Bench
Area					110.97	106.10	
Width					27.72	27.10	
Mean Depth					4.00	3.92	
Max Depth					7.09	7.38	
W/D					6.92	6.92
