OVERHILLS STREAM AND WETLAND RESTORATION MONITORING REPORT (YEAR 2 OF 5)

Harnett County, North Carolina
NCEEP Project Number 199

Status of Plan: Final
Submission Date: April 2009

Stantec Consulting Services Inc
801 Jones Franklin Road, Suite 300
Raleigh, NC 27606

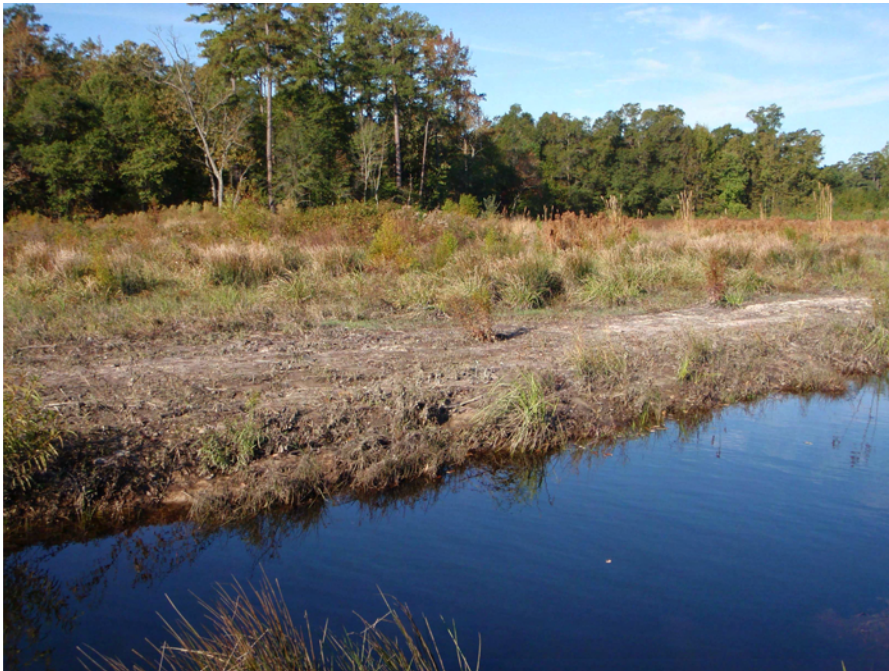
Minor problem areas such as bank scour and bare floodplains were found from Station 0+00 to Station 32+00 (Upper Reach) of the restoration reach (SPA Photo 4), but overall this area of the restoration appears to be stable (Appendix B.4, Photo 2). Normal water surface elevations are at or near the constructed bankfull, allowing the channel to access the floodplain under very small storm events, reducing shear stress in the channel. The areas immediately surrounding the channel were ponded near the channel banks. The beaver dam near Station 6+30 continues to cause problems such as scour and excessive sediment deposition. Minor scouring and sediment deposition was also observed around the two smaller beaver dams present at the time of the stream monitoring survey on August 12, 2008. The beaver dams were located at Stations 23+15 and 27+77. These are both shown on the longitudinal profiles and monitoring plan view; however, they were not present during the latest site visit in November of 2008. Significant storm events during the early fall most likely washed the dams downstream.

Photo 4. Bare floodplain and minor bank scour (10/23/2008).

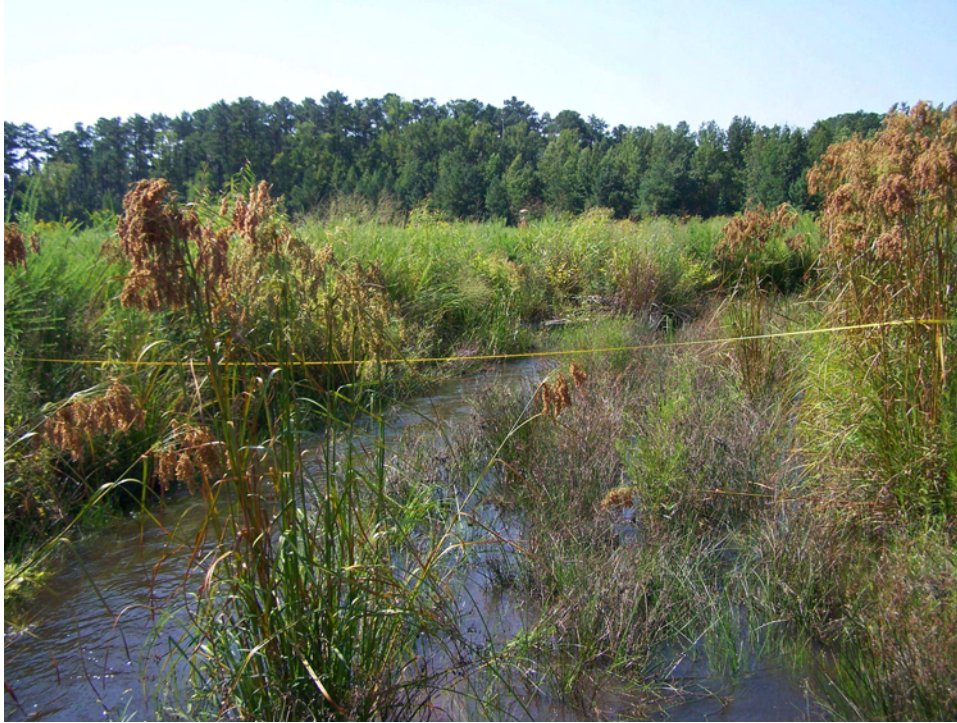
Photo 5. Mid-channel bar formation at Cross section 6 (8/12/2008).

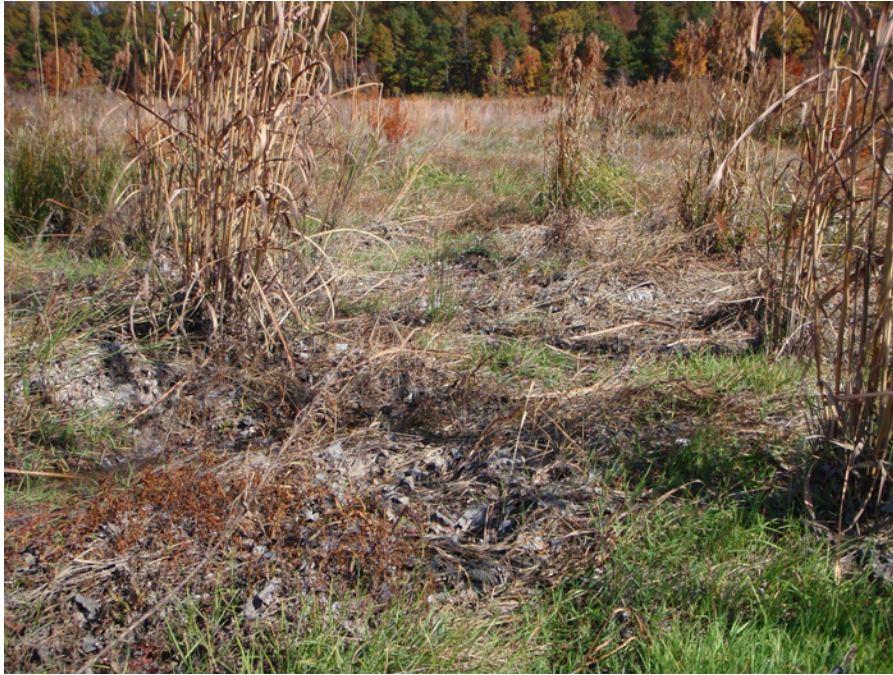
A crest gauge was found onsite during the February field visit and is believed to have been placed there prior to the Year 1 monitoring. However, no markings were found on the gauge and therefore cannot be used to verify bankfull events. Other evidence of bankfull events has been observed onsite during field reconnaissance. During a site visit in November of 2008, there was evidence of flooding as seen by flattened vegetation and sediment deposits on the floodplain near Vegetation Plot 3 (Appendix B.4, Photo 1). This likely occurred when Hurricane Hanna passed through the area on September 7, 2008.

Photo 1. Evidence of bankfull overflow near Vegetation Plot 3 (11/07/2008).

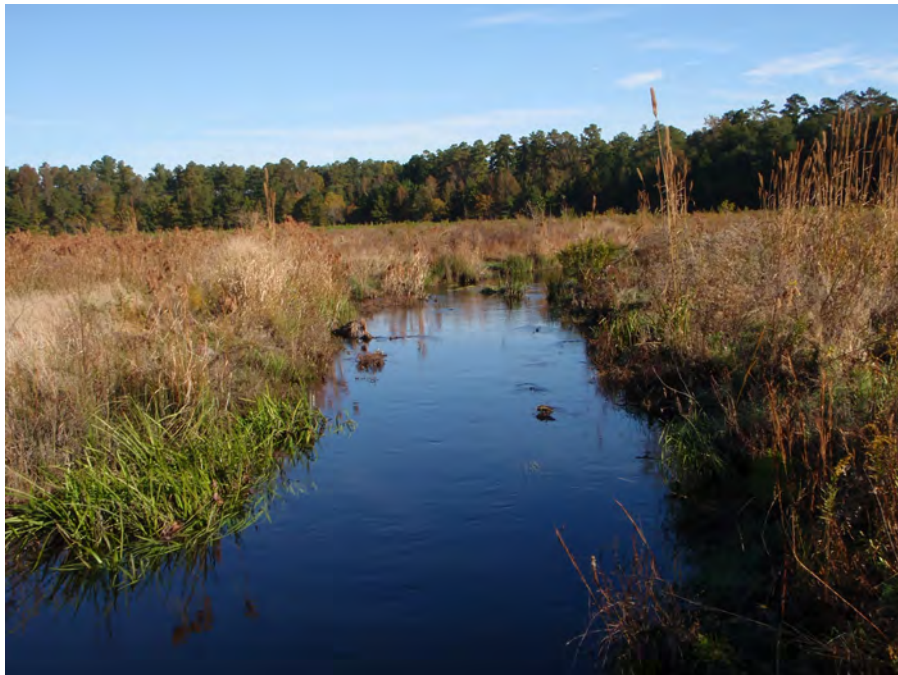
Photo 2. Typical example of the restored channel upstream of headcut area.
