OVERHILLS STREAM AND WETLAND
RESTORATION MONITORING REPORT (YEAR 5)

Harnett County, North Carolina

EEP Project No. 199

Status of Plan: Final
Submission Date: November 2011

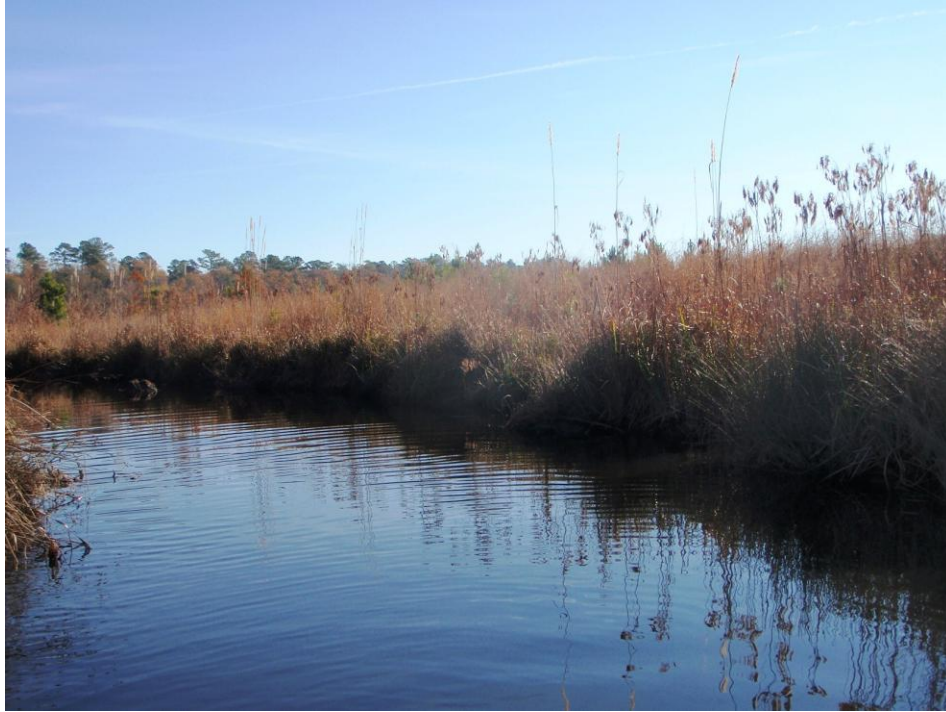
Photo Station 2 – Cross Section 1 – looking downstream (12/13/11)

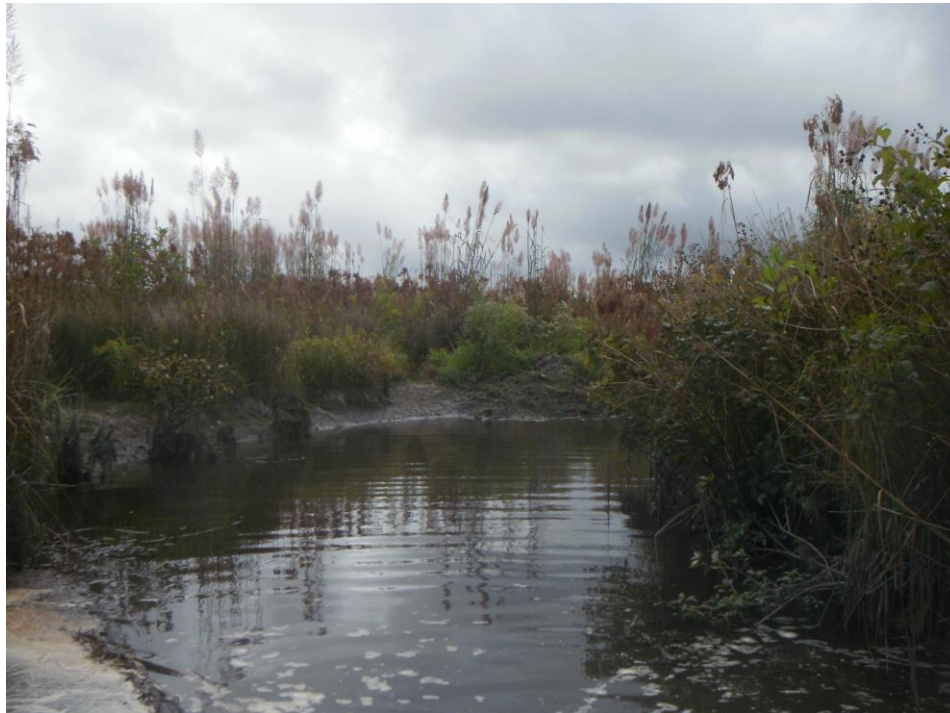
Photo Station 3 – Cross Section 2 – looking downstream (9/21/11)

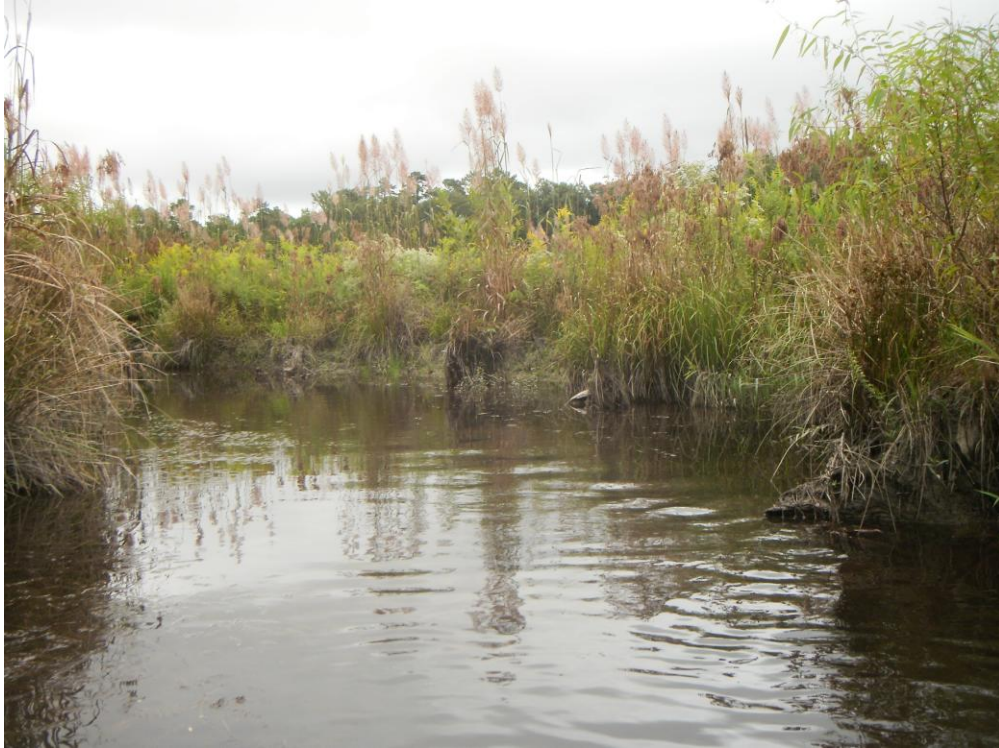
Photo Station 4 – Cross Section 3 – looking downstream (9/21/11)

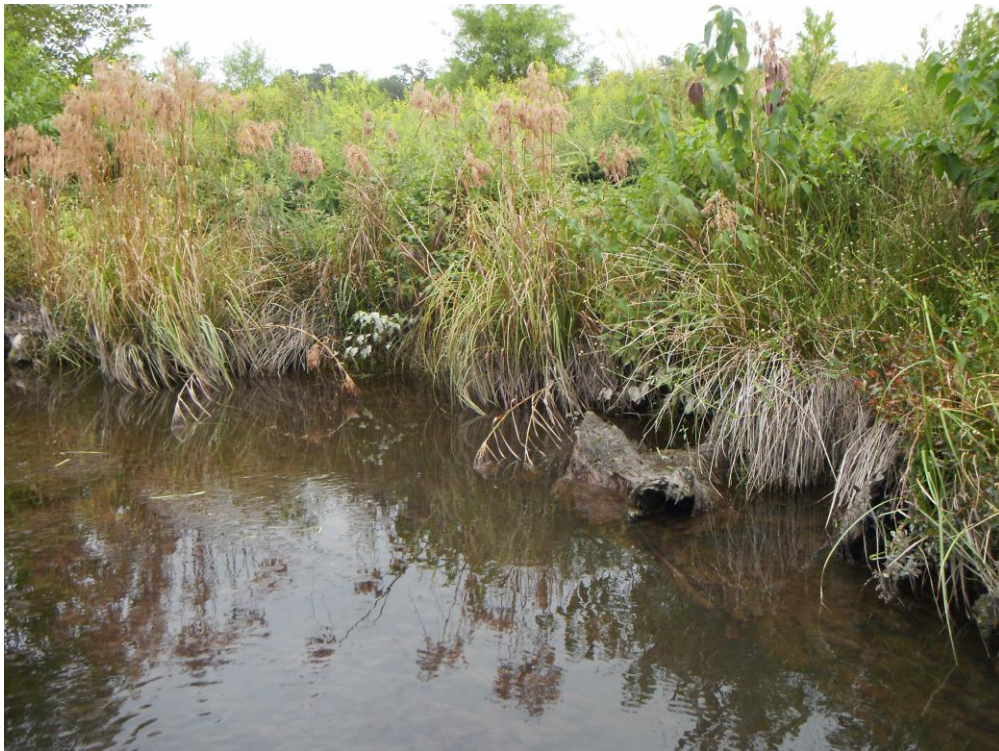
Photo Station 5 – Cross Section 4 – looking downstream (9/21/11)

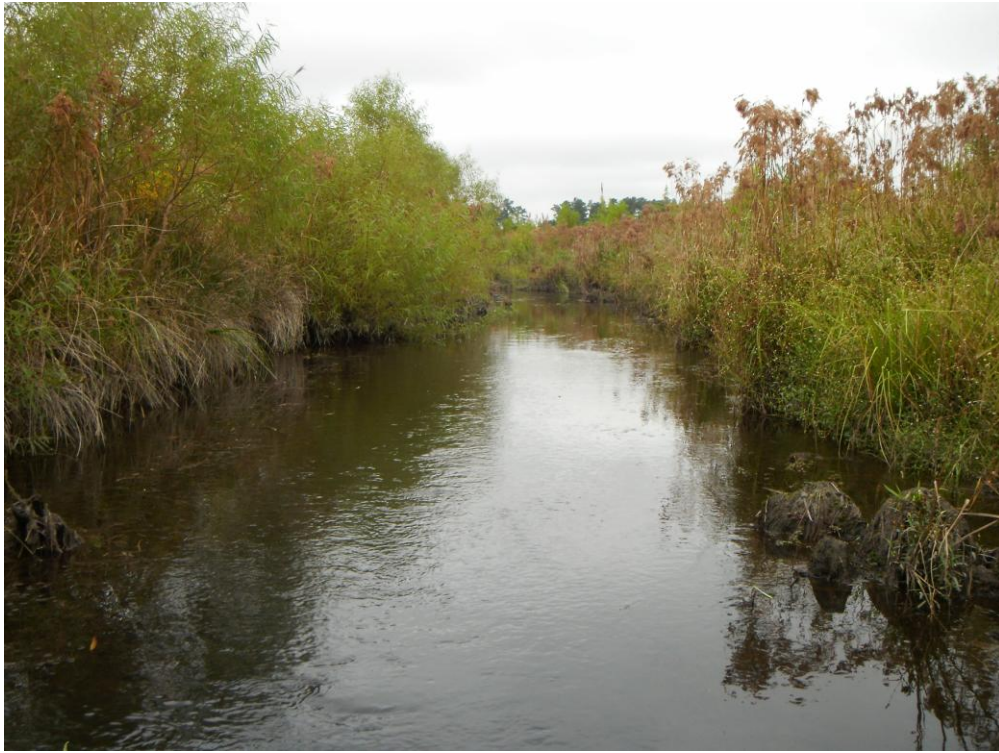
Photo Station 6 – Cross Section 5 – looking downstream (9/21/11)

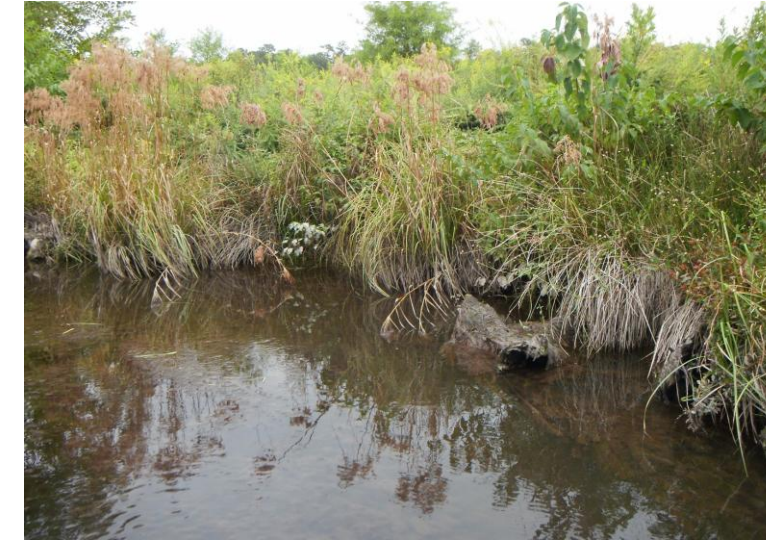
Photo of Cross-Section 4 - Looking Upstream @ STA 20+93

Year 5 - 2011	Year 4 - 2010	Year 3 - 2009	Year 2 - 2008	Year 1 - 2007	Baseline
BKF Area	64.16	65.77	66.54	64.86	59.60	49.19
BKF Width	24.06	22.40	23.39	23.11	22.25	23.19
BKF Mean Depth	2.67	2.94	2.84	2.81	2.68	2.12
BKF Max Depth	4.66	5.00	5.28	5.59	5.91	4.26
W/D	9.02	7.70	8.23	8.23	8.31	10.93

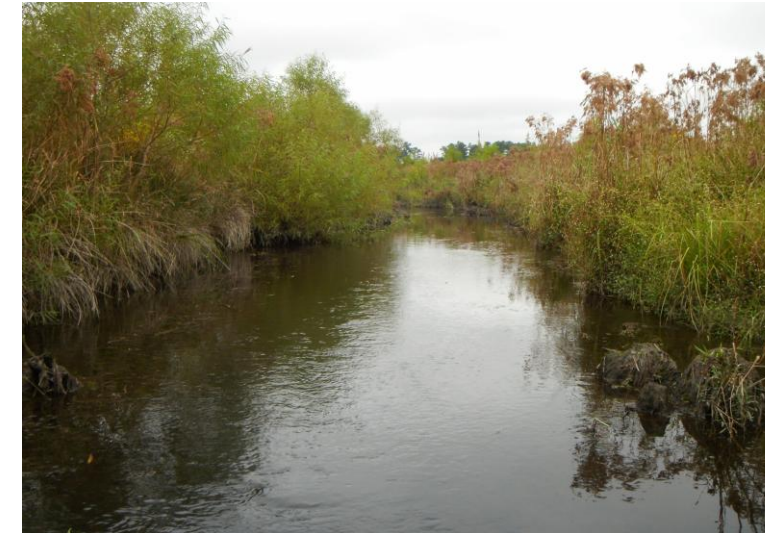
Photo of Cross-Section 5 - Looking Downstream @ STA 26+86

Year 5 - 2011	Year 4 - 2010	Year 3 - 2009	Year 2 - 2008	Year 1 - 2007	Baseline
BKF Area	37.99	39.37	39.36	44.36	40.91	37.70
BKF Width	26.08	24.30	24.41	24.63	24.50	24.16
BKF Mean Depth	1.46	1.62	1.61	1.80	1.67	1.56
BKF Max Depth	2.57	2.70	2.53	2.71	2.55	2.42
W/D	17.90	15.00	15.14	13.67	14.68	15.48

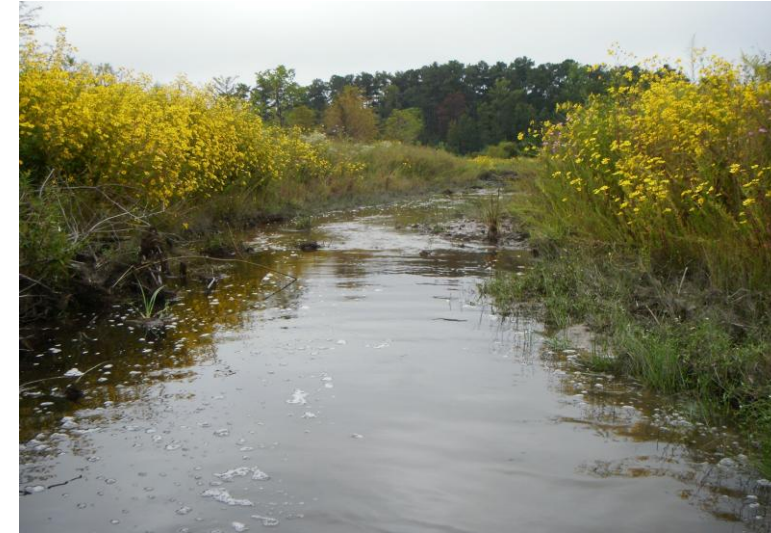
Photo of Cross-Section R1 - Looking Downstream @ STA 32+82

Year 6- 2012	Year 5 - 2011	Asbuilt - 2011			
BKF Area		44.50				
BKF Width		26.62				
BKF Mean Depth		1.67				
BKF Max Depth		2.65				
W/D		15.94

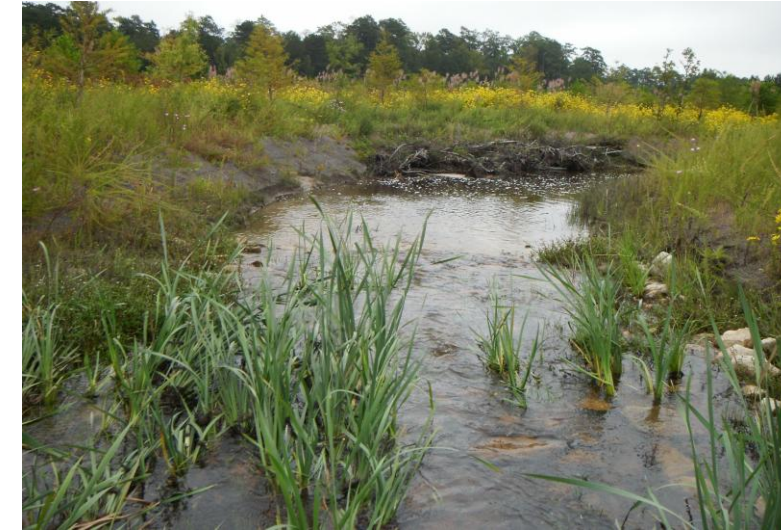
Photo of Cross-Section R2 - Looking Downstream @ STA 34+09

Year 6 - 2012	Year 5 - 2011	Baseline
BKF Area		43.02	
BKF Width		30.69	
BKF Mean Depth		1.40	
BKF Max Depth		2.90	
W/D		21.92
